สถิติการเกิดอุบัติเหตุในโรงไฟฟ้า
บริษัท ราชบุรีเพาเวอร์ จำกัด

| โรงไฟฟ้าบริษัท ราชบุรีเพาเวอร์ จำกัด | | RPCL Incident Inform | |
|---|--|---|---|
| Title: Concrete curb was damaged by oil tanker at fuel oil unloading. | | | |

| บริษัท ผลิตไฟฟ้าราชบุรีโฮลดิ้ง จำกัด | | RPCL Incident Inform | |
|---|--|---|--|
| Title: Water flow out from HP/IP FWP 20A barrel during pump overhaul work. | | | |

| โรงไฟฟ้าบริษัท ราชบุรีไฟฟ้า จำกัด | | RPCL Incident Inform | |
|--|--|---|--|
| Title: GT22 Control Oil Supply Diff. Pressure Switch A B Terminal Socket broken | | | |

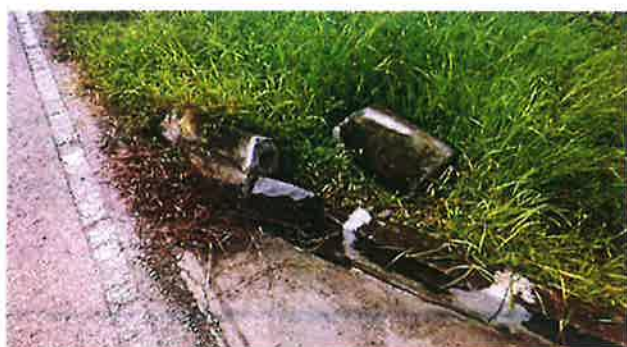
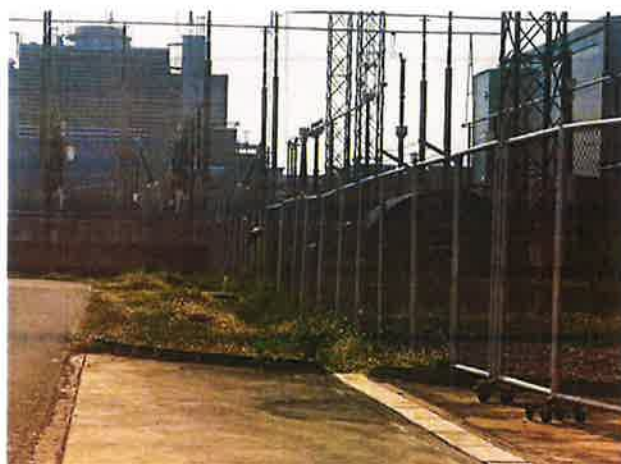
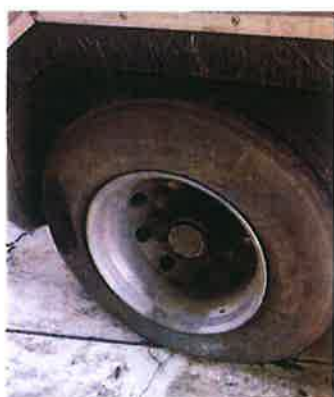
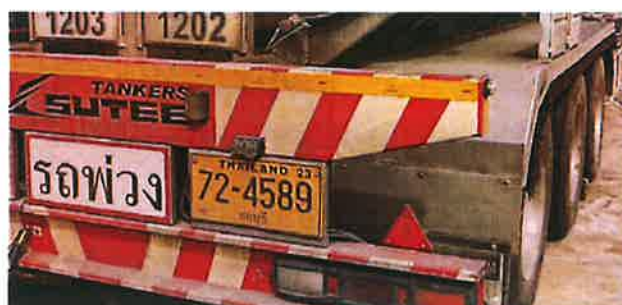
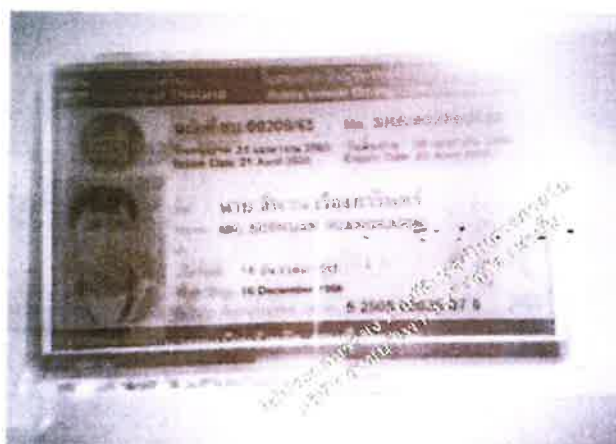
| On 19 May 2022, at 08.45 hrs. During the parking management to prepare the fuel Truck license plate no. 75-4580 Chon Buri (72-4589 Chon Buri, trailer's license plate) turned to right side to prepare to reverse into fuel oil unloading. At that time, the rear wheel of the trailer on the left side got stuck with concrete curb. Make the concrete curb and Tires of trailer damaged. After the incident asked the driver he inform vehicle that during the right turn. He did not see a concrete curb because Overgrown grass obscured the concrete curb. Makes he thinks that the rear of the truck can pass. | | |
| Root Cause (สาเหตุ) (Describe the cause and the counter measures proposed in/after the investigation) Truck driver can't see concrete curb clearly. | | |

| Painting the concrete curb with Black and white | Responsible by Paveen | Date 24/06/22 |
| Install poles to show the curb line complying with arrangements for safe parking of oil tankers. | Responsible by Paveen | Date 24/06/22 |
| Road Marking Paint for truck parking during diesel unloading | Responsible by Paveen | Date 24/06/22 |

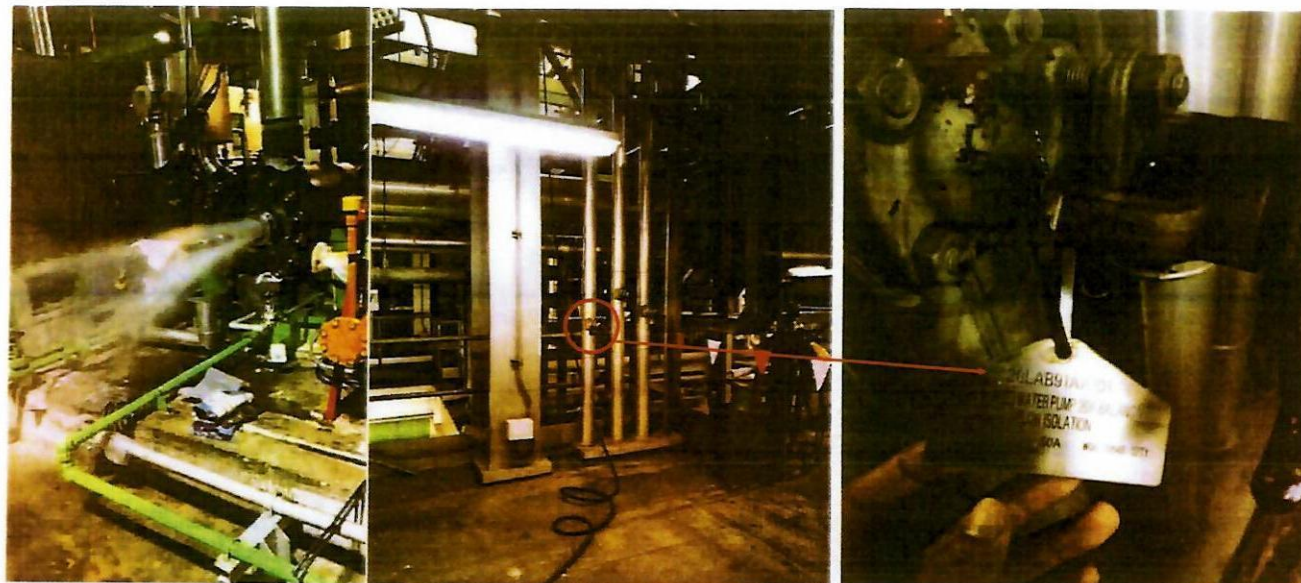
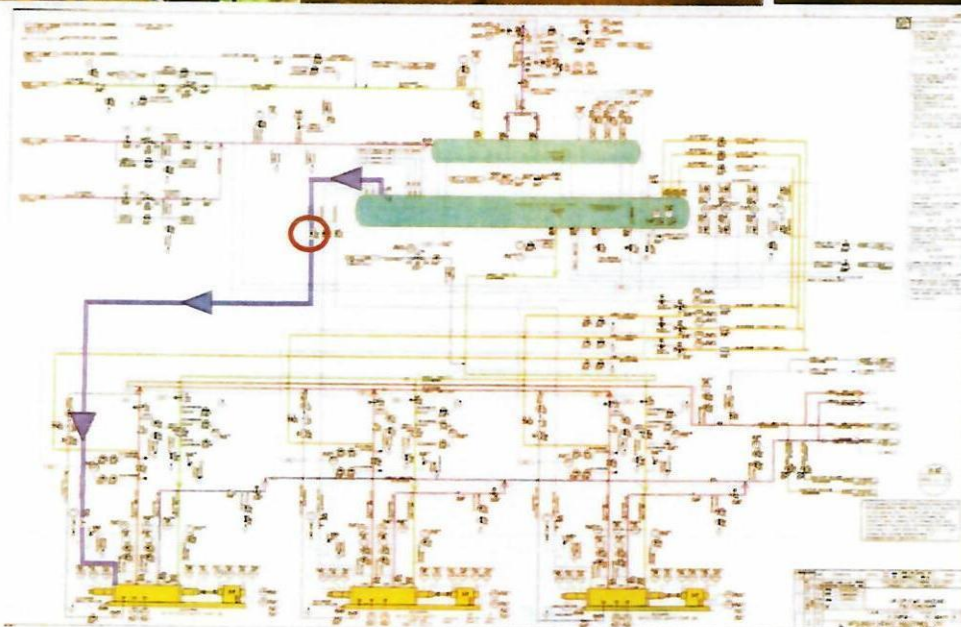
Incident Image

| After Operator filled the water in the Pre-heater coil HRSG21&22 completed. Operator has been checked that all LP&HP/IP-FWPs. Suction motor operate valve was closed with LOTO Tag already After that Operator start CEP to fill the water to the Deaerator Storage Tank for manhole leakage check. While deaerator storage tank level almost full, it was found that water came out from casing HP/IP-FWP 20A continuously. Therefore, the filling was stopped and the water drained from the Deaerator immediately. | | |
| Root Cause (สาเหตุ) (Describe the cause and the counter measures proposed in/after the investigation) When filled Deaerator complete. Water from Deaerator flow back to HP/IP FWP20A through HP/IP Feed Water Pump 20A Balancing flow isolation valve.(20LAB91AA101) | | |

| Mark up Deaerator storage tank upper manhole position at Level indicator (Sight glass) and compare with Level transmitter at DCS (55 mm) | Responsible by | Operator Date 18/1/2022 |
| Additional 6 block valves X0LAB91AA101, AA102, AA103, AA021, AA022, AA023 | Responsible by | Operator Date 18/1/2022 |

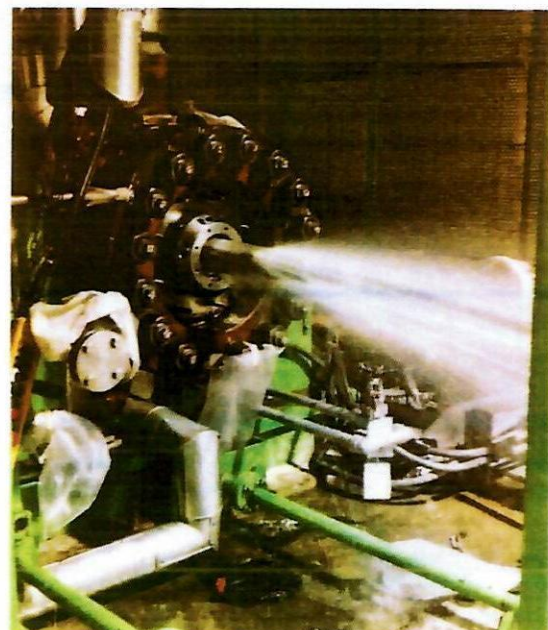
While BMD assembly HP/IP Feed
water pump 20A found air and water
came out from gap between shaft
NDE side.

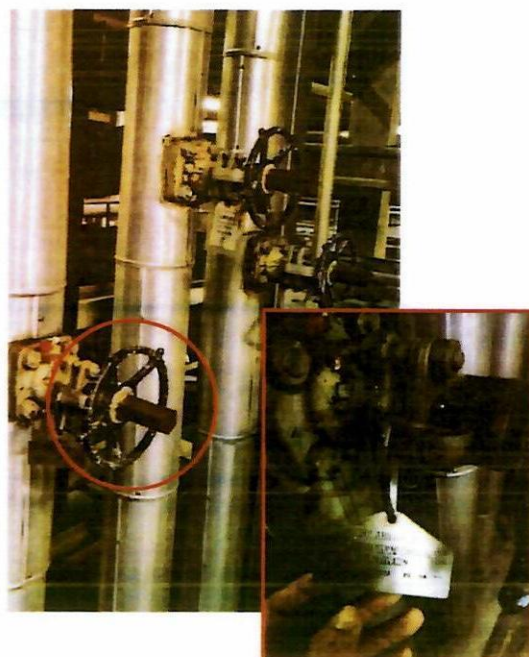
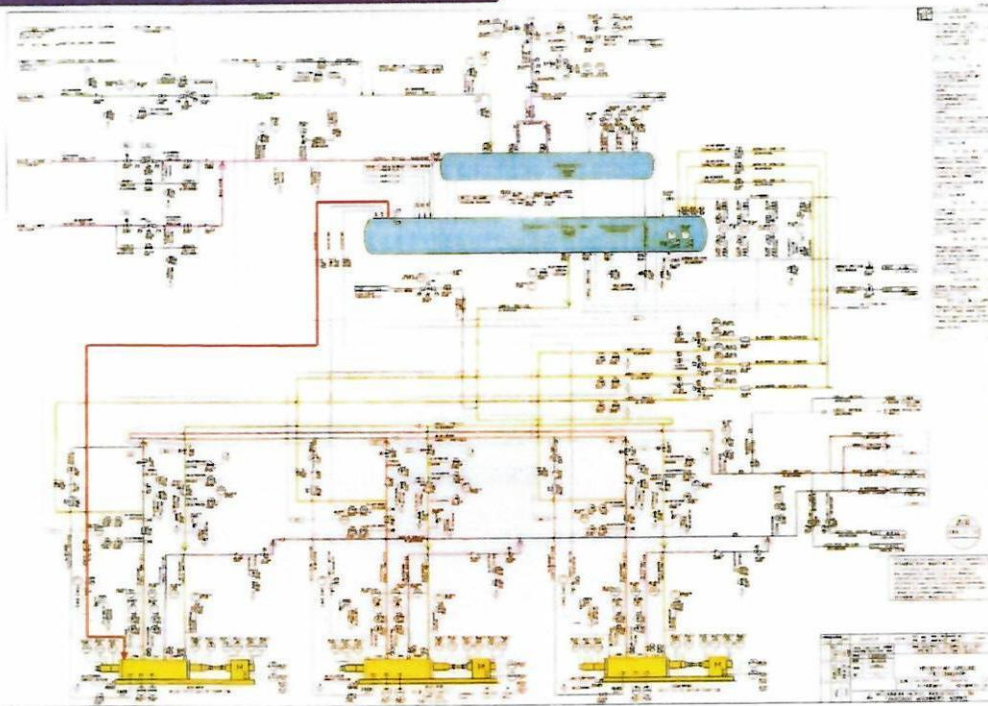
- Water level in Deaerator Storage Tank too high and overflow pass through Balancing Flow Isolation Valve.
- Balancing Flow Isolation Valve was open

- Add to close Balancing Flow Isolation Valve (KKS=x0LAB91AA101,102,103) to safety plan for overhaul HP/IP FWP

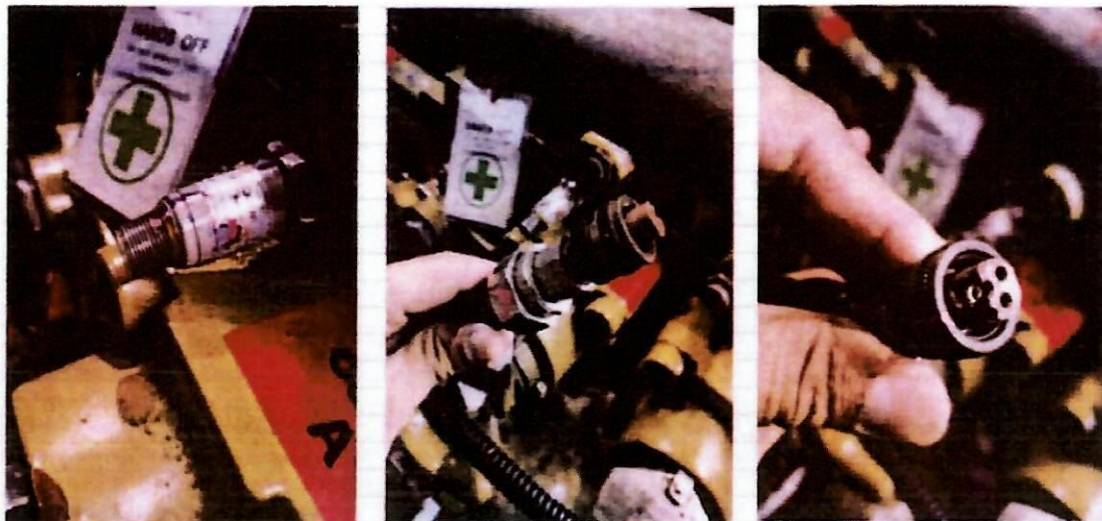
Diff Pressure Switch A

| โรงไฟฟ้าบริษัท ราชบุรีไฟฟ้า จำกัด | | RPCL Incident Inform | |
|--|--|---|--|
| 8.30 hrs EGAT EMD staff found the GT22 Control Oil Supply Diff. Pressure Switch Terminal Socket broken. 8.40 hrs They found some pipe of scaffolding located very close to the damage point. 8.44 hrs Inform Inspector. Event found by (ผู้พบเหตุการณ์)...Rewat Ruenrawat... Party (หน่วยงาน) ...EMD... Tel. | | | |

| Describe the details of investigation including when,what, how, where etc. (อธิบายรายละเอียดการสอบสวนฯ) According to more parties have a work at Control Oil Skid GT22 area . EGAT team have the internal meeting which work group for face finding. They found that the subcontractor of motor , they have some activity for lifting and movement the control motor but some pipe scaffolding oil pump of obstruct them job. They movement and relocate the pipe by themselves but the locking couplers between horizontal pipe and vertical pipe was not proper. It is a possible cause for horizontal pipe sliding down and hit to the Diff. Pressure Switch if somebody stand on the pipe. | | | |

| โรงไฟฟ้าบริษัท ราชบุรีไฟฟ้า จำกัด | | RPCL Incident Inform | |
|--|--|---|--|
| 1) Purchase the new pressure switches to replace the damaged one. (New PS will receive on June 2022) 2) Review Risk assessment for working at control skid area. SAR was issued and Project manager will warning vendor in every safety training. | | | |
