**INSPECTION REPORT  
FOR  
S&L SPECIALTY POLYMERS CO., LTD.**

**VISUAL EXAMINATION  
FOR  
LINE CHLORINE GAS**

**INSPECTION DATE  
4 - 7 April 2022**

<b>PROJECT :</b>	Pipeline Inspection	<b>DATE:</b>	4 - 7 April 2022
<b>CLIENT :</b>	S&L SPECIALTY POLYMERS CO., LTD.	<b>LOCATION:</b>	Rayong
<b>WELDER No.:</b>	N/A	<b>WELDING PROCCE:</b>	N/A
<b>NDE METHOD:</b>	Visual inspection	<b>REFERENCE CODE :</b>	API 570

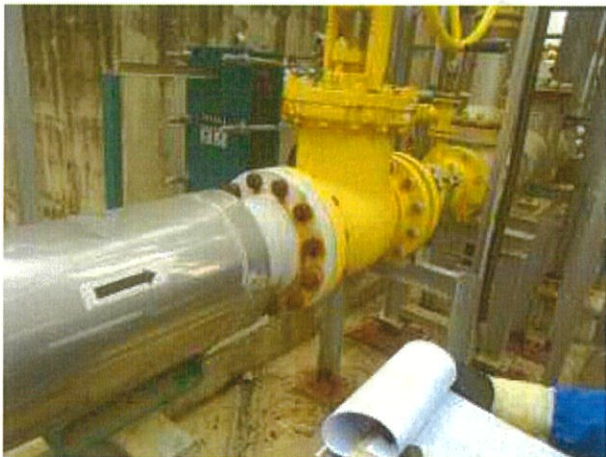
Item	Picture	Description
1

<p><b>For Visual Overview</b> <b>Date : 4 - 7 April 2022</b></p> <p>Bolts were light surface rust only, did not found rust scale due to corrosion. (General corrosion on bolts and nuts).</p>
2

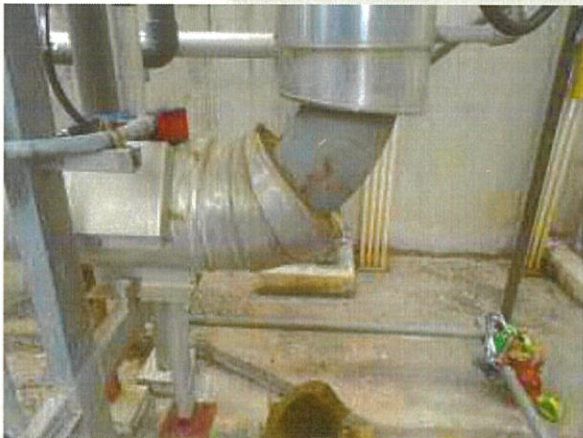
<p><b>For Visual ( CUI )</b> <b>Date : 4 - 7 April 2022</b></p> <p>On the local Open insulation Elbow was good surface condition of piping under insulation. No visible rust from visual inspection on this area.</p>
3

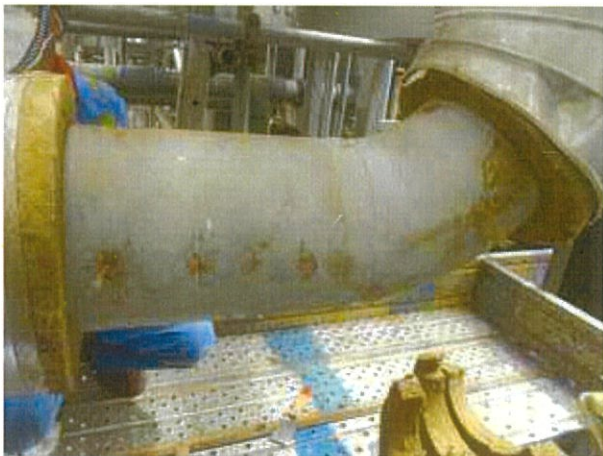
<p><b>For Visual ( CUI )</b> <b>Date : 4 - 7 April 2022</b></p> <p>On the local Open insulation Elbow and straight pipe were good surface condition of piping under insulation. No visible rust from visual inspection on this area.</p>

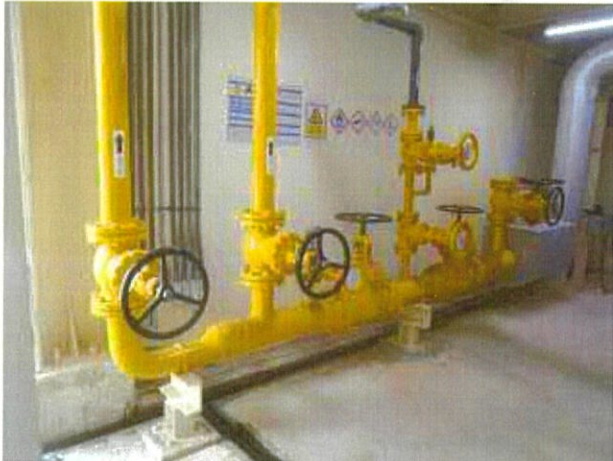
Item	Picture	Description
7

<p>For Visual External Date : 4 - 7 April 2022</p> <p>Good surface condition.</p> <p>Joint connection of piping system. No leak.</p>
8

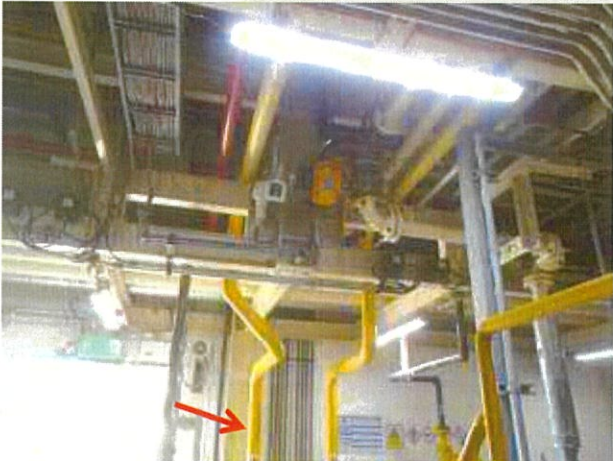
<p>For Visual External Date : 4 - 7 April 2022</p> <p>Good surface condition.</p>
9

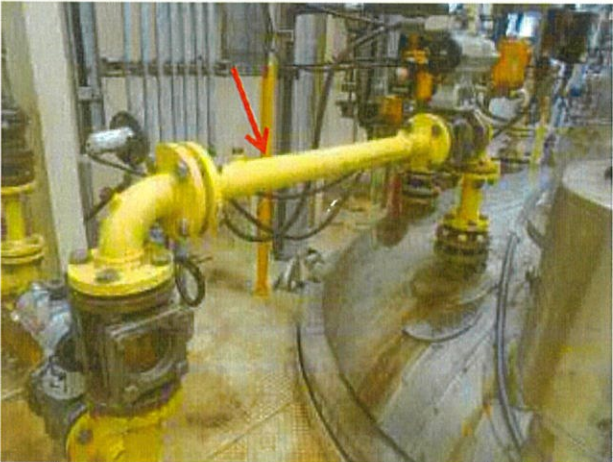
<p>For Visual External ( Painting/Coating ) Date : 4 - 7 April 2022</p> <p>Good surface condition.</p> <p>Joint connection of piping system. No leak.</p>
