รายงานการตรวจสอบสภาพและความหนาของระบบท่อ

PIPING INSPECTION SUMMARY REPORT

Report/ Project	Sheet
			2112012	S 1/1
STT-CC-001-02-01 (TRL 001 G-Base 95 Tank Receiving line (Jetty to Tank No.1,2,3))				
Date of inspections: 24 December 2021

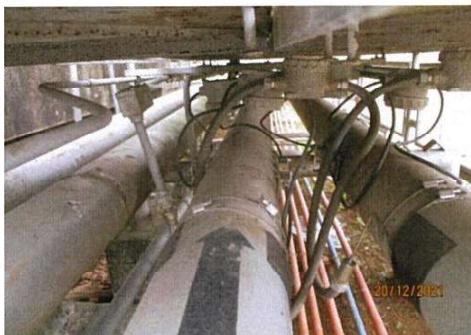
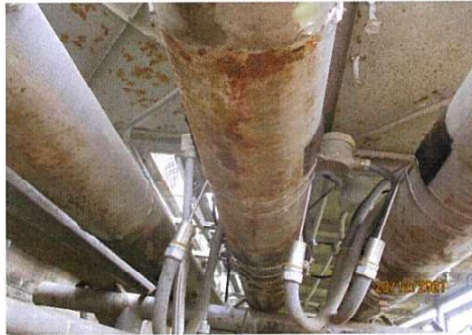
Name of part / Location		Findings		Name of part / Location		Findings	
TRL 001 Tank Receiving line (Jetty to Tank No.3,10) Anomaly no : 2.1		Painting deterioration and general corrosion on pipe		TRL 001 Tank Receiving line (Jetty to Tank No.3,10) Anomaly no : 2.1		Painting deterioration and general corrosion on pipe

Recommendations
Visual Inspection (VT) - Recommendation to arrest corrosion by sufficient surface preparation (blasting preferred) and application of coating following approved procedures within 6 months.
Ultrasonic Thickness Measurement (UTM) - Thickness monitoring should be performed at next 5 yrs interval.

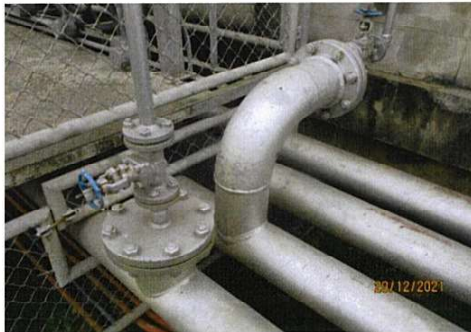
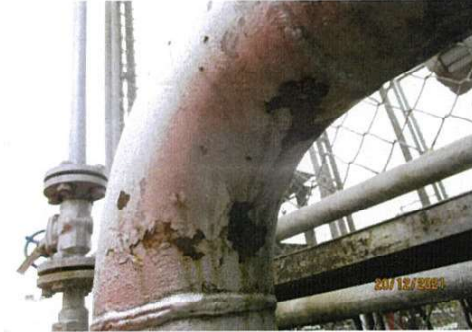
Name of part / Location		Findings		Name of part / Location		Findings	
TRL 001 Tank Receiving line (Jetty to Tank No.3,10) Anomaly no : 2.2		Painting deterioration and general corrosion on elbow		TRL 001 Tank Receiving line (Jetty to Tank No.3,10) Anomaly no : 2.2		Painting deterioration and general corrosion on elbow

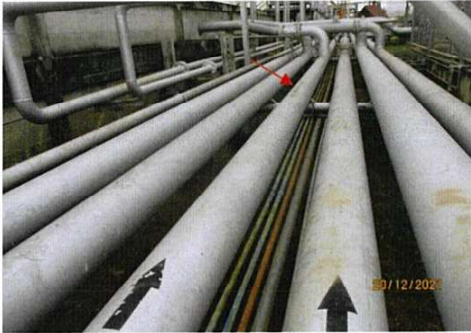
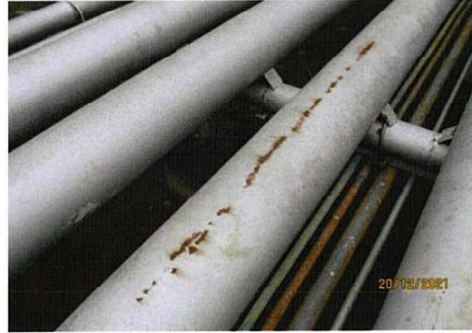
TRL 001 Tank Receiving line (Jetty to Tank No.3,10) Anomaity no : 2.3		Painting deterioration and general corrosion on pipe		TRL 001 Tank Receiving line (Jetty to Tank No.3,10) Anomaly no : 2.3		Painting deterioration and general corrosion on pipe
