PIPING INSPECTION PICTURE LOG

Report/ Project	Sheet
						2112012	PL 1/7
TRL 002 G-Base 91 Tank Receiving line (Jetty to Tank No.9&Tank No.2)

Report/ Project		Sheet				
						2112012		UTM 1/8				
STT-CC-001-03-01_Gbase 91												
CML	Size	Type	Direction	Nom. (Thk) 1-Jan-95 (mm)	Min Required (mm)	UTM date 6-Dec-16 (mm)	UTM date 16-Dec-21 (mm)	UTM date (mm)	Short term corrosion Rate (mm)/yr	Long term corrosion Rate (mm)/yr	Short term remaining life (yr)	Long term remaining life (yr)
1A	6"	Elbow	0°	7.11	2.80	6.57	7.31		-0.147	-0.007	No Corrosion	No Corrosion
			90°			6.98	7.51		-0.105	-0.015	No Corrosion	No Corrosion
			180°			6.47	7.37		-0.179	-0.010	No Corrosion	No Corrosion
			270°			6.99	7.86		-0.173	-0.028	No Corrosion	No Corrosion
1B	6"	Elbow	0°	7.11	2.80	6.42	6.96		-0.107	0.006	No Corrosion	748.12
			90°			6.95	7.51		-0.111	-0.015	No Corrosion	No Corrosion
			180°			7.08	7.41		-0.066	-0.011	No Corrosion	No Corrosion
			270°			6.76	7.44		-0.135	-0.012	No Corrosion	No Corrosion
1C	6"	Elbow	0°	7.11	2.80	6.64	7.17		-0.105	-0.002	No Corrosion	No Corrosion

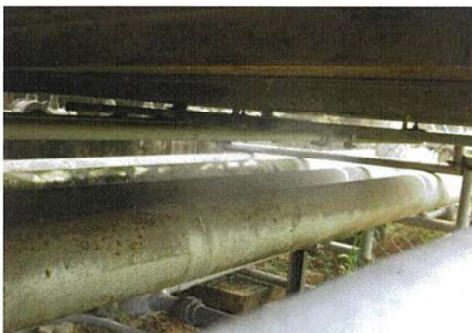
Name of part / Location		Findings	Name of part / Location		Findings
TRL 002 G-Base 91 Tank Receiving line (Jetty to Tank No.9&Tank No.2)		Slight corrosion on piping&Painting deterioration (1)	TRL 002 G-Base 91 Tank Receiving line (Jetty to Tank No.9&Tank No.2)		Still in normal condition

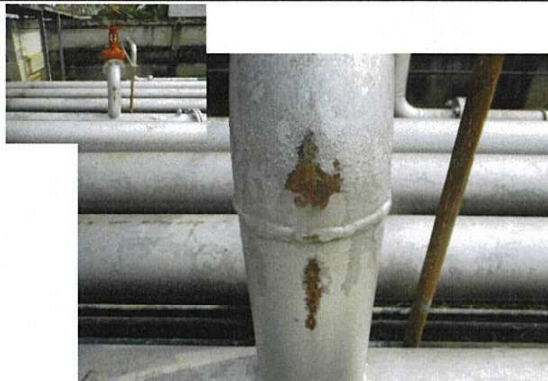
Name of part / Location		Findings	Name of part / Location		Findings
TRL 002 G-Base 91 Tank Receiving line (Jetty to Tank No.9&Tank No.2)		Still in normal condition	TRL 002 G-Base 91 Tank Receiving line (Jetty to Tank No.9&Tank No.2)		Painting deterioration (2)

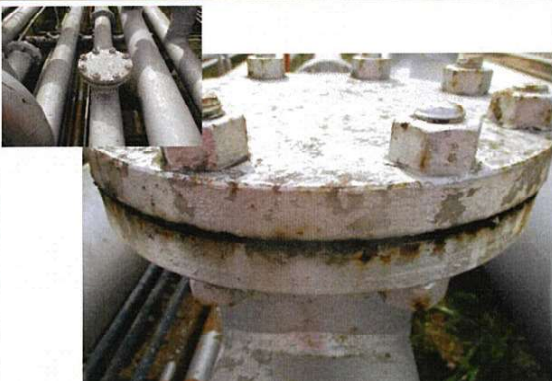
Name of part / Location		Findings	
TRL 002 G-Base 91 Tank Receiving line (Jetty to Tank No.9&Tank No.2)		Slight corrosion on flange (3)		TRL 002 G-Base 91 Tank Receiving line (Jetty to Tank No.9&Tank No.2)		Painting deterioration (4)

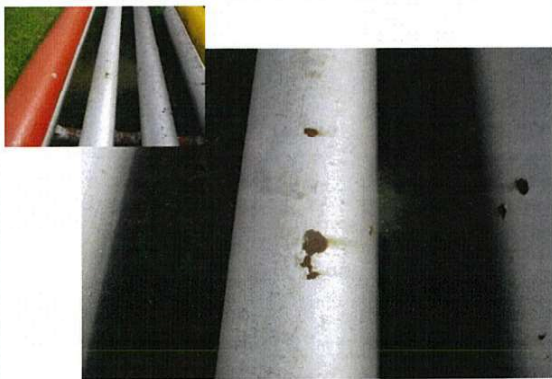
Name of part / Location		Findings	
TRL 002 G-Base 91 Tank Receiving line (Jetty to Tank No.9&Tank No.2)		Painting deterioration (5)		TRL 002 G-Base 91 Tank Receiving line (Jetty to Tank No.9&Tank No.2)		Painting deterioration (6)

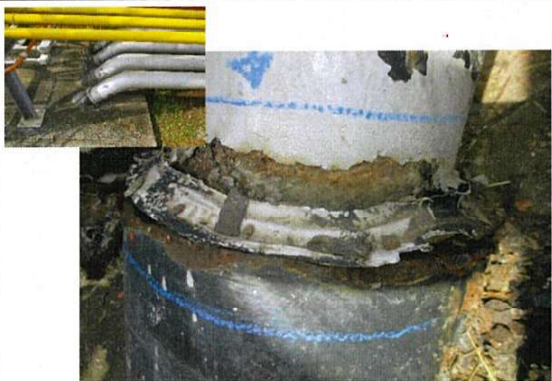
Name of part / Location		Findings	
TRL 002 G-Base 91 Tank Receiving line (Jetty to Tank No.9&Tank No.2)		Severe corrosion under sealing&Sealing damage. (7)		TRL 002 G-Base 91 Tank Receiving line (Jetty to Tank No.9&Tank No.2)		Still in normal condition

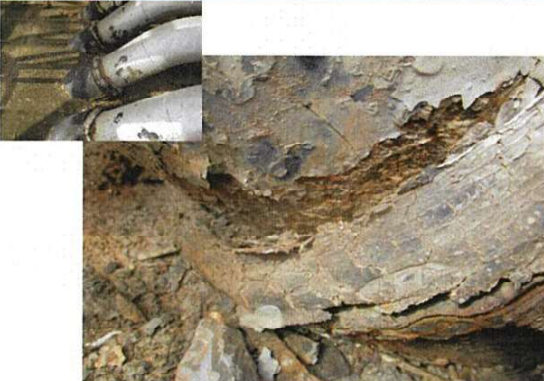
Name of part / Location		Findings		Name of part / Location		Findings	
TRL 002 G-Base 91 Tank Receiving line (Jetty to Tank No.9&Tank No.2)		Severe corrosion under pipe sleeve & Sealing damage. (8)		TRL 002 G-Base 91 Tank Receiving line (Jetty to Tank No.9&Tank No.2)		Still in normal condition

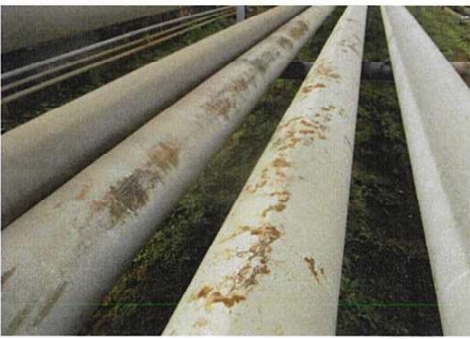
Name of part / Location		Findings		Name of part / Location		Findings	
TRL 002 G-Base 91 Tank Receiving line (Jetty to Tank No.9&Tank No.2)		Still in normal condition		TRL 002 G-Base 91 Tank Receiving line (Jetty to Tank No.9&Tank No.2)		Painting deterioration (9)

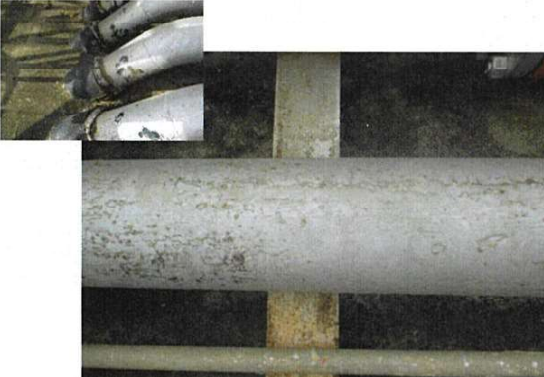
Name of part / Location		Findings		Name of part / Location		Findings	
TRL 002 G-Base 91 Tank Receiving line (Jetty to Tank No.9)		Painting deterioration (10)		TRL 002 G-Base 91 Tank Receiving line (Jetty to Tank No.9)		Painting deterioration (11)

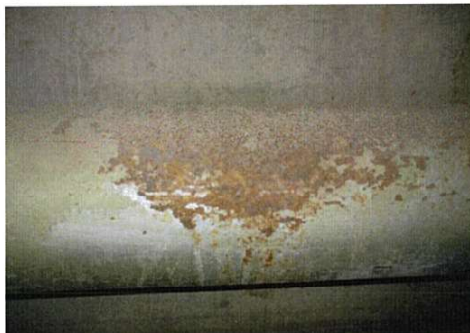
Name of part / Location		Findings	Name of part / Location		Findings
TRL 002 G-Base 91 Tank Receiving line (Jetty to Tank No.9&Tank No.2)		Slight corrosion on pipe. (15)	TRL 002 G-Base 91 Tank Receiving line (Jetty to Tank No.9&Tank No.2)		Still in normal condition

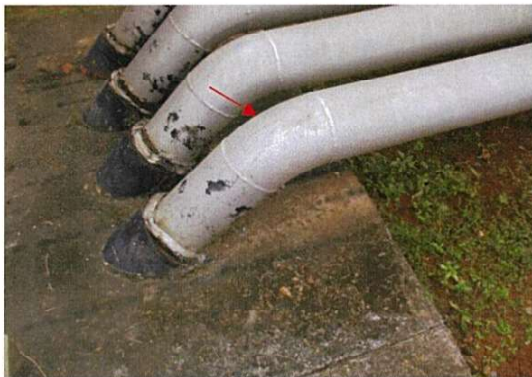
1. Sealing sleeve underground pipe was found degradation, damage and corrosion under sleeve underground pipe.
Approximate corrosion depth 1.5 mm. (as mark)
2. Sealing sleeve underground pipe was found degradation, damage and corrosion under sleeve underground pipe.
Approximate corrosion depth 1 mm. (as mark)

Name of part / Location	Findings	Name of part / Location	Findings	
TRL 003 Diesel Tank Receiving Line (Jetty to Tank No.6,8)	Sealing sleeve underground pipe was found degradation, damage and corrosion under sleeve underground pipe.	TRL 003 Diesel Tank Receiving Line (Jetty to Tank No.6,8)	Sealing sleeve underground pipe was found degradation, damage and corrosion under sleeve underground pipe.

- Carry out alternative NDE (CUS) to determine condition within 2 months., Then re-painting as per original design to prevention future corrosion.

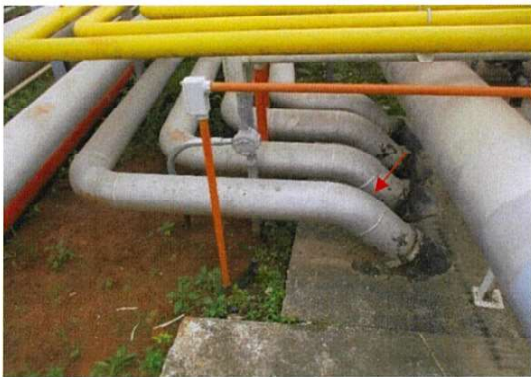
Name of part / Location	Findings	Name of part / Location	Findings	
TRL 003 Diesel Tank Receiving Line (Jetty to Tank No.6,8)	Sealing sleeve underground pipe was found degradation, damage and corrosion under sleeve underground pipe.	TRL 003 Diesel Tank Receiving Line (Jetty to Tank No.6,8)	Sealing sleeve underground pipe was found degradation, damage and corrosion under sleeve underground pipe.
