ภาคผนวก 8

การตรวจสภาพอุปกรณ์ป้องกันอันตรายส่วนบุคคล
เครื่องมือ เครื่องจักร และเครื่องยนต์

Doc. No.: PP4-HS-REP-0006 (Reporting Period: 26 Feb.2022 ~ 25 Mar.2022)	Rev. 0

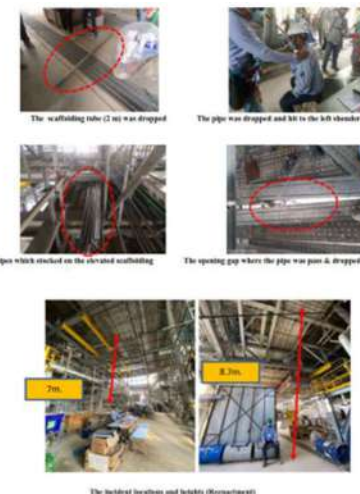
Sungdo's Piping Supervisor was standing at temporary desk, he was checking the drawing and suddenly one of scaffolding pipe, 2m length hit his left shoulder and broken the left collarbone (X-ray result- Restricted Work Case), he was visited doctor in BKK Rayong hospital and back to stay at home, no necessary operation. At the same time, another scaffolding pipe same size and length hit another one, DYR, not major injury (First Aid Case).

- The Western and Eastern entrances of Extrusion are closed to prevent and reduce the pedestrians' access to Extrusion building unnecessarily
- Removed chairs and tables have been removed
- Safety netting at East-South side of Extrusion ground level has been applied
- Housekeeping has been being carried out for elevated level
- Continue to housekeeping at elevated level and scaffolding platforms by Jan 24, 2022
- Pedestrian safe Access way with Scaffolding Roof is provided at Southern access way of Extrusion Building
- Site walk through for fall object prevention has been done with HMC Management, related subcontractor management and GS construction team Jan 25, 2022

- Review safety protection, all in construction area
- Strictly Supervision / controllable are effectiveness
- Provide focal point to manage construction activities
- All construction supervisor are involvement at site
- Not allow, modification the scaffolding without re-inspection and reapproval
- Provide safety net below unsafe area
- Follow Safety Regulations

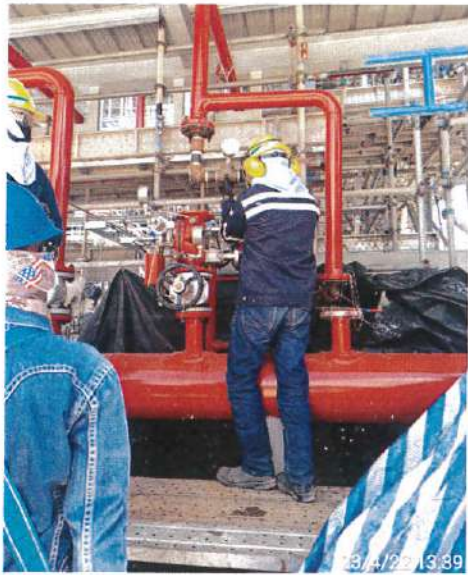
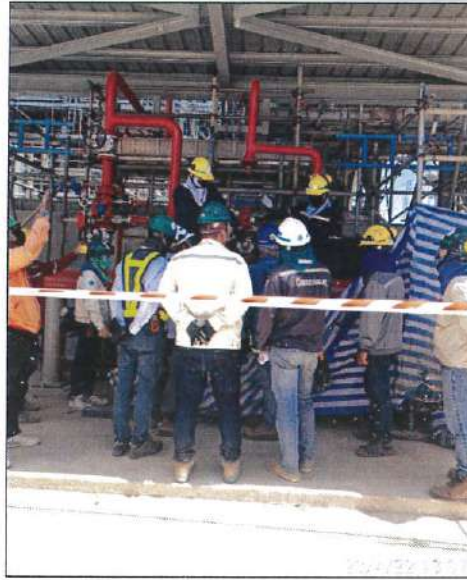
1. First Investigation on 23rd April 2022, at site with HMC
 - Temporary air blowout spool was disconnected since the connection was not strong enough to endure the air blowing pressure (4~ 5 bars)
 - There was no hand rail on the platform where the injured person stood on

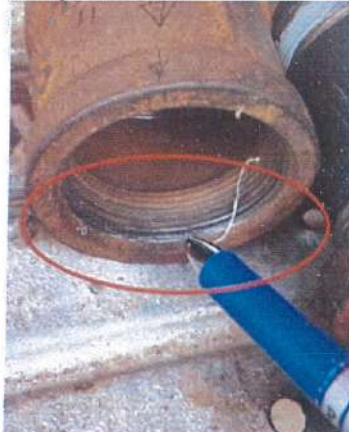
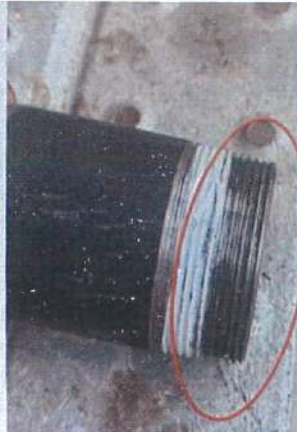
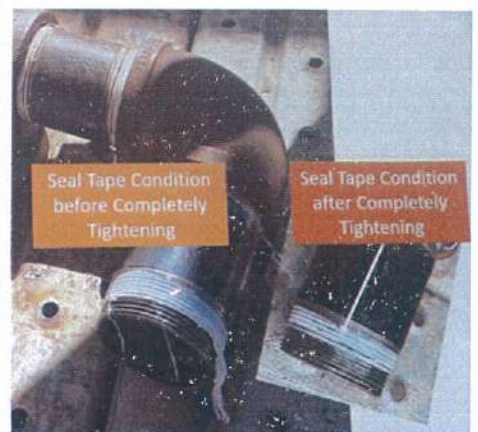
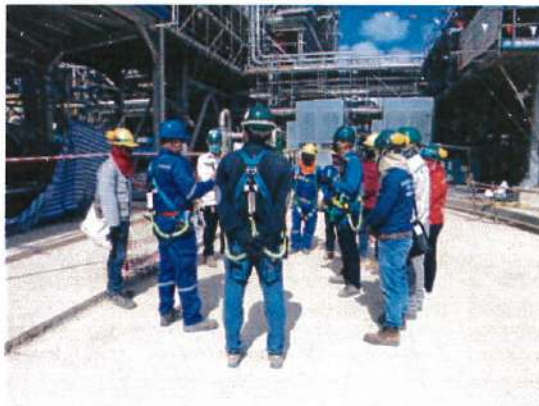
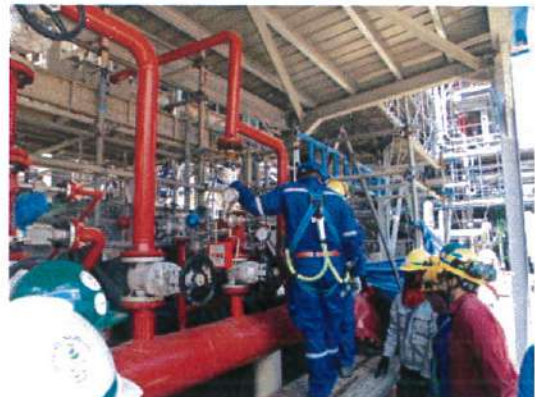
2. Second Investigation on 24th April 2022, at site with HMC

- The seal tape condition at the detached part was found worn thread and the tightening of the pipe was only 50% of full threads.
- After the full tightening of the pipe by Pipe wrench all threads were able to be inserted to the socket pipe
- The investigation team infers that the worker tightened the temporary spool with hand, not using a wrench.
