รายงานการตรวจสอบอาคารทำเทียบเรือสินค้า

ทำเทียบเรือหมายเลข BI-1, BI-2, BI-3 และ MBM

โรงกลั่นน้ำมันเอสโซ่ ศรีราชา

รายงานผลการตรวจสอบอาคารตามมาตรา 32 ทวิ
อาคารทำเทียบเรือสินค้าขนาดมากกว่า 500 ตันกรอสต์

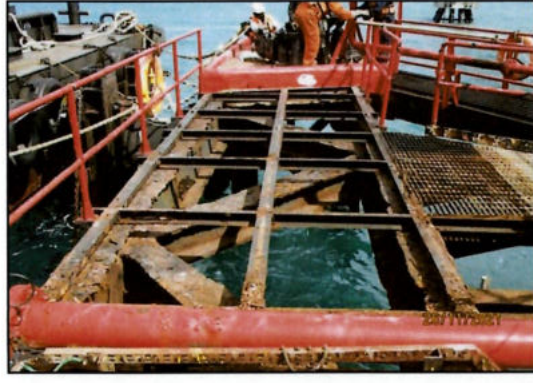
สภาพโดยทั่วไปของท่าเทียบเรือ BI-1

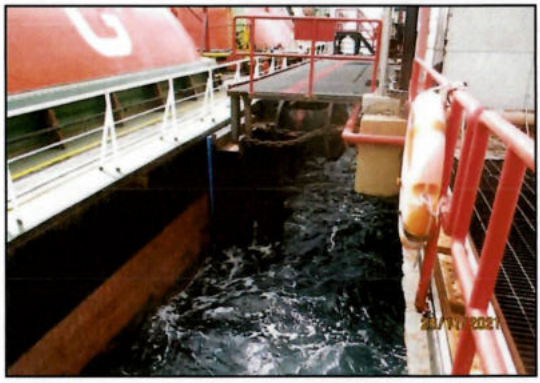
ลำดับ	สภาพโดยทั่วไป	
1

สภาพโดยทั่วไปของท่าเทียบเรือ BI-2

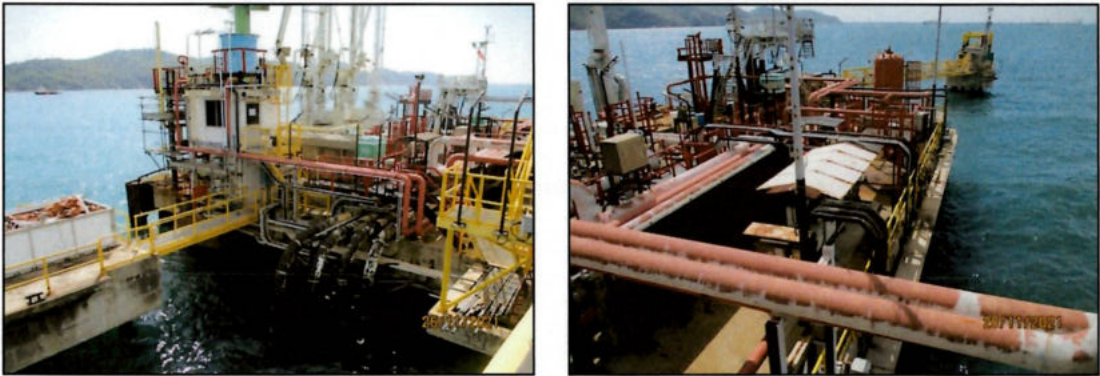
ลำดับ	สภาพโดยทั่วไป
1

สภาพโดยทั่วไปของท่าเทียบเรือ BI-3
