# ภาคผนวกที่ 1

## เอกสารแนบ

กราฟแสดงผลการตรวจสอบคุณภาพอากาศจากปล่องระบายของระบบ CEMs ปล่อง HRSG 1

Preliminary Inspection Report

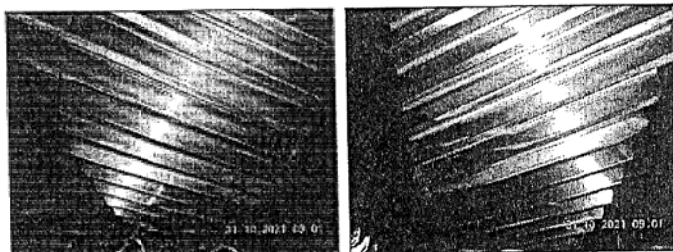
- White marked found on bull gear wheel cogs both turbine and generator sides, show little to no changes compare to previous inspection.
- White marked on bull gear wheel generator side appears on all cogs on inactive side.

Example of wheel cogs white marks generator side. Example of wheel cogs white marks turbine side.

- Continue to monitor condition of white marked found on bull gear wheel cogs both turbine and generator sides. Current condition compares to previous condition of white marked show little to no progress on generator side. White marked on turbine side were notice since previous B-inspection with no sign of progression found during this inspection.
- Continue to monitor for varnish condition on cogs, performed oil sampling analysis every six months to determine condition of contamination circulating in the system and keep track of lubrication oil health.

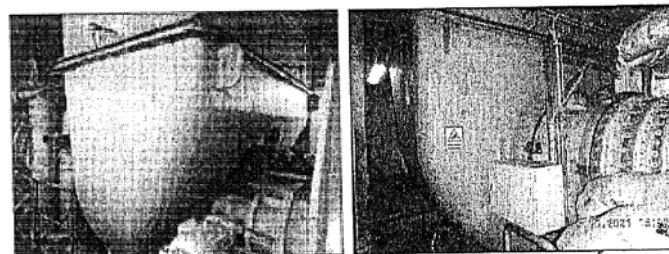
Inlet casing overall condition seen on left side.

Inlet casing overall condition seen on right side.

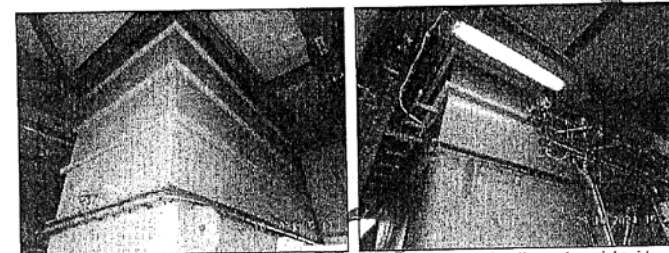
Inlet silencer external wall seen from left side.

Inlet silencer external wall seen from right side.

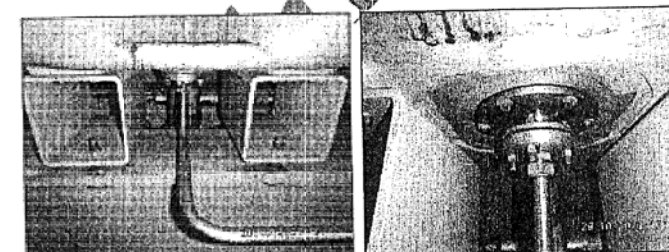
Inlet casing foundation support overall condition.

Inlet casing drain port overall condition.

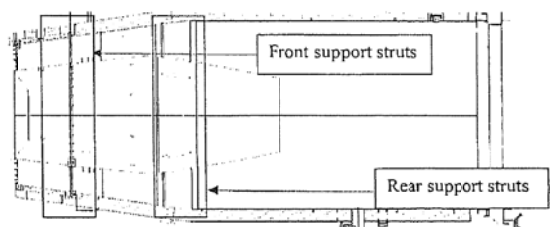
- Small cracks found on welded joint on front and rear support struts.
- Inner cone securing bolt found broken 1 piece.
- HRSG liner part found at front of heat exchanger fins, suspect it came loose from exhaust diffuser to HRSG integration section.

Example of rear support struts overall condition.

- During next major inspection perform PT check for cracks at weld seam on all front and rear support struts and repair cracks.
- Check condition of bolts securing inner cone on the next shutdown opportunity for any sign of loose or broken bolts.
- Repair HRSG liner before return machine to operation to prevent any hot gases leakages to external environment.

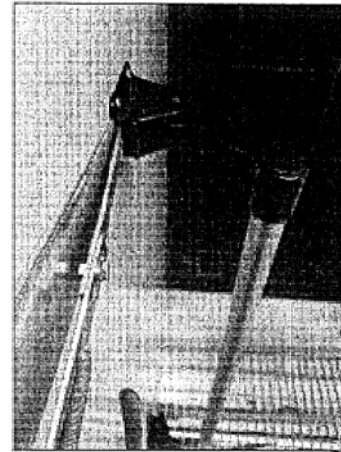
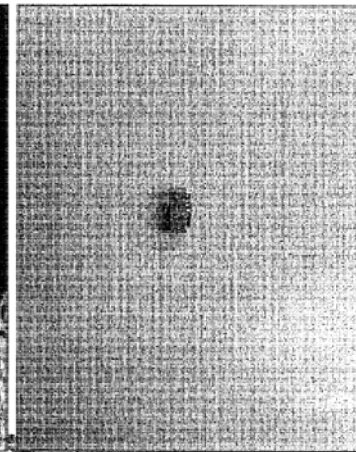
Sup28/2019/SGT-800: Change tension arm press nut & bolt in Type P Emergency Door Opener SGT-800B.

This Sup28/2019/SGT-800: has already completed on all the emergency doors.
