ภาคผนวก ง

ตัวอย่างสำเนาเอกสารบันทึกการซ่อมบำรุงเชิงป้องกัน

ภาคผนวก ง-2
ตัวอย่างเอกสารบันทึก
การซ่อมบำรุงเชิงป้องกัน - ไฟฟ้า

CENTARA GRAND
MIRAGE
BEACH RESORT PATTAYA

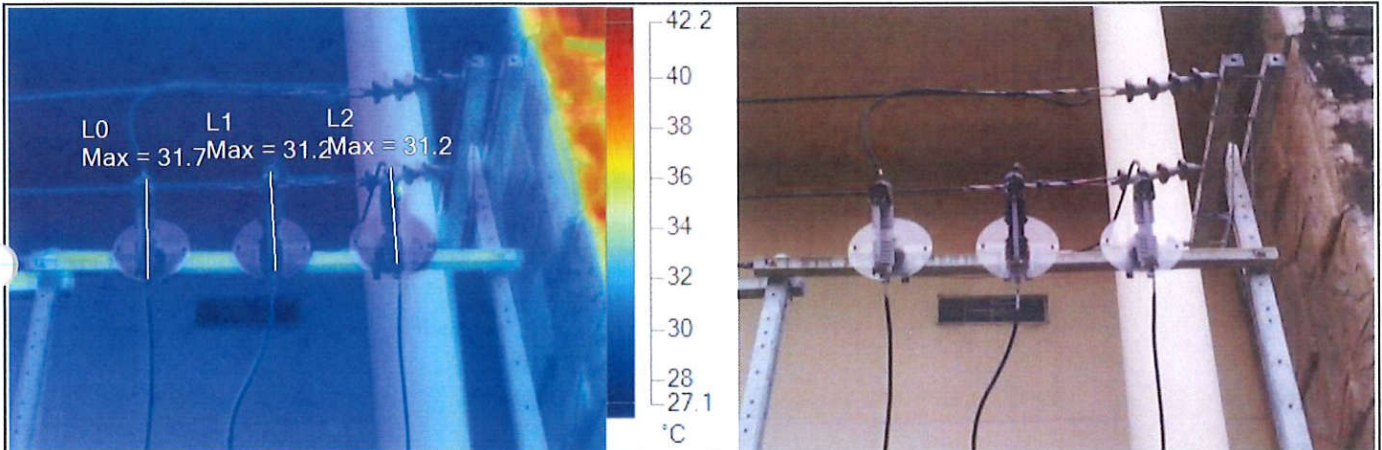
IR_06211.IS212/21/2021 12:26:56 PM

Equipment Name :	Drop Out Fuse 22 kV	Distance :	5	Metre
Hotspot Point :	Joint Connect	Ambient Temp :	28	°C
Emissivity :	0.95	Year/Month :	12/2021

# No fault found	Conditions detectable (วิเคราะห์สาเหตุ)	Recommended Action. (แนะนำ / ควรดำเนินการ)
4	<input checked="" type="checkbox"/> Normal	<input checked="" type="checkbox"/> Normal Condition.
	<input type="checkbox"/> Loose Connection	<input type="checkbox"/> Remove and Replace
	<input type="checkbox"/> Load of Overload	<input type="checkbox"/> Tightening and Clean
	<input type="checkbox"/> Open Circuit	<input type="checkbox"/> Measure current or PQ. Measurement
	<input type="checkbox"/> Other	<input type="checkbox"/> Maintenance and Electrical Test.
	<input type="checkbox"/> Unbalanced Load

Recommendation : - พิจารณาว่าอุปกรณ์มีสภาพปกติ
- อุปกรณ์ไฟฟ้าต้องการบำรุงรักษาตามปกติและการทดสอบทางไฟฟ้าตามกระบวนการปกติ

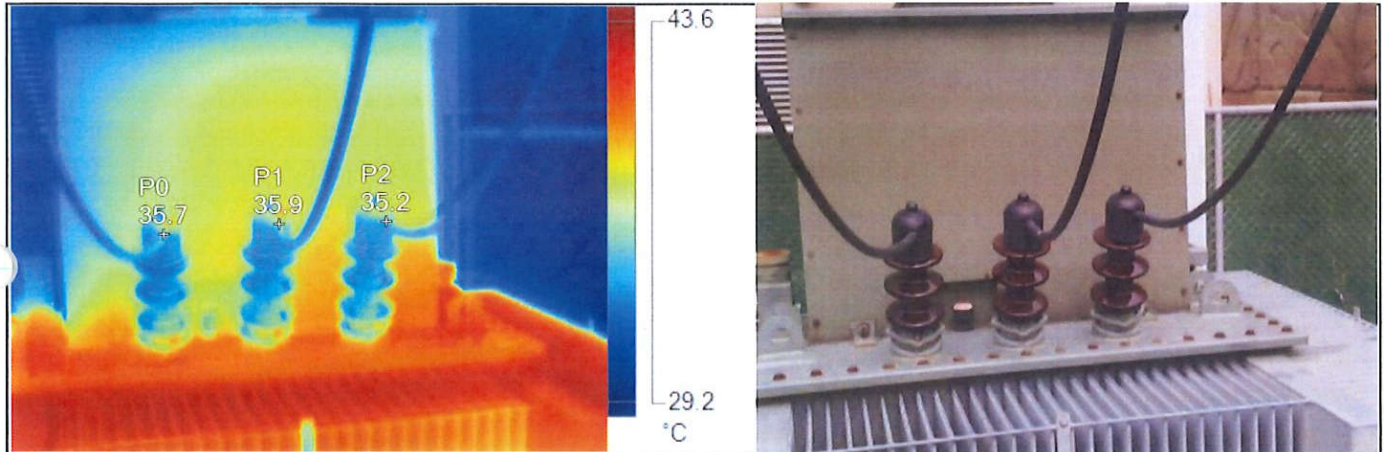
IR_06215.IS212/21/2021 12:28:47 PM

Equipment Name :	Bushing Hight Volt	Distance :	1	Metre
Hotspot Point :	Joint Connect	Ambient Temp :	28	°C
Emissivity :	0.95	Year/Month :	12/2021

# No fault found	Conditions detectable (วิศวกรพิจารณา)	Recommended Action. (แนะนำ / ควรดำเนินการ)
4	<input checked="" type="checkbox"/> Normal	<input checked="" type="checkbox"/> Normal Condition.
	<input type="checkbox"/> Loose Connection	<input type="checkbox"/> Remove and Replace
	<input type="checkbox"/> Load of Overload	<input type="checkbox"/> Tightening and Clean
	<input type="checkbox"/> Open Circuit	<input type="checkbox"/> Measure current or PQ. Measurement
	<input type="checkbox"/> Other.....	<input type="checkbox"/> Maintenance and Electrical Test.
	<input type="checkbox"/> Unbalanced Load

Recommendation : - พิจารณาว่าอุปกรณ์มีสภาพปกติ
- อุปกรณ์ไฟฟ้าต้องการบำรุงรักษาตามปกติและการทดสอบทางไฟฟ้าตามกระบวนการปกติ

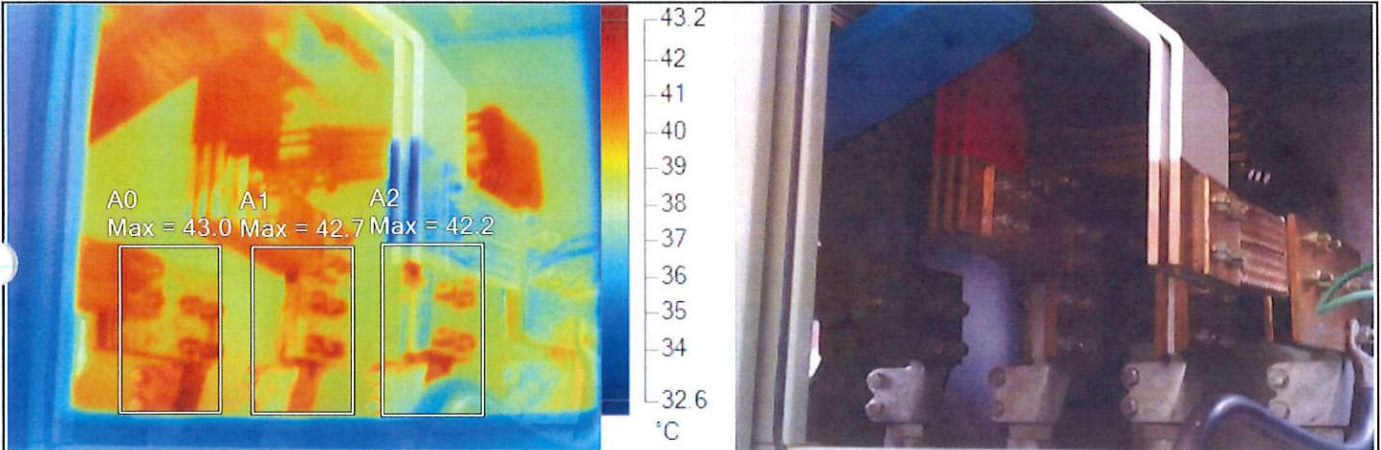
IR_06226.IS212/21/2021 12:40:26 PM

Equipment Name :	Bushing Low Volt	Distance :	1	Metre
Hotspot Point :	Joint Connect	Ambient Temp :	28	°C
Emissivity :	0.95	Year/Month :	12/2021

# No fault found	Conditions detectable (วิเคราะห์สาเหตุ)	Recommended Action. (แนะนำ / ควรดำเนินการ)
4	<input checked="" type="checkbox"/> Normal	<input checked="" type="checkbox"/> Normal Condition.
	<input type="checkbox"/> Loose Connection	<input type="checkbox"/> Remove and Replace
	<input type="checkbox"/> Load of Overload	<input type="checkbox"/> Tightening and Clean
	<input type="checkbox"/> Open Circuit	<input type="checkbox"/> Measure current or PQ. Measurement
	<input type="checkbox"/> Other.....	<input type="checkbox"/> Maintenance and Electrical Test.
	<input type="checkbox"/> Unbalanced Load

Recommendation : - พิจารณาว่าอุปกรณ์มีสภาพปกติ
- อุปกรณ์ไฟฟ้าต้องการบำรุงรักษาตามปกติและการทดสอบทางไฟฟ้าตามกระบวนการปกติ

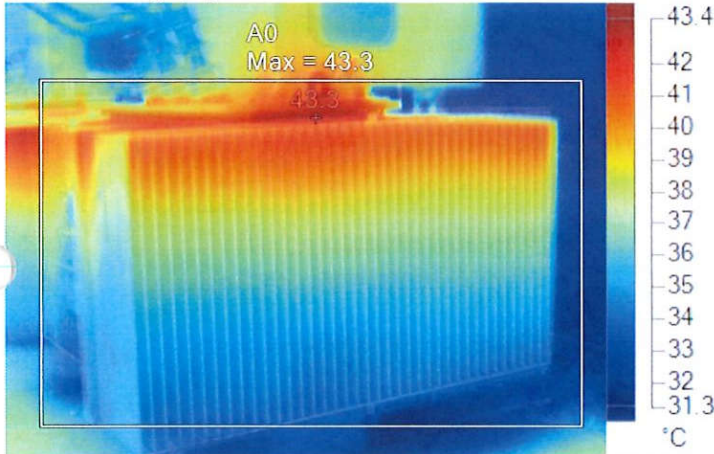
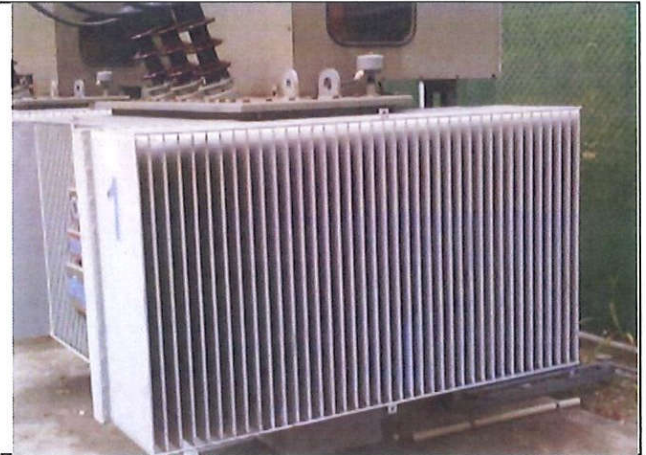
IR_06230.IS212/21/2021 12:41:47 PM

Equipment Name :	Main Tank Transformer	Distance :	1	Metre
Hotspot Point :	Oil Temp & Winding Temp	Ambient Temp :	28	°C
Emissivity :	0.95	Year/Month :	12/2021

Diagnosis: ☐ ΔT (Temperature difference) ☒ Equipment Referent Temp (Max Temp ...Oil Temp & Winding Temp ... =....85.....°C)

# No fault found	Conditions detectable (วิเคราะห์สาเหตุ)	Recommended Action. (แนะนำ/ควรดำเนินการ)
4	<input checked="" type="checkbox"/> Normal	<input checked="" type="checkbox"/> Normal Condition.
	<input type="checkbox"/> Loose Connection	<input type="checkbox"/> Remove and Replace
	<input type="checkbox"/> Load of Overload	<input type="checkbox"/> Tightening and Clean
	<input type="checkbox"/> Open Circuit	<input type="checkbox"/> Measure current or PQ. Measurement
	<input type="checkbox"/> Other.....	<input type="checkbox"/> Maintenance and Electrical Test.
	<input type="checkbox"/> Unbalanced Load

Recommendation : - พิจารณาว่าอุปกรณ์มีสภาพปกติ
- อุปกรณ์ไฟฟ้าต้องการบำรุงรักษาด้านปกติและการทดสอบทางไฟฟ้าตามกระบวนการปกติ

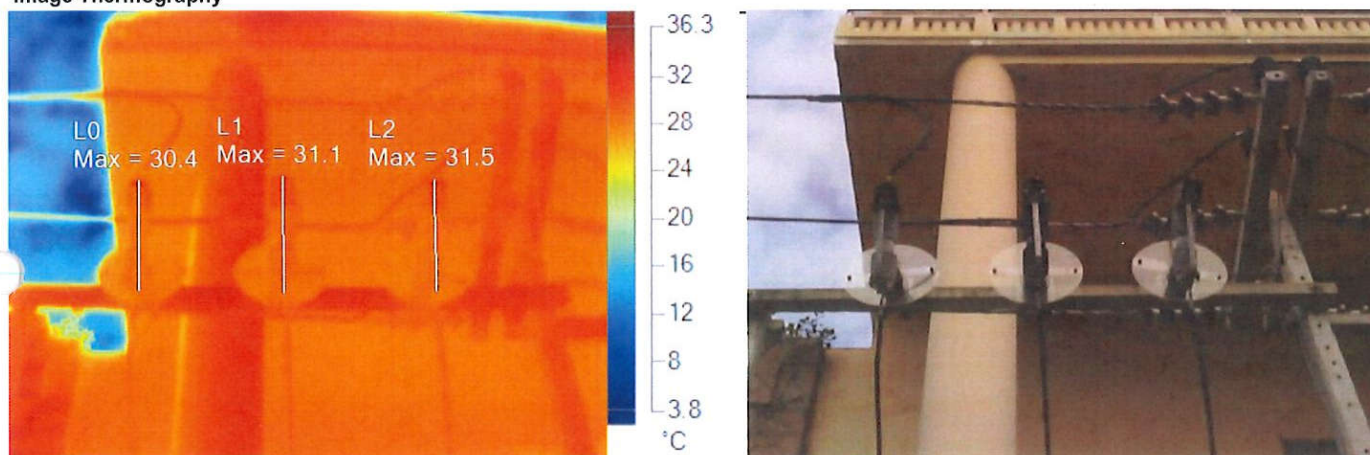
IR_06213.IS212/21/2021 12:28:01 PM

Equipment Name :	Drop Out Fuse 22 kV	Distance :	5	Metre.
Hotspot Point :	Joint Connect	Ambient Temp :	28	°C
Emissivity :	0.95	Year/Month :	12/2021

Diagnosis: ☒ ΔT (Temperature difference) ☐ Equipment Referent Temp (Max Temp =..... °C)

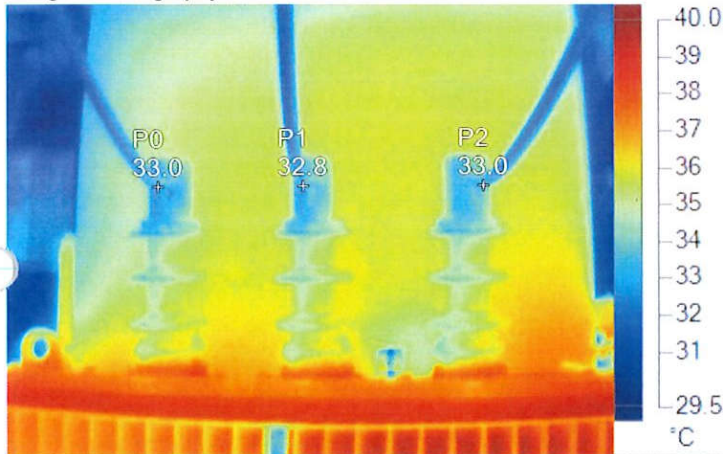
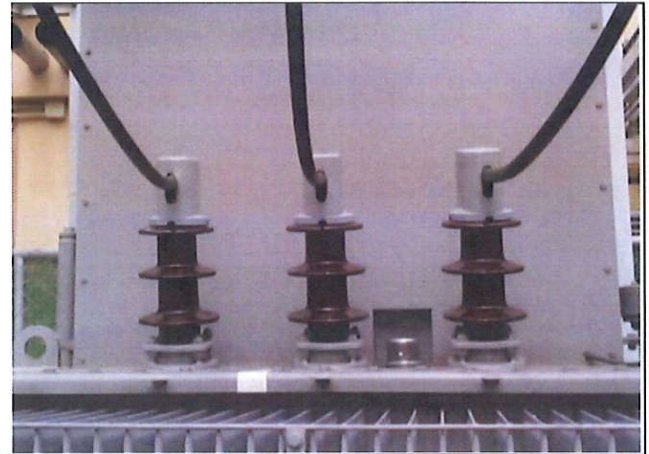
IR_06224.IS212/21/2021 12:39:33 PM

Equipment Name :	Bushing Hight Volt	Distance :	1	Metre
Hotspot Point :	Joint Connect	Ambient Temp :	28	°C
Emissivity :	0.95	Year/Month :	12/2021

Diagnosis:	<input checked="" type="checkbox"/> ΔT (Temperature difference)	<input type="checkbox"/> Equipment Referent Temp (Max Temp = °C)
------------	---	--

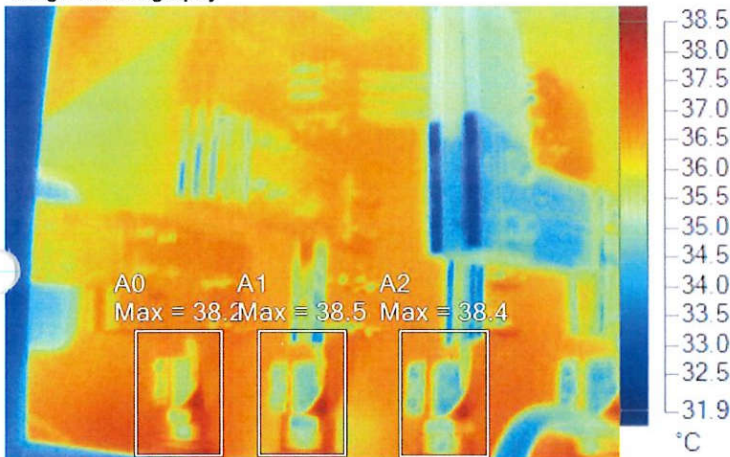
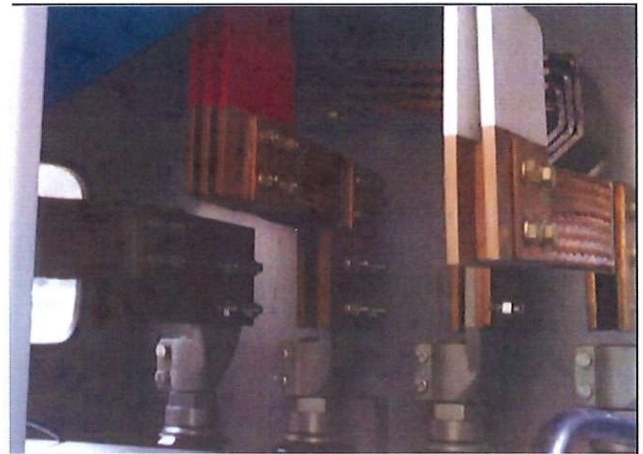
IR_06228.IS212/21/2021 12:41:11 PM

Equipment Name :	Bushing Low Volt	Distance :	1	Metre
Hotspot Point :	Joint Connect	Ambient Temp :	28	°C
Emissivity :	0.95	Year/Month :	12/2021

Diagnosis: ☒ ΔT (Temperature difference) ☐ Equipment Referent Temp (Max Temp = °C)

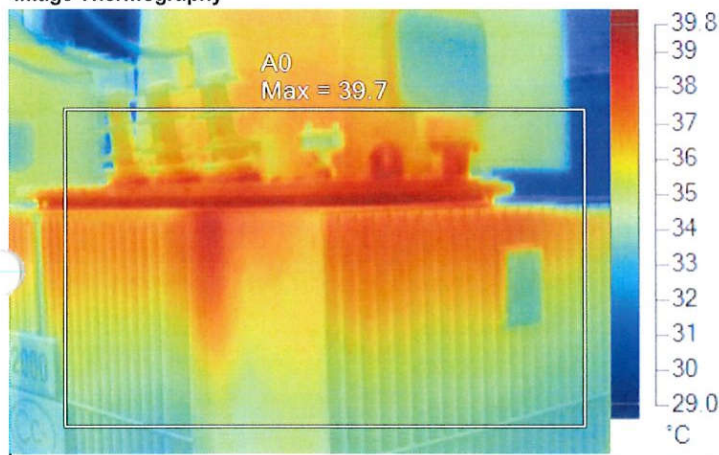
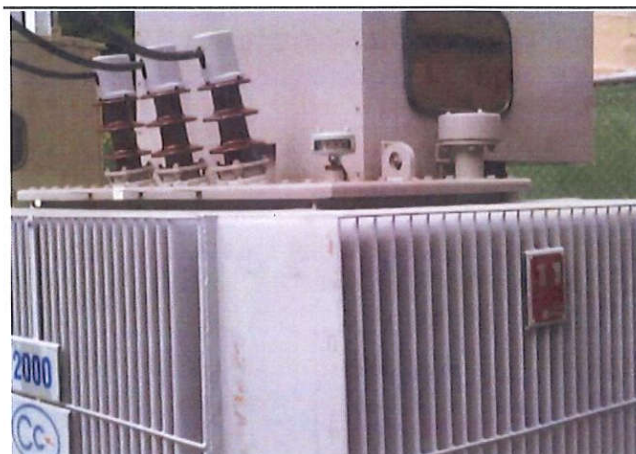
IR_06232.IS212/21/2021 12:42:09 PM

Equipment Name :	Main Tank Transformer	Distance :	1	Metre.
Hotspot Point :	Oil Temp & Winding Temp	Ambient Temp :	28	°C
Emissivity :	0.95	Year/Month :	12/2021

Diagnosis: ☐ ΔT (Temperature difference) ☒ Equipment Referent Temp (Max Temp ...Oil Temp & Winding Temp ... =....85.....°C)

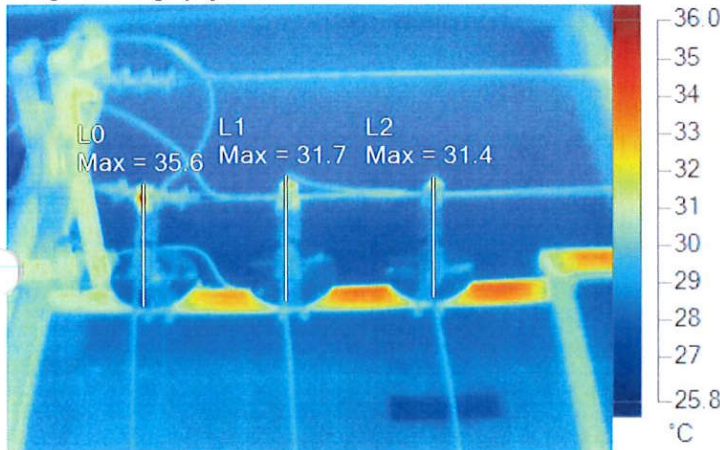
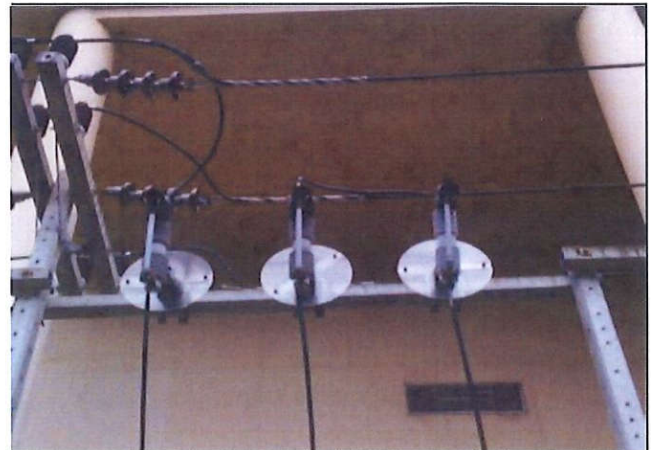
IR_06212.IS212/21/2021 12:27:31 PM

Equipment Name :	Drop Out Fuse 22 kV	Distance :	5	Metre
Hotspot Point :	Joint Connect	Ambient Temp :	28	°C
Emissivity :	0.95	Year/Month :	12/2021

Diagnosis:	<input checked="" type="checkbox"/> ΔT (Temperature difference)	<input type="checkbox"/> Equipment Referent Temp (Max Temp = °C)
------------	---	--

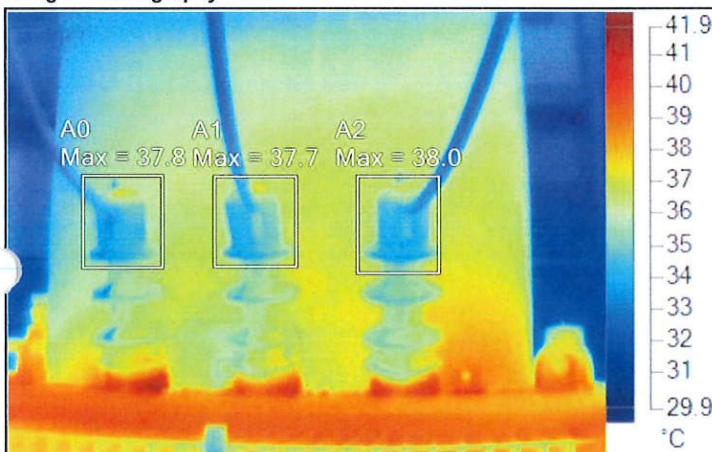
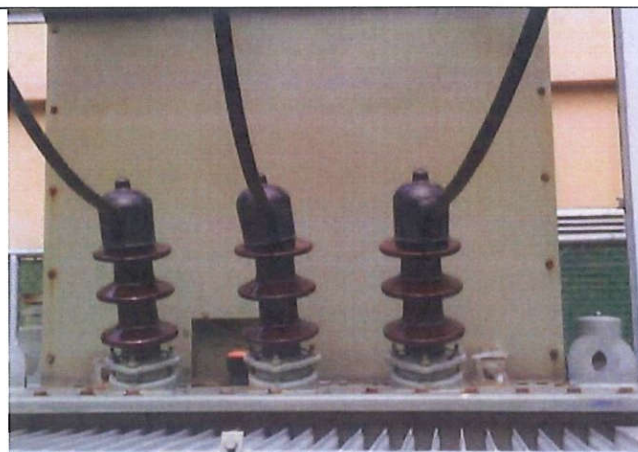
IR_06223.IS212/21/2021 12:37:47 PM

Equipment Name :	Bushing Hight Volt	Distance :	1	Metre.
Hotspot Point :	Joint Connect	Ambient Temp :	28	°C
Emissivity :	0.95	Year/Month :	12/2021

Diagnosis: ☒ ΔT (Temperature difference) ☐ Equipment Referent Temp (Max Temp = °C)

Recommendation : - พิจารณาว่าอุปกรณ์มีสภาพปกติ

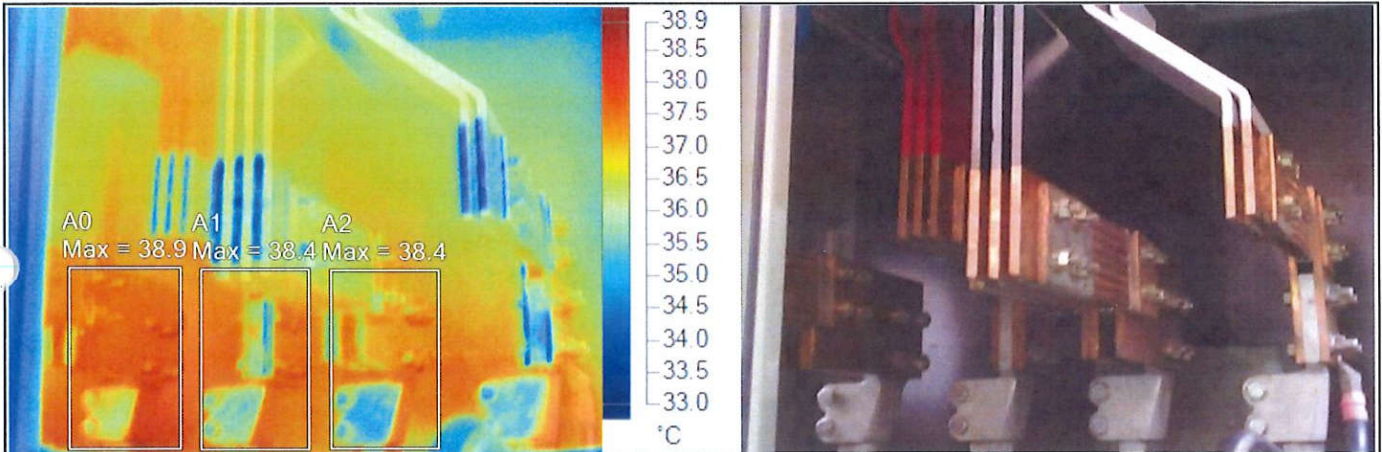
IR_06227.IS212/21/2021 12:40:47 PM

Equipment Name :	Bushing Low Volt	Distance :	1	Metre
Hotspot Point :	Joint Connect	Ambient Temp :	28	°C
Emissivity :	0.95	Year/Month :	12/2021

Diagnosis: ☒ ΔT (Temperature difference) ☐ Equipment Referent Temp (Max Temp = °C)

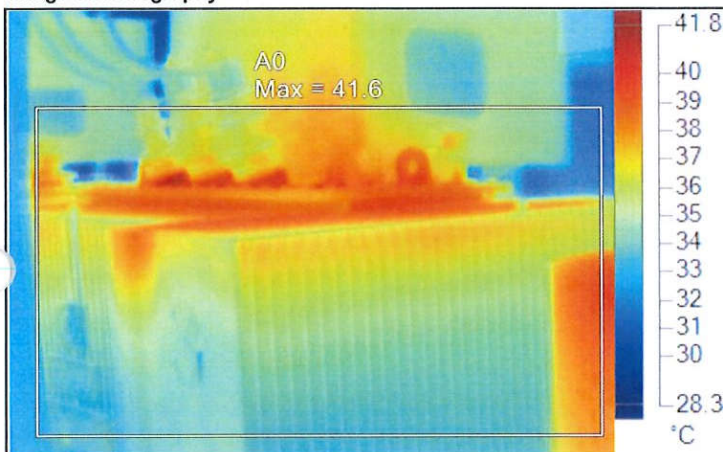
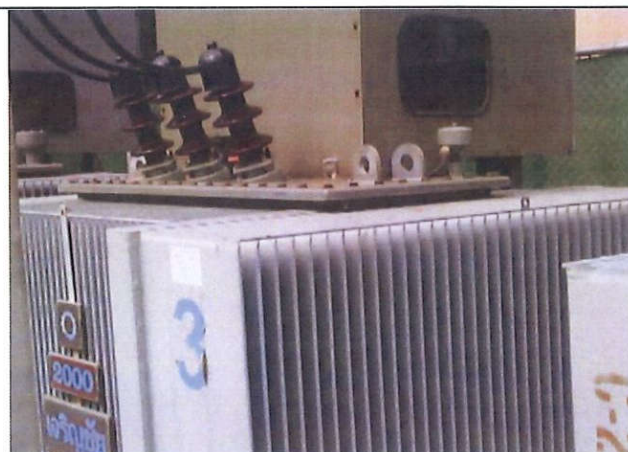
IR_06231.IS212/21/2021 12:42:00 PM

Equipment Name :	Main Tank Transformer	Distance :	1	Metre
Hotspot Point :	Oil Temp & Winding Temp	Ambient Temp :	28	°C
Emissivity :	0.95	Year/Month :	12/2021

Diagnosis: ☐ ΔT (Temperature difference) ☒ Equipment Referent Temp (Max Temp ...Oil Temp & Winding Temp ... =...85.....°C)

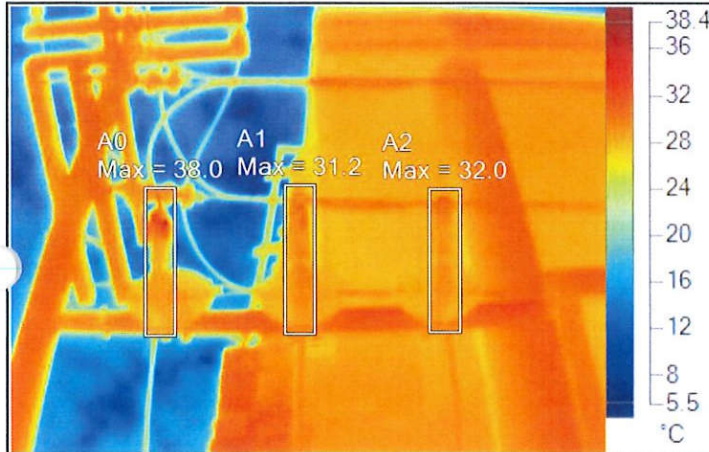
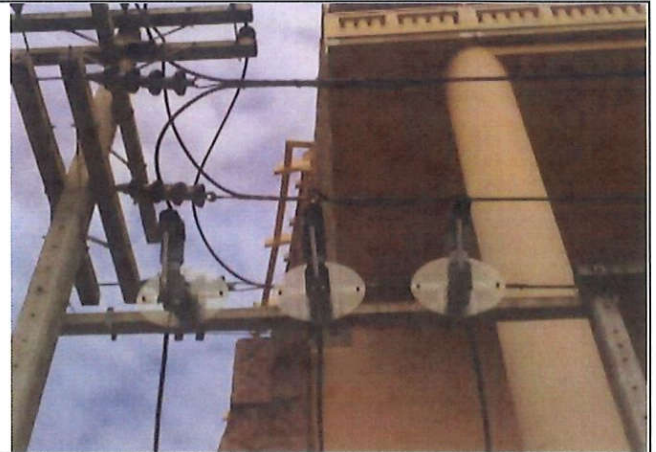
IR_06214.IS212/21/2021 12:28:16 PM

Equipment Name :	Drop Out Fuse 22 kV	Distance :	5	Metre
Hotspot Point :	Joint Connect	Ambient Temp :	28	°C
Emissivity :	0.95	Year/Month :	12/2021

Diagnosis: ☒ ΔT (Temperature difference) ☐ Equipment Referent Temp (Max Temp = °C)

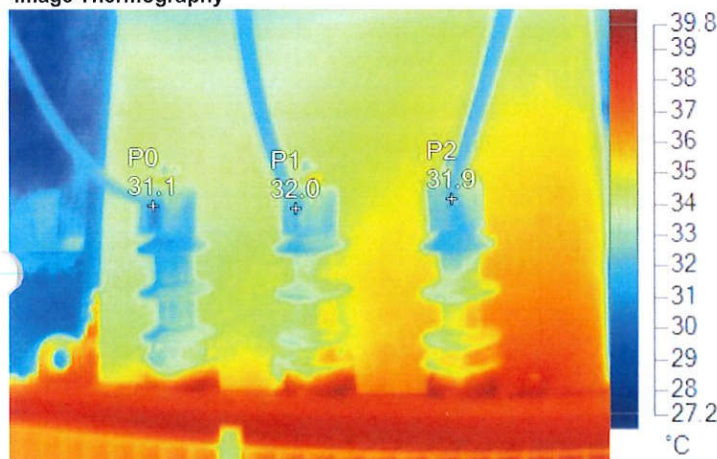
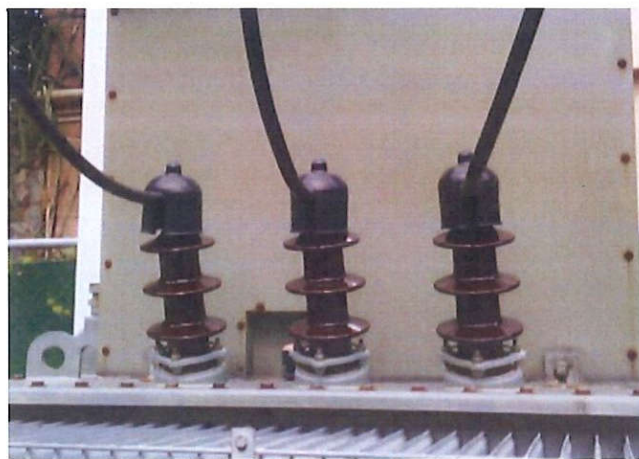
IR_06225.IS212/21/2021 12:39:42 PM

Equipment Name :	Bushing Hight Volt	Distance :	1	Metre
Hotspot Point :	Joint Connect	Ambient Temp :	28	°C
Emissivity :	0.95	Year/Month :	12/2021

Diagnosis: ☒ ΔT (Temperature difference) ☐ Equipment Referent Temp (Max Temp = °C)

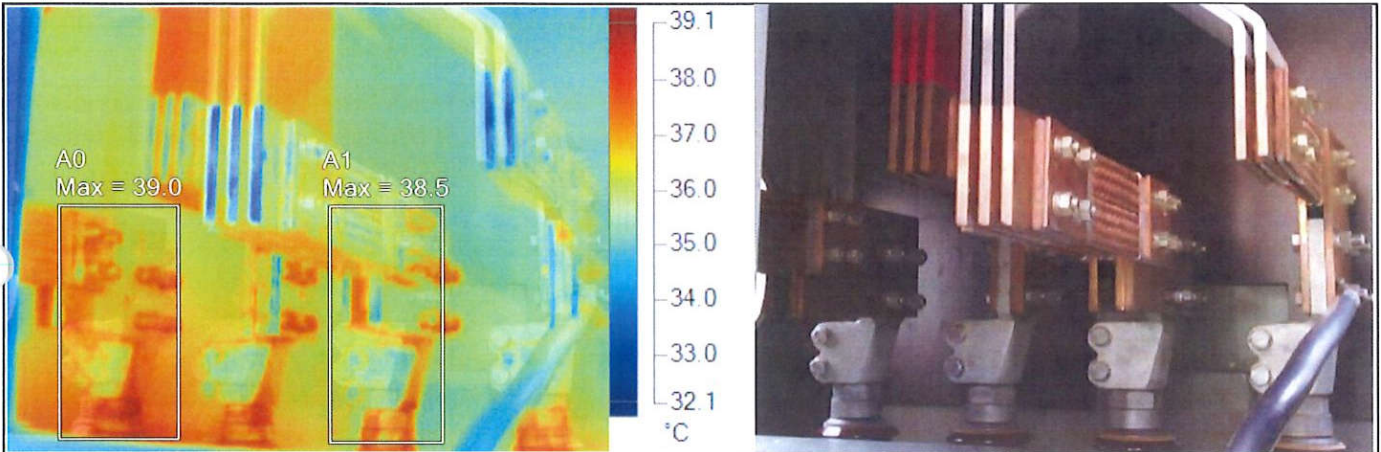
IR_06229.IS212/21/2021 12:41:25 PM

Equipment Name :	Bushing Low Volt	Distance :	1	Metre.
Hotspot Point :	Joint Connect	Ambient Temp :	28	°C
Emissivity :	0.95	Year/Month :	12/2021

Diagnosis: ☒ ΔT (Temperature difference) ☐ Equipment Referent Temp (Max Temp = °C)

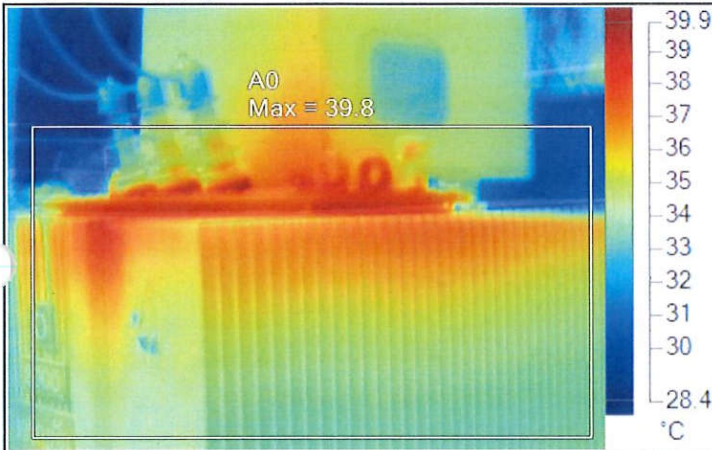
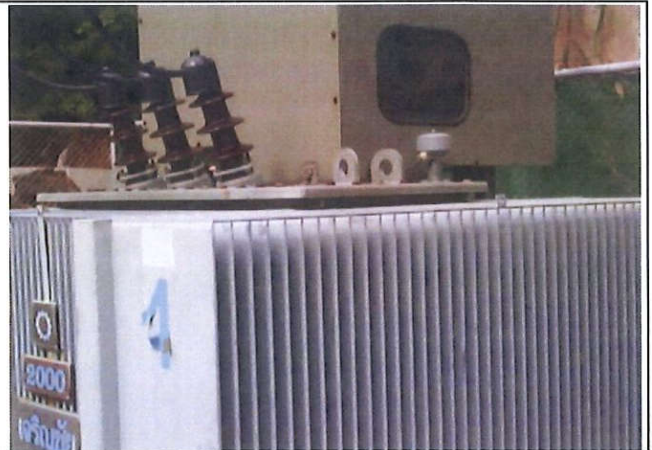
IR_06233.IS212/21/2021 12:42:17 PM

Equipment Name :	Main Tank Transformer	Distance :	1	Metre.
Hotspot Point :	Oil Temp & Winding Temp	Ambient Temp :	28	°C
Emissivity :	0.95	Year/Month :	12/2021

Diagnosis: ☐ ΔT (Temperature difference) ☒ Equipment Referent Temp (Max Temp ...Oil Temp & Winding Temp ... =.....85.....°C)

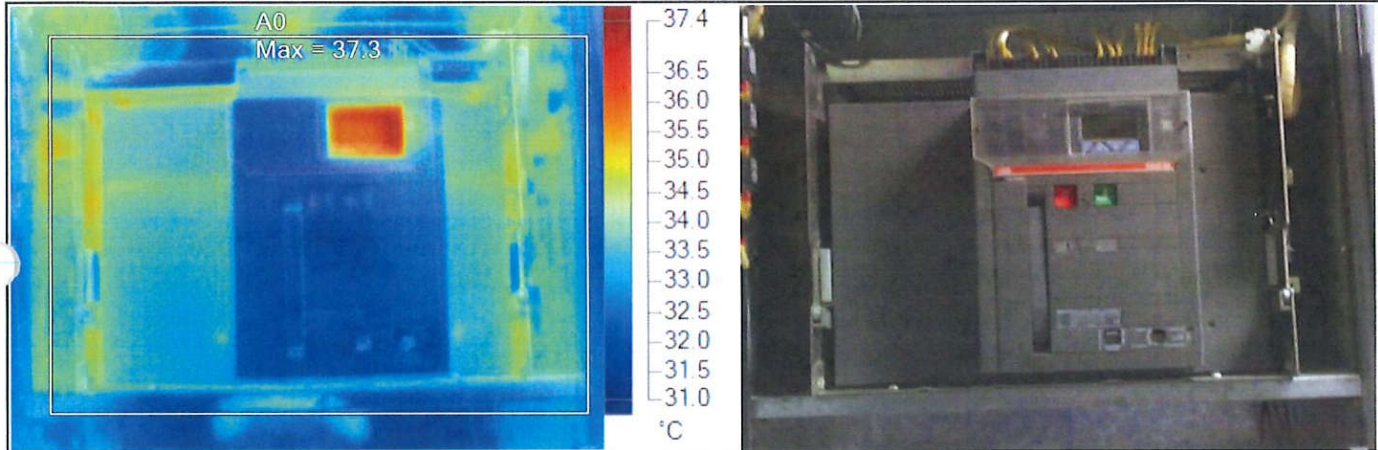
IR_06234.IS212/21/2021 12:47:07 PM

Equipment Name :	Air Circuit Breaker	Distance :	0.3	Metre
Hotspot Point :	Air Circuit Breaker	Ambient Temp :	28	°C
Emissivity :	0.95	Year/Month :	12/2021

Diagnosis: ☐ ΔT (Temperature difference) ☒ Equipment Referent Temp (Max Temp ...Air Circuit Breaker..... =60.....°C)

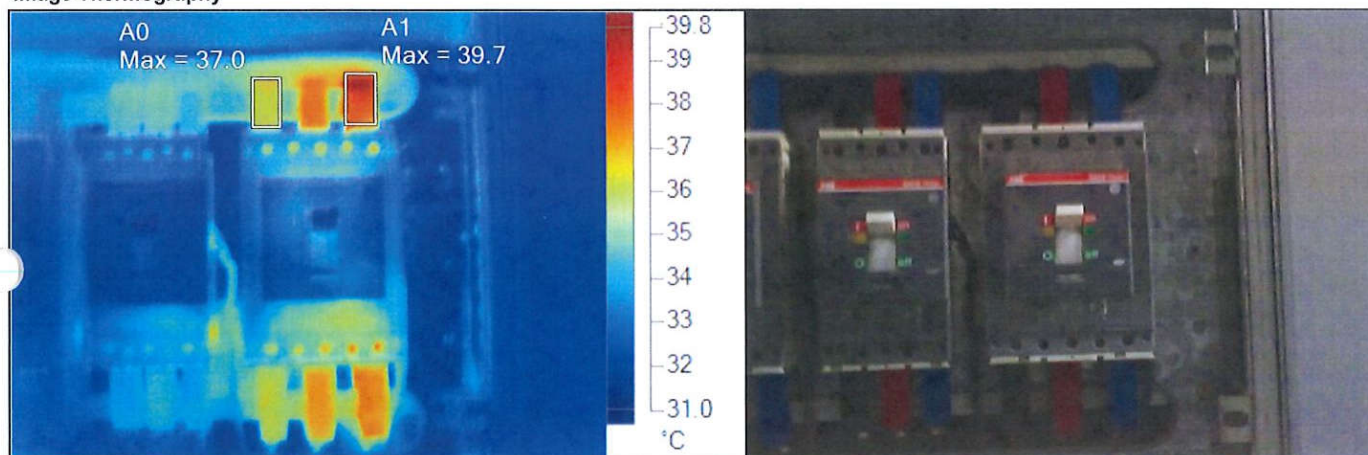
IR_06235.IS212/21/2021 12:48:31 PM

Equipment Name :	Molded Case Circuit Breaker	Distance :	0.3	Metre
Hotspot Point :	Bus Bar	Ambient Temp :	28	°C
Emissivity :	0.95	Year/Month :	12/2021

Diagnosis: ☒ ΔT (Temperature difference) ☐ Equipment Referent Temp (Max Temp = °C)

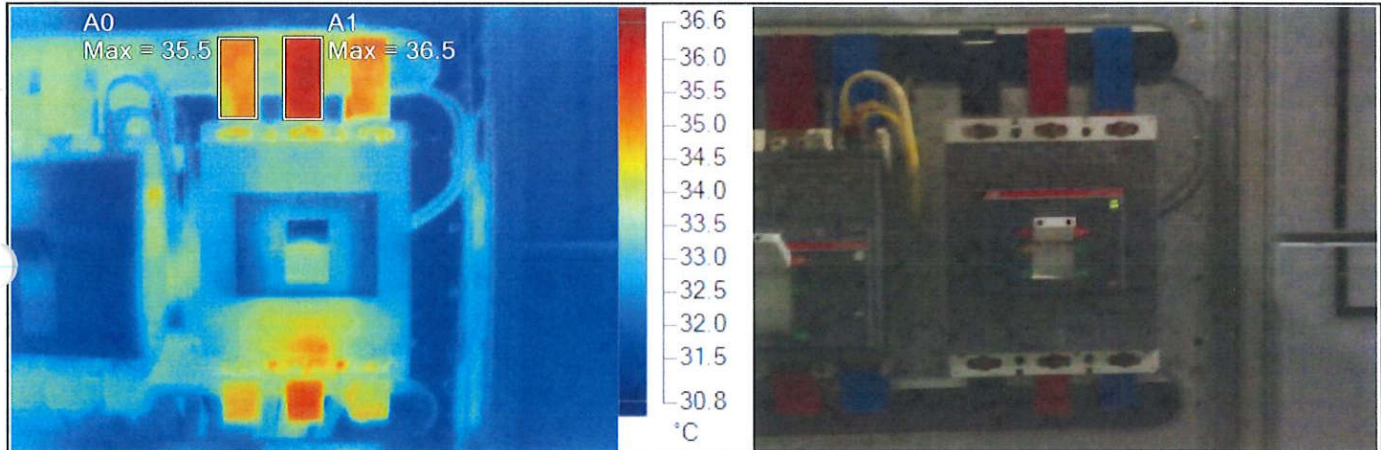
IR_06236.IS212/21/2021 12:49:00 PM

Equipment Name :	Molded Case Circuit Breaker	Distance :	0.3	Metre
Hotspot Point :	Bus Bar	Ambient Temp :	28	°C
Emissivity :	0.95	Year/Month :	12/2021

Diagnosis: ☒ ΔT (Temperature difference) ☐ Equipment Referent Temp (Max Temp = °C)

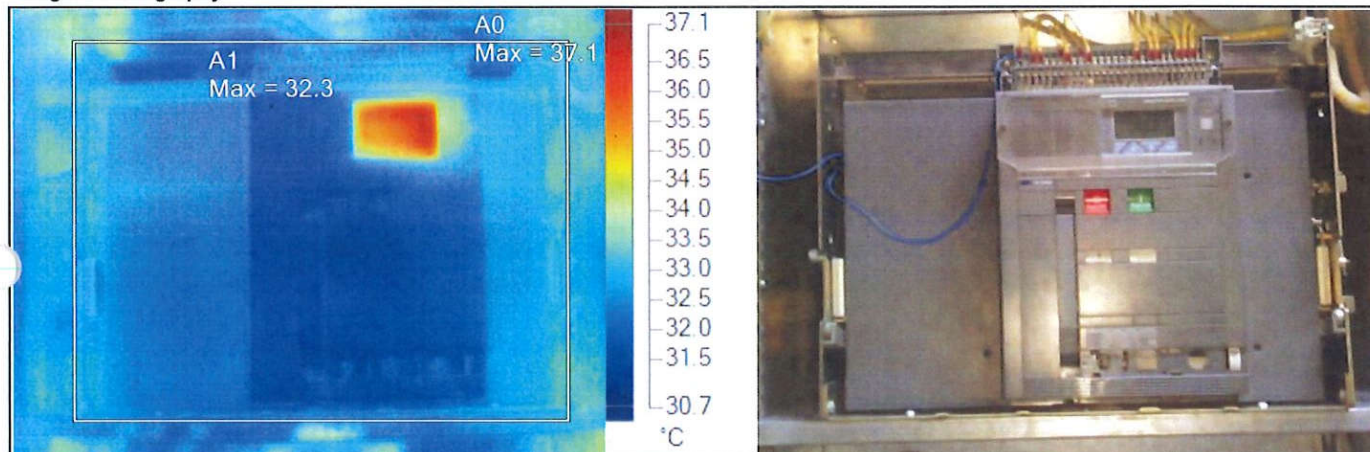
IR_06237.IS212/21/2021 12:49:47 PM

Equipment Name :	Air Circuit Breaker	Distance :	0.3	Metre.
Hotspot Point :	Air Circuit Breaker	Ambient Temp :	28	°C
Emissivity :	0.95	Year/Month :	12/2021

Diagnosis: ☐ ΔT (Temperature difference) ☒ Equipment Referent Temp (Max Temp ...Air Circuit Breaker..... =60.....°C)

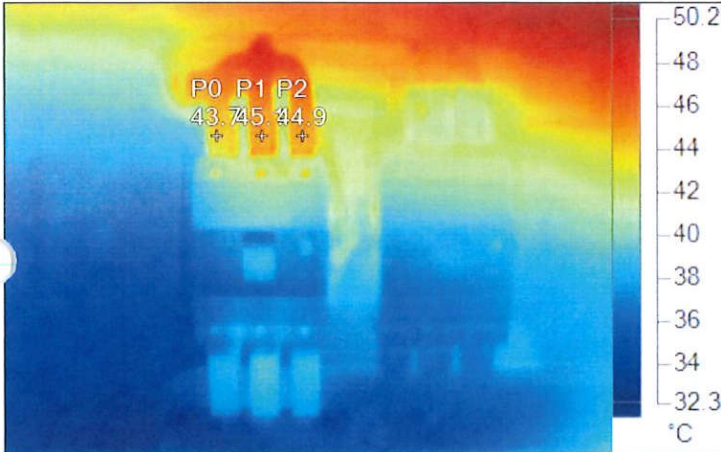
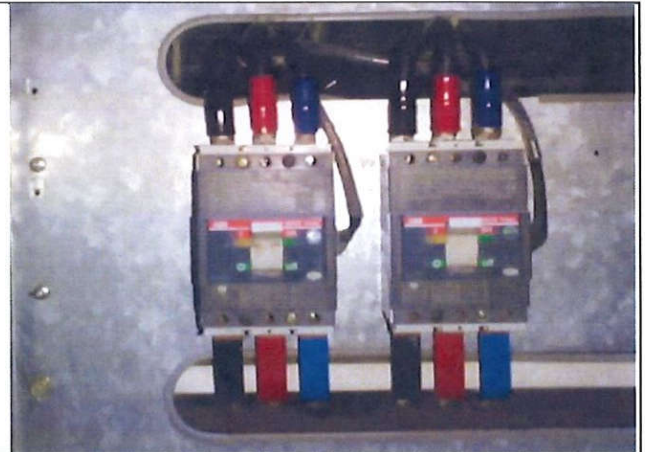
IR_06238.IS212/21/2021 12:50:13 PM

Equipment Name :	Molded Case Circuit Breaker	Distance :	0.3	Metre
Hotspot Point :	Bus Bar	Ambient Temp :	28	°C
Emissivity :	0.95	Year/Month :	12/2021

Diagnosis: ☒ ΔT (Temperature difference) ☐ Equipment Referent Temp (Max Temp = °C)

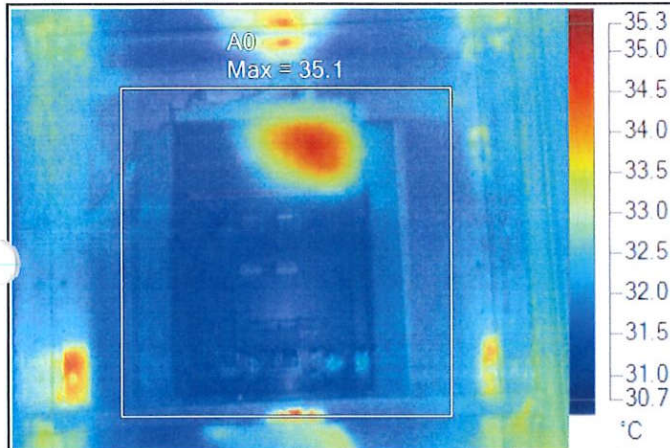
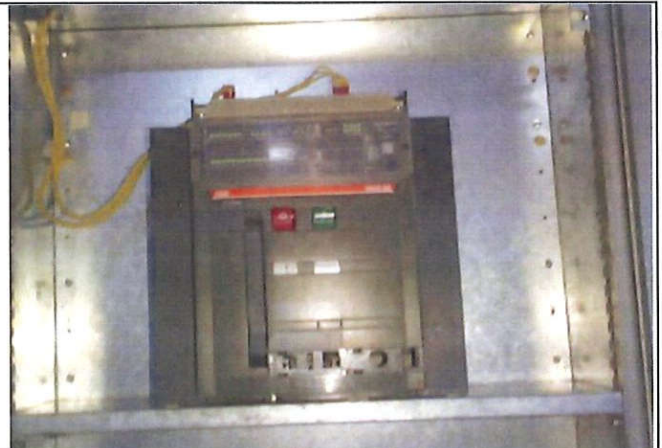
IR_06239.IS212/21/2021 12:51:10 PM

Equipment Name :	Air Circuit Breaker	Distance :	0.3	Metre
Hotspot Point :	Air Circuit Breaker	Ambient Temp :	28	°C
Emissivity :	0.95	Year/Month :	12/2021

Diagnosis: ☒ ΔT (Temperature difference) ☐ Equipment Referent Temp (Max Temp ...Air Circuit Breaker..... =.....60.....°C)

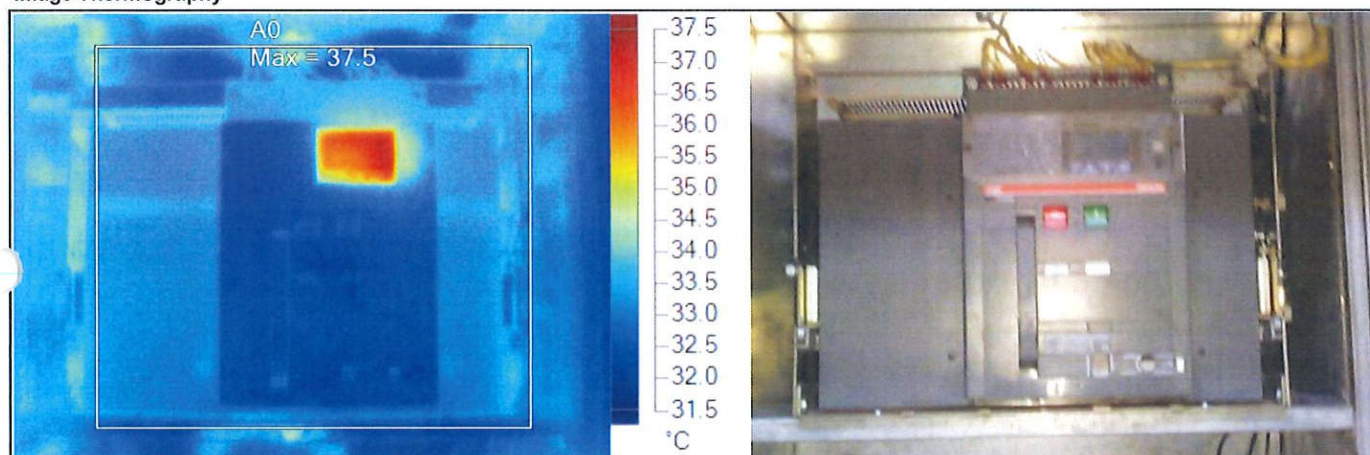
IR_06240.IS212/21/2021 12:51:29 PM

Equipment Name :	Air Circuit Breaker	Distance :	0.3	Metre.
Hotspot Point :	Air Circuit Breaker	Ambient Temp :	28	°C
Emissivity :	0.95	Year/Month :	12/2021

Diagnosis: ☐ ΔT (Temperature difference) ☒ Equipment Referent Temp (Max Temp ...Air Circuit Breaker..... =60.....°C)

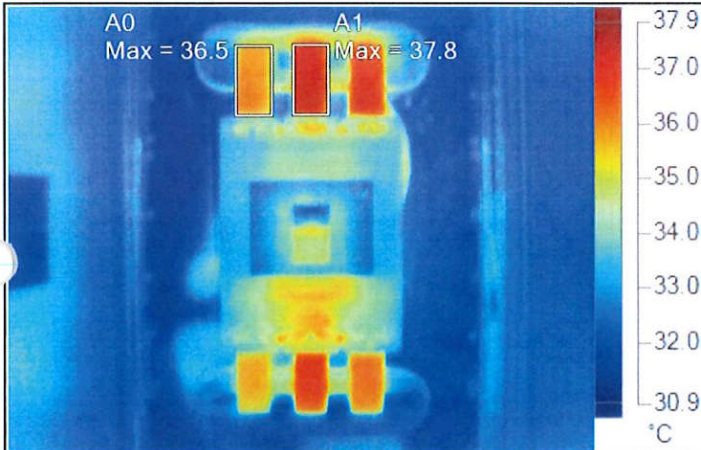
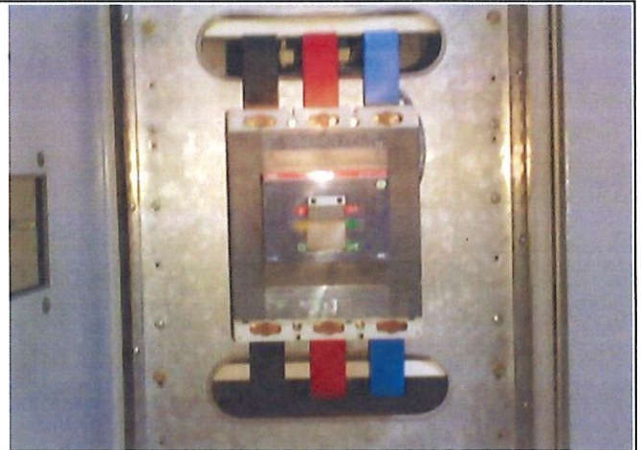
IR_06241.IS212/21/2021 12:52:01 PM

Equipment Name :	Molded Case Circuit Breaker	Distance :	0.3	Metre
Hotspot Point :	Bus Bar	Ambient Temp :	28	°C
Emissivity :	0.95	Year/Month :	12/2021

Diagnosis: ☒ ΔT (Temperature difference) ☐ Equipment Referent Temp (Max Temp = °C)

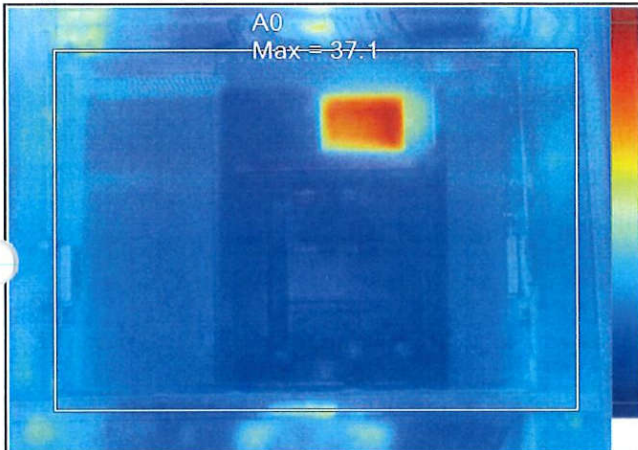
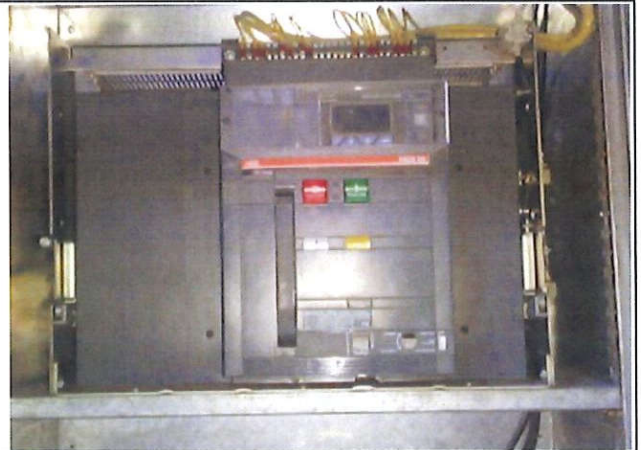
IR_06242.IS212/21/2021 12:52:41 PM

Equipment Name :	Air Circuit Breaker	Distance :	0.3	Metre
Hotspot Point :	Air Circuit Breaker	Ambient Temp :	28	°C
Emissivity :	0.95	Year/Month :	12/2021

Diagnosis: ☐ ΔT (Temperature difference) ☒ Equipment Referent Temp (Max Temp ...Air Circuit Breaker..... =.....60.....°C)

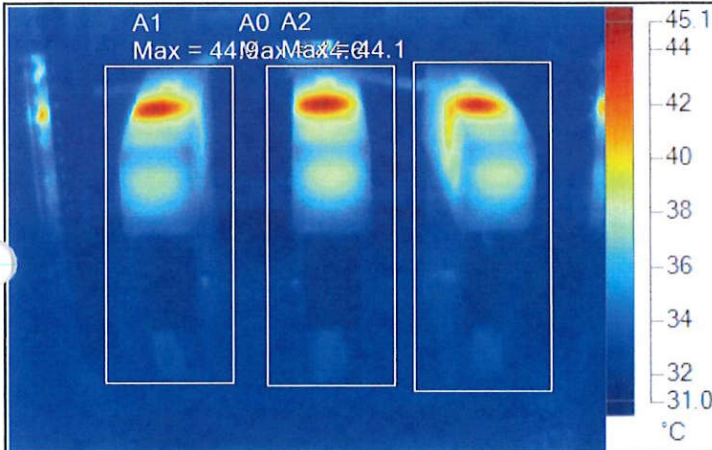
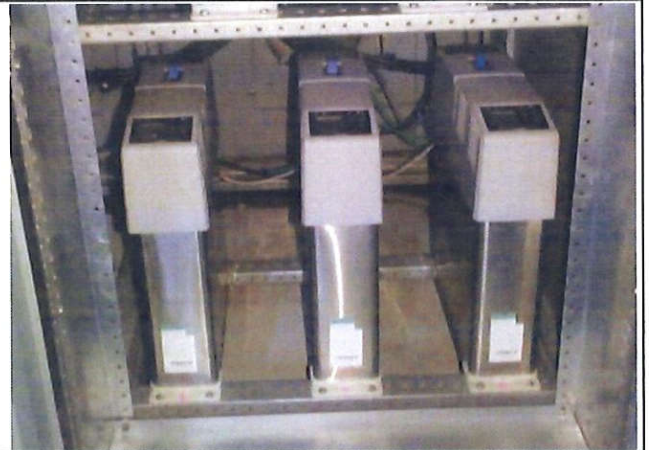
IR_06243.IS212/21/2021 12:54:09 PM

Equipment Name :	Capacitor Bank	Distance :	0.3	Metre
Hotspot Point :	Body Capacitor Bank	Ambient Temp :	28	°C
Emissivity :	0.95	Year/Month :	12/2021

Diagnosis: ☐ ΔT (Temperature difference) ☒ Equipment Referent Temp (Max Temp ...Body Capacitor Bank..... =....70....°C)

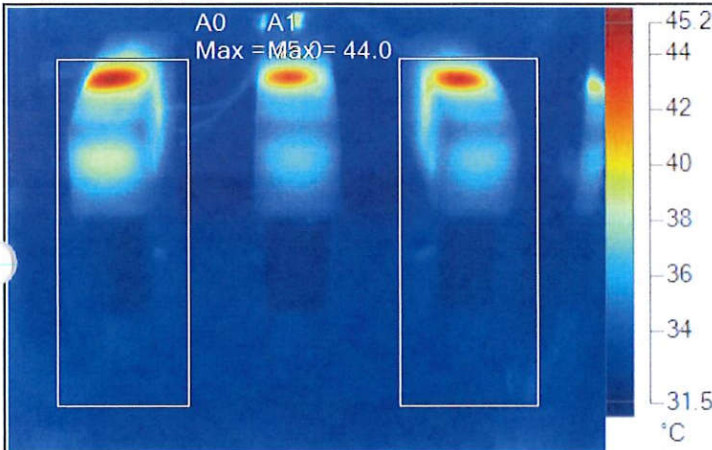
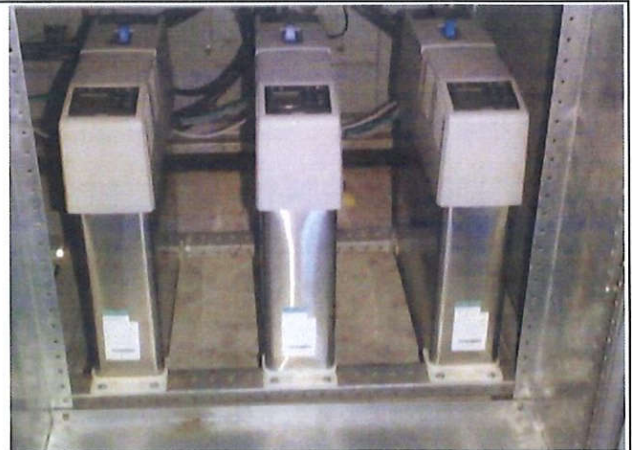
IR_06244.IS212/21/2021 12:55:36 PM

Equipment Name :	Capacitor Bank	Distance :	0.3	Metre
Hotspot Point :	Body Capacitor Bank	Ambient Temp :	28	°C
Emissivity :	0.95	Year/Month :	12/2021

Diagnosis: ☐ ΔT (Temperature difference) ☒ Equipment Referent Temp (Max Temp ...Body Capacitor Bank..... =....70....°C)

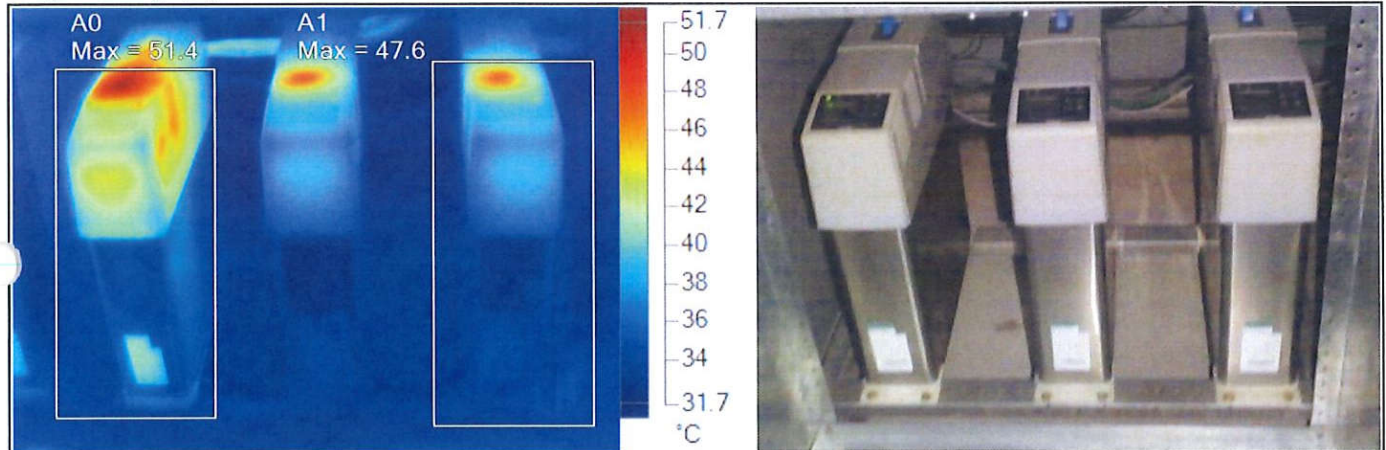
IR_06245.IS212/21/2021 12:56:38 PM

Equipment Name :	Capacitor Bank	Distance :	0.3	Metre
Hotspot Point :	Body Capacitor Bank	Ambient Temp :	28	°C
Emissivity :	0.95	Year/Month :	12/2021

Diagnosis: ☐ ΔT (Temperature difference) ☒ Equipment Referent Temp (Max Temp ...Body Capacitor Bank..... =....70....°C)

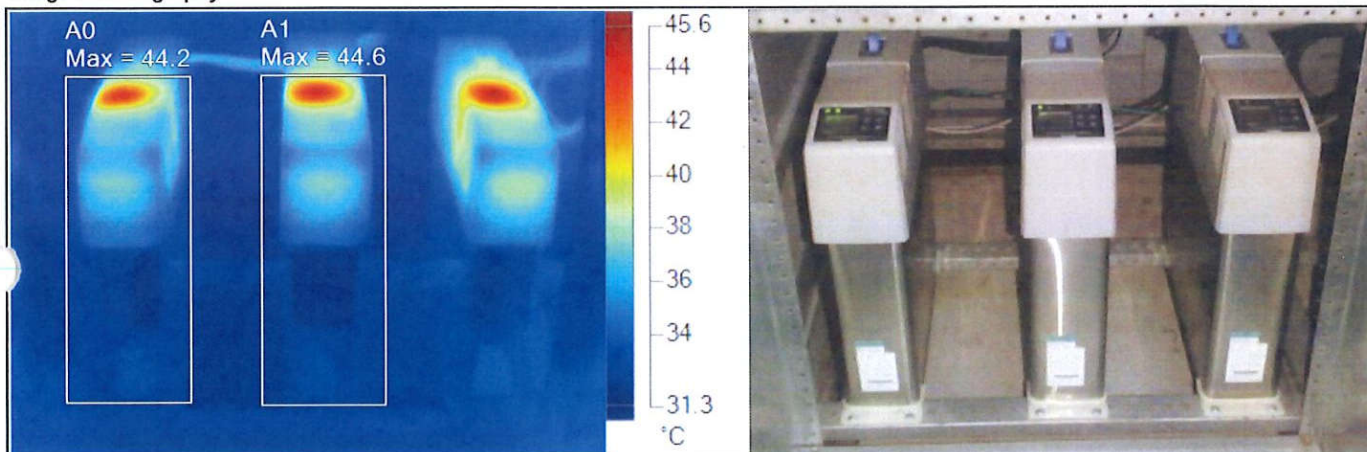
IR_06246.IS212/21/2021 12:56:55 PM

Equipment Name :	Capacitor Bank	Distance :	0.3	Metre
Hotspot Point :	Body Capacitor Bank	Ambient Temp :	28	°C
Emissivity :	0.95	Year/Month :	12/2021

Diagnosis: ☐ ΔT (Temperature difference) ☒ Equipment Referent Temp (Max Temp ...Body Capacitor Bank..... =....70....°C)

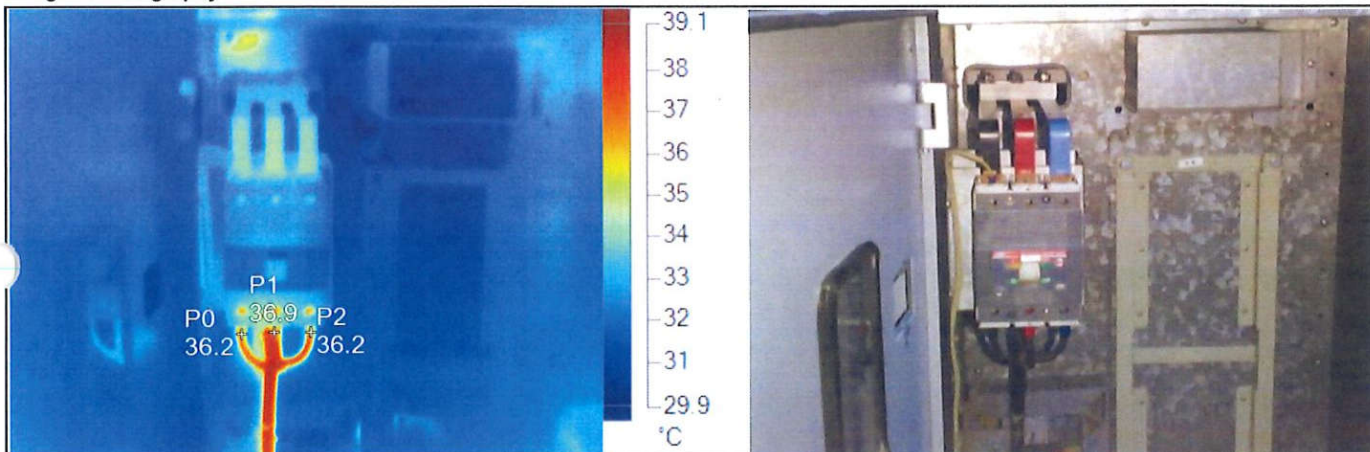
IR_06247.IS212/21/2021 12:59:26 PM

Equipment Name :	Molded Case Circuit Breaker	Distance :	0.3	Metre
Hotspot Point :	Joint Connect	Ambient Temp :	28	°C
Emissivity :	0.95	Year/Month :	12/2021

Diagnosis: ☒ ΔT (Temperature difference) ☐ Equipment Referent Temp (Max Temp = °C)

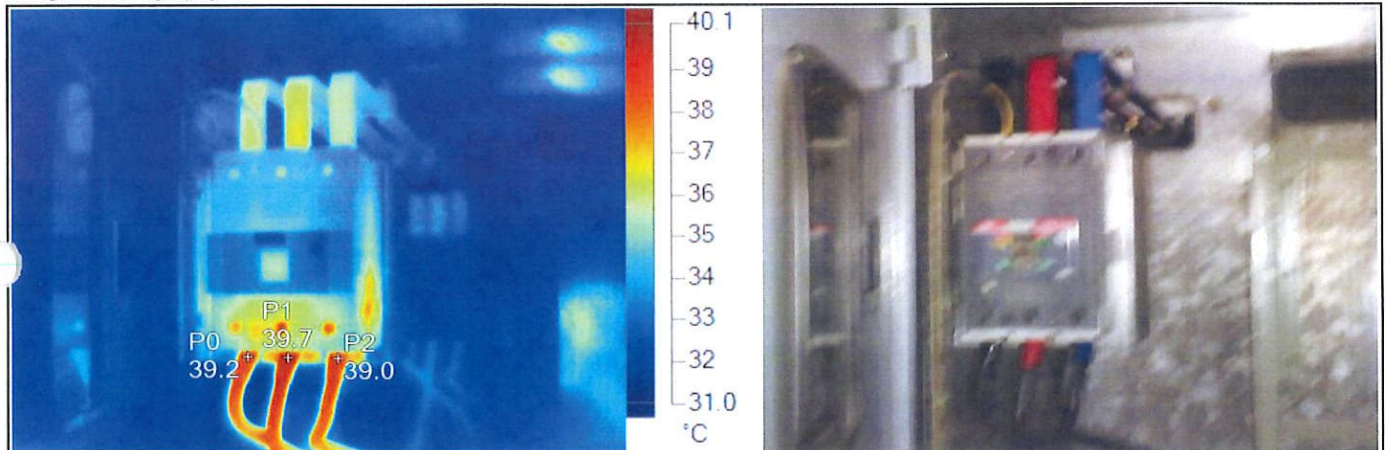
IR_06249.IS212/21/2021 1:01:41 PM

Equipment Name :	Molded Case Circuit Breaker	Distance :	0.3	Metre
Hotspot Point :	Joint Connect	Ambient Temp :	28	°C
Emissivity :	0.95	Year/Month :	12/2021

Diagnosis: ☒ ΔT (Temperature difference) ☐ Equipment Referent Temp (Max Temp = °C)
