ภาคผนวก ง

ตัวอย่างสำเนาเอกสารบันทึกการซ่อมบำรุงเชิงป้องกัน

ภาคผนวก ง-2
ตัวอย่างเอกสารบันทึก
การซ่อมบำรุงเชิงป้องกัน - ไฟฟ้า

CENTARA GRAND
MIRAGE
BEACH RESORT PATTAYA

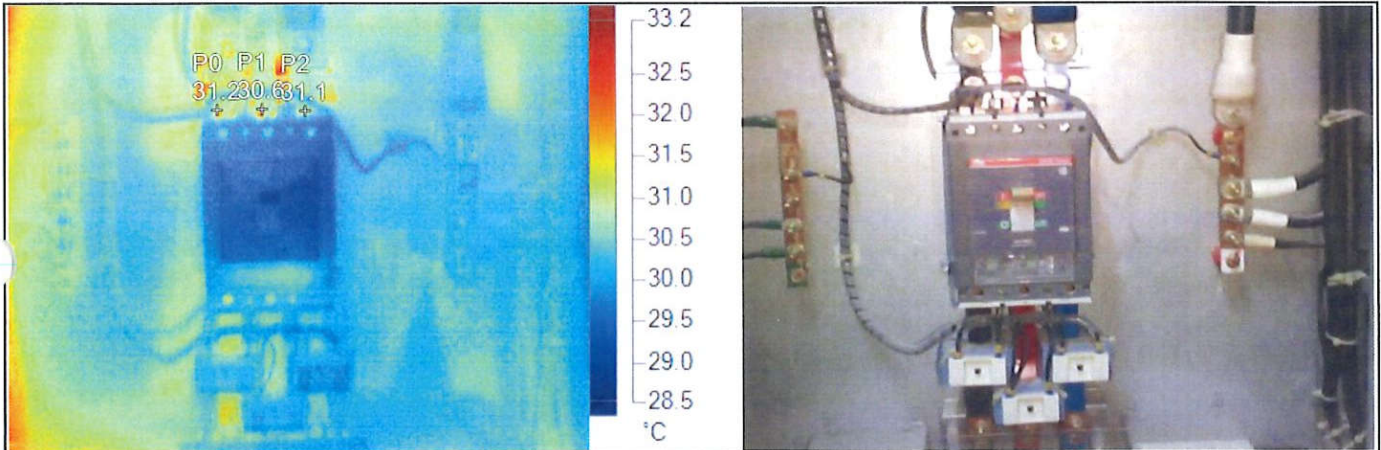
IR_06250.IS212/21/2021 1:09:47 PM

Equipment Name :	Molded Case Circuit Breaker	Distance :	0.3	Metre
Hotspot Point :	Joint Connect	Ambient Temp :	28	°C
Emissivity :	0.95	Year/Month :	12/2021

Diagnosis: ☒ ΔT (Temperature difference) ☐ Equipment Referent Temp (Max Temp = °C)

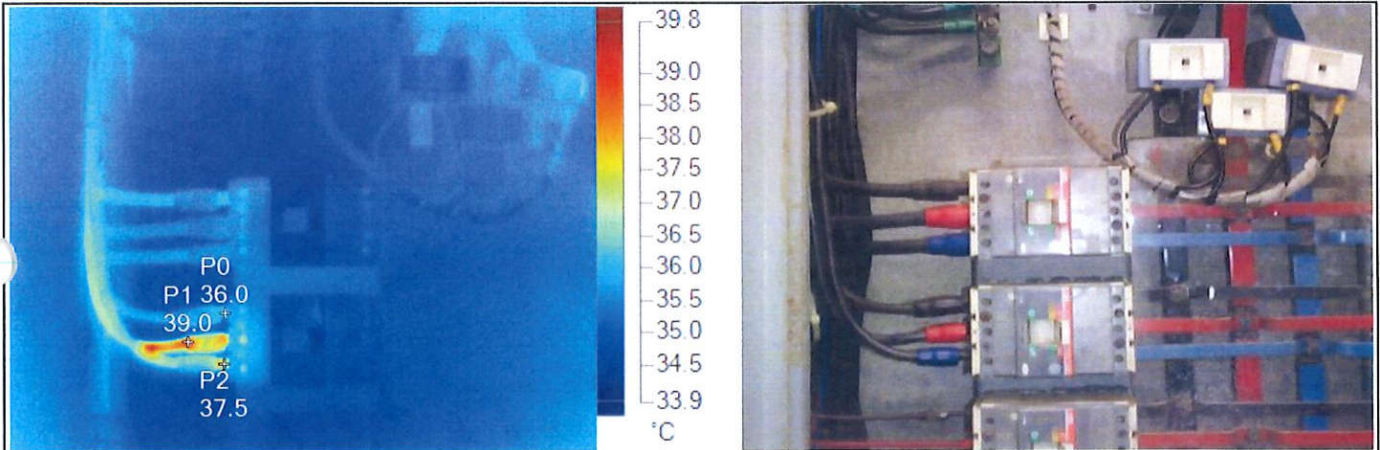
IR_06252.IS212/21/2021 1:14:46 PM

Equipment Name :	Molded Case Circuit Breaker	Distance :	0.3	Metre
Hotspot Point :	Joint Connect	Ambient Temp :	28	°C
Emissivity :	0.95	Year/Month :	12/2021

Diagnosis: ☒ ΔT (Temperature difference) ☐ Equipment Referent Temp (Max Temp = °C)

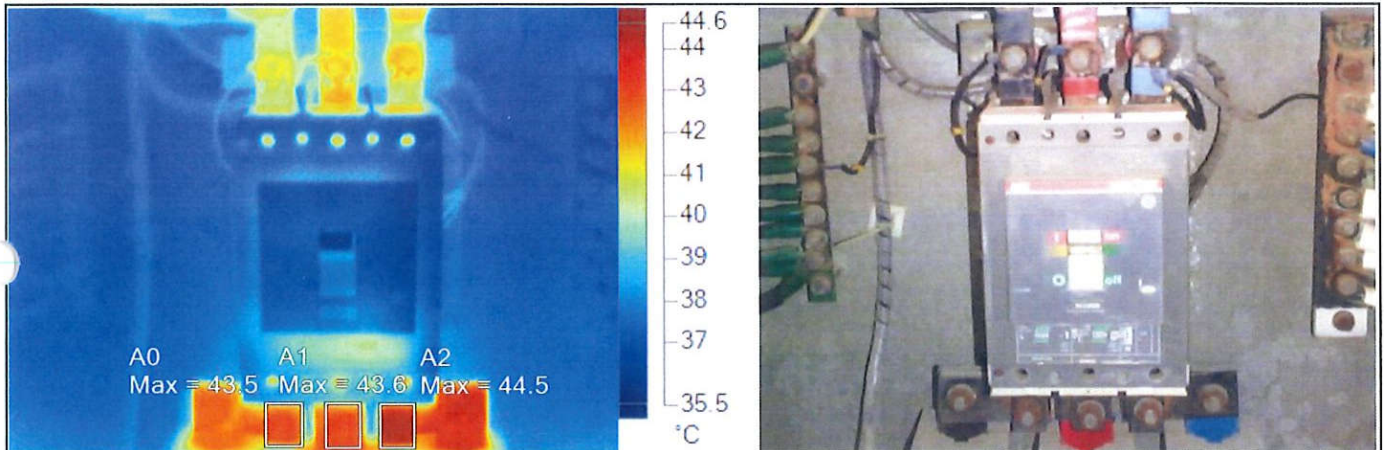
IR_06253.IS212/21/2021 1:16:28 PM

Equipment Name :	Molded Case Circuit Breaker	Distance :	0.3	Metre
Hotspot Point :	Bus Bar	Ambient Temp :	28	°C
Emissivity :	0.95	Year/Month :	12/2021

Diagnosis: ☒ ΔT (Temperature difference) ☐ Equipment Referent Temp (Max Temp = °C)

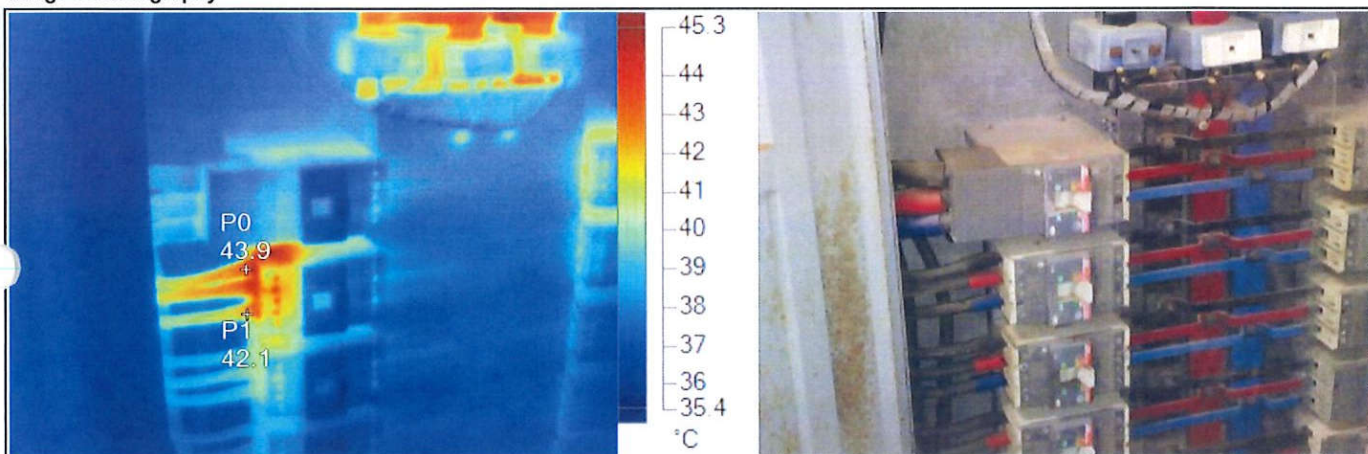
IR_06254.IS212/21/2021 1:17:08 PM

Equipment Name :	Molded Case Circuit Breaker	Distance :	0.3	Metre.
Hotspot Point :	Joint Connect	Ambient Temp :	28	°C
Emissivity :	0.95	Year/Month :	12/2021

Diagnosis: ☒ ΔT (Temperature difference) ☐ Equipment Referent Temp (Max Temp =..... °C)

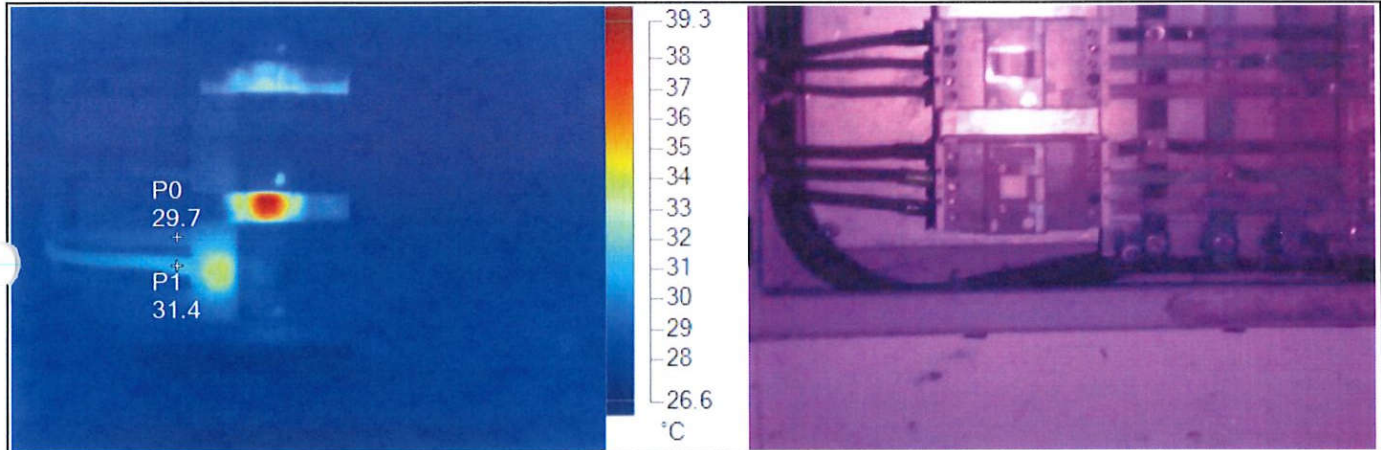
IR_06257.IS212/21/2021 1:36:49 PM

Equipment Name :	Molded Case Circuit Breaker	Distance :	0.3	Metre
Hotspot Point :	Joint Connect	Ambient Temp :	28	°C
Emissivity :	0.95	Year/Month :	12/2021

Diagnosis:	<input checked="" type="checkbox"/> ΔT (Temperature difference)	<input type="checkbox"/> Equipment Referent Temp (Max Temp = °C)
------------	---	--
