**INSPECTION REPORT
FOR
S&L SPECIALTY POLYMERS CO., LTD.**

**VISUAL EXAMINATION
FOR
LINE CHLORINE GAS**

**INSPECTION DATE
4 - 7 April 2022**

**PREPARED BY
IS INDUSTRIE (THAILAND) LTD.**

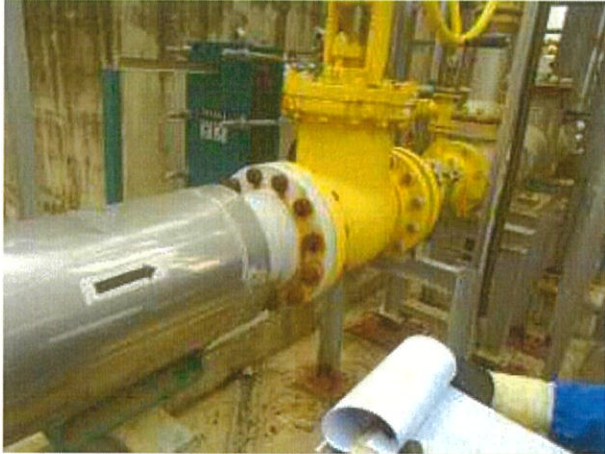
<p>For Visual Overview Date : 4 - 7 April 2022</p> <p>Bolts were light surface rust only, did not found rust scale due to corrosion. (General corrosion on bolts and nuts).</p>
2

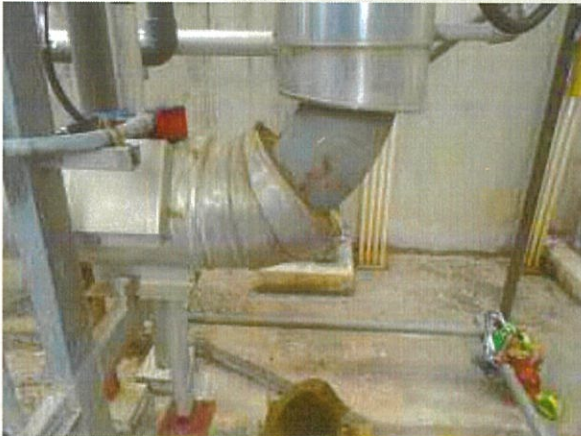
<p>For Visual (CUI) Date : 4 - 7 April 2022</p> <p>On the local Open insulation Elbow was good surface condition of piping under insulation. No visible rust from visual inspection on this area.</p>
3

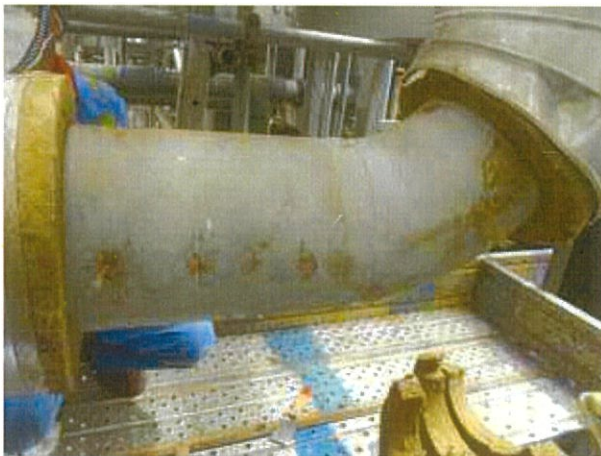
<p>For Visual (CUI) Date : 4 - 7 April 2022</p> <p>On the local Open insulation Elbow and straight pipe were good surface condition of piping under insulation. No visible rust from visual inspection on this area.</p>

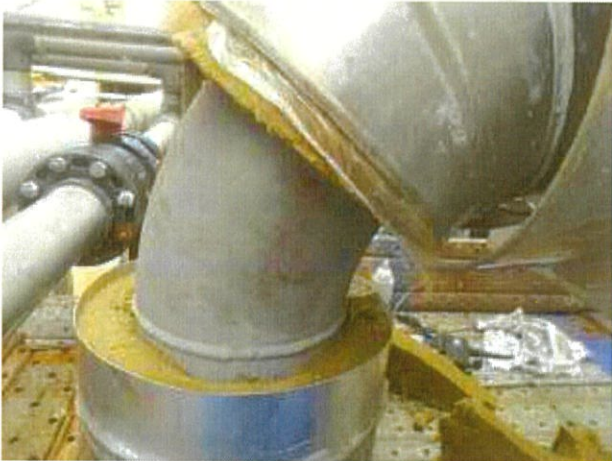
<p>For Visual (CUI) Date : 4 - 7 April 2022</p> <p>On the local Open insulation Elbow was good surface condition of piping under insulation. No visible rust from visual inspection on this area.</p>
5

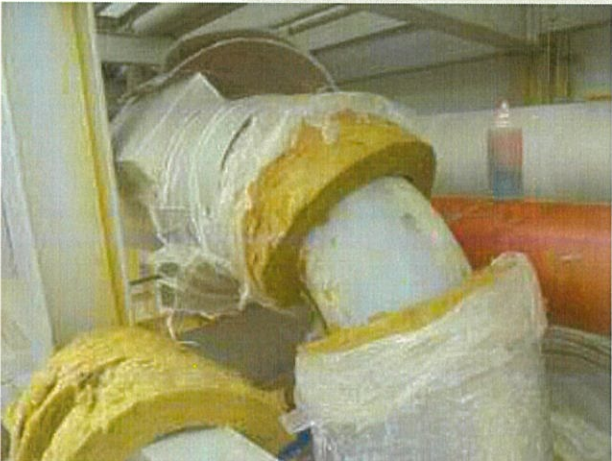
<p>For Visual (CUI) Date : 4 - 7 April 2022</p> <p>On the local Open insulation Elbow was good surface condition of piping under insulation. No visible rust from visual inspection on this area.</p>
6

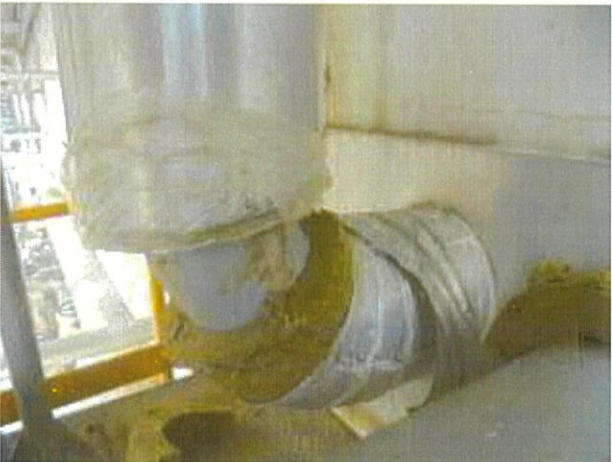
<p>For Visual (CUI) Date : 4 - 7 April 2022</p> <p>On the local Open insulation Elbow was good surface condition of piping under insulation. No visible rust from visual inspection on this area.</p>

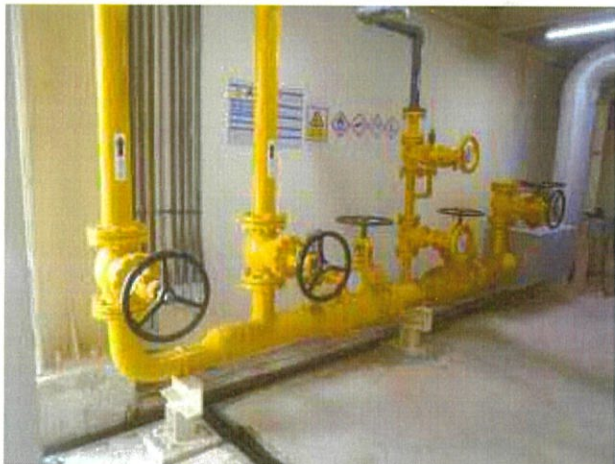
<p>For Visual External Date : 4 - 7 April 2022</p> <p>Good surface condition.</p> <p>Joint connection of piping system. No leak.</p>
8

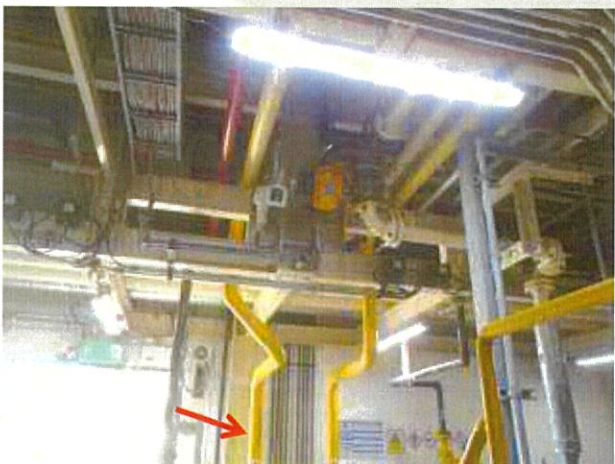
<p>For Visual External Date : 4 - 7 April 2022</p> <p>Good surface condition.</p>
9

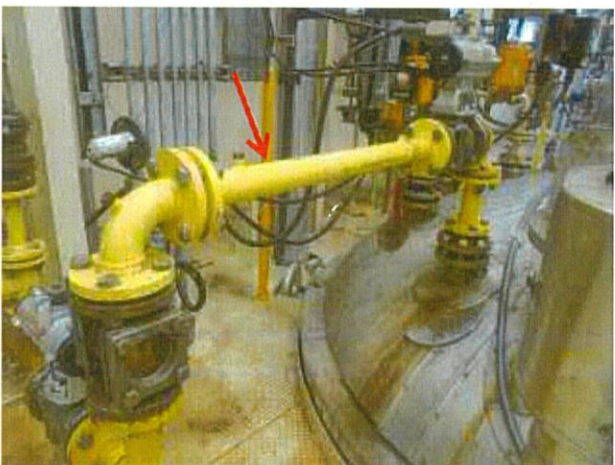
<p>For Visual External (Painting/Coating) Date : 4 - 7 April 2022</p> <p>Good surface condition.</p> <p>Joint connection of piping system. No leak.</p>

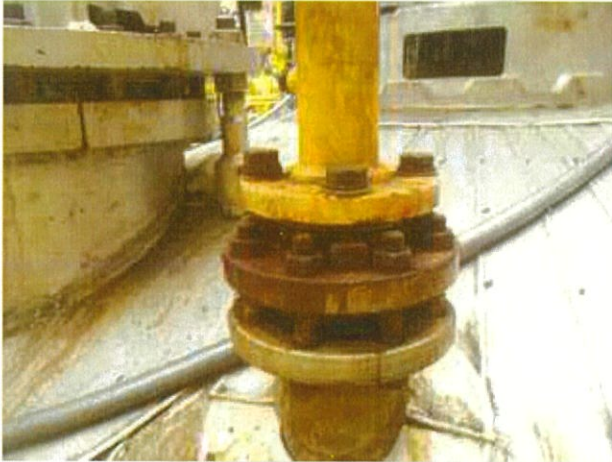
<p>For Visual External (Joint Flange) Date : 4 - 7 April 2022</p> <p>On the local Bolts & Nuts were light surface rust only, did not found rust scale due to corrosion.</p> <p>Type of corrosion</p> <ul style="list-style-type: none"> - General corrosion on bolts and nuts.
11

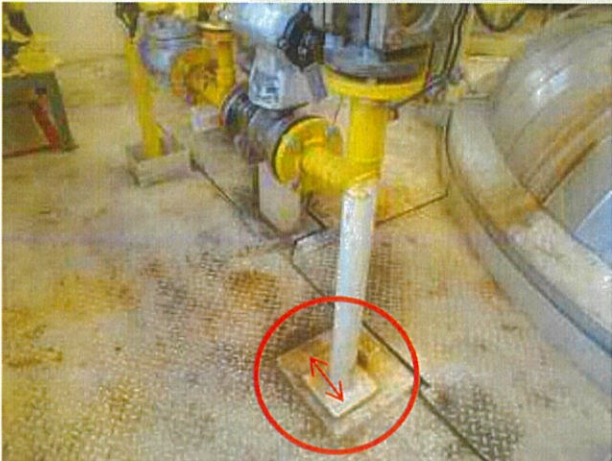
<p>For Visual External (on the local pipe support) Date : 4 - 7 April 2022</p> <p>VT was found base plate not contract with floor.</p> <p>Recommended should be install guide support stopper at both sides dummy support and insert plate.</p>
12

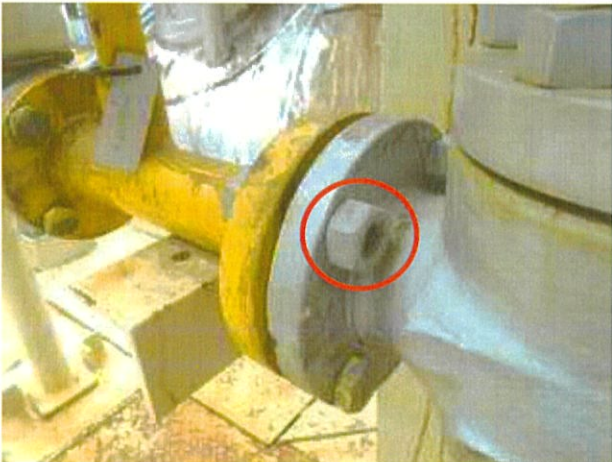
<p>For Visual External (Joint flange) Date : 4 - 7 April 2022</p> <p>VT was found bolts not extend through nut.</p> <p>Recommend should be replacing Bolts.</p> <p>Note; in acc. Code B31.3 para. 335.2.3 Bolt Length. Bolts shall extend through their nuts.</p>

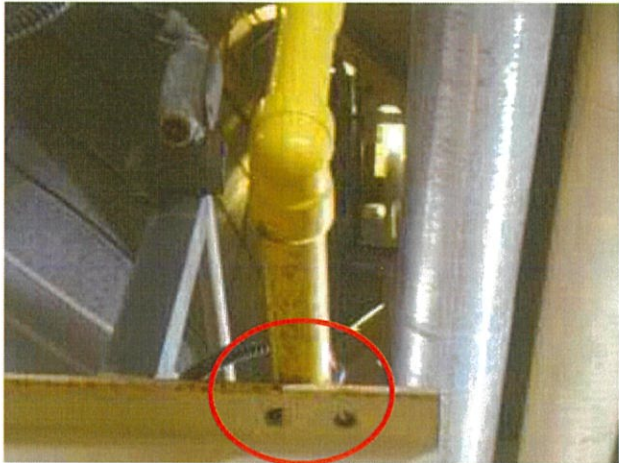
<p>For Visual External (pipe support) Date : 4 - 7 April 2022</p> <p>Incorrect fix pipe support Was found many points on the local pipe lost of u-bolt at first floor area.</p>
11

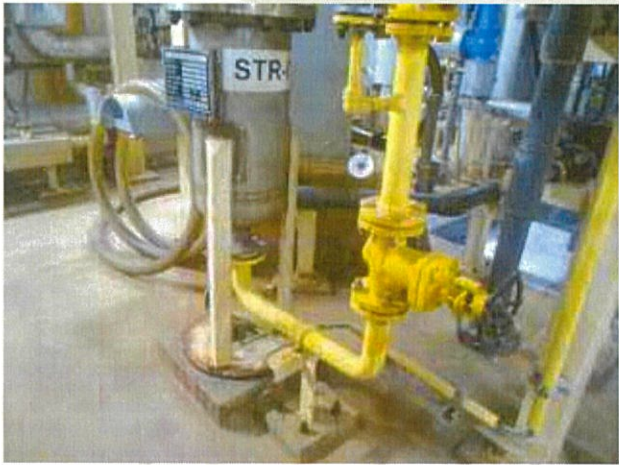
<p>For Visual External (Coating) Date : 4 - 7 April 2022</p> <p>Good surface condition.</p> <p>Joint connection of piping system. No leak.</p>
