แผนการดูแลบำรุงรักษาท่อส่งก๊าซ ประจำปี 2565

รายการตรวจสอบแนวท่อก๊าซธรรมชาติ
เดือนมีนาคมถึงเดือนธันวาคม 2565

รายการตรวจสอบแนวท่อก๊าซธรรมชาติ (Pipeline Patrolling Form)

Route Code: RC447301 **Survey Route:** RC447301 **Region:** Region9

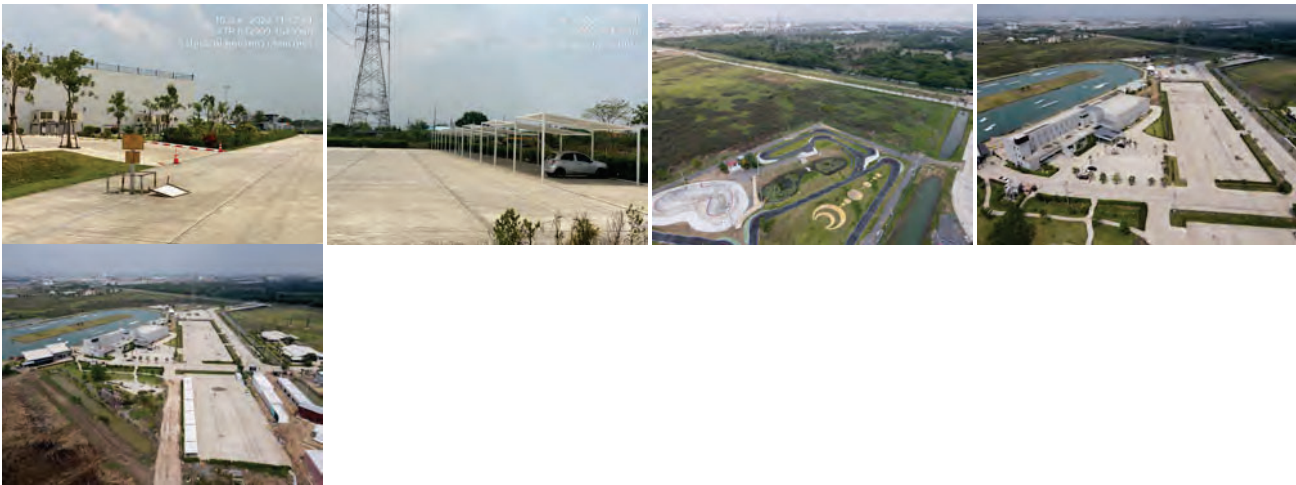
Anomaly Data	Location	GPS			Anomaly Type	Anomaly Detail	Fix Plan	Status
		North	East	Zone				
25/03/2022	0+450 - 0+900	1,549,277.368	672,932.345	47P	งานก่อสร้างในระยะ ROW	โครงการ ESC Park	25 Mar 2022	Issue

NO.	Anomaly Date	Location KP	Anomaly Detail	Fix Plan	Status
1	25/03/2022	0+450 - 0+900	โครงการ ESC Park	25 Mar 2022	Issue
Before Fix Problem

After Fix Problem					
N/A

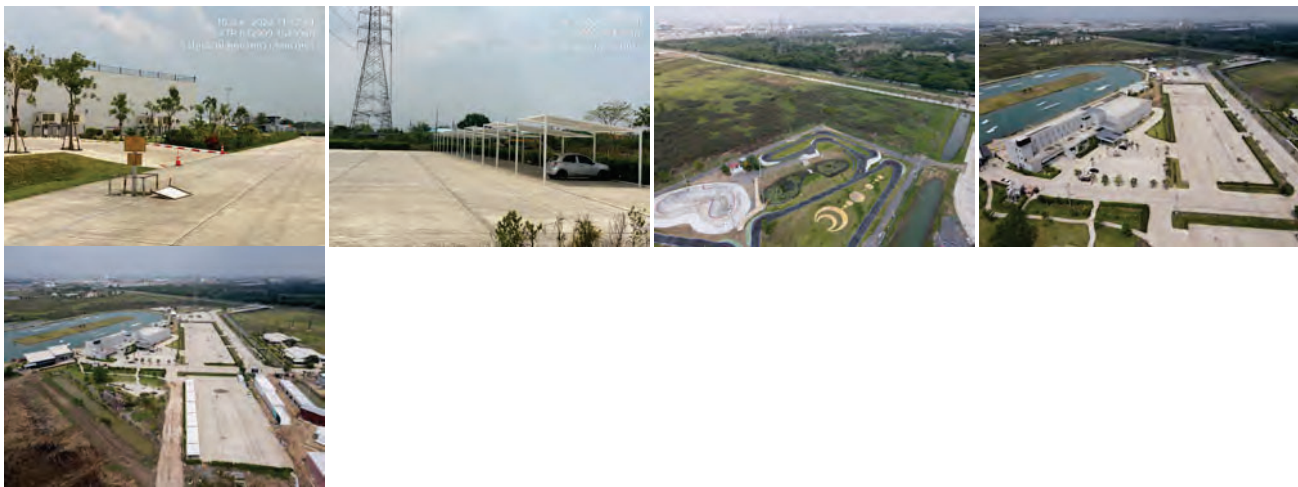
Anomaly Data	Location	GPS			Anomaly Type	Anomaly Detail	Fix Plan	Status
		North	East	Zone				
25/03/2022	0+450 - 0+900	1,549,277.36M	672,932.345	47P	งานก่อสร้างในระยะ ROW	โครงการ HSC Park	25 8 ar 2022	Issue

NO.	Anomaly Date	Location KP	Anomaly Detail	Fix Plan	Status
1	25/03/2022	0+450 - 0+900	โครงการ HSC Park	25 8 ar 2022	Asue
Before Fix Problem

After Fix Problem					
N/J

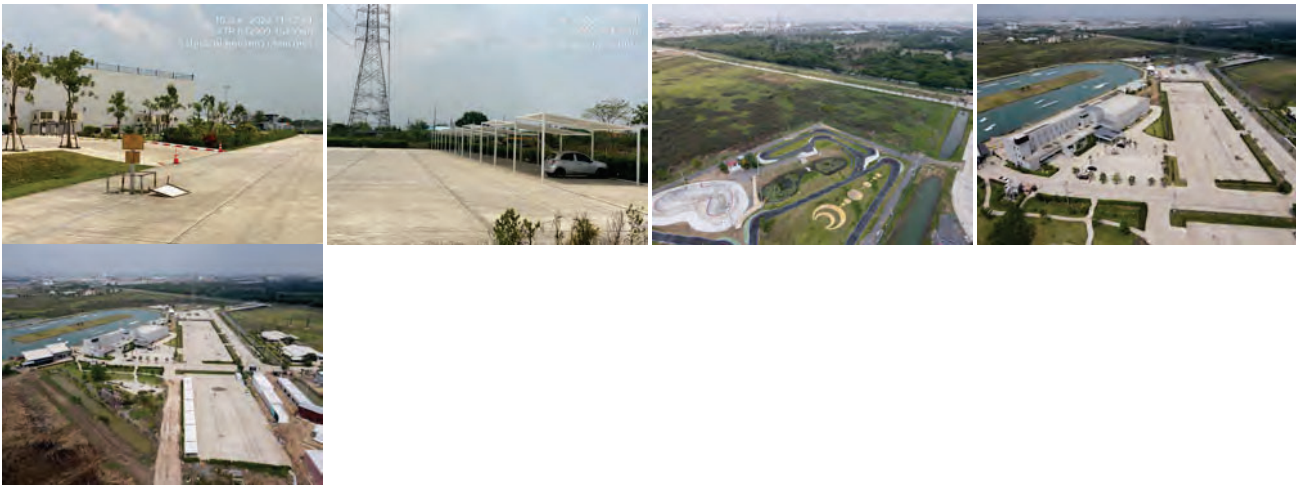
Anomaly Data	Location	GPS			Anomaly Type	Anomaly Detail	Fix Plan	Status
		North	East	Zone				
25/03/2022	0+450 - 0+900	1,549,277.368	672,932.345	47P	งานก่อสร้างในระยะ ROW	โครงการ ESC Park	25 Mar 2022	Issue

NO.	Anomaly Date	Location KP	Anomaly Detail	Fix Plan	Status
1	25/03/2022	0+450 - 0+900	โครงการ ESC Park	25 Mar 2022	Issue
Before Fix Problem

After Fix Problem					
N/A

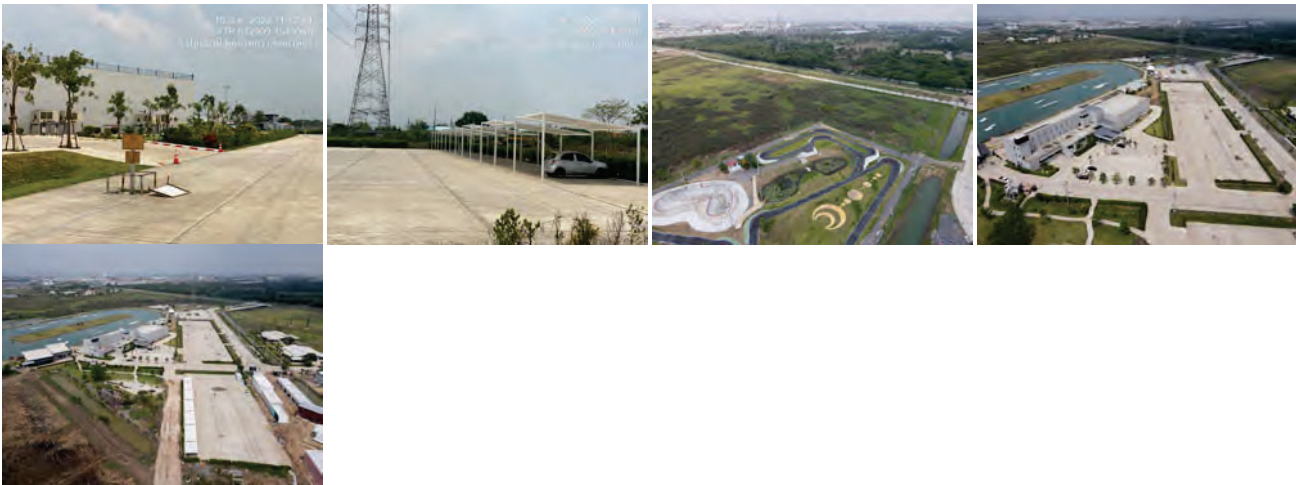
Anomaly Data	Location	GPS			Anomaly Type	Anomaly Detail	Fix Plan	Status
		North	East	Zone				
25/03/2022	0+450 - 0+900	1,549,277.368	672,932.345	47P	งานก่อสร้างในระยะ ROW	โครงการ ESC Park	25 Mar 2022	Issue

NO.	Anomaly Date	Location KP	Anomaly Detail	Fix Plan	Status
1	25/03/2022	0+450 - 0+900	โครงการ ESC Park	25 Mar 2022	Issue
Before Fix Problem

After Fix Problem					
N/A

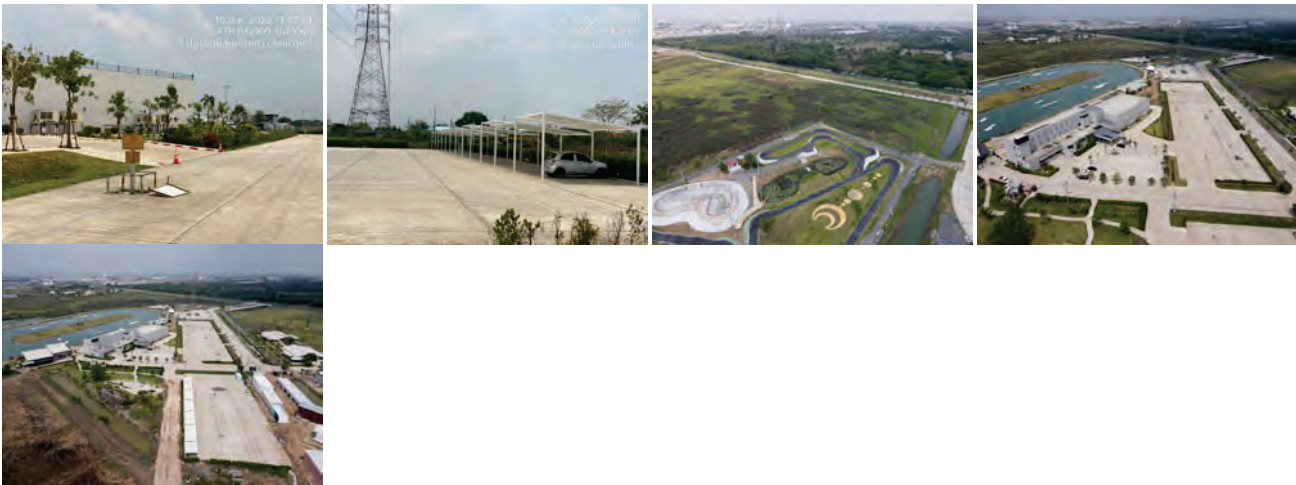
Anomaly Data	Location	GPS			Anomaly Type	Anomaly Detail	Fix Plan	Status
		North	East	Zone				
25 Nov 2022	0+450 - 0+900	1,549,277.386	872,932.345	47P	งานก่อสร้างในระยะ ROW	โครงการ BSC Park	25 / ar 2022	Issue

NO.	Anomaly Date	Location KP	Anomaly Detail	Fix Plan	Status
1	25/03/2022	0+450 - 0+900	โครงการ BSC Park	25 / ar 2022	Issue
Before Fix Problem

After Fix Problem					
b ME

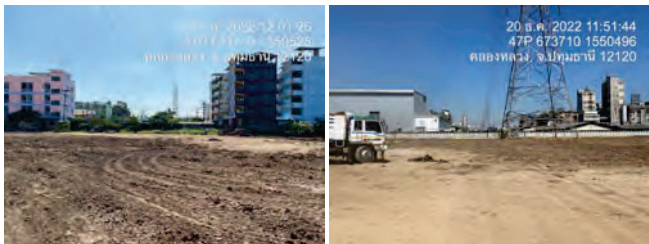
NO.	Anomaly Date	Location KP	Anomaly Detail	Fix Plan	Status
2	20M2M2022	1-950 , 2-028	งานถมดินหลังแนวท่อเพื่อเตรียมงานก่อสร้าง	20 bec 2022	OnProcess
Before Fix Problem

After Fix Problem					
J NK

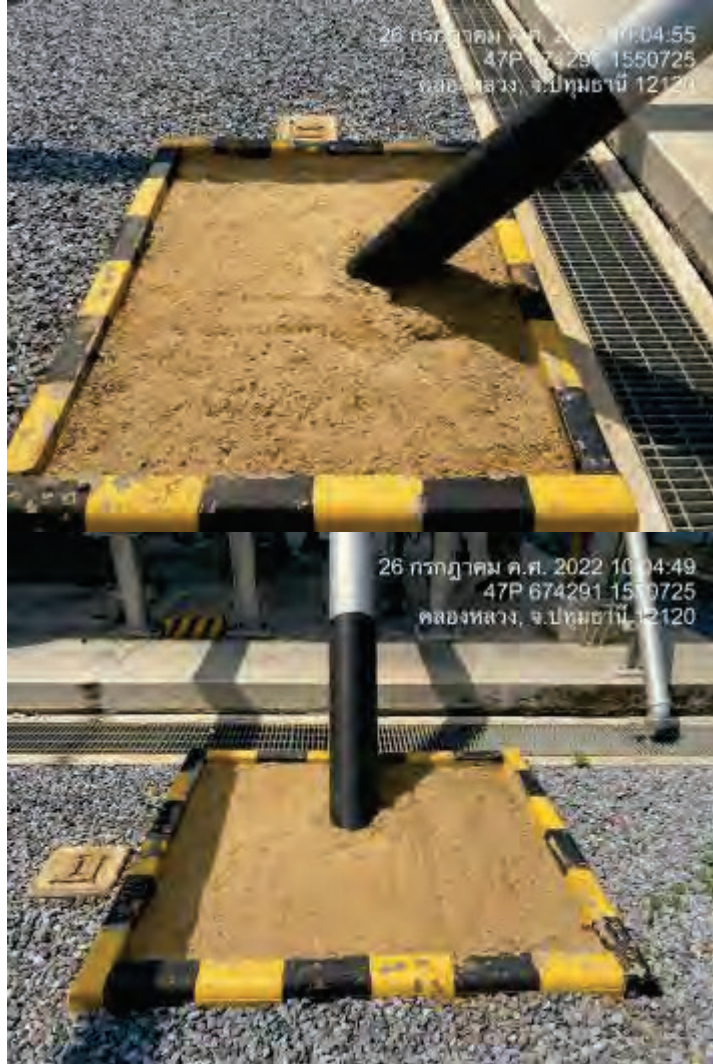
จุดที่ 1 Pipe Description or Line ID : Inlet Inspection Date : 26/07/2022

Water condensed / มีหยดน้ำเกาะท่อ ☐ Yes ☒ No

Surface temperature / อุณหภูมิผิวท่อ 30.00 °C

☒ Good ☐ Local Disbonding ☐ Extensive Disbonding

☒ No corrosion ☐ <20% w.t. ☐ 20-80% w.t. ☐ >80% w.t.

☒ No repair ☐ Coating with ☐ อื่นๆ

31/07/2023
