รายงานการตรวจสอบสภาพและความหนาของระบบท่อ

PIPING INSPECTION SUMMARY REPORT

Report/ Project	Sheet
			2112012	S 1/1
STT-CC-001-02-01 (TRL 001 G-Base 95 Tank Receiving line (Jetty to Tank No.1,2,3))

Date of inspections: 24 December 2021

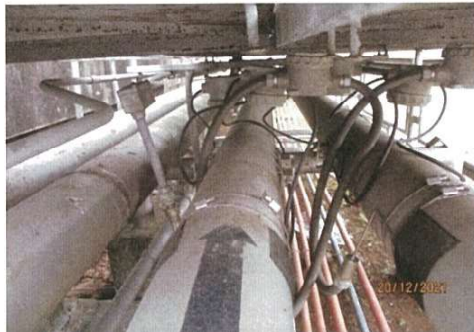
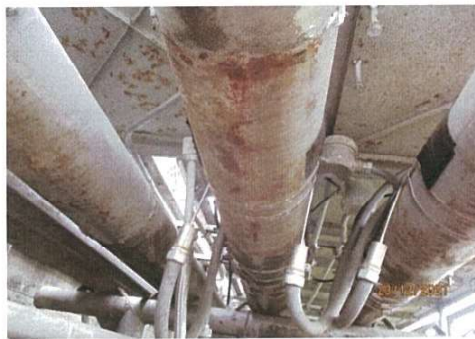
Pipe inspection summary
Visual Inspection (VT) - Painting deterioration and general corrosion on pipe.
Ultrasonic Thickness Measurement (UTM) - UTM : The actual minimum thickness found as 5.96 mm. - Maximum Corrosion rate: 0.347 mm/yr -Minimum Remaining Life: 10.04 yrs

Name of part / Location		Findings		
TRL 001 Tank Receiving line (Jetty to Tank No.3,10) Anomaly no : 2.1		Painting deterioration and general corrosion on pipe		
Name of part / Location		Findings		
TRL 001 Tank Receiving line (Jetty to Tank No.3,10) Anomaly no : 2.1		Painting deterioration and general corrosion on pipe

Recommendations
Visual Inspection (VT) -Recommendation to arrest corrosion by sufficient surface preparation (blasting preferred) and application of coating following approved procedures within 6 months.
Ultrasonic Thickness Measurement (UTM) - Thickness monitoring should be performed at next 5 yrs interval.

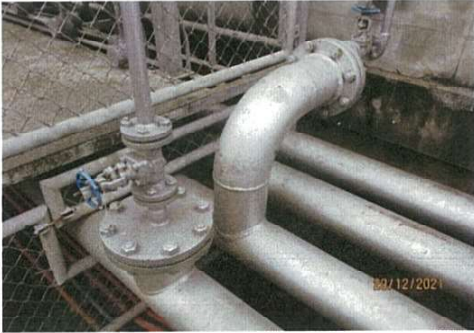
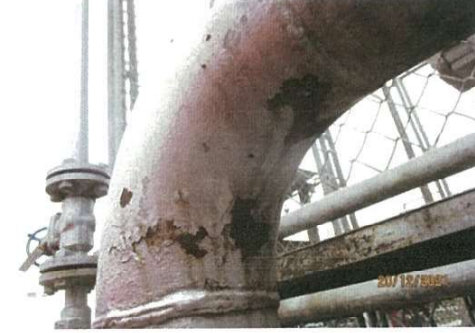
Name of part / Location		Findings		
TRL 001 Tank Receiving line (Jetty to Tank No.3,10) Anomaly no : 2.2		Painting deterioration and general corrosion on elbow		
Name of part / Location		Findings		
TRL 001 Tank Receiving line (Jetty to Tank No.3,10) Anomaly no : 2.2		Painting deterioration and general corrosion on elbow

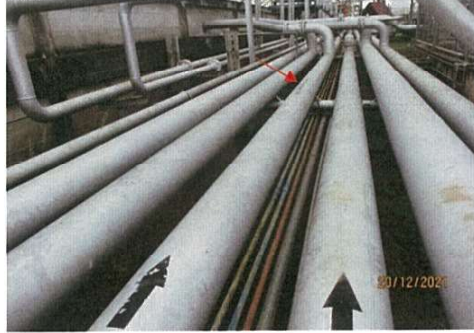
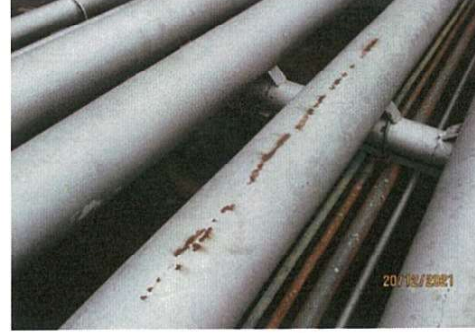
Name of part / Location		Findings		
TRL 001 Tank Receiving line (Jetty to Tank No.3,10) Anomaia no : 2.3		Painting deterioration and general corrosion on pipe

Name of part / Location		Findings		
TRL 001 Tank Receiving line (Jetty to Tank No.3,10) Anomaly no : 2.3		Painting deterioration and general corrosion on pipe

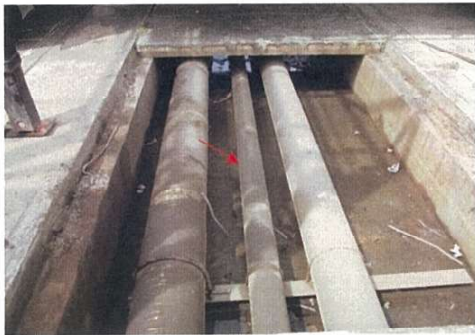
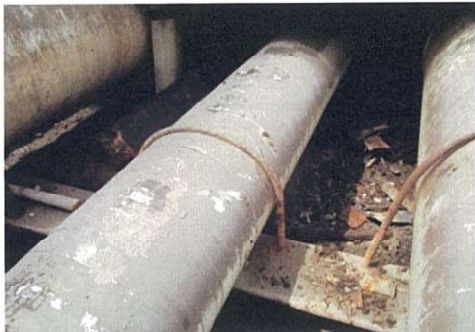
Name of part / Location			Findings		Name of part / Location			Findings	
TRL 001 Tank Receiving line (Jetty to Tank No.3,10) Anomaly no : 6.1			general corrosion on U-bolt support		TRL 001 Tank Receiving line (Jetty to Tank No.3,10) Anomaly no : 6.1			general corrosion on U-bolt support

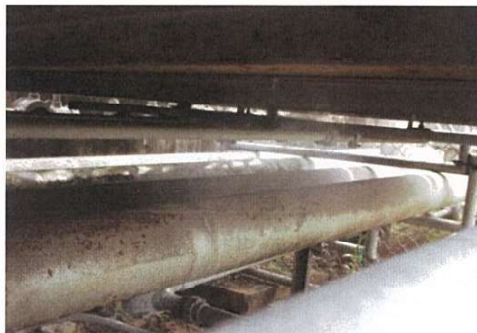
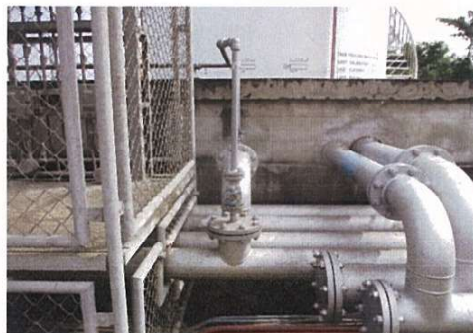
Name of part / Location			Findings		Name of part / Location			Findings	
TRL 002 G-Base 91 Tank Receiving line (Jetty to Tank No.9&Tank No.2)			Slight corrosion on piping&Painting deterioration (1)		TRL 002 G-Base 91 Tank Receiving line (Jetty to Tank No.9&Tank No.2)			Still in normal condition

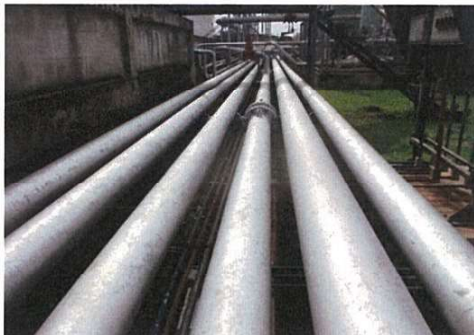
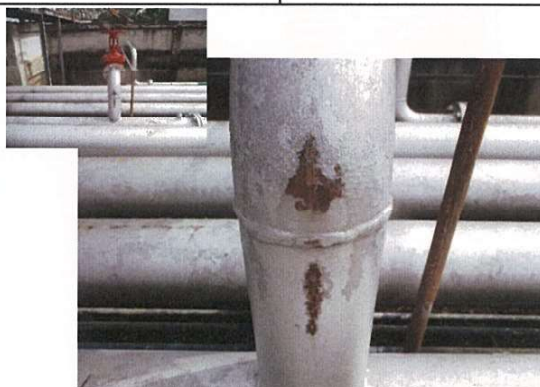
Name of part / Location			Findings		Name of part / Location			Findings	
TRL 002 G-Base 91 Tank Receiving line (Jetty to Tank No.9&Tank No.2)			Still in normal condition		TRL 002 G-Base 91 Tank Receiving line (Jetty to Tank No.9&Tank No.2)			Painting deterioration (2)

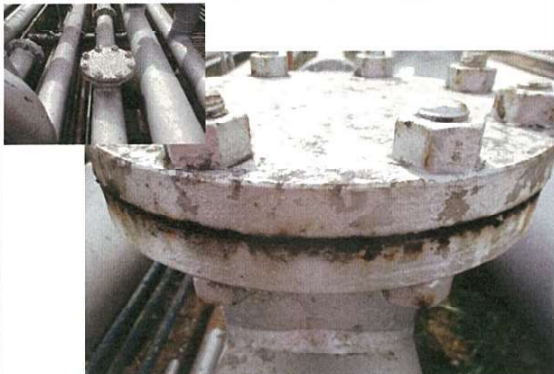
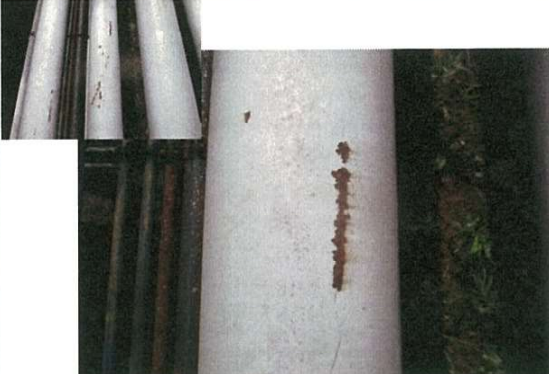
Name of part / Location		Findings		Name of part / Location		Findings	
TRL 002 G-Base 91 Tank Receiving line (Jetty to Tank No.9&Tank No.2)		Slight corrosion on flange (3)		TRL 002 G-Base 91 Tank Receiving line (Jetty to Tank No.9&Tank No.2)		Painting deterioration (4)

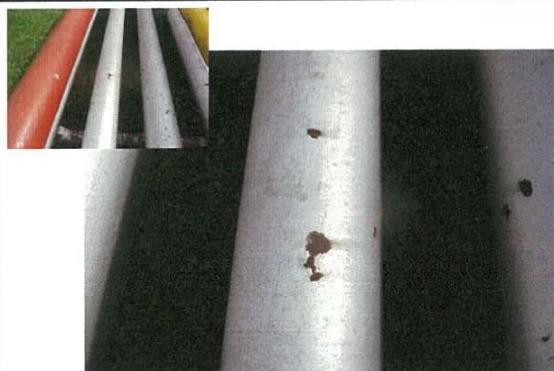
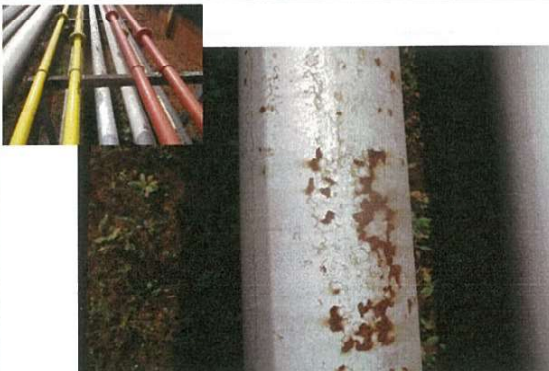
Name of part / Location		Findings		Name of part / Location		Findings	
TRL 002 G-Base 91 Tank Receiving line (Jetty to Tank No.9&Tank No.2)		Painting deterioration (5)		TRL 002 G-Base 91 Tank Receiving line (Jetty to Tank No.9&Tank No.2)		Painting deterioration (6)

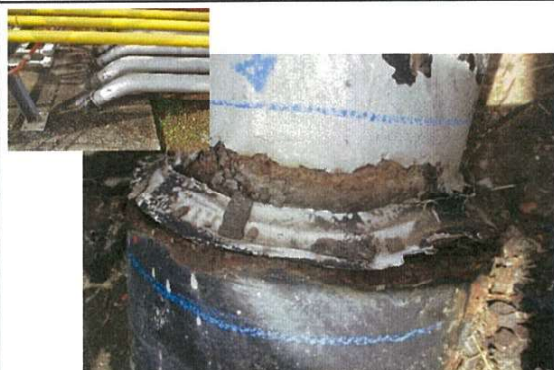
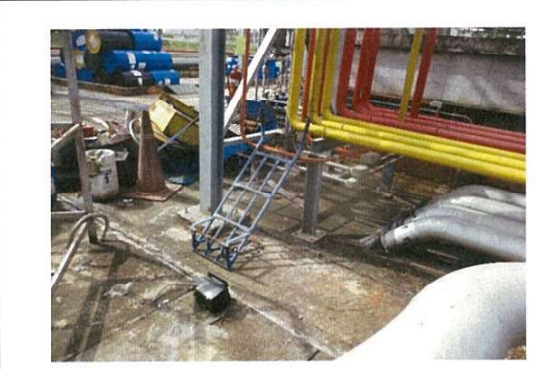
Name of part / Location		Findings		Name of part / Location		Findings	
TRL 002 G-Base 91 Tank Receiving line (Jetty to Tank No.9&Tank No.2)		Severe corrosion under sealing&Sealing damage. (7)		TRL 002 G-Base 91 Tank Receiving line (Jetty to Tank No.9&Tank No.2)		Still in normal condition

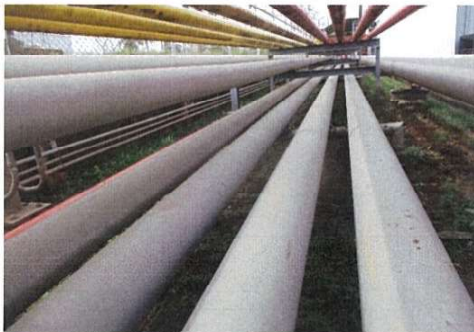
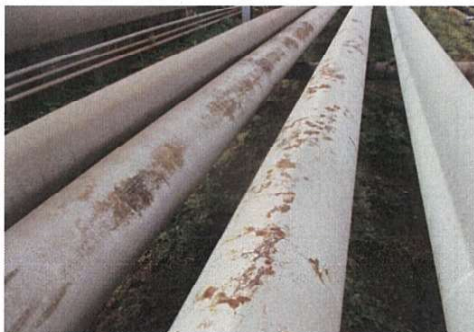
Name of part / Location		Name of part / Location		Findings
TRL 002 G-Base 91 Tank Receiving line (Jetty to Tank No.9&Tank No.2)		TRL 002 G-Base 91 Tank Receiving line (Jetty to Tank No.9&Tank No.2)		Painting deterioration (9)

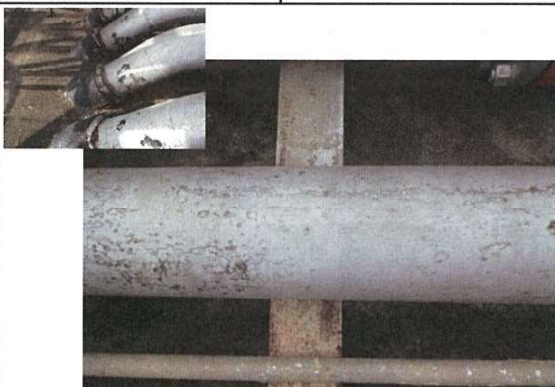
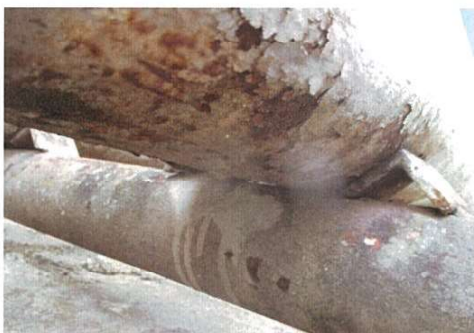
Name of part / Location		Name of part / Location		Findings
TRL 002 G-Base 91 Tank Receiving line (Jetty to Tank No.9)		TRL 002 G-Base 91 Tank Receiving line (Jetty to Tank No.9)		Painting deterioration (11)

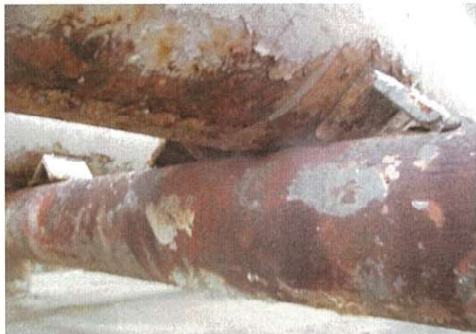
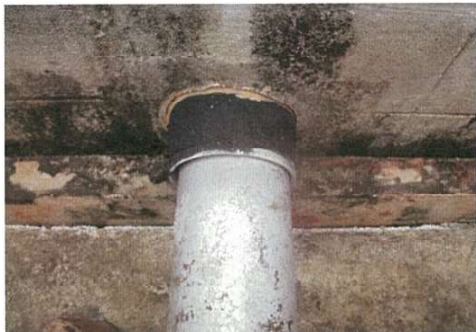
Name of part / Location		Findings		Name of part / Location		Findings	
TRL 002 G-Base 91 Tank Receiving line (Jetty to Tank No.9&Tank No.2)		Painting deterioration (13)		TRL 002 G-Base 91 Tank Receiving line (Jetty to Tank No.9&Tank No.2)		Still in normal condition

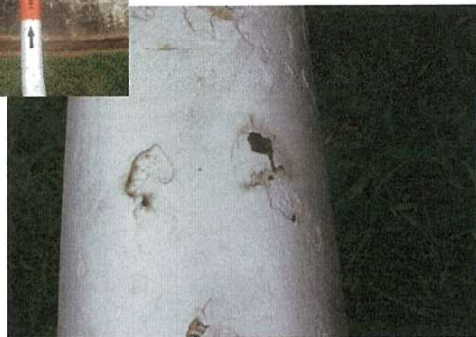
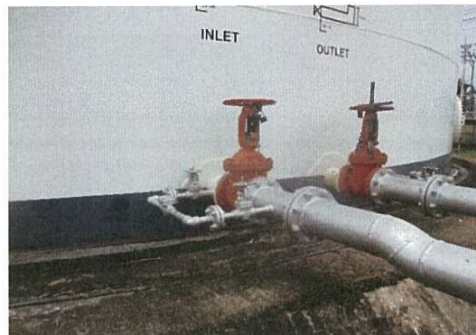
Name of part / Location		Findings		Name of part / Location		Findings	
TRL 002 G-Base 91 Tank Receiving line (Jetty to Tank No.9)		Painting deterioration (14)		TRL 002 G-Base 91 Tank Receiving line (Jetty to Tank No.9)		Still in normal condition

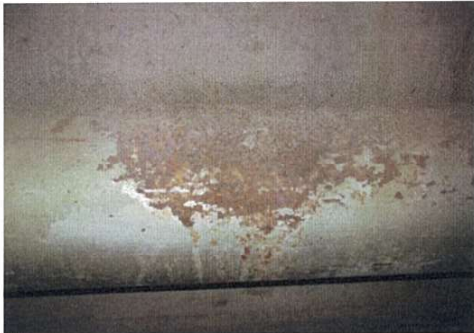
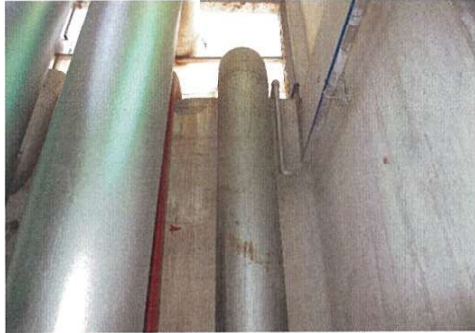
Name of part / Location		Findings		Name of part / Location		Findings	
TRL 002 G-Base 91 Tank Receiving line (Jetty to Tank No.9&Tank No.2)		Slight corrosion on pipe. (15)		TRL 002 G-Base 91 Tank Receiving line (Jetty to Tank No.9&Tank No.2)		Still in normal condition
