INSPECTION REPORT

**LOADING ARM
BI-1, B-2 AND BI-3**

**ESSO SRIRACHA REFINERY PLANT,
CHONBURI**

18-21 And 24 April 2023
Report No: 2304019_Rev.00

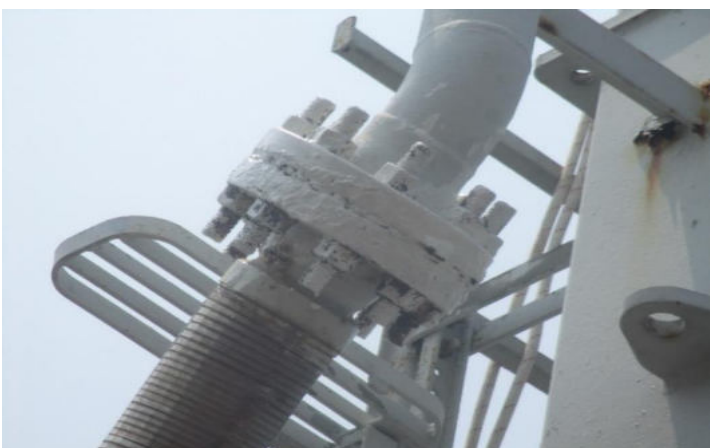
<p>Name of part:</p> <p>3" L-1105 A Loading arm</p> <p>Findings:</p> <p>After paint repair</p>

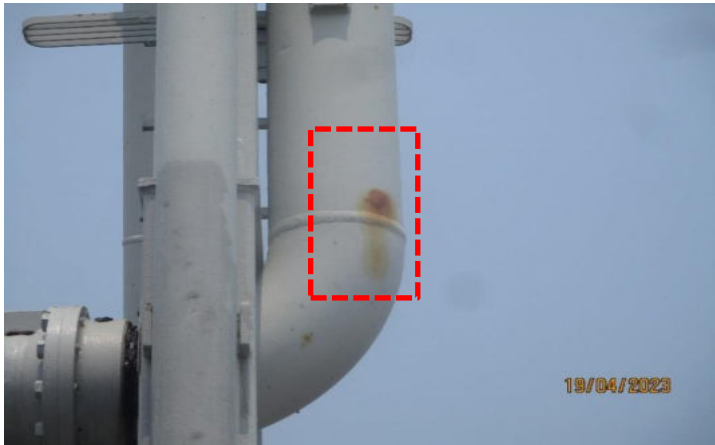
<p>Name of part:</p> <p>8" L-1108 A Loading arm</p> <p>Findings:</p> <p>Corrosion on Pipe.</p>

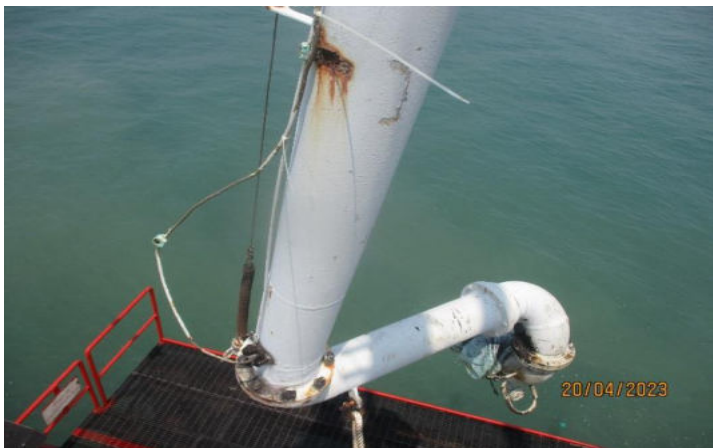
<p>Name of part:</p> <p>8" L-1101 B Loading arm</p> <p>Findings:</p> <p>Was found corrosion on Pipe Support.</p>

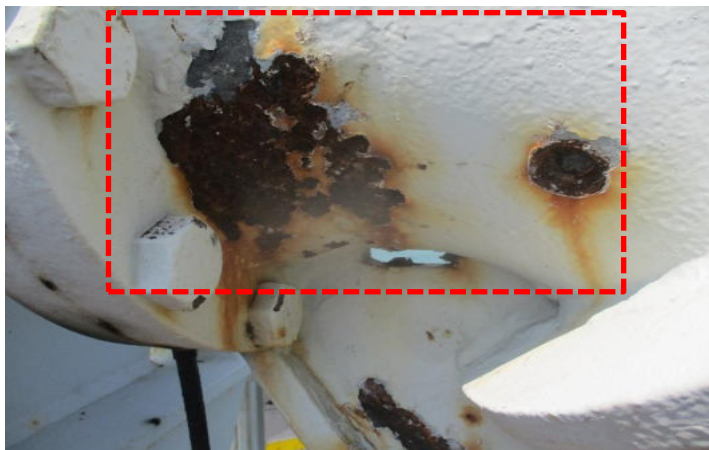
<p>Name of part:</p> <p>8" L-1101 B Loading arm</p> <p>Findings:</p> <p>Corrosion on Elbow.</p>

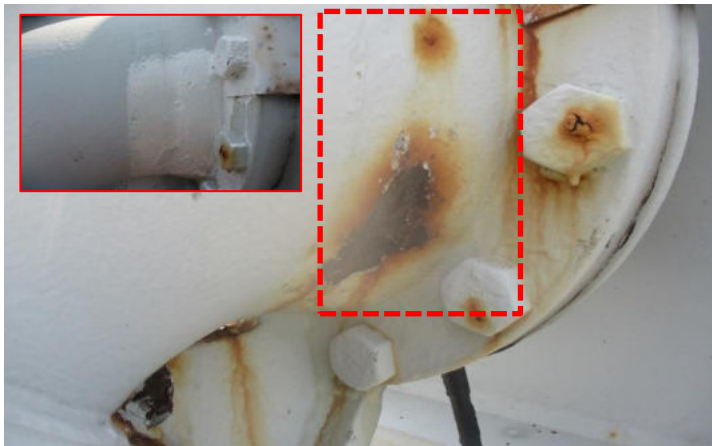
<p>Name of part:</p> <p>8" L-1101 B Loading arm</p> <p>Findings:</p> <p>Corrosion on Elbow. And After paint repair</p>

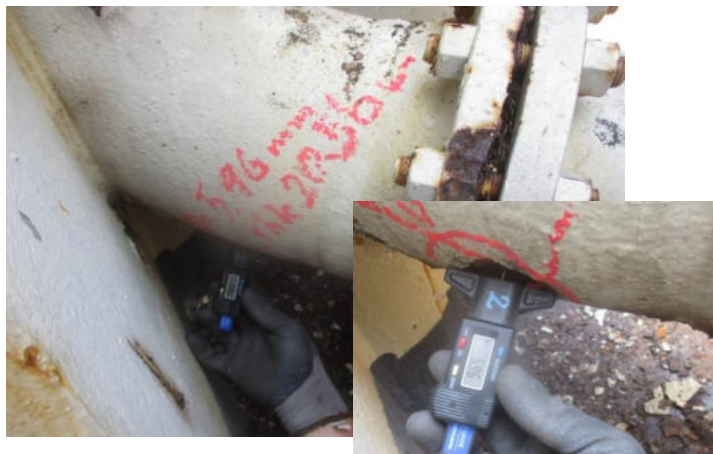
<p>Name of part:</p> <p>8" L-1102 B Loading arm</p> <p>Findings:</p> <p>Corrosion on Elbow. Good area 20.56 mm. Depth = 5.96 mm.</p>

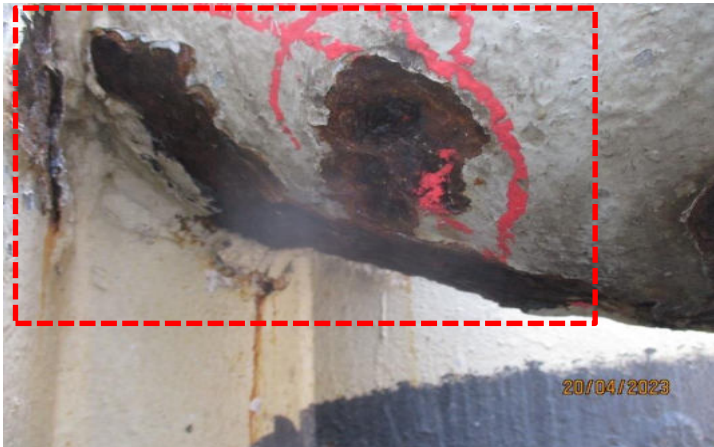
<p>Name of part:</p> <p>8" L-1102 B Loading arm</p> <p>Findings:</p> <p>Corrosion on Elbow. Good area 20.56 mm. Depth = 5.96 mm.</p>

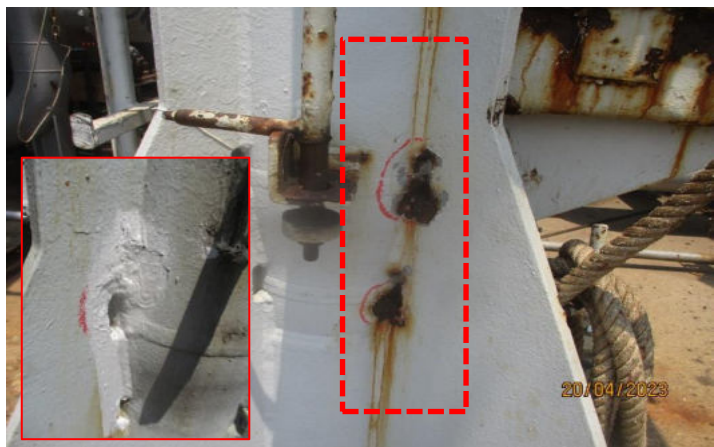
<p>Name of part:</p> <p>8" L-1102 B Loading arm</p> <p>Findings:</p> <p>Corrosion on Structure support.</p>

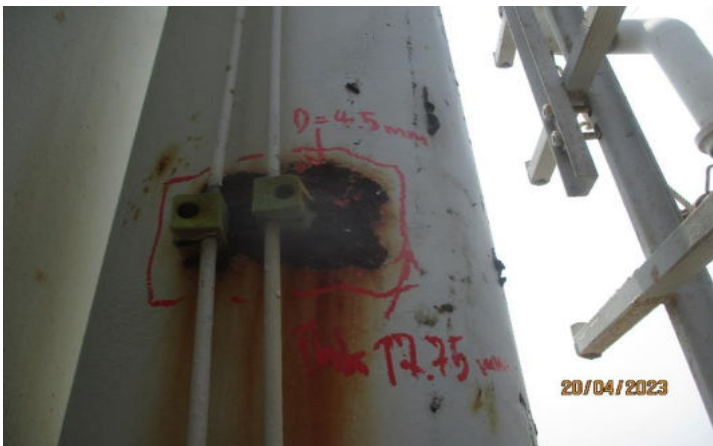
<p>Name of part:</p> <p>8" L-1102 B Loading arm</p> <p>Findings:</p> <p>Corrosion on pipe. Good area 17.75 mm. Depth = 4.50 mm.</p>

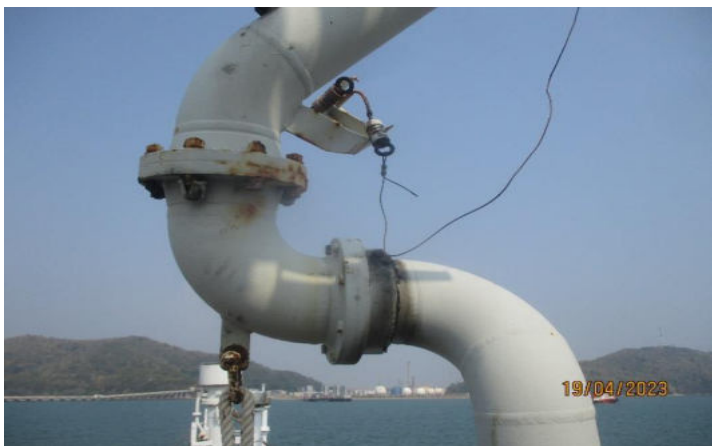
<p>Name of part:</p> <p>8" L-1103 B Loading arm</p> <p>Findings:</p> <p>Corrosion on Flange stud bolt & nuts area.</p>

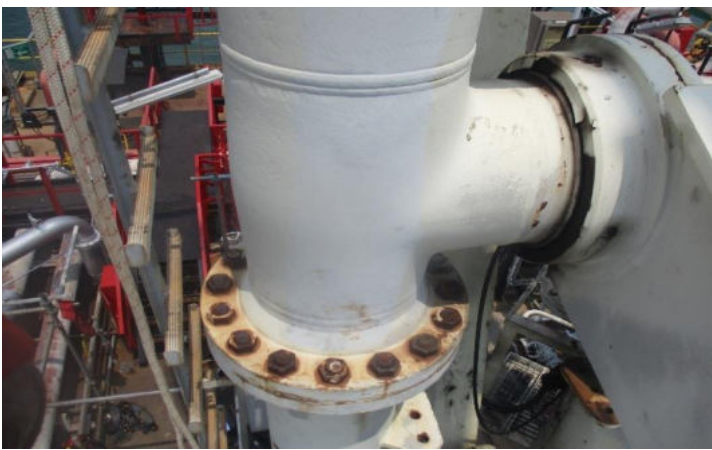
<p>Name of part:</p> <p>8"-LA-P vapor return</p> <p>Findings:</p> <p>Corrosion on stud bolt & nuts area.</p>
