รายงานการตรวจสอบสภาพและความหนาของระบบท่อ

PIPING INSPECTION SUMMARY REPORT

Report/ Project	Sheet
			2112012	S 1/1
STT-CC-001-02-01 (TRL 001 G-Base 95 Tank Receiving line (Jetty to Tank No.1,2,3))

Date of inspections: 24 December 2021

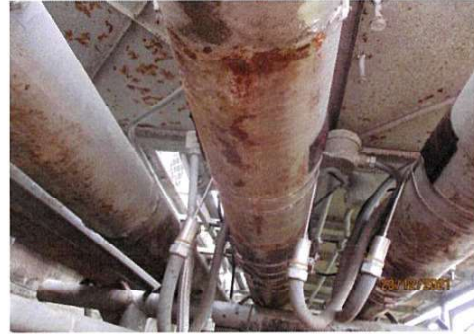
TRL 001 Tank Receiving line
(Jetty to Tank No.3,10)
Anomaly no : 2.1Painting deterioration and
general corrosion on pipe

Recommendations
Visual Inspection (VT) -Recommendation to arrest corrosion by sufficient surface preparation (blasting preferred) and application of coating following approved procedures within 6 months.
Ultrasonic Thickness Measurement (UTM) - Thickness monitoring should be performed at next 5 yrs interval.

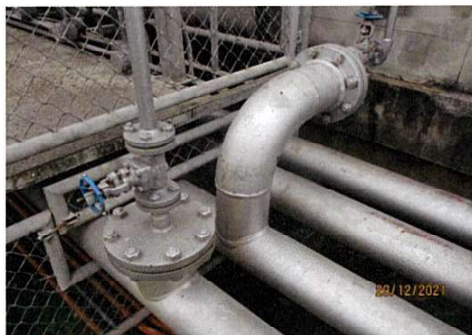
TRL 001 Tank Receiving line
(Jetty to Tank No.3,10)
Anomaly no : 2.1Painting deterioration and
general corrosion on pipe

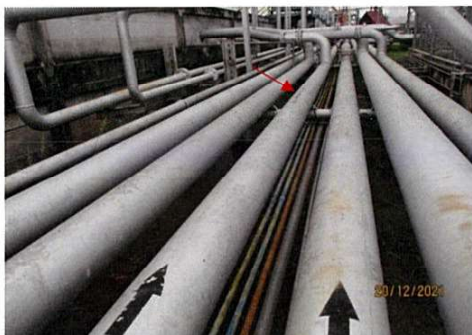
TRL 001 Tank Receiving line
(Jetty to Tank No.3,10)
Anomaly no : 2.2Painting deterioration and
general corrosion on elbow

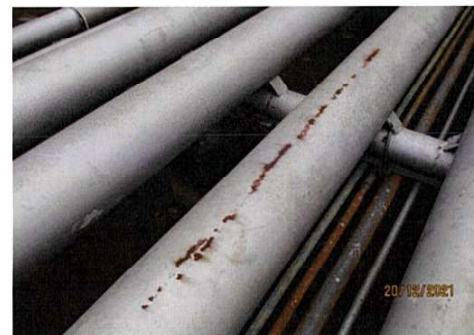
TRL 001 Tank Receiving line
(Jetty to Tank No.3,10)
Anomaly no : 2.3Painting deterioration and
general corrosion on pipe

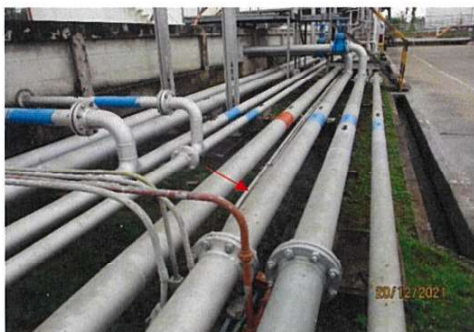
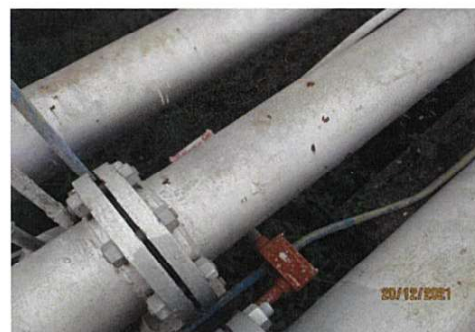
Name of part / Location		Findings	Name of part / Location		Findings
TRL 001 Tank Receiving line (Jetty to Tank No.3,10) Anomaly no : 3.1		Painting deterioration and general corrosion on pipe	TRL 001 Tank Receiving line (Jetty to Tank No.3,10) Anomaly no : 3.1		Painting deterioration and general corrosion on pipe

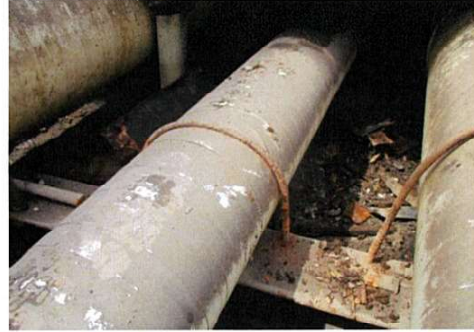
Name of part / Location	Findings	Name of part / Location	Findings
TRL 001 Tank Receiving line (Jetty to Tank No.3,10) Anomaly no : 6.1	general corrosion on U-bolt support	TRL 001 Tank Receiving line (Jetty to Tank No.3,10) Anomaly no : 6.1	general corrosion on U-bolt support

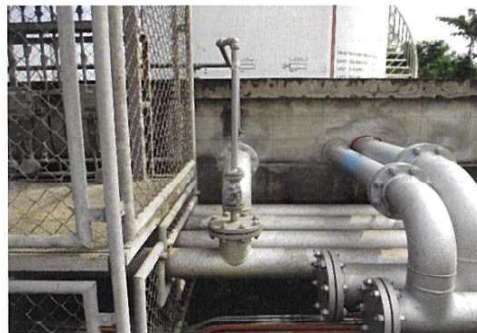
Name of part / Location			Findings			Name of part / Location			Findings		
TRL 002 G-Base 91 Tank Receiving line (Jetty to Tank No.9&Tank No.2)			Slight corrosion on piping&Painting deterioration (1)			TRL 002 G-Base 91 Tank Receiving line (Jetty to Tank No.9&Tank No.2)			Still in normal condition

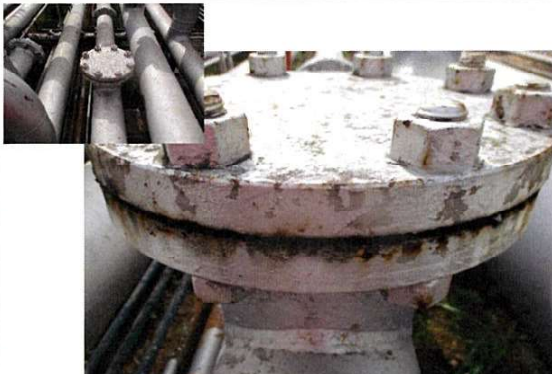
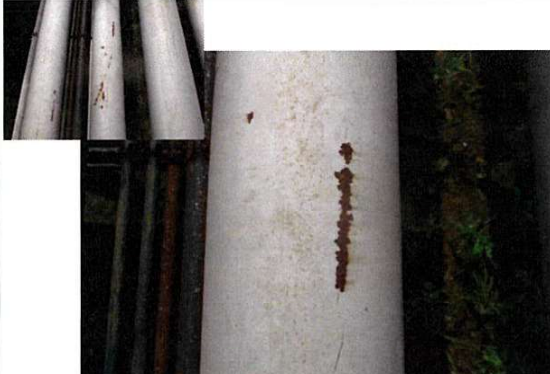
Name of part / Location		Findings		Name of part / Location		Findings	
TRL 002 G-Base 91 Tank Receiving line (Jetty to Tank No.9&Tank No.2)		Slight corrosion on flange (3)		TRL 002 G-Base 91 Tank Receiving line (Jetty to Tank No.9&Tank No.2)		Painting deterioration (4)

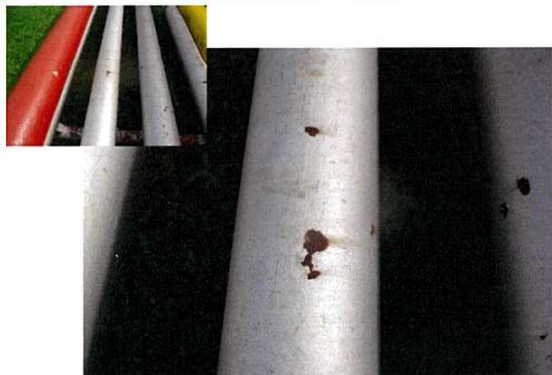
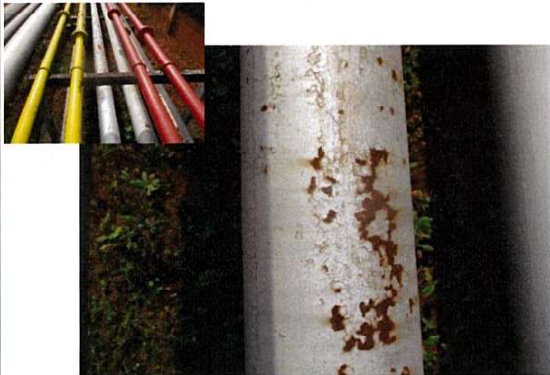
Name of part / Location		Findings		Name of part / Location		Findings	
TRL 002 G-Base 91 Tank Receiving line (Jetty to Tank No.9&Tank No.2)		Painting deterioration (5)		TRL 002 G-Base 91 Tank Receiving line (Jetty to Tank No.9&Tank No.2)		Painting deterioration (6)

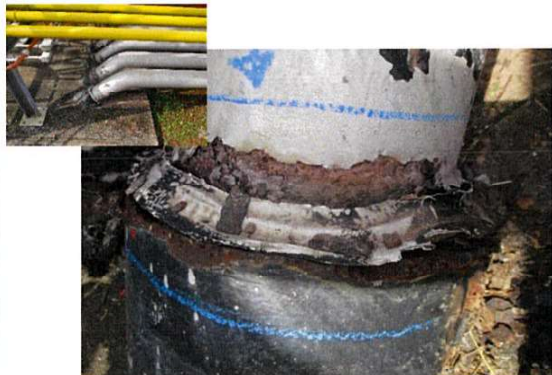
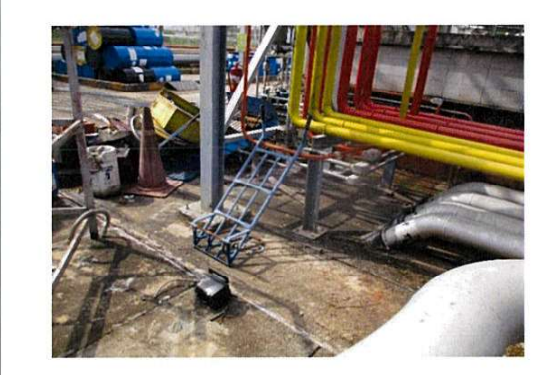
Pipe inspection summary
<p>Visual Inspection (VT)</p> <p>1. Sealing sleeve underground pipe was found degradation,damage and corrosion under sleeve underground pipe. Approximate corrosion depth 1.5 mm.</p> <p>Ultrasonic Thickness Measurement (UTM)</p> <p>- UTM : The actual minimum thickness found as 5.44 mm.</p> <p>- Maximum Corrosion rate: 0.147 mm/yr</p> <p>-Minimum Remaining Life: 23.18 yrs</p>

Name of part / Location		Findings		Name of part / Location		Findings	
TRL 002 G-Base 91 Tank Receiving line (Jetty to Tank No.9&Tank No.2)		Severe corrosion under sealing&Sealing damage. (7)		TRL 002 G-Base 91 Tank Receiving line (Jetty to Tank No.9&Tank No.2)		Still in normal condition

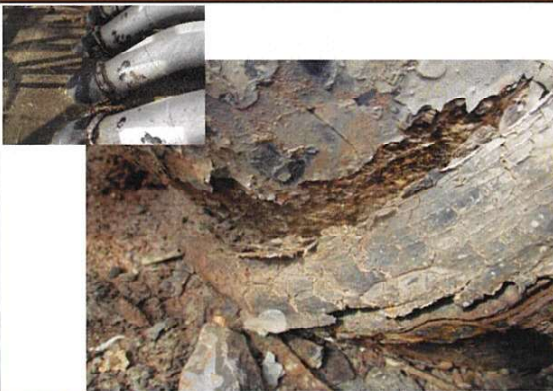
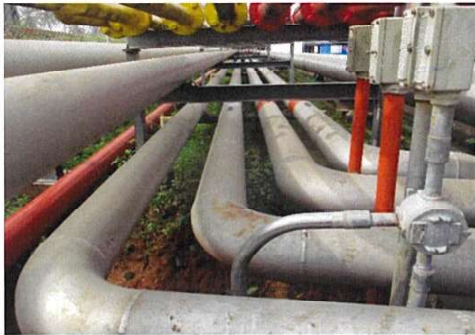
Name of part / Location		Findings		Name of part / Location		Findings	
TRL 002 G-Base 91 Tank Receiving line (Jetty to Tank No.9&Tank No.2)		Severe corrosion under pipe sleeve & Sealing damage. (8)		TRL 002 G-Base 91 Tank Receiving line (Jetty to Tank No.9&Tank No.2)		Still in normal condition

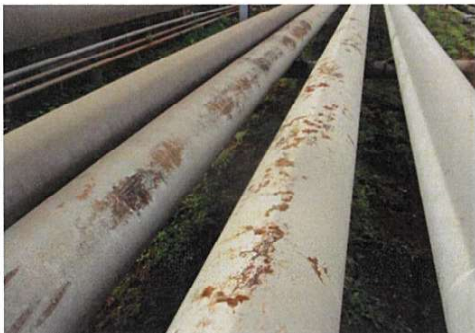
Name of part / Location		Findings	
TRL 002 G-Base 91 Tank Receiving line (Jetty to Tank No.9&Tank No.2)		Still in normal condition		TRL 002 G-Base 91 Tank Receiving line (Jetty to Tank No.9&Tank No.2)		Painting deterioration (9)

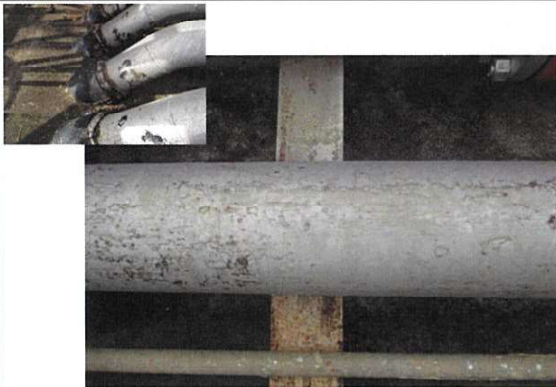
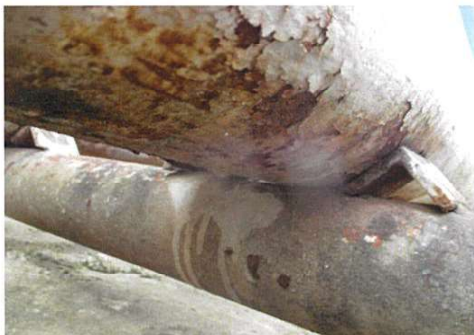
Name of part / Location		Findings		Name of part / Location		Findings	
TRL 002 G-Base 91 Tank Receiving line (Jetty to Tank No.9)		Painting deterioration (10)		TRL 002 G-Base 91 Tank Receiving line (Jetty to Tank No.9)		Painting deterioration (11)

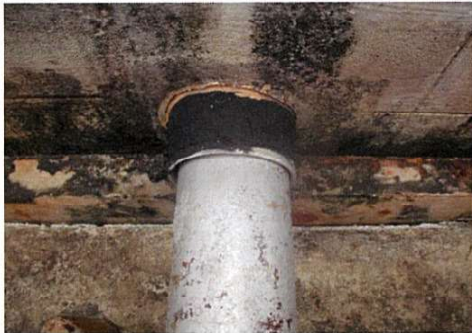
Name of part / Location		Findings		Name of part / Location		Findings	
TRL 002 G-Base 91 Tank Receiving line (Jetty to Tank No.9&Tank No.2)		Painting deterioration (13)		TRL 002 G-Base 91 Tank Receiving line (Jetty to Tank No.9&Tank No.2)		Still in normal condition

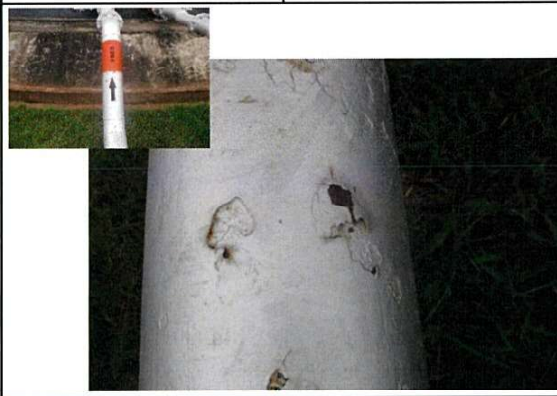
Name of part / Location		Findings		Name of part / Location		Findings	
TRL 002 G-Base 91 Tank Receiving line (Jetty to Tank No.9)		Painting deterioration (14)		TRL 002 G-Base 91 Tank Receiving line (Jetty to Tank No.9)		Still in normal condition

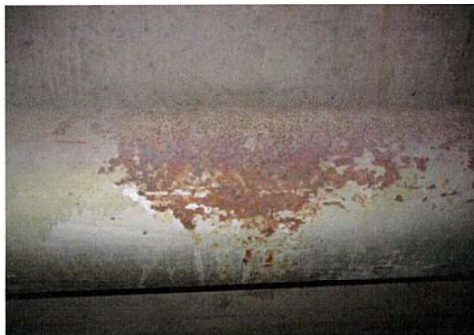
Name of part / Location		Findings	Name of part / Location		Findings
TRL 002 G-Base 91 Tank Receiving line (Jetty to Tank No.9&Tank No.2)		Slight corrosion on pipe. (15)	TRL 002 G-Base 91 Tank Receiving line (Jetty to Tank No.9&Tank No.2)		Still in normal condition
