PIPING INSPECTION SUMMARY REPORT

Report/ Project	Sheet
			2112012	S 1/1
STT-CC-003-01-01 (TRL 003 Diesel Tank Receiving Line (Jetty to Tank No.6,8))

Date of inspections: 23 December 2021

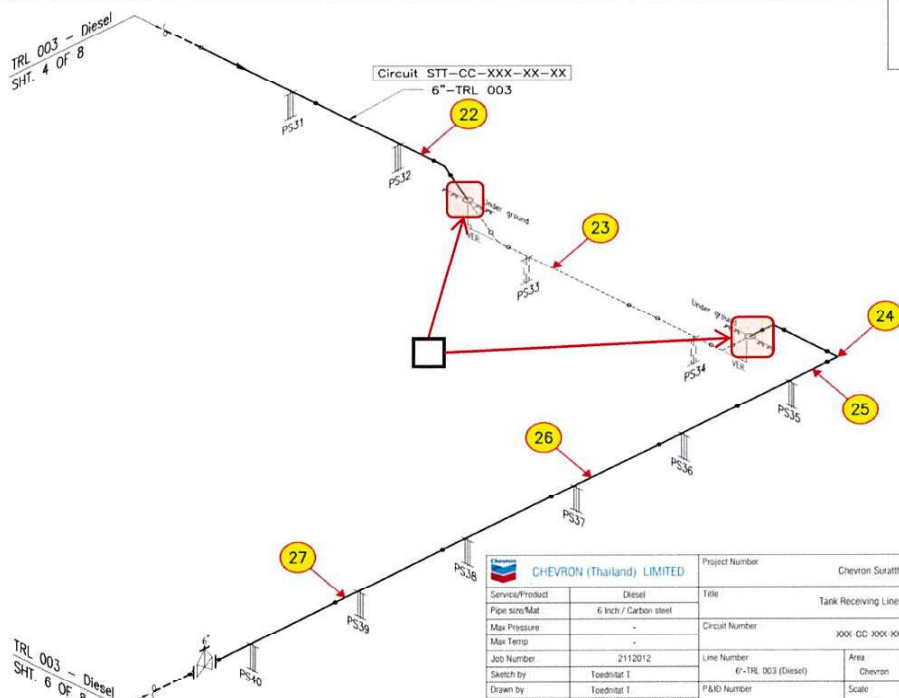
Report/ Project	Sheet																																																																																																
								2112012	VT 5/8																																																																																																
STT-CC-003-01-01 (TRL 003 Diesel Tank Receiving Line (Jetty to Tank No.6,8))																																																																																																									
Degradation	N/A	Normal	Minor	Moderate	Severe	Remark																																																																																																			
<input type="checkbox"/> Corrosion <small>x.x-x.x mm</small>	<input type="checkbox"/>	<input type="checkbox"/>	<input checked="" type="checkbox"/>	<input type="checkbox"/>	<input type="checkbox"/>	1. Sealing sleeve underground pipe was found degradation, damage and corrosion under sleeve underground pipe. Approximate corrosion depth 1.5 mm. (as mark) 2. Sealing sleeve underground pipe was found degradation, damage and corrosion under sleeve underground pipe. Approximate corrosion depth 1 mm. (as mark)

Recommendations
<p>Visual Inspection (VT)</p> <p>- Carry out alternative NDE (CUS) to determine condition within 2 months., Then re-painting as per original design to prevention future corrosion.</p> <p>Ultrasonic Thickness Measurement (UTM)</p> <p>- Thickness monitoring should be performed at next 10 yrs interval.</p>

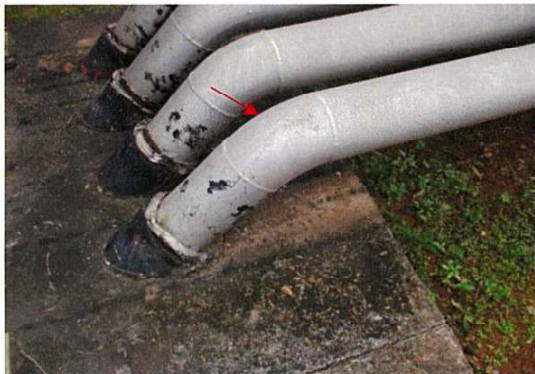
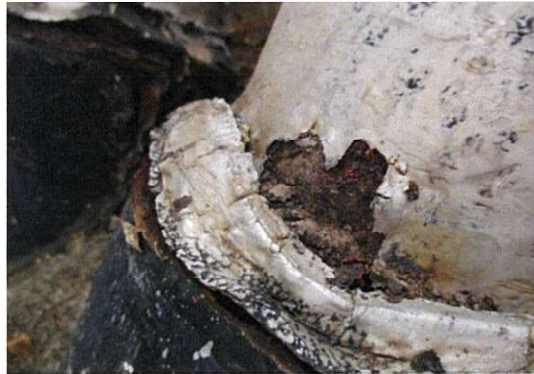
Name of part / Location	Findings	Name of part / Location	Findings	
TRL 003 Diesel Tank Receiving Line (Jetty to Tank No.6,8)	Sealing sleeve underground pipe was found degradation, damage and corrosion under sleeve underground pipe.	TRL 003 Diesel Tank Receiving Line (Jetty to Tank No.6,8)	Sealing sleeve underground pipe was found degradation, damage and corrosion under sleeve underground pipe.

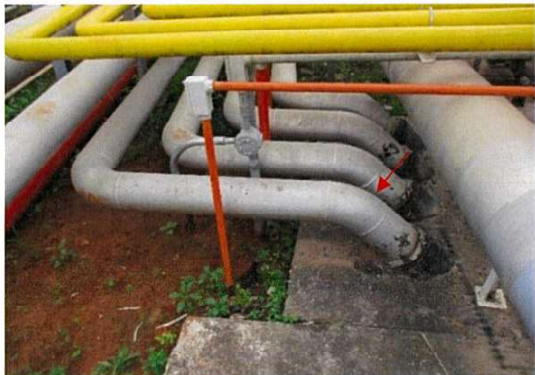
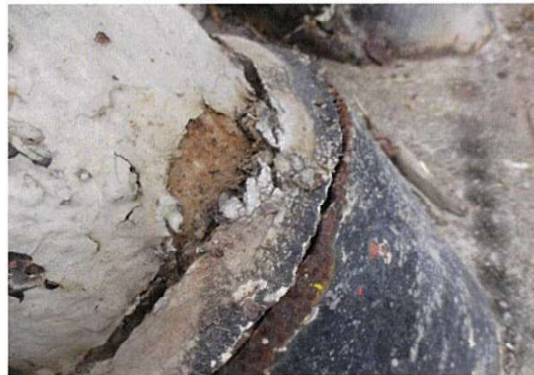
Name of part / Location	Findings	Name of part / Location	Findings	
TRL 003 Diesel Tank Receiving Line (Jetty to Tank No.6,8)	Sealing sleeve underground pipe was found degradation, damage and corrosion under sleeve underground pipe.	TRL 003 Diesel Tank Receiving Line (Jetty to Tank No.6,8)	Sealing sleeve underground pipe was found degradation, damage and corrosion under sleeve underground pipe.
