รายงานการตรวจสอบสภาพและความหนาของระบบท่อ

Dacon		PIPING VISUAL INSPECTION LOG				Report/Project	Sheet						
						2112012	VT 2/9						
ST1-CC-001-02-01 (TRL 001 G-Base 95 Tank Receiving Line (Jetty to Tank No.1,2,3))													
Degradation		N/A	Normal	Minor	Moderate	Severe	Remark						
Corrosion		<input type="checkbox"/>	<input type="checkbox"/>	<input checked="" type="checkbox"/>	<input type="checkbox"/>	<input type="checkbox"/>							
CUI		<input type="checkbox"/>	<input checked="" type="checkbox"/>	<input type="checkbox"/>	<input type="checkbox"/>	<input type="checkbox"/>							
Paint		<input type="checkbox"/>	<input type="checkbox"/>	<input checked="" type="checkbox"/>	<input type="checkbox"/>	<input type="checkbox"/>							
Insulation		<input checked="" type="checkbox"/>	<input type="checkbox"/>	<input type="checkbox"/>	<input type="checkbox"/>	<input type="checkbox"/>							
Supports		<input type="checkbox"/>	<input type="checkbox"/>	<input checked="" type="checkbox"/>	<input type="checkbox"/>	<input type="checkbox"/>							
Vibration		<input type="checkbox"/>	<input checked="" type="checkbox"/>	<input type="checkbox"/>	<input type="checkbox"/>	<input type="checkbox"/>

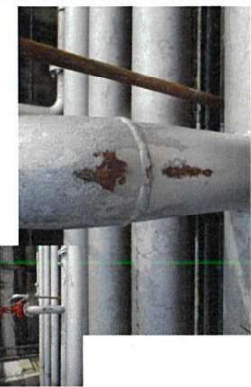
Name of part / Location	Findings	Name of part / Location	Findings
	TRL 002 G-Base 91 Tank Receiving line (Jetty to Tank No.9&Tank No.2)	Slight corrosion on piping&Painting deterioration (1)	TRL 002 G-Base 91 Tank Receiving line (Jetty to Tank No.9&Tank No.2)	Still in normal condition

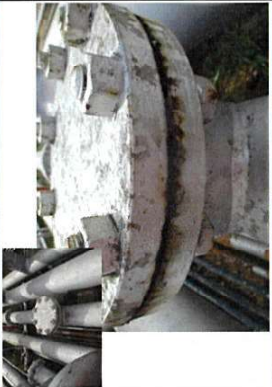
Name of part / Location	Findings	Name of part / Location	Findings
	TRL 002 G-Base 91 Tank Receiving line (Jetty to Tank No.9&Tank No.2)	Slight corrosion on flange (3)	TRL 002 G-Base 91 Tank Receiving line (Jetty to Tank No.9&Tank No.2)	Painting deterioration (4)

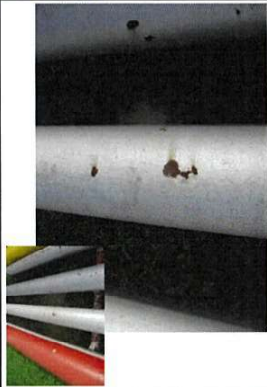
Name of part / Location	Findings	Name of part / Location	Findings
	TRL 002 G-Base 91 Tank Receiving line (Jetty to Tank No.9&Tank No.2)	Painting deterioration (5)	TRL 002 G-Base 91 Tank Receiving line (Jetty to Tank No.9&Tank No.2)	Painting deterioration (6)

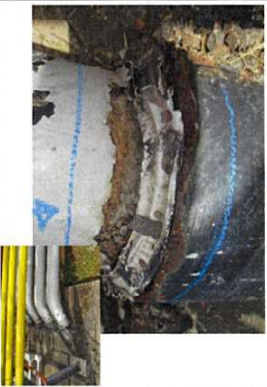
Name of part / Location	Findings	Name of part / Location	Findings
	TRL 002 G-Base 91 Tank Receiving line (Jetty to Tank No.9&Tank No.2)	Severe corrosion under sealing&sealing damage. (7)	TRL 002 G-Base 91 Tank Receiving line (Jetty to Tank No.9&Tank No.2)	Still in normal condition

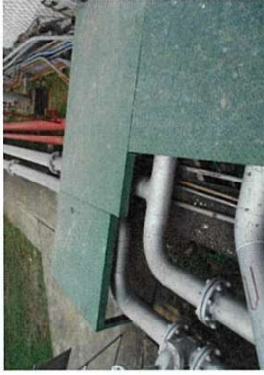
Name of part / Location	Findings	Name of part / Location	Findings
	TRL 003 Diesel Tank Receiving Line (Jetty to Tank No.6,8)	Still in normal condition	TRL 003 Diesel Tank Receiving Line (Jetty to Tank No.6,8)	Still in normal condition

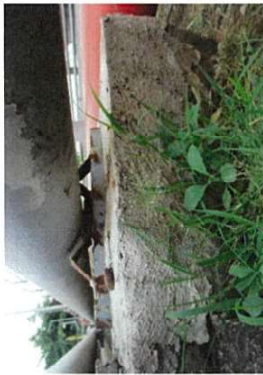
Name of part / Location	Findings	Name of part / Location	Findings
	TRL 003 Diesel Tank Receiving Line (Jetty to Tank No.6,8)	Still in normal condition	TRL 003 Diesel Tank Receiving Line (Jetty to Tank No.6,8)	Still in normal condition

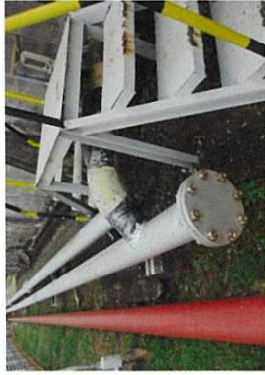
Name of part / Location	Findings	Name of part / Location	Findings
	TRL 003 Diesel Tank Receiving Line (Jetty to Tank No.6,8)	Still in normal condition	TRL 003 Diesel Tank Receiving Line (Jetty to Tank No.6,8)	Still in normal condition

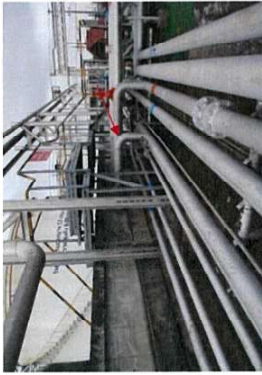
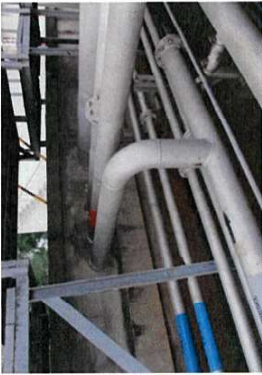
Name of part / Location	Findings	Name of part / Location	Findings	
TRL 003 Diesel Tank Receiving Line (Jetty to Tank No.6,8)	Still in normal condition	TRL 003 Diesel Tank Receiving Line (Jetty to Tank No.6,8)	Still in normal condition

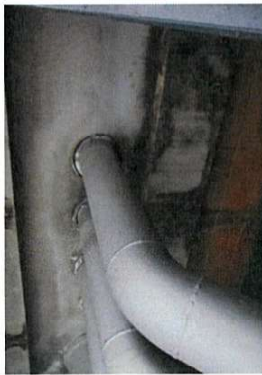
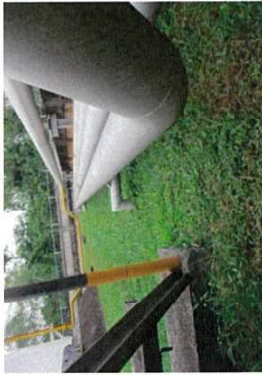
Name of part / Location	Findings	Name of part / Location	Findings	
TRL 003 Diesel Tank Receiving Line (Jetty to Tank No.6,8)	Still in normal condition	TRL 003 Diesel Tank Receiving Line (Jetty to Tank No.6,8)	Still in normal condition

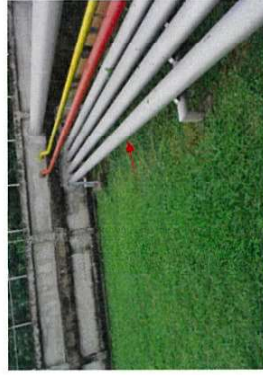
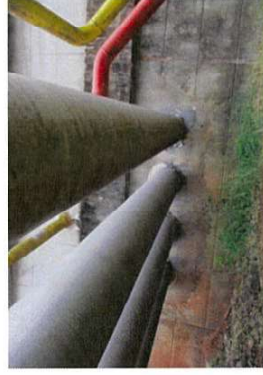
Name of part / Location	Findings	Name of part / Location	Findings	
TRL 003 Diesel Tank Receiving Line (Jetty to Tank No.6,8)	Still in normal condition	TRL 003 Diesel Tank Receiving Line (Jetty to Tank No.6,8)	Still in normal condition

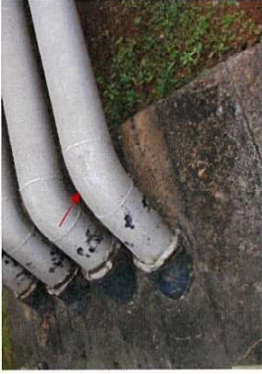
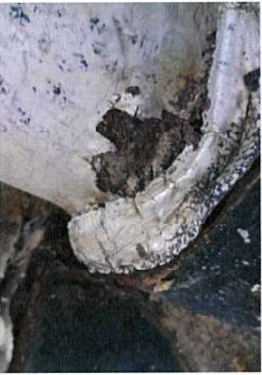
Visual Inspection (VT)									
1. Sealing sleeve underground pipe was found degradation, damage and corrosion under sleeve underground pipe.									
Approximate corrosion depth 1.5 mm.									
Ultrasonic Thickness Measurement (UTM)									
- UTM : The actual minimum thickness found as 5.44 mm.									
- Maximum Corrosion rate: 0.147 mm/yr									
- Minimum Remaining Life 23.18 yrs

Name of part / Location	Findings	Name of part / Location	Findings	
TRL 003 Diesel Tank Receiving Line (Jetty to Tank No.6,8)	Sealing sleeve underground pipe was found degradation, damage and corrosion under sleeve underground pipe.	TRL 003 Diesel Tank Receiving Line (Jetty to Tank No.6,8)	Sealing sleeve underground pipe was found degradation, damage and corrosion under sleeve underground pipe.

Visual Inspection (VT)									
1. Carry out alternative NDE (LRUT) to determine condition within 2 months. Then re-painting as per original design to prevention future corrosion.

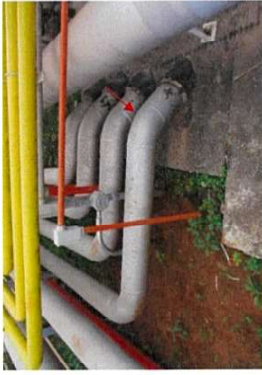
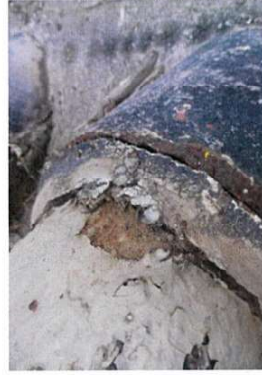
Name of part / Location	Findings	Name of part / Location	Findings	
TRL 003 Diesel Tank Receiving Line (Jetty to Tank No.6,8)	Sealing sleeve underground pipe was found degradation, damage and corrosion under sleeve underground pipe.	TRL 003 Diesel Tank Receiving Line (Jetty to Tank No.6,8)	Sealing sleeve underground pipe was found degradation, damage and corrosion under sleeve underground pipe.

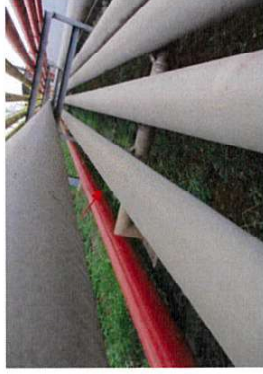
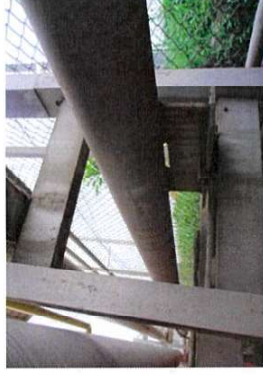
Name of part / Location	Findings	Name of part / Location	Findings	
TRL 003 Diesel Tank Receiving Line (Jetty to Tank No.6,8)	Still in normal condition	TRL 003 Diesel Tank Receiving Line (Jetty to Tank No.6,8)	Still in normal condition

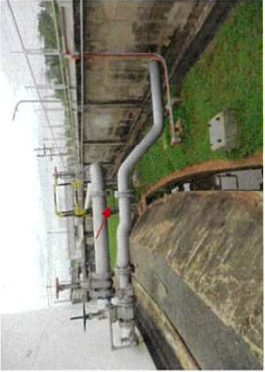
Name of part / Location	Findings	Name of part / Location	Findings
	TRL 003 Diesel Tank Receiving Line (Jetty to Tank No.6,8)	Still in normal condition	TRL 003 Diesel Tank Receiving Line (Jetty to Tank No.6,8)	Still in normal condition

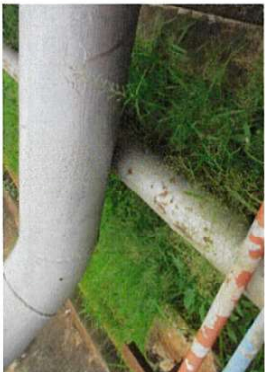
Name of part / Location	Findings	Name of part / Location	Findings
	TRL 003 Diesel Tank Receiving Line (Jetty to Tank No.6,8)	Still in normal condition	TRL 003 Diesel Tank Receiving Line (Jetty to Tank No.6,8)	Still in normal condition

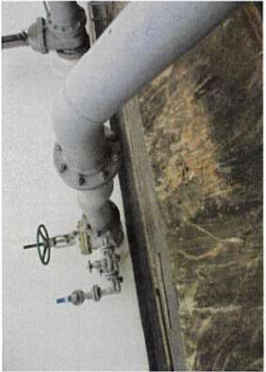
Name of part / Location	Findings	Name of part / Location	Findings
	TRL 003 Diesel Tank Receiving Line (Jetty to Tank No.6,8)	Still in normal condition	TRL 003 Diesel Tank Receiving Line (Jetty to Tank No.6,8)	Still in normal condition
