เอกสารตรวจสอบหม้อแปลงไฟฟ้าประจำปี 2566

Chanalai Garden - MDB PM2023

Maintenance Report

Date of work : 5 Oct 2023

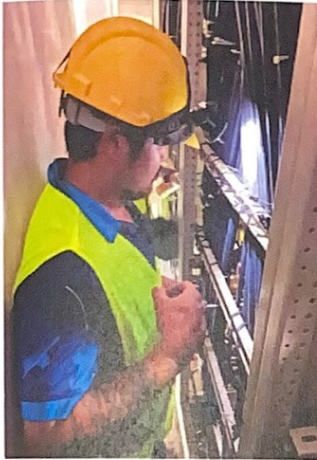
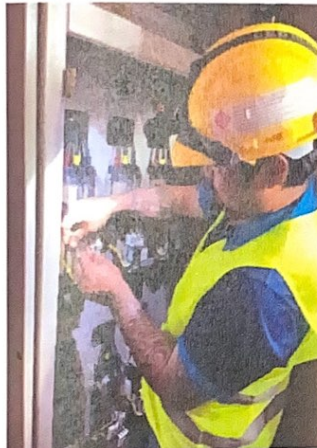
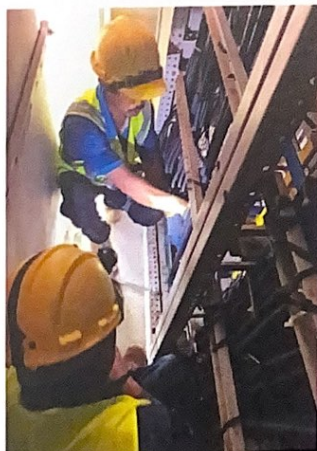
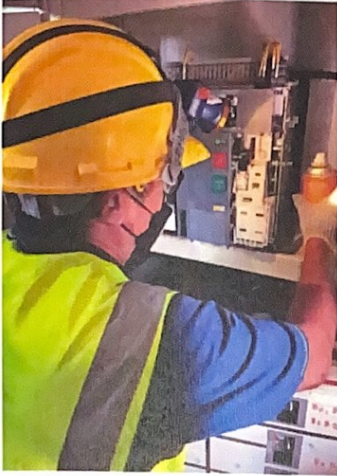
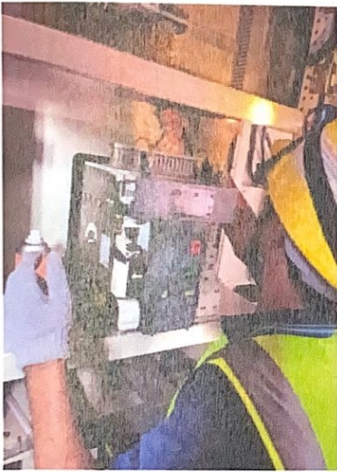
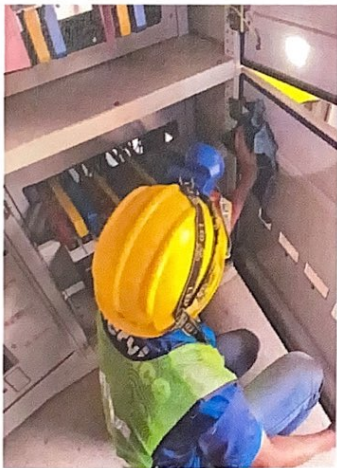
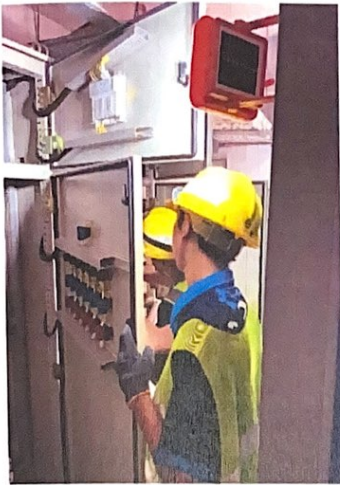
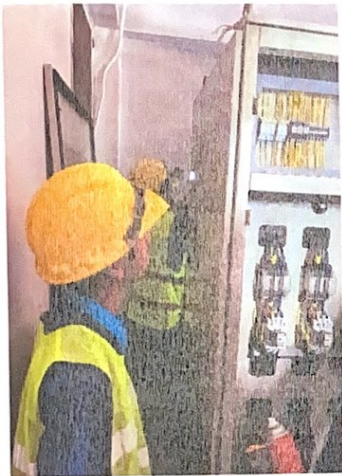
รูปที่ 1-18

Preventive maintenance of PM MDB

- Inspect physical and mechanical condition
- Cleaning overall
- Test Insulation Resistance
- Test Grounding System
- Connection tightening torque

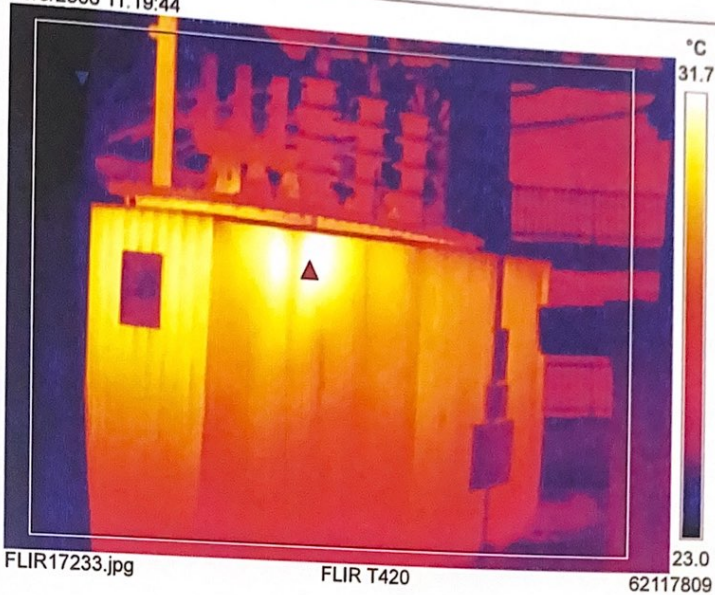
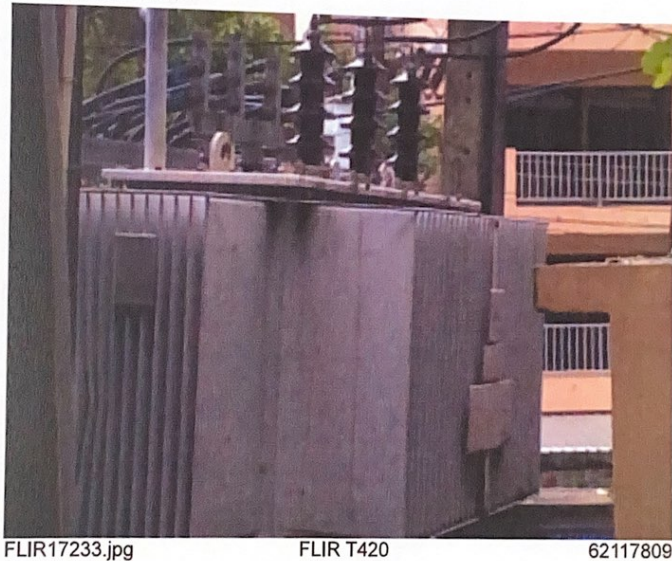
Location :	EE Substation
Equipment :	Transformer
Detail :	High/Low Volt Side Connection
Comment :	Normal operation, Not found hotspot
	Should also keep for your future reference

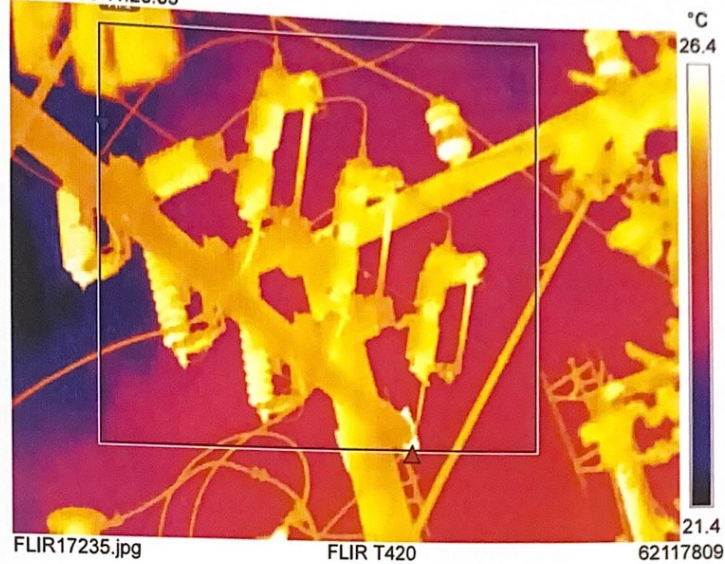
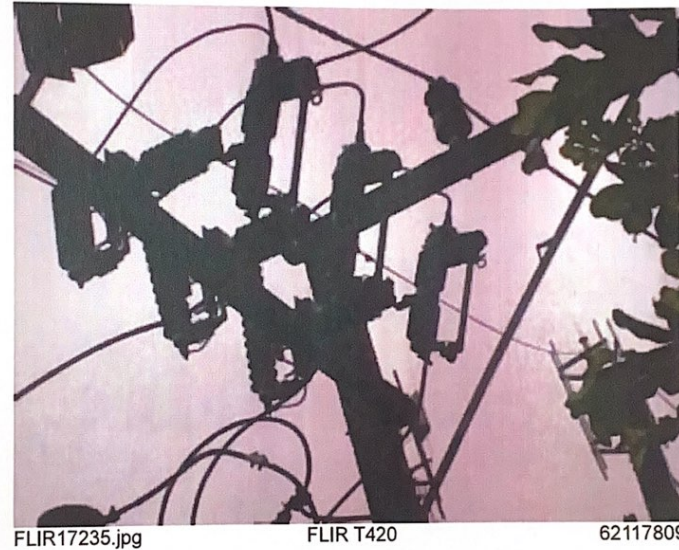
Location :	EE Substation
Equipment :	Transformer
Detail :	Dropout Fuse From PEA
Comment :	Normal operation, Not found hotspot
	Should also keep for your future reference

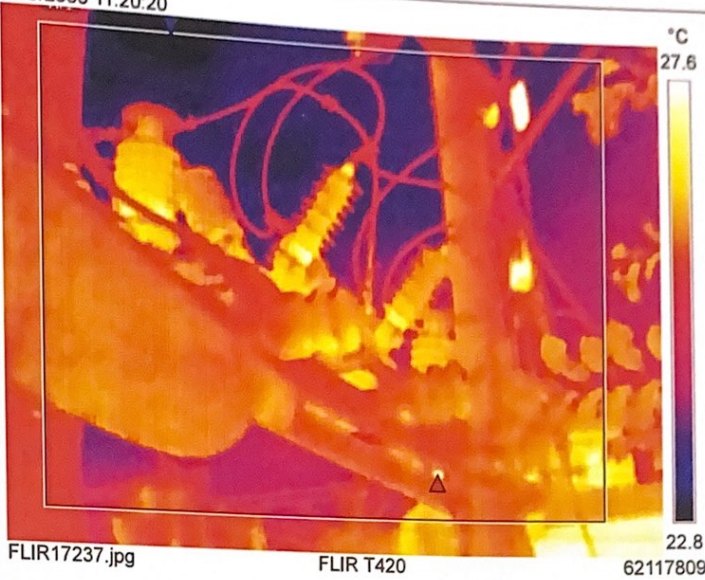
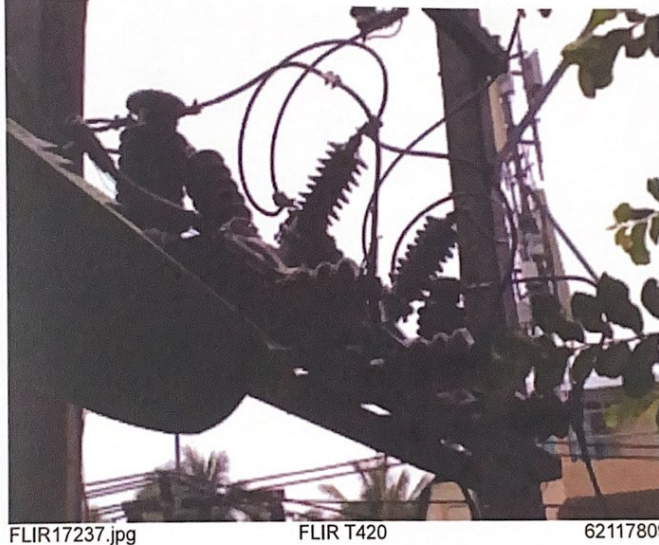
Location :	EE Substation
Equipment :	Transformer
Detail :	CT/PT Form PEA
Comment :	Normal operation, Not found hotspot Should also keep for your future reference

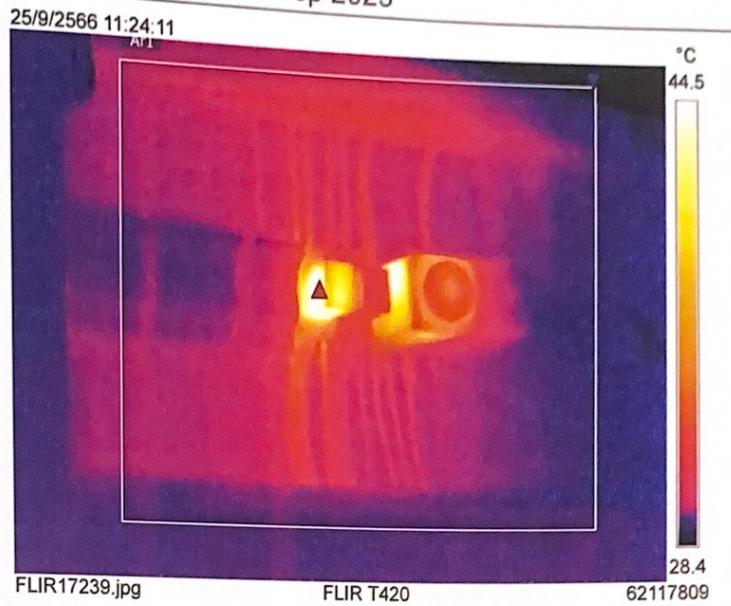
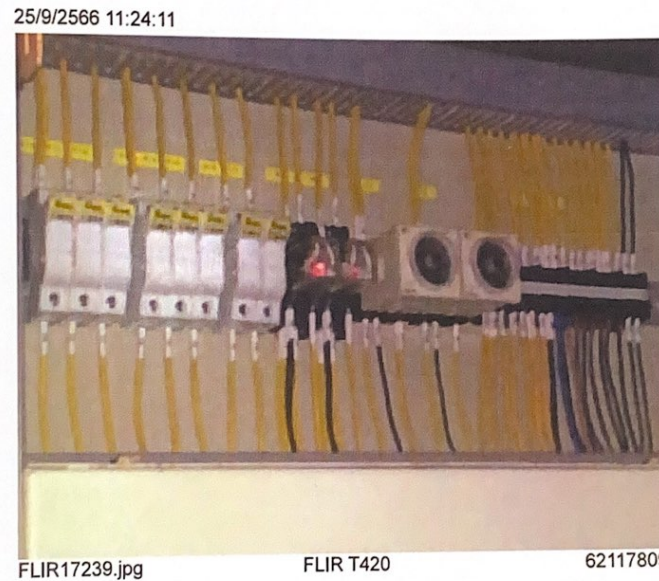
Location :	EE Room
Equipment :	MDB
Detail :	Fuse and Relay Control
Comment :	Normal operation, Not found hotspot Should also keep for your future reference

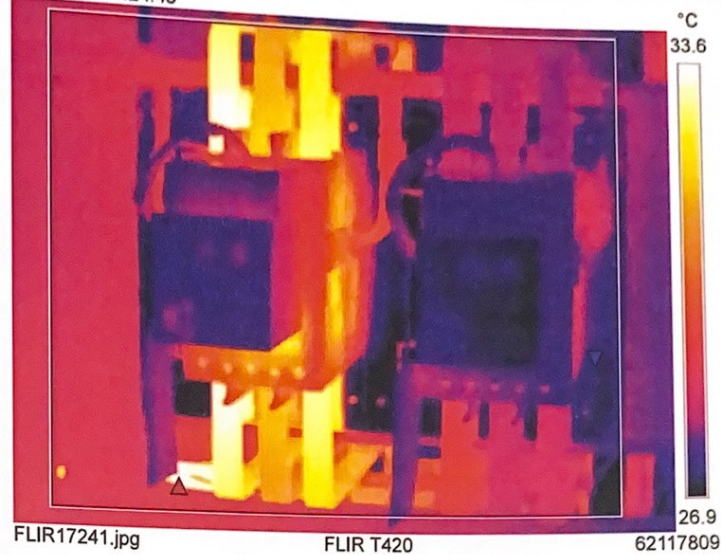
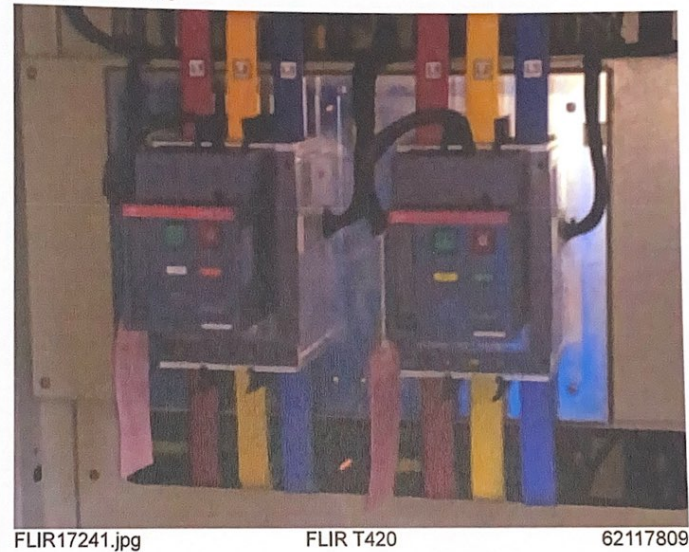
Location :	EE Room
Equipment :	MDB
Detail :	ATS Normal and Emergency
Comment :	Normal operation, Not found hotspot
	Should also keep for your future reference

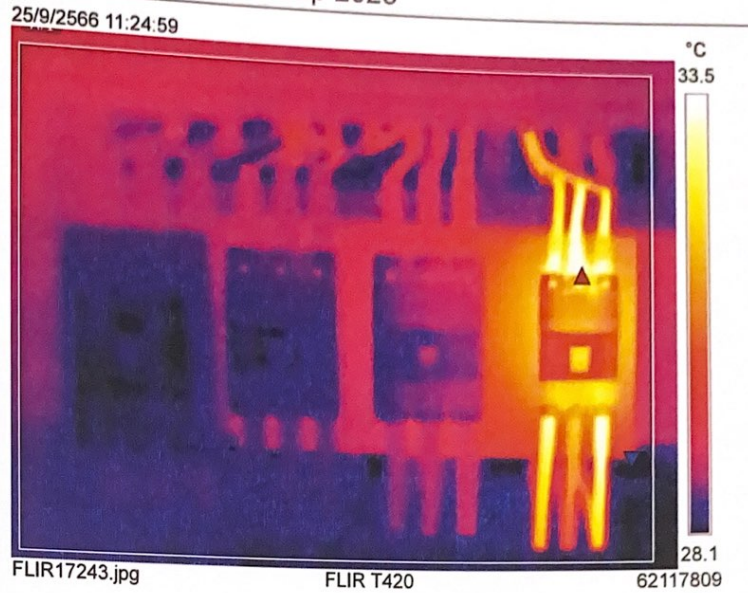
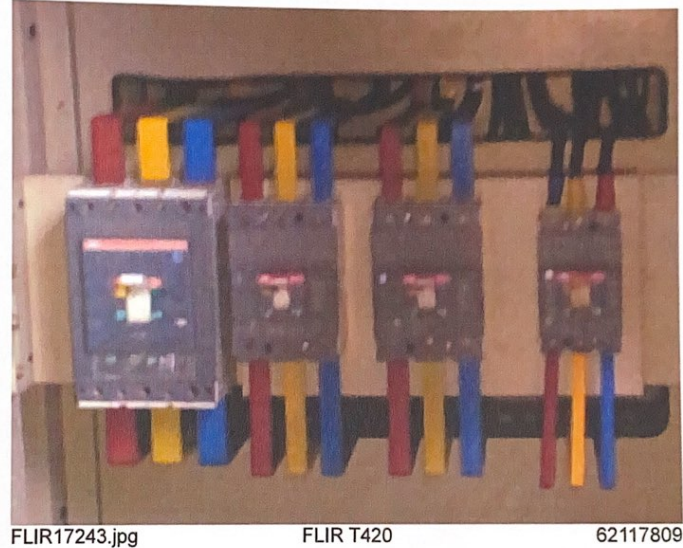
Location :	EE Room
Equipment :	MDB
Detail :	MCCB For Branch
Comment :	Normal operation, Not found hotspot Should also keep for your future reference

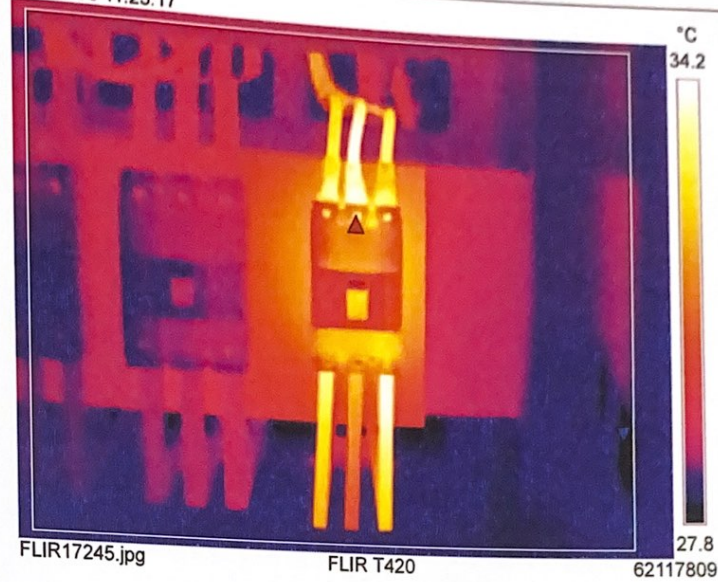
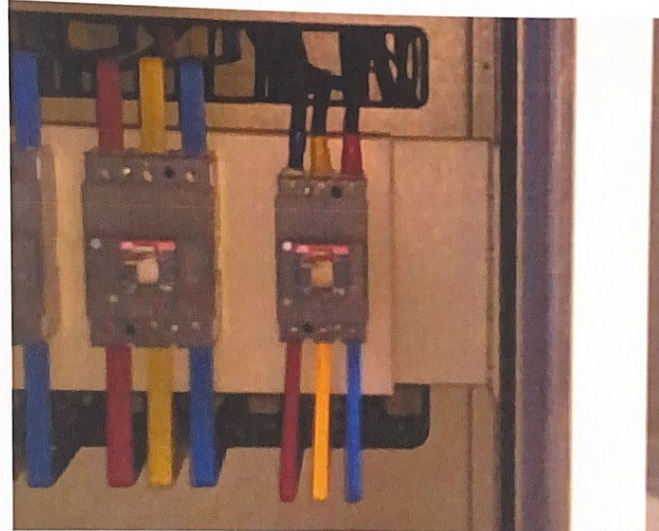
Location :	EE Room
Equipment :	MDB
Detail :	MCCB For Branch
Comment :	Normal operation, Not found hotspot Should also keep for your future reference

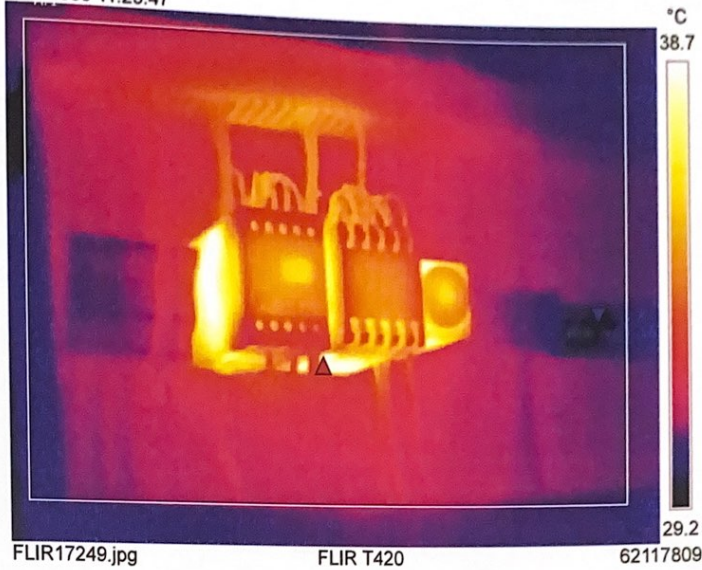
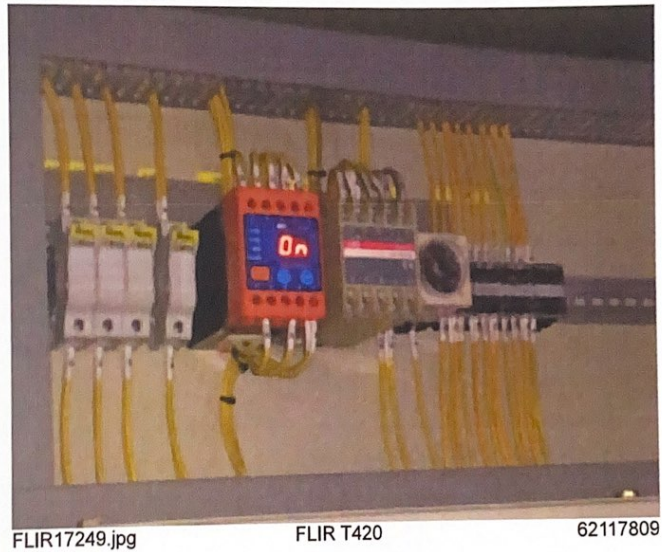
Location :	EE Room
Equipment :	MDB
Detail :	Phase Protection
Comment :	Normal operation, Not found hotspot
	Should also keep for your future reference

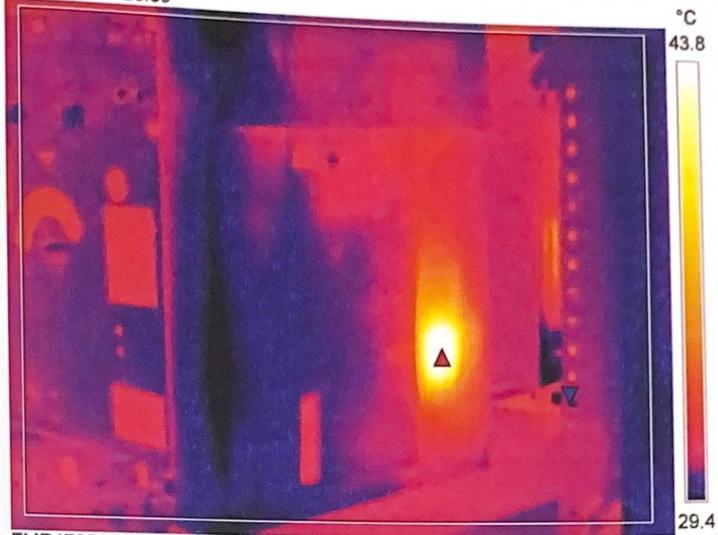
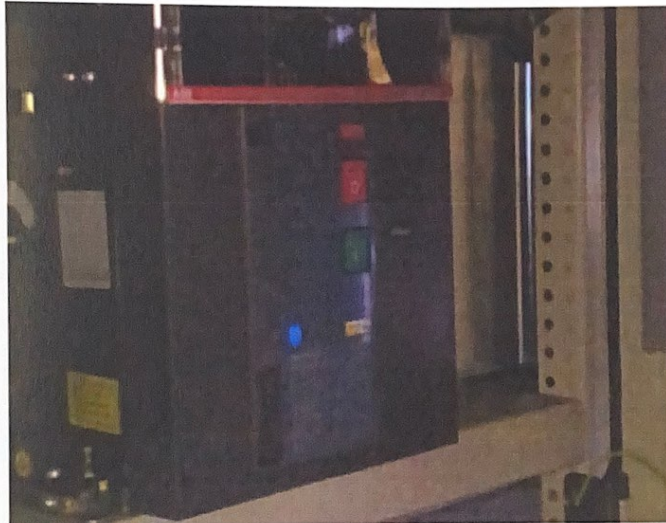
Location :	EE Room
Equipment :	MDB
Detail :	Main ACB
Comment :	Normal operation, Not found hotspot Should also keep for your future reference

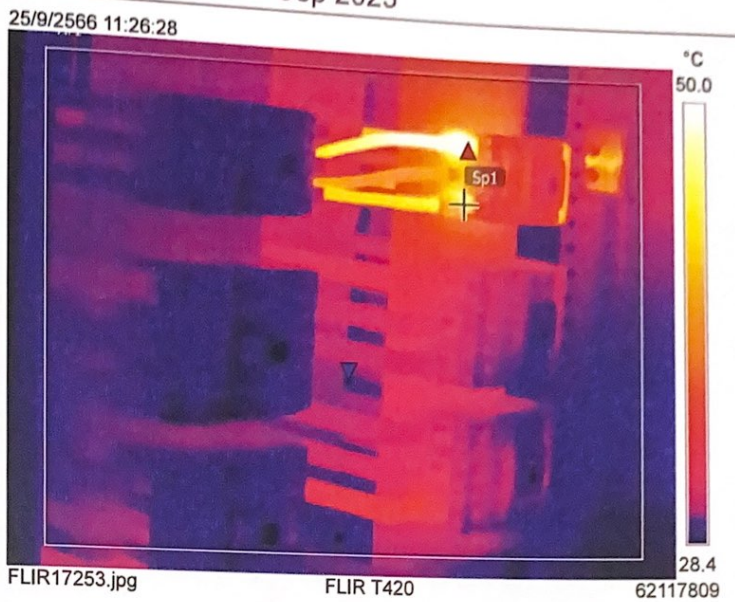
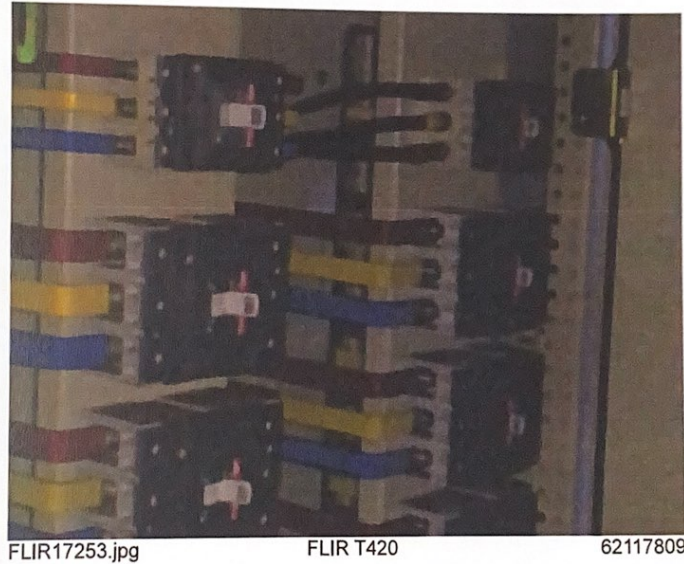
Location :	EE Room
Equipment :	MDB
Detail :	MCCB For Branch
Comment :	Normal operation, Not found hotspot
	Should also keep for your future reference

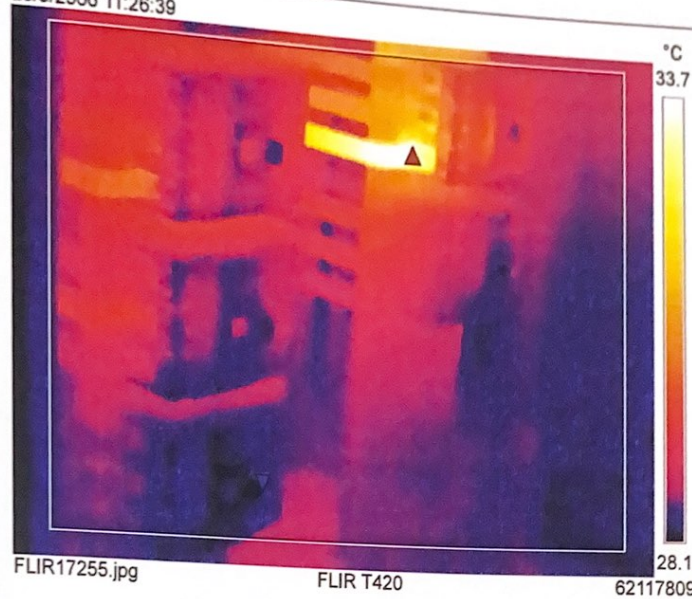
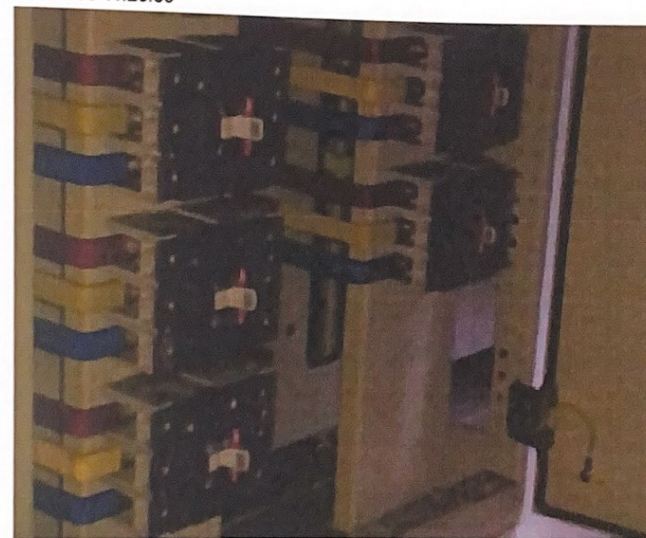
Location :	EE Room
Equipment :	MDB
Detail :	MCCB For Branch
Comment :	Normal operation, Not found hotspot Should also keep for your future reference

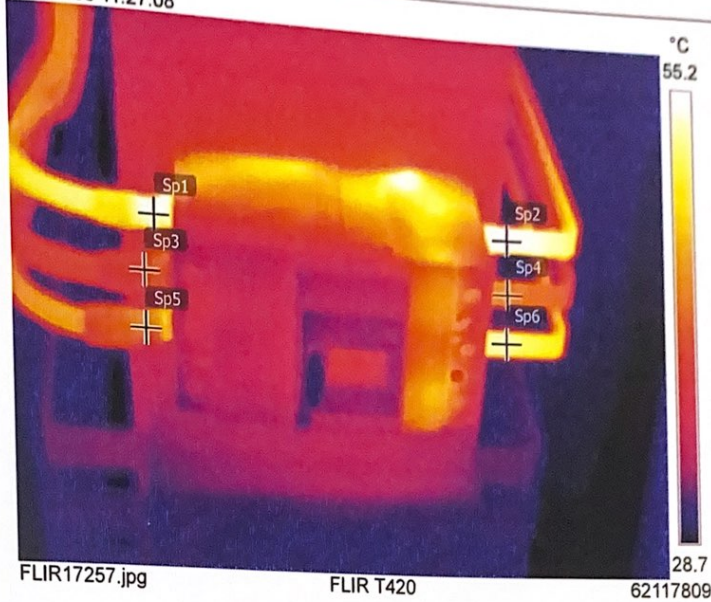
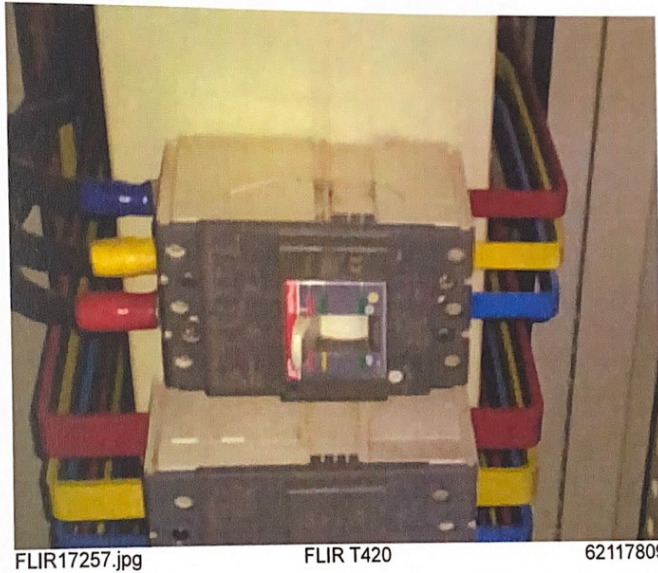
Location :	EE Room
Equipment :	MDB
Detail :	MCCB For Branch
Comment :	Normal operation, Not found hotspot Should also keep for your future reference

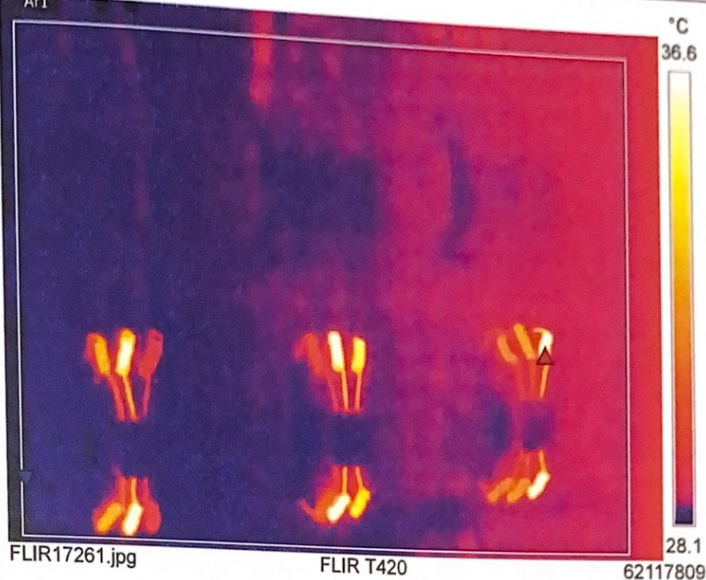
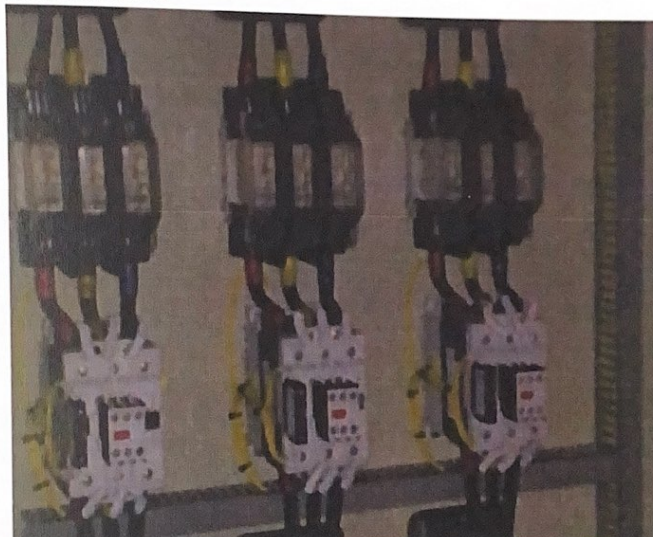
Location :	EE Room
Equipment :	MDB
Detail :	HRC Fuse and Magnetic For Cap Bank
Comment :	Normal operation, Not found hotspot Should also keep for your future reference

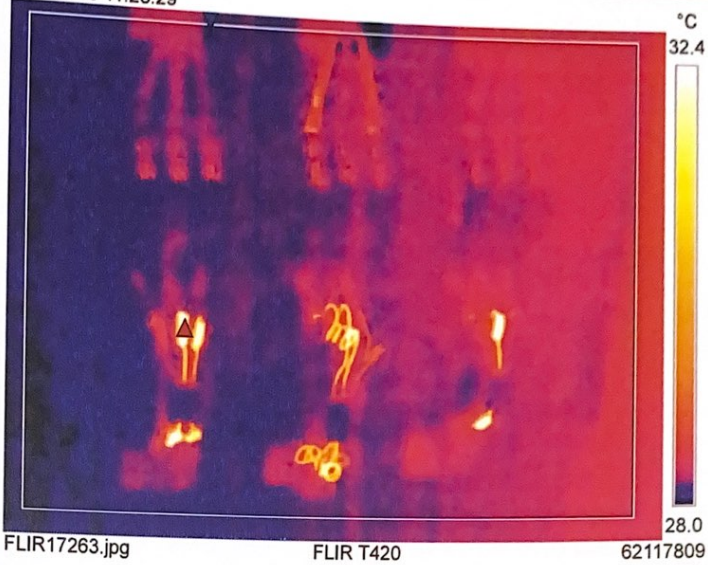
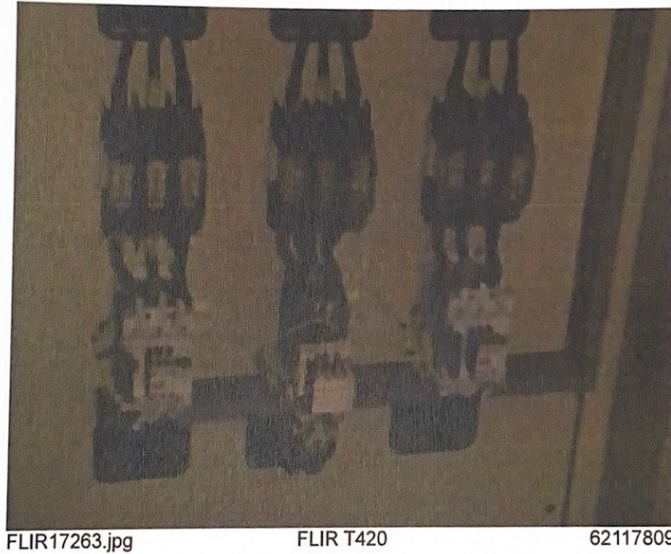
Location :	EE Room
Equipment :	MDB
Detail :	HRC Fuse and Magnetic For Cap Bank
Comment :	Normal operation, Not found hotspot Should also keep for your future reference

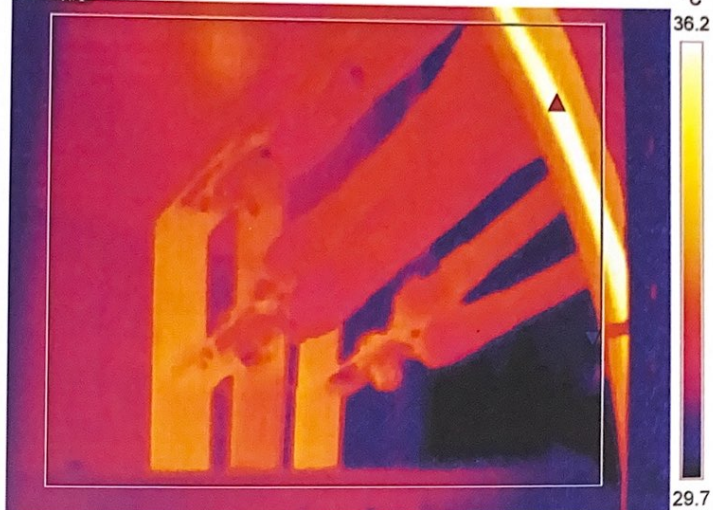
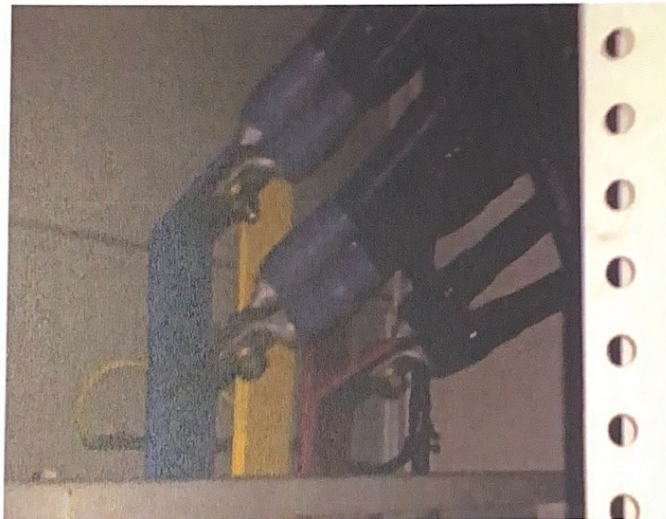
Location :	EE Room
Equipment :	MDB
Detail :	Main Cable and Busbar Connection
Comment :	Normal operation, Not found hotspot
	Should also keep for your future reference

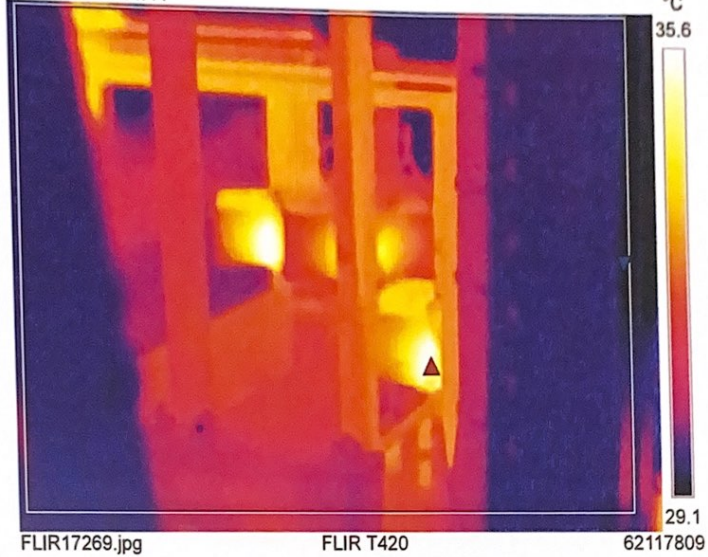
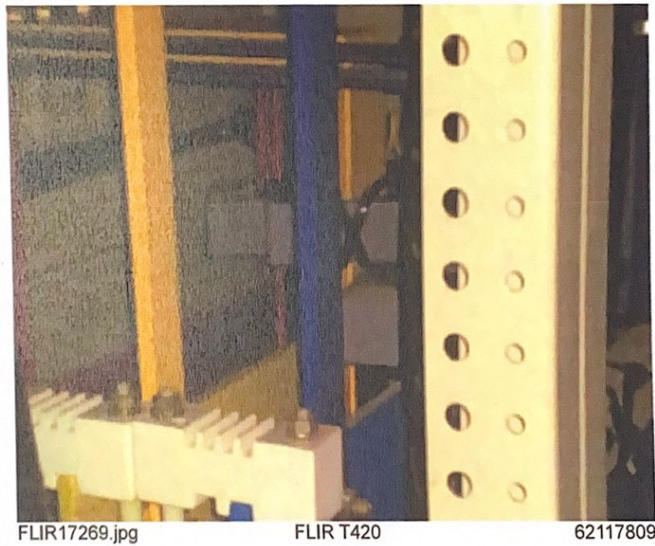
Location :	EE Room
Equipment :	MDB
Detail :	Main Cable and Busbar Connection
Comment :	Normal operation, Not found hotspot
	Should also keep for your future reference

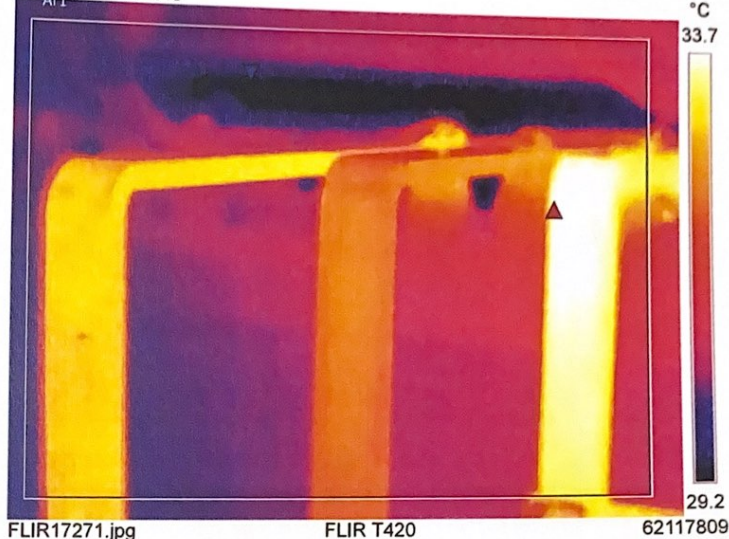
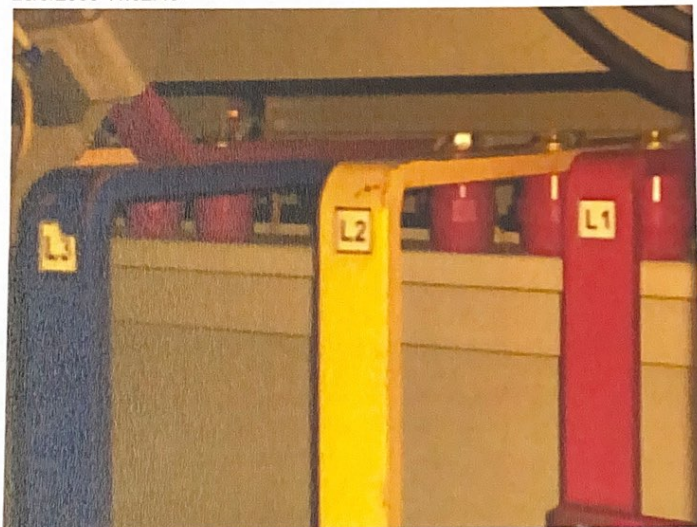
Location :	EE Room
Equipment :	MDB
Detail :	Main Cable and Busbar Connection
Comment :	Normal operation, Not found hotspot
	Should also keep for your future reference

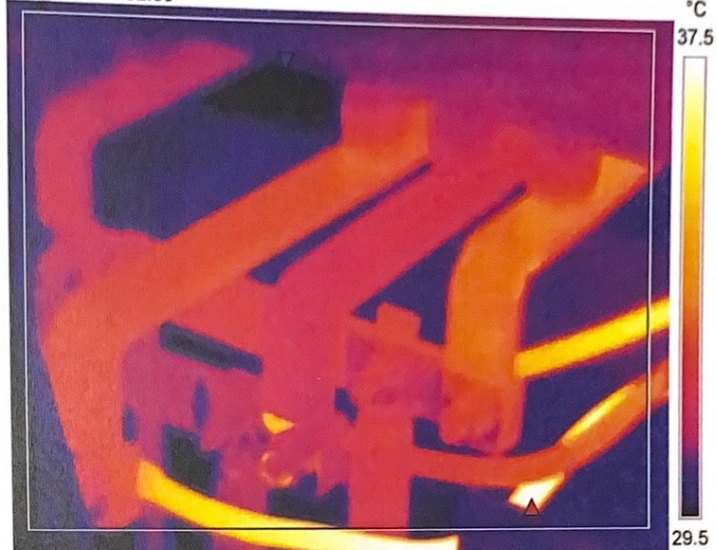
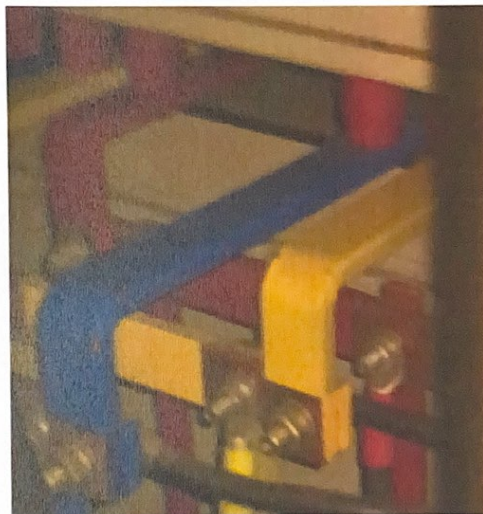
Location :	EE Room
Equipment :	MDB
Detail :	Main Cable and Busbar Connection
Comment :	Normal operation, Not found hotspot Should also keep for your future reference

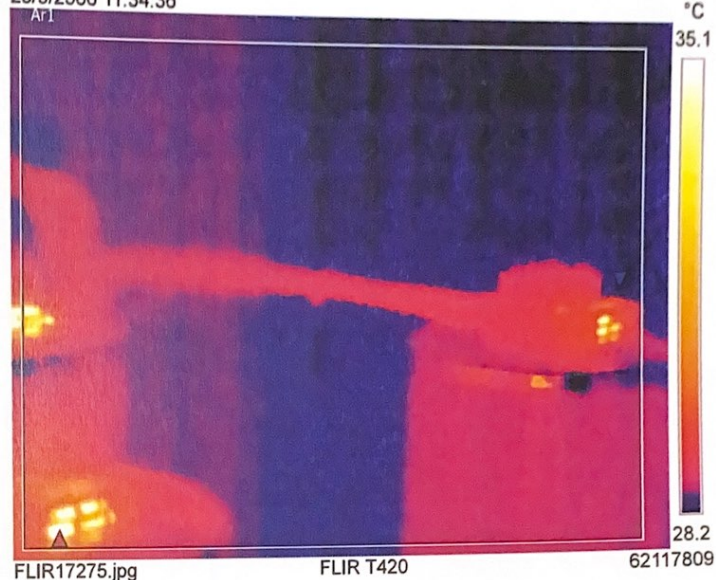
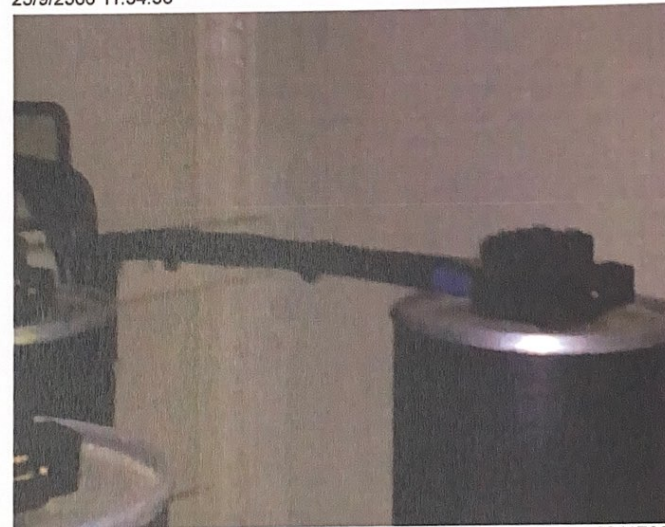
Location :	EE Room
Equipment :	MDB
Detail :	Capacitor Bank
Comment :	Normal operation, Not found hotspot Should also keep for your future reference

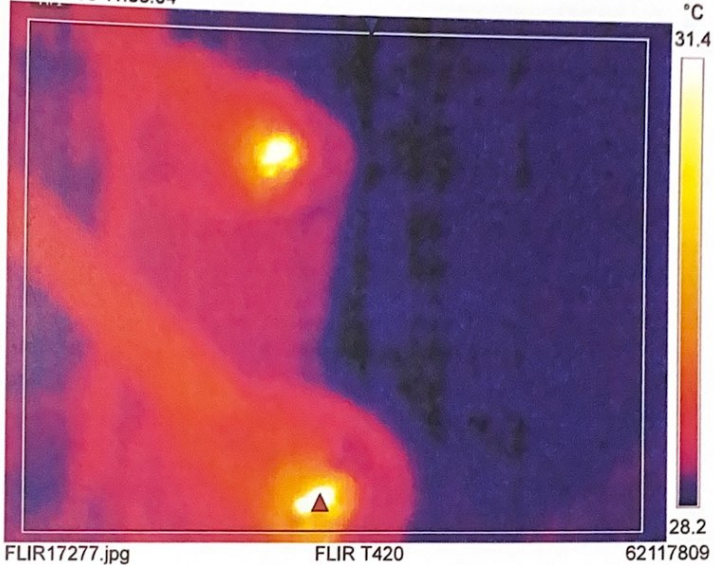
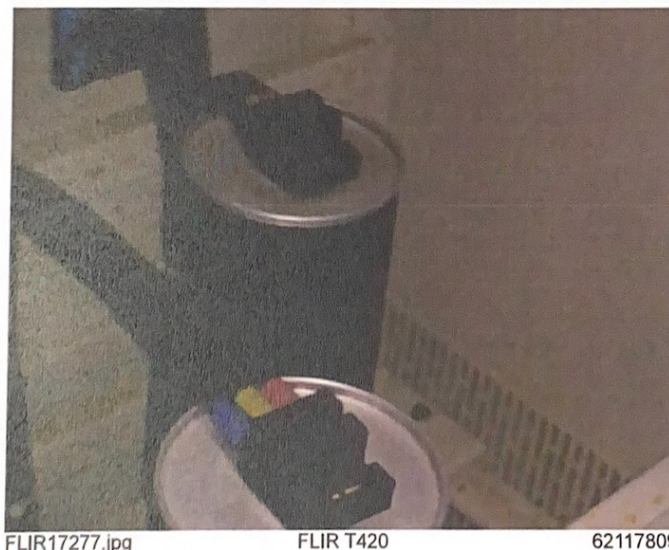
Location :	EE Room
Equipment :	MDB
Detail :	Capacitor Bank
Comment :	Normal operation, Not found hotspot Should also keep for your future reference

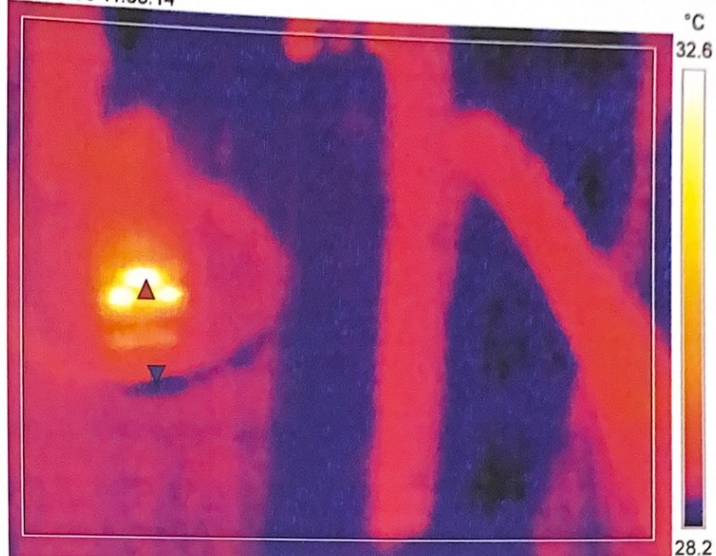
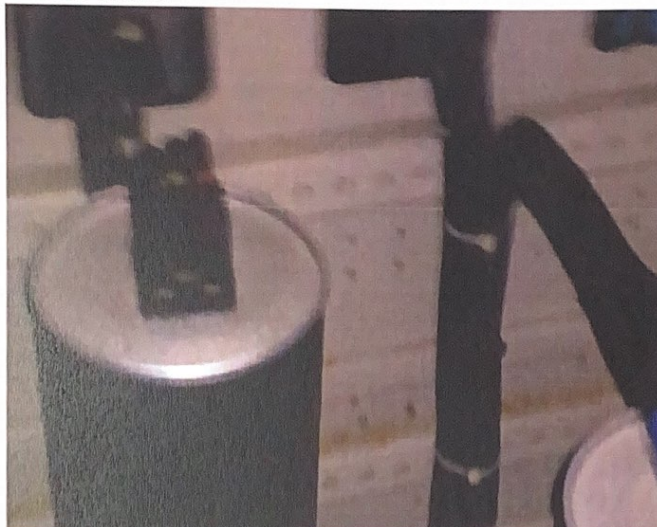
Location :	EE Room
Equipment :	MDB
Detail :	Capacitor Bank
Comment :	Normal operation, Not found hotspot Should also keep for your future reference
