HPEO Explosion on June 18, 2022

GEOTEM 2023
Navigating Change

From the Investigation Report

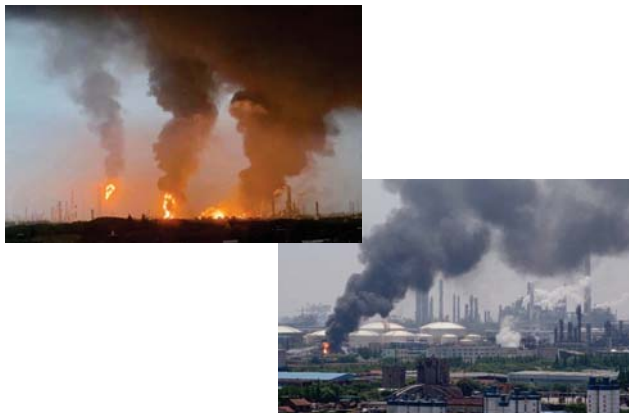
- Leaked EO led to a fire
- This was followed by the explosion of the HPEO column
- Debris from the explosion caused fires to break out in four other locations
- An EOG operator was injured during evacuation
- A truck driver died due to a falling 3" N₂ pipe

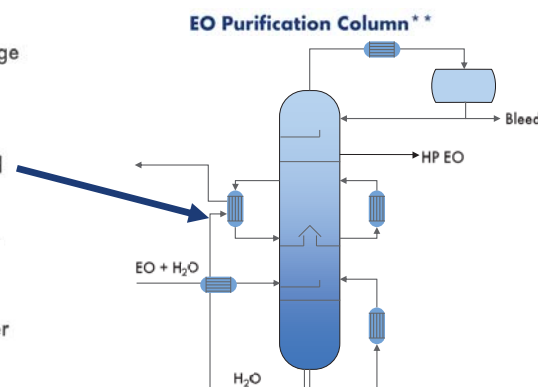
- Field operator hear a loud bang and saw a large steam plume
- Panel operator noticed low flow and low level
- Leak point was in the bottom line after the feed preheater
- Field operator tried to turn on a water cannon, but he felt dizzy and evacuated to the control room
- A flash fire started, followed a few minutes later by the explosion

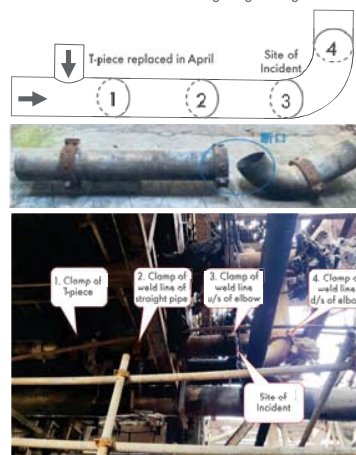
- The leak was in a SS 304 line (7 barg, ~110°C)
 - For several months, the line had 4 clamps because of leaks
 - Clamp 3 violently failed
- Via the ruptured pipe, first water, then EO escaped
- EO in air has a very low ignition energy; a fire started
- The external fire caused a self-decomposition reaction of EO inside the column, leading to the explosion
- The leaks in the line were caused by chloride stress cracking (Cl-SCC)
 - The leaks were close to / at welded connections
 - [Chloride concentrations are not mentioned in the report]

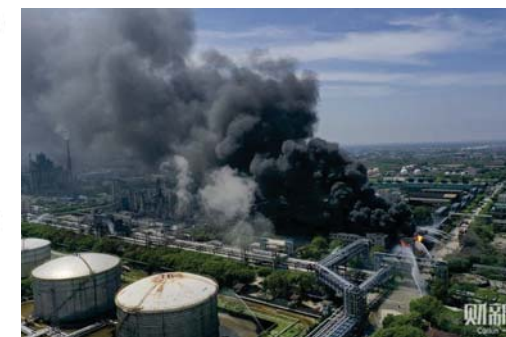
- The clamps used at this plant to seal leaks were iron bands; they were unable to add strength to the pipe or hold it in the event of a pipe failure
 - Having 4 clamps over such a short piping length is exceptional and a warning that cannot be ignored
- Welds and bends are locations with higher stress and are more susceptible to Cl-SCC
 - Welding sensitisation may occur in SS 304; these zones are susceptible to intergranular stress cracking corrosion mechanisms
- The MOC for allowing the clamps may have only considered water leakage and not the potential for line failure and massive EO leakage

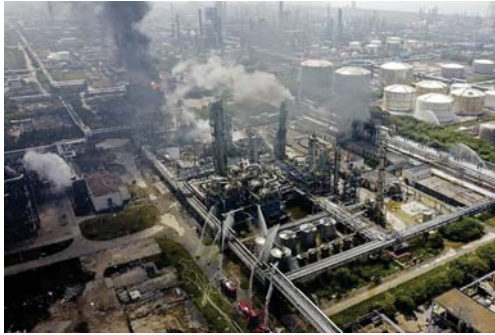
- CI-SCC can happen at very low concentrations and high temperatures in water
 - Other contributing parameters are pH and aeration (O_2 content)
 - CI-SCC is often first seen at areas of higher stress, near welds or bends
 - CI-SCC is unpredictable, and cracks will propagate in a branched shape
- It is mentioned in the report that the CI-SCC started from the inside
 - Stainless steel lines need to be inspected for and protected against external CI-SCC as well
