Shutdown Report

Report of Shutdown: Mechanical work SD Inspection GT 11 _16-17 Apr 2024
Date: 16 - 17 Apr 2024
Report By: RC

Department: Mechanical Team

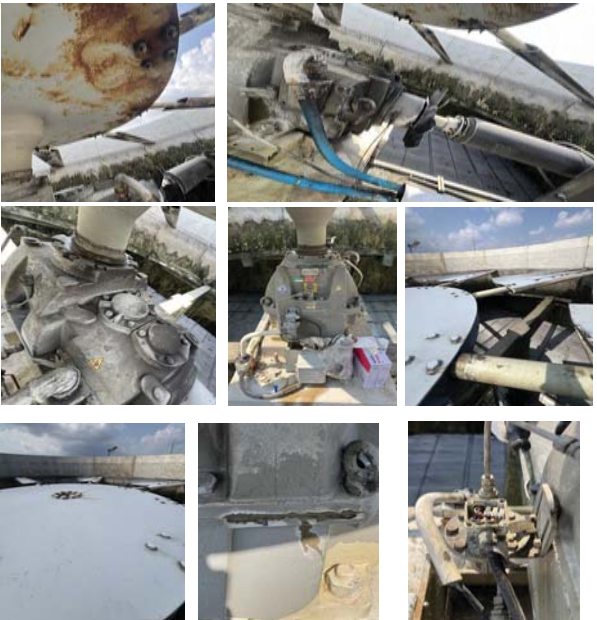
Date	Description	Remark
16 Apr 2024	<p>Inspection CT Fan no.1 (After overhaul 7 month later by Bgrimm Tech , Last Sep 2023)</p> <p><u>Item no.1</u> - CT Inspection Cell no.1 For Gearbox 1.Inspection of gear teeth and internal condition. > Found side cover plate gear was leakage - Action : Replace with new O-ring and add 587 sealant > Base plate gear was begin rust corrosion / Action: Coating NIPPON Epoxy Rust Protective 2.Inspection shaft bolt coupling Motor-Gear End 3.Inspection Fan CT ,Corrosion damaged. >Found abnormal scale calcium sulphate (CaSO_4) at all of surface area >Found coat Hub was rust corrosion / Action: Spray coating NIPPON Epoxy Rust Protective >Cover fan side gear (black) was damaged / Action: Remove all 4.Inspection and remove coating clog at Nozzle Spray. > Not found coating clog nozzle > Found Nozzle was loosen / Action: Tightening check all</p>    	<div>Mech Team</div>

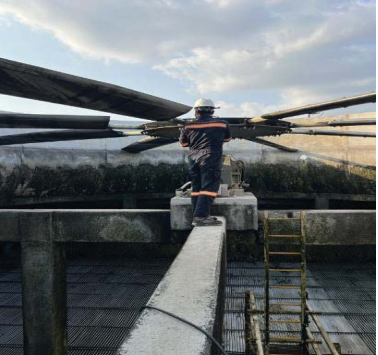
<p>After Cleaned and Coating NIPPON Epoxy Rust Protective</p>

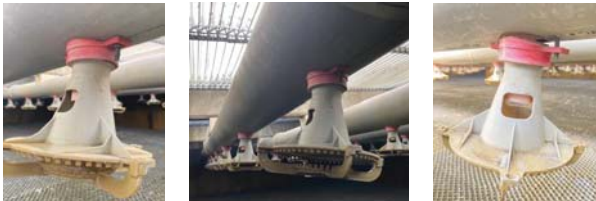
Date	Description	Remark
	  <div style="border: 1px solid black; padding: 5px; margin-top: 10px;"> <p>Inspection and remove coating clog at Nozzle Spray. > Not found coating clog nozzle > Found Nozzle was loosen / Action: Tightening check all</p> </div>

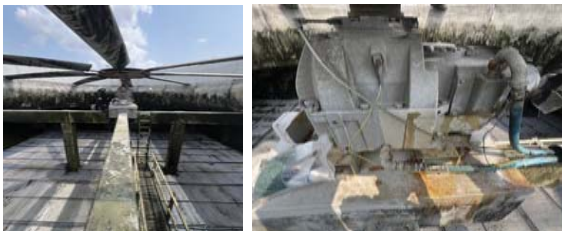
Date	Description	Remark
17 Apr 2024	<p>Inspection CT Fan no.2 (After overhaul 7 month later by Bgrimm Tech , Last Sep 2023)</p> <p><u>Item no.1</u> - CT annual inspection Cell no.2 For Gearbox 1.Inspection of gear teeth and internal condition. > Found side cover plate gear was leakage - Action : Replace with new O-ring and add 587 sealant > Base plate gear was begin rust corrosion / Action: Coating NIPPON Epoxy Rust Protective 2.Inspection shaft bolt coupling Motor-Gear End 3.Inspection Fan CT , Corrosion damaged. >Found abnormal scale calcium sulphate (CaSO₄) at all of surface area >Found coat Hub was rust corrosion / Action: Roller coating NIPPON Epoxy Rust Protective >Cover fan side gear (black) was damaged / Action: Remove all 4.Inspection and remove coating clog at Nozzle Spray. > Not found coating clog nozzle > Found Nozzle was loosen - lost 2 Ea / Action: Tightening check all and install new</p>

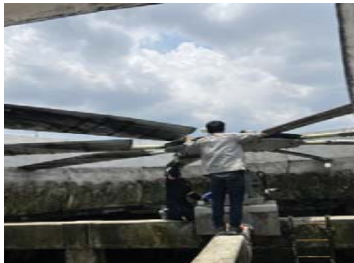
<p>After Cleaned and Coating NIPPON Epoxy Rust Protective</p>
