รายงานผลการตรวจสอบการกีดกร่อนของผิวในท่อ
ด้วยการปล่อยกระสวยสำรวจท่อ (Intelligent PIG)

FINAL REPORT
ROGEO INSPECTION SERVICE
XT

36" Natural Gas Pipeline
Songkhla Gas Separation Plant to BV ML 417 Lunas Station

FINAL REPORT
ROCOMBO INSPECTION SERVICE
MFL-A/XT

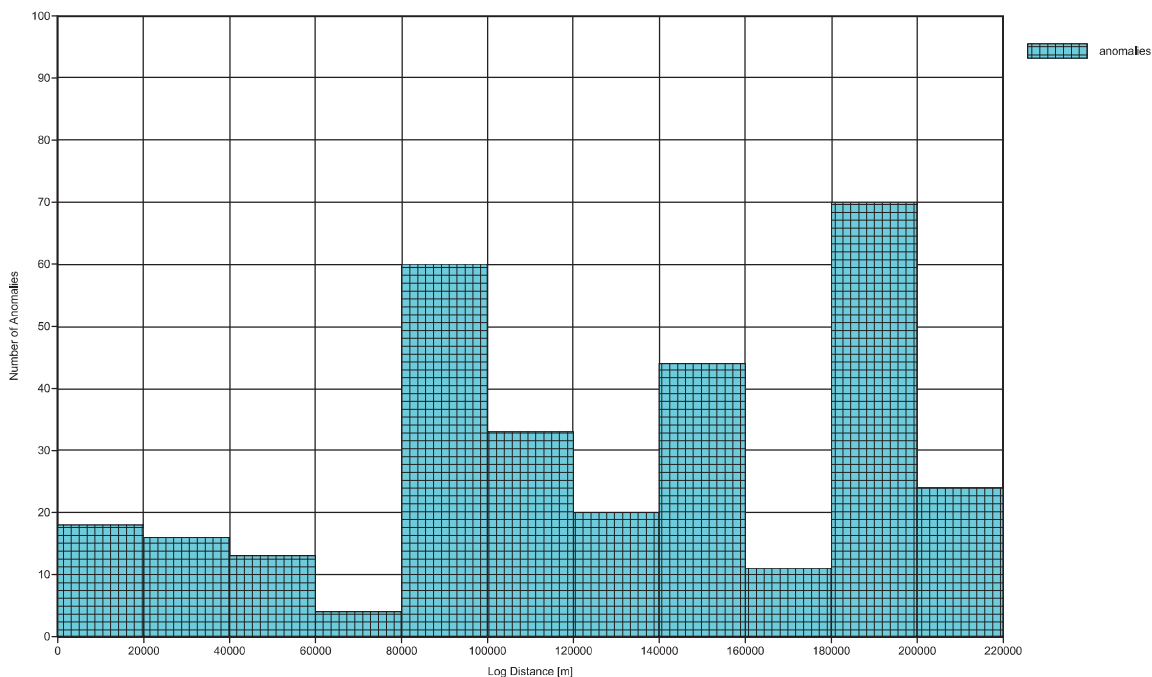
Final Inline Inspection Report
DISTRIBUTION OF ALL GEOMETRY ANOMALIES

This graph includes all geometry anomalies that meet and exceed the reporting threshold. It displays the number of anomalies versus pipeline length in increments of 20000 meter.

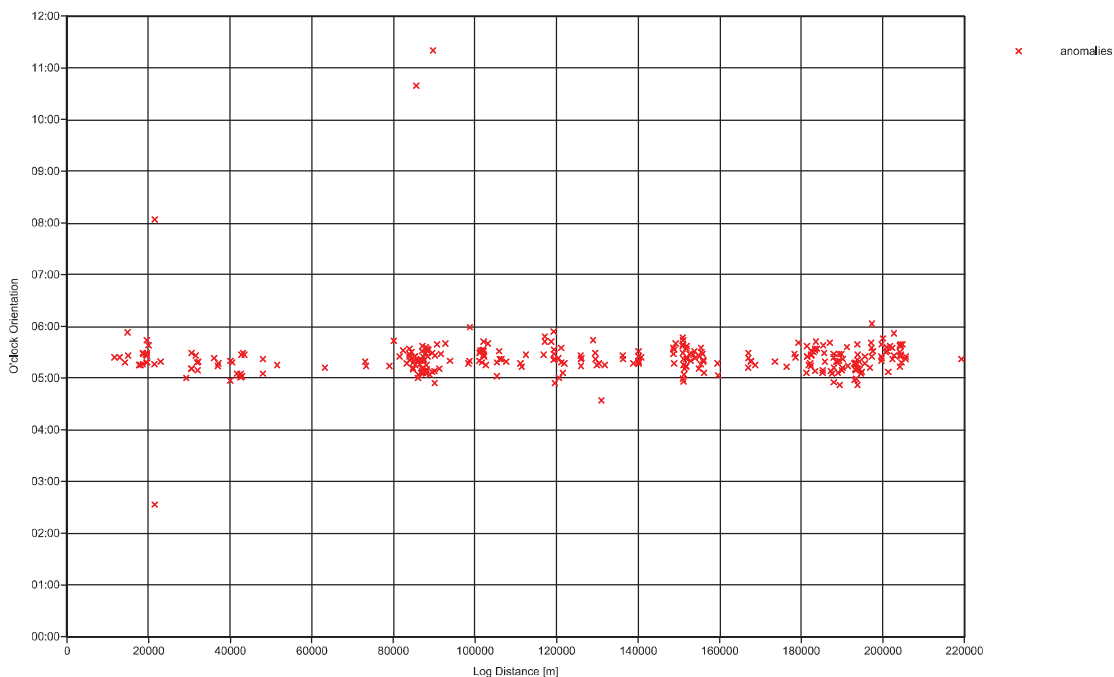
36" Songkhla GSP to BV ML417 Lunas, 220.0 km Final Inline Inspection Report O'CLOCK POSITION OF ALL GEOMETRY ANOMALIES

This plot shows the o'clock orientation of all reported geometry anomalies versus pipeline length. The o'clock position is given as the leading upper corner of the anomaly rectangle looking in the downstream direction of the pipeline.

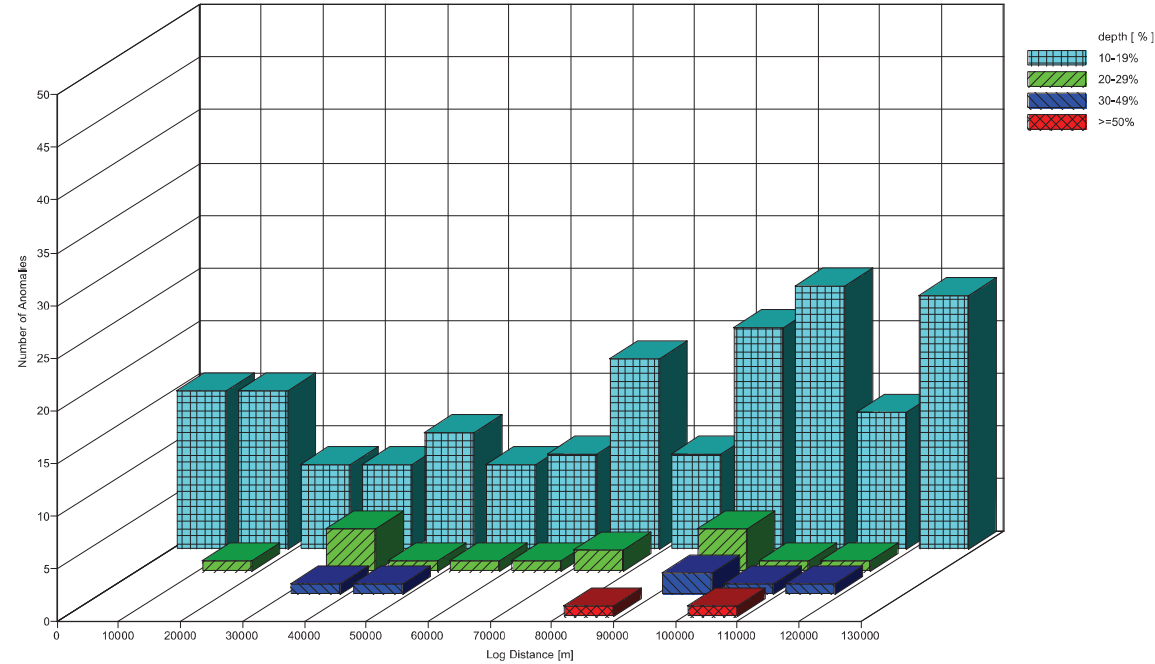
Depth Distribution of All Metal Loss Anomalies

This graph includes all metal loss anomalies that meet and exceed the reporting threshold. It displays the number of anomaly versus pipeline length in increments of 10000 meter.

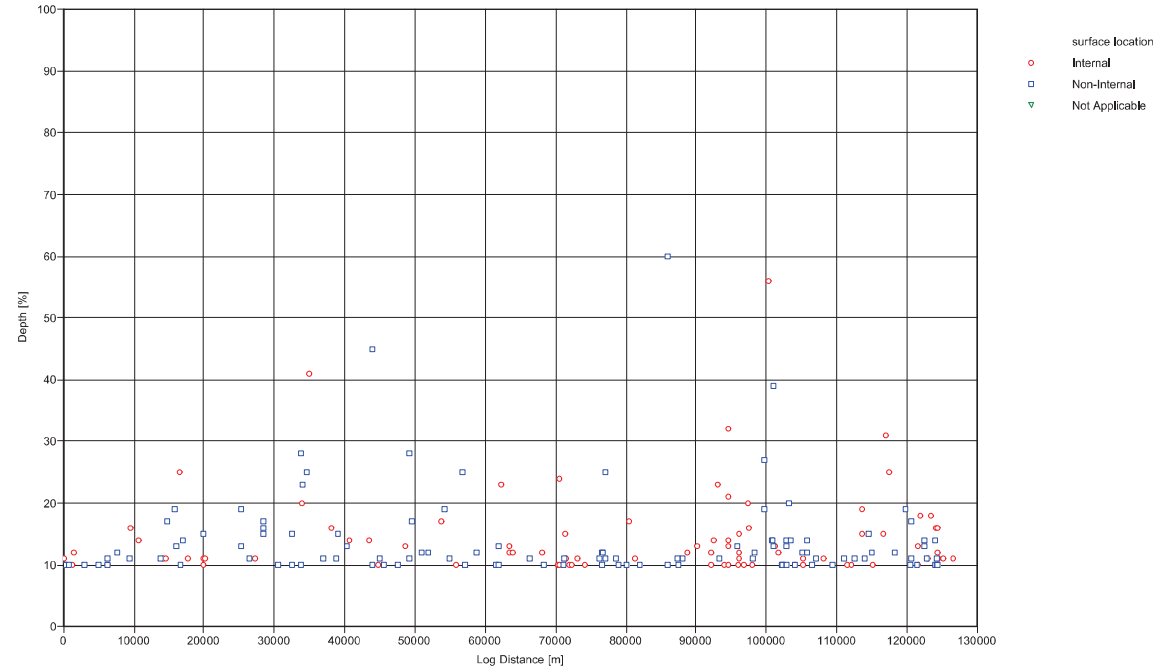
Wall Loss Distribution Plot

The plot shows the anomaly wall loss distribution versus pipeline length for all metal loss anomalies with surface location.
