ภาคผนวก ข-4

สำเนาหนังสือชี้แจงกรณีมีผลการติดตามตรวจสอบคุณภาพอากาศ
ไม่เป็นไปตามมาตรฐาน

เรื่อง ขออนุญาตการระบายปริมาณฝุ่นละอองของบริษัท บีแอลซีพี เพาเวอร์ จำกัด หน่วยผลิตที่ 1 มีค่าสูงผิดปกติ
เรียน อธิบดีกรมควบคุมมลพิษ

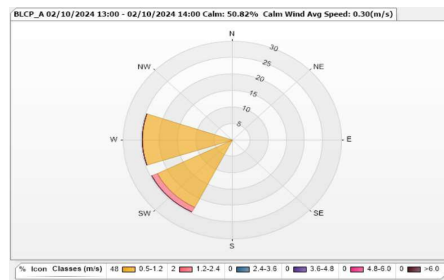
สิ่งที่ส่งมาด้วย 1

ตามที่บริษัท บีแอลซีพี เพาเวอร์ จำกัด ได้มีการติดตั้งเครื่องมือตรวจวัดคุณภาพอากาศแบบต่อเนื่อง (Continuous Emissions Monitoring System; CEMS) เพื่อติดตามคุณภาพอากาศที่ระบายออกจากปล่องระบายอากาศ พบว่า ปริมาณฝุ่นละอองที่ระบายออกจากปล่องโรงไฟฟ้าบีแอลซีพี หน่วยผลิตที่ 1 (เฉลี่ย 1 ชั่วโมงสูงสุด) 2 ตุลาคม 2567 เวลาประมาณ 13.00 – 14.00 น. สูงกว่าข้อกำหนด EIA ที่กำหนดไว้ 43 มิลลิกรัมต่อลูกบาศก์เมตร ดังสิ่งที่ส่งมาด้วย 1 จากการตรวจสอบพบว่า มีการสะสมของฝุ่นในหม้อต้มไอน้ำปริมาณมาก จึงคาดว่าเป็นสาเหตุที่ทำให้ค่าฝุ่นละอองสูงผิดปกติ

ผลการตรวจวัดค่าการระบายจากปล่องระบายอากาศของโรงไฟฟ้าบีแอลซีพี หน่วยการผลิตที่ 1 วันที่ 2 - 3 ตุลาคม 2567

ทิศทางลมส่วนใหญ่
พัดจากทิศตะวันตกเฉียงใต้ไปยังทิศตะวันออกเฉียงเหนือ
และพัดจากทิศตะวันตกไปยังทิศตะวันออก

ในการนี้บริษัทฯ จึงได้เร่งดำเนินการตรวจสอบกระบวนการผลิตและควบคุมการเผาไหม้ เพื่อให้ค่าการระบายฝุ่นละอองกลับเข้าสู่ค่าปกติในวันที่ 3 ตุลาคม เวลา 09.00 น. พร้อมกันนี้ได้เฝ้าระวังค่าฝุ่นละอองในบรรยากาศทั่วไป พบว่า ฝุ่นละอองรวมและฝุ่นละอองขนาดไม่เกิน 10 ไมครอน มีค่าปกติตามเกณฑ์มาตรฐาน ดังมีรายละเอียดตามสิ่งที่ส่งมาด้วย 2 นี้

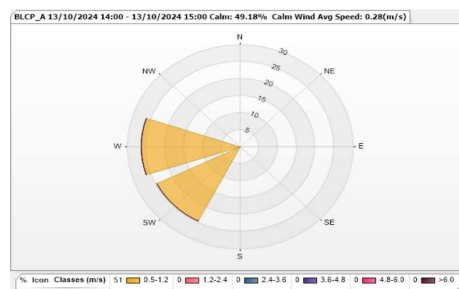
สิ่งที่ส่งมาด้วย 1

ตามที่บริษัท บีแอลซีพี เพาเวอร์ จำกัด ได้มีการติดตั้งเครื่องมือตรวจวัดคุณภาพอากาศแบบต่อเนื่อง (Continuous Emissions Monitoring System; CEMS) เพื่อติดตามคุณภาพอากาศที่ระบายออกจากปล่องระบายอากาศ พบว่า ปริมาณฝุ่นละอองที่ระบายออกจากปล่องโรงไฟฟ้าบีแอลซีพี หน่วยผลิตที่ 1 (เฉลี่ย 1 ชั่วโมงสูงสุด) วันที่ 13 ตุลาคม 2567 เวลาประมาณ 14.00 - 15.00 น. สูงกว่าข้อกำหนด EIA ที่กำหนดไว้ 43 มิลลิกรัมต่อลูกบาศก์เมตร ดังสิ่งที่ส่งมาด้วย 1 จากการตรวจสอบพบว่าการหยุดเดินเครื่องจักร (Shut down) ส่วนล้าเสี่ยงเชื้อเพลิงย่อยเพื่อซ่อมบำรุง ขณะเริ่มเดินเครื่องจักร (Start up) ส่วนล้าเสี่ยงเชื้อเพลิงย่อยหลังกิจกรรมซ่อมบำรุง ส่งผลให้ค่าฝุ่นละอองสูงผิดปกติชั่วคราว

ผลการตรวจวัดค่าการระบายจากปล่องระบายอากาศของโรงไฟฟ้าบีแอลซีพี หน่วยการผลิตที่ 1 วันที่ 13 ตุลาคม 2567

ทิศทางลมส่วนใหญ่
และพัดจากทิศตะวันตกไปยังทิศตะวันออก
และพัดจากทิศตะวันตกเฉียงใต้ไปยังทิศตะวันออกเฉียงเหนือ

ในการนี้บริษัทฯ จึงได้ดำเนินการปรับกระบวนการผลิต ตลอดจนควบคุมการเผาไหม้ เพื่อให้ค่าการระบายฝุ่นละอองกลับเข้าสู่ปกติ พร้อมกันนี้ได้ตรวจสอบและเฝ้าระวังค่าฝุ่นละอองในบรรยากาศทั่วไป พบว่า ฝุ่นละอองรวมและฝุ่นละอองขนาดเล็กไม่เกิน 10 ไมครอน มีค่าปกติตามเกณฑ์มาตรฐาน ดังมีรายละเอียดตามสิ่งที่ส่งมาด้วย 2 นี้

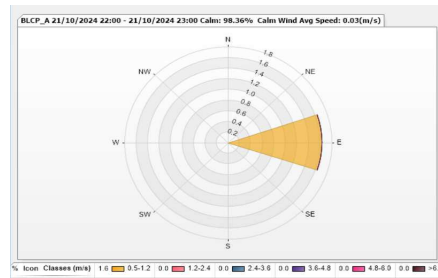
ตามที่บริษัท บีแอลซีพี เพาเวอร์ จำกัด ได้มีการติดตั้งเครื่องมือตรวจวัดคุณภาพอากาศแบบต่อเนื่อง (Continuous Emissions Monitoring System; CEMS) เพื่อติดตามคุณภาพอากาศที่ระบายออกจากปล่องระบายอากาศ พบว่า ปริมาณฝุ่นละอองที่ระบายออกจากปล่องโรงไฟฟ้าบีแอลซีพี หน่วยผลิตที่ 1 (เฉลี่ย 1 ชั่วโมงสูงสุด) วันที่ 21 ตุลาคม 2567 เวลาประมาณ 22.00 - 23.00 น. สูงกว่าข้อกำหนด EIA ที่กำหนดไว้ 43 มิลลิกรัมต่อลูกบาศก์เมตร ดังสิ่งที่ส่งมาด้วย 1 จากการตรวจสอบพบว่ามีการปรับแต่งกระบวนการผลิต ทำให้อุณหภูมิของก๊าซร้อนสูงขึ้น ซึ่งส่งผลต่อให้ประสิทธิภาพของอุปกรณ์ดักจับฝุ่นละอองแบบไฟฟ้าสถิตย์ (Electrostatic Precipitator; EP) ลดลง จึงเป็นสาเหตุที่ทำให้ค่าฝุ่นละอองสูงผิดปกติ

ผลการตรวจวัดค่าการระบายจากปล่องระบายอากาศของโรงไฟฟ้าบีแอลซีพี หน่วยการผลิตที่ 1 วันที่ 21-22 ตุลาคม 2567

ทิศทางลมส่วนใหญ่
พัดจากทิศตะวันออกไปยังทิศตะวันตก

ในการนี้บริษัทฯ จึงได้ดำเนินการปรับกระบวนการผลิต ตลอดจนควบคุมการเผาไหม้ เพื่อให้ค่าการระบายฝุ่นละอองกลับเข้าสู่ค่าปกติ พร้อมกันนี้ได้ตรวจสอบและเผื่อระงับค่าฝุ่นละอองในบรรยากาศทั่วไป พบว่า ฝุ่นละอองรวมและฝุ่นละอองขนาดไม่เกิน 10 ไมครอน มีค่าปกติตามเกณฑ์มาตรฐาน ดังมีรายละเอียดตามสิ่งที่ส่งมาด้วย 2 นี้

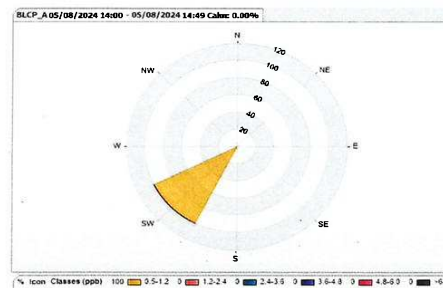
สิ่งที่ส่งมาด้วย 1

ตามที่บริษัท บีแอลซีพี เพาเวอร์ จำกัด ได้มีการติดตั้งเครื่องมือตรวจวัดคุณภาพอากาศแบบต่อเนื่อง (Continuous Emissions Monitoring System; CEMS) เพื่อติดตามคุณภาพอากาศที่ระบายออกจากปล่องระบายอากาศ พบว่า ปริมาณฝุ่นละอองที่ระบายออกจากปล่องโรงไฟฟ้าบีแอลซีพี หน่วยผลิตที่ 2 (เฉลี่ย 1 ชั่วโมงสูงสุด) วันที่ 5 สิงหาคม 2567 เวลาประมาณ 14.00 – 15.00 น. สูงกว่าข้อกำหนด EIA ที่กำหนดไว้ 43 มิลลิกรัมต่อลูกบาศก์เมตร ดังสิ่งที่ส่งมาด้วย 1 จากการตรวจสอบเบื้องต้นพบว่า ในช่วงเวลาดังกล่าวมีกิจกรรมปรับกระบวนการผลิตประกอบกับคุณสมบัติของเชื้อเพลิงมีค่าความร้อนต่ำกว่าปกติ ทำให้ระบบการเผาไหม้ใช้เชื้อเพลิงปริมาณมากขึ้น ส่งผลให้ปริมาณฝุ่นละอองสูงขึ้น

ผลการตรวจวัดค่าการระบายจากปล่องระบายอากาศของโรงไฟฟ้าบีแอลซีพี หน่วยการผลิตที่ 2 วันที่ 5 สิงหาคม 2567

ทิศทางลมวันที่ 5 สิงหาคม 2567
ทิศทางทิศตะวันตกเฉียงใต้ไปยัง
ทิศตะวันออกเฉียงเหนือ

ในการนี้บริษัทฯ ได้ดำเนินการแก้ไขโดยปรับกระบวนการผลิต ตลอดจนควบคุมการเผาไหม้ เพื่อให้ค่าการระบายฝุ่นละอองกลับมาสู่ค่าปกติ พร้อมทั้งนี้ได้ตรวจสอบและเผื่อระวังค่าฝุ่นละอองในบรรยากาศทั่วไป พบว่า ฝุ่นละอองรวมและฝุ่นละอองขนาดเล็กไม่เกิน 10 ไมครอน มีค่าปกติตามเกณฑ์มาตรฐาน ดังมีรายละเอียดตามสิ่งที่ส่งมาด้วย 2 นี้

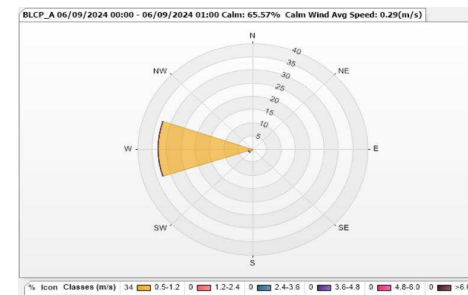
ตามที่บริษัท บีแอลซีพี เพาเวอร์ จำกัด ได้มีการติดตั้งเครื่องมือตรวจวัดคุณภาพอากาศแบบต่อเนื่อง (Continuous Emissions Monitoring System; CEMS) เพื่อติดตามคุณภาพอากาศที่ระบายออกจากปล่องระบายอากาศ พบว่า ปริมาณฝุ่นละอองที่ระบายออกจากปล่องโรงไฟฟ้าบีแอลซีพี หน่วยผลิตที่ 2 (เฉลี่ย 1 ชั่วโมงสูงสุด) 6 กันยายน 2567 เวลาประมาณ 00.00 – 01.00 น. สูงกว่าข้อกำหนด EIA ที่กำหนดไว้ 43 มิลลิกรัมต่อลูกบาศก์เมตร ดังสิ่งที่ส่งมาด้วย 1 จากการตรวจสอบพบว่าอุปกรณ์ดักจับฝุ่นละอองแบบไฟฟ้าสถิตย์ (Electrostatic Precipitator; EP) เกิดการขัดข้องชั่วคราว จึงเป็นสาเหตุที่ทำให้ค่าฝุ่นละอองสูงผิดปกติ

ทิศทางลมวันที่ 6 กันยายน 2567
พัดจากทิศตะวันตกไปยังทิศตะวันออก

ในการนี้บริษัทฯ จึงได้ดำเนินการปรับกระบวนการผลิตและดำเนินการแก้ไข ตลอดจนควบคุมการเผาไหม้เพื่อให้ค่าการระบายฝุ่นละอองกลับเข้าสู่ค่าปกติ พร้อมกันนี้ได้ตรวจสอบและเฝ้าระวังค่าฝุ่นละอองในบรรยากาศทั่วไป พบว่า ฝุ่นละอองรวมและฝุ่นละอองขนาดไม่เกิน 10 ไมครอน มีค่าปกติตามเกณฑ์มาตรฐาน ดังมีรายละเอียดตามสิ่งที่ส่งมาด้วย 2 นี้
