เอกสารประกอบการปฏิบัติตาม
มาตรการป้องกันและแก้ไขผลกระทบสิ่งแวดล้อม

Star Petroleum Refining Public Company Limited (SPRC)

Ocean Works Asia (Thailand) Co., Ltd. has been requested by Star Petroleum Refining Company (SPRC) for the provision of ROV services, to carry out an inspection of the Map Ta Phut 48" Subsea Crude Import Pipeline. The inspection is part of the ongoing inspection, repair and maintenance (IRM) contract for the SPM off Map Ta Phut, Thailand.

Visual Inspection

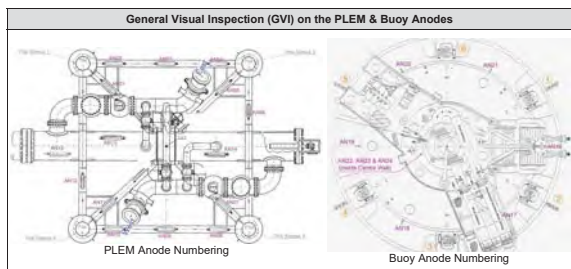
- Anode depletion was ranged from approximately 0-25% and 25-50%.
- Oxide deposits on the anodes would suggest they were active.
- Maring growth coverage varied between 10% to 100%

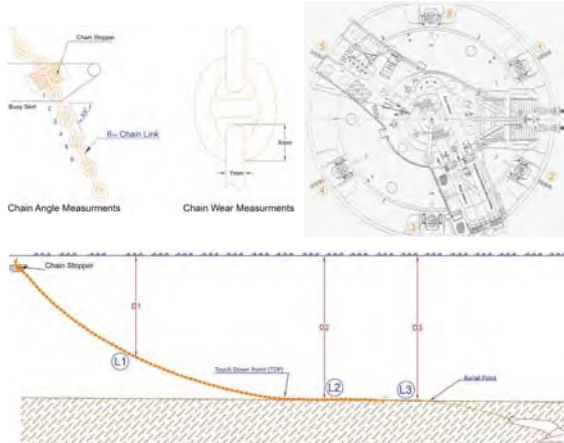
- Fishing net fouled on sections of the mooring chain
- Mooring was noted to be in generally good condition
- On all chains marine growth coverage 100% approx. 20-40mm thick.
- Depth at the touch down point (TDP) range between 93fsw to 99fsw
- Chain angle measurements were found to range between 44° to 50°
- No significant chain ware was noted at the areas where the dimensional survey was carried out

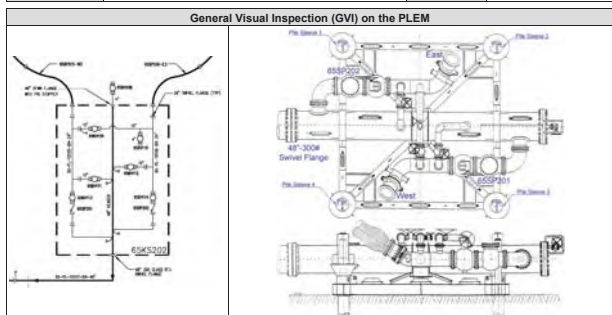
Mainline & Flanges (Including 48"-300# Swivel Flange) <ul style="list-style-type: none">Generally, in good condition.All bolts appear to be secureNo signs of anomalies	
Pipework & Flanges – East (Including 24" Check Valve 65SP-201) <ul style="list-style-type: none">Generally, in good condition.All bolts appear to be secureNo signs of anomalies	
Pipework & Flanges – West (Including 24" Check Valve 65SP-202) <ul style="list-style-type: none">Generally, in good condition.All bolts appear to be secureNo signs of anomalies	
Base Frame Structure (Including condition of Sand Slit) <ul style="list-style-type: none">North Side Gap - 140mm East Side Gap - 120mmSouth Side Gap - 170mm West Side Gap - 160mmNo signs of anomalies	
Piles & Pile Sleeves (Four (4) pile columns visual inspection and take photograph) <ul style="list-style-type: none">No signs of anomaliesCP readings on Piles refer to PLEM CP datasheet (55-66001-01-CP-01 CP Measurement - PLEM 24-08-09)

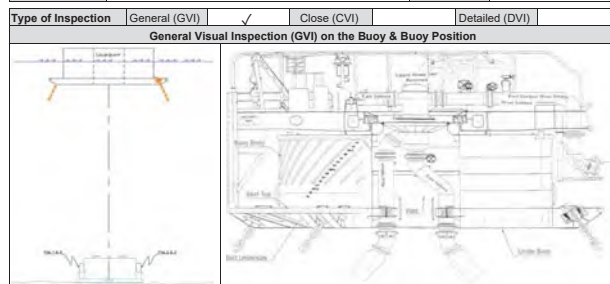
Buoy Position Relative to PLEM Distance: P1/E1: 5.25m P2/E2: 5.45m P2/W1: 4.60m P4/W2: 4.64m	
General Condition of Skirt: <ul style="list-style-type: none">General condition – Good.No signs of anomalies	
General Condition of Buoy Side Shell: <ul style="list-style-type: none">General condition – Good.No signs of anomalies	
General Condition of Centre Well: <ul style="list-style-type: none">General condition – Good.No signs of anomalies	
Marine Growth Coverage (Prior to marine growth cleaning) Overall: 30-40% Hard: 100% Soft: 50%	
Overall Coating Condition <ul style="list-style-type: none">General condition – Good.Pitting (40-50%) in some areas	
Additional Remarks Nil

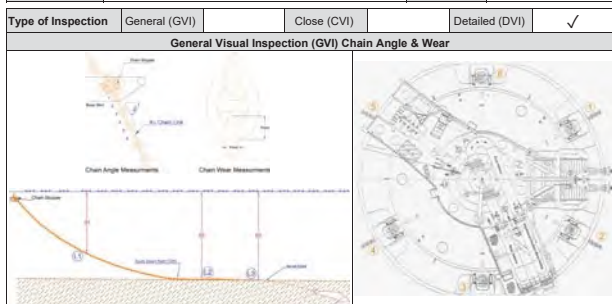
Note: Chain angle measurements to be taken on the 6 th link down from the chain stopper.	
Additional Comments <ul style="list-style-type: none">Fishing net debris noted on all chains. Due to time constraints net was not cleared.On all chains marine growth coverage 100% approx. 20-40mm thick.

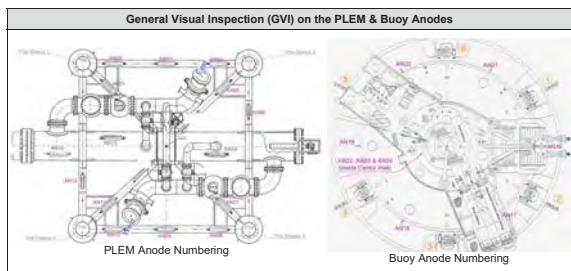
- Anode depletion was ranged from approximately 0% and 50%.
- Oxide deposits on the anodes would suggest they were active.
- Maring growth coverage varied between 10% to 100%

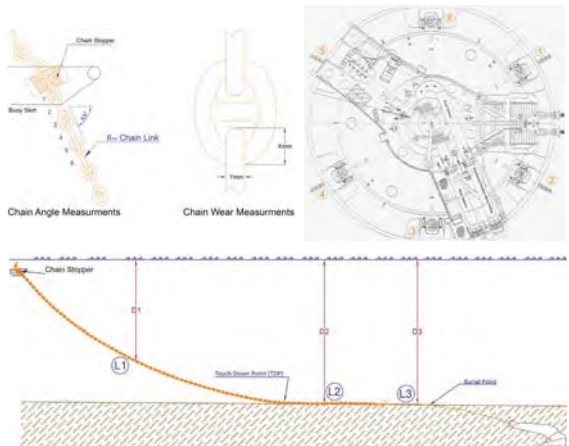
- Mooring chains was noted to be in generally good condition
- On all chains marine growth coverage 100% approx. 20-40mm thick.
- Chain angle measurements were found to range between 44° to 48°
- No significant chain wear was noted at the areas where the dimensional survey was carried out
