Baan Mai Khao - MDB PM2024

Maintenance Report

Date of work : 14 Mar 2024

Project Name : Baan Mai Khao - MDB PM2024
Location : Phuket
Subject : Infrared Thermography Scan
Inspection date : 14 Mar 2024

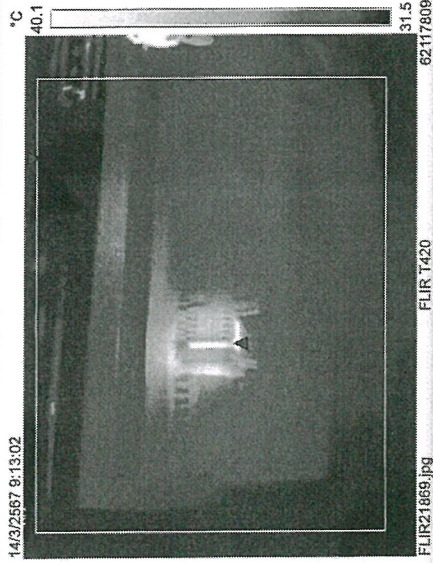
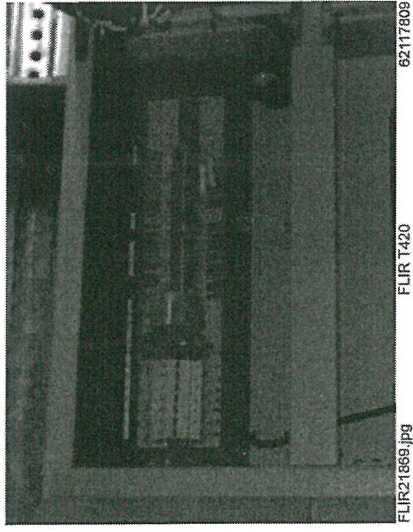
Measurements			°C
Ar1	Max	43.9	31.5
	Min	31.5	
	Average	32.9	
Parameters			
Emissivity			0.92
Ref. temp.			20 °C
Geolocation			
Compass	N

Location :	EE Room
Equipment :	MDB
Detail :	Fuse and Relay Control
Comment :	Normal operation, Not found hotspot Should also keep for your future reference

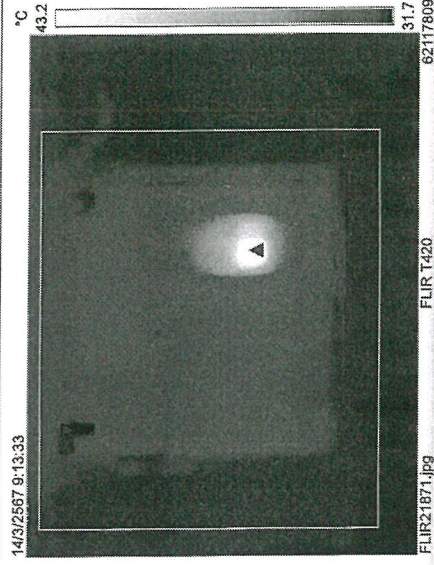
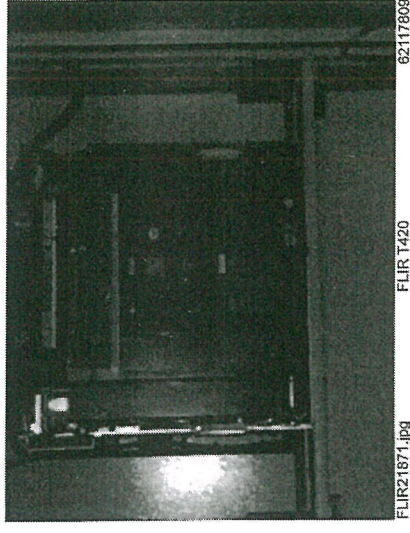
Measurements			°C
Ar1	Max	46.7	31.7
	Min	31.5	
	Average	32.6	
Parameters			
Emissivity			0.92
Ref. temp.			20 °C
Geolocation			
Compass	N

Location :	EE Room
Equipment :	MDB
Detail :	Main ACB
Comment :	Normal operation, Not found hotspot Should also keep for your future reference

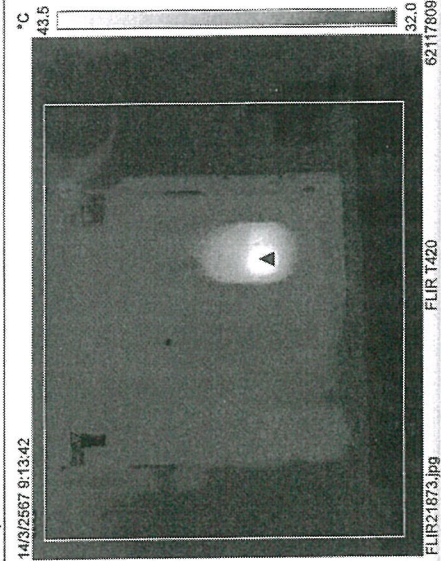
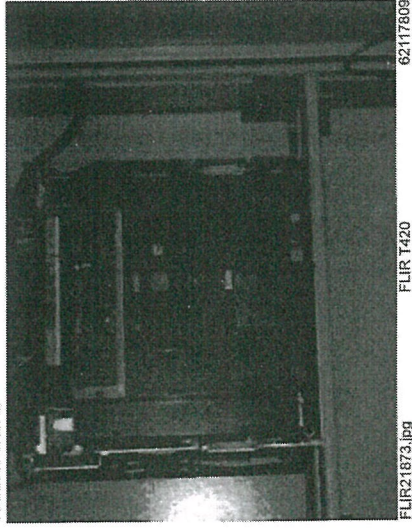
Measurements			°C
Ar1	Max	46.8	
	Min	31.6	
	Average	32.8	
Parameters			
Emissivity		0.92	
Ref. temp.		20 °C	
Geolocation			
Compass		N

Location :	EE Room
Equipment :	MDB
Detail :	Main ACB
Comment :	Normal operation, Not found hotspot Should also keep for your future reference

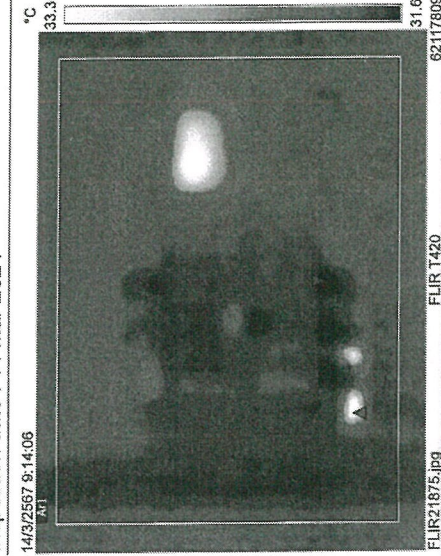
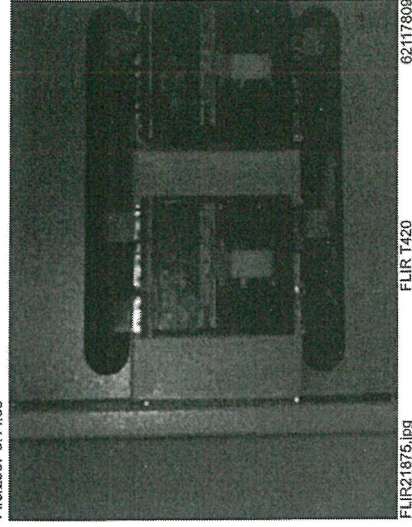
Measurements			°C
Ar1	Max	33.6	
	Min	31.5	
	Average	31.8	
Parameters			
Emissivity		0.92	
Ref. temp.		20 °C	
Geolocation			
Compass	N

Location :	EE Room
Equipment :	MDB
Detail :	MCCB For Branch
Comment :	Normal operation, Not found hotspot Should also keep for your future reference

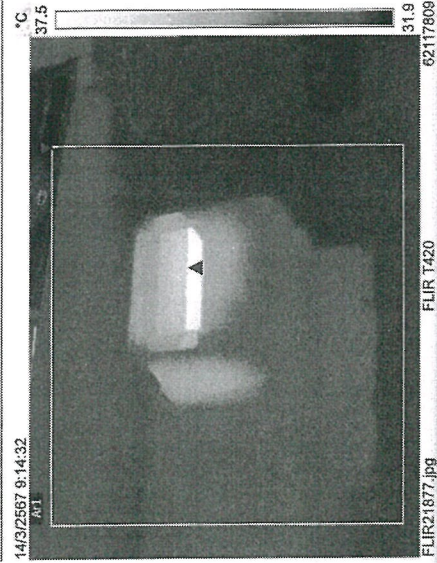
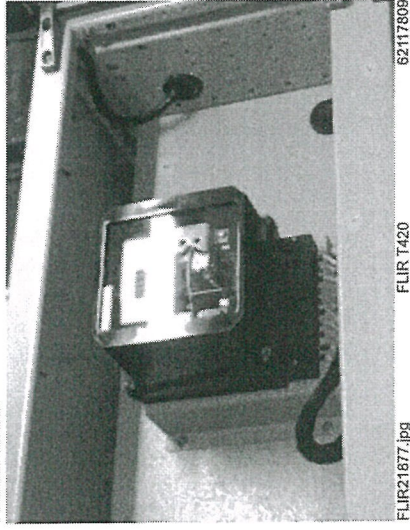
Measurements			°C
Ar1	Max	37.9	
	Min	32.0	
	Average	32.9	
Parameters			
Emissivity	0.92		
Ref. temp.	20 °C		
Geolocation			
Compass	NE

Location :	EE Room
Equipment :	MDB
Detail :	kWh Meter
Comment :	Normal operation, Not found hotspot Should also keep for your future reference

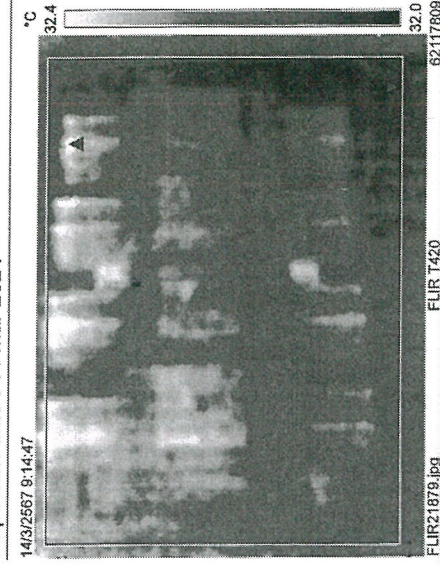
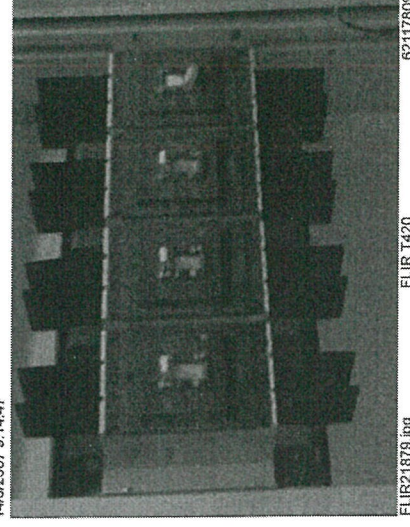
Measurements			°C
Ar1	Max	32.5	
	Min	31.9	
	Average	32.2	
Parameters			
Emissivity	0.92		
Ref. temp.	20 °C		
Geolocation			
Compass	N

Location :	EE Room
Equipment :	MDB
Detail :	MCCB For Branch
Comment :	Normal operation, Not found hotspot Should also keep for your future reference

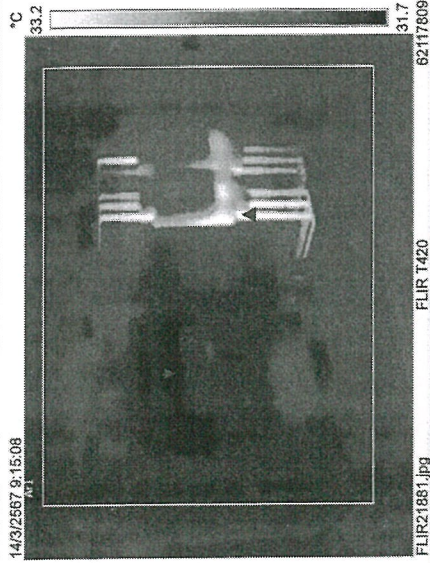
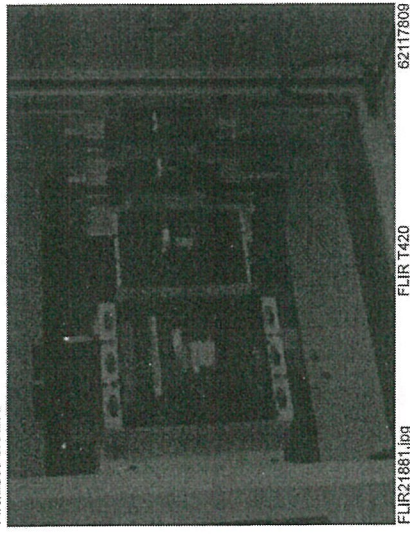
Measurements		°C
Ar1	Max	33.5
	Min	31.7
	Average	32.0
Parameters		
Emissivity	0.92	
Ref. temp.	20 °C	
Geolocation		
Compass	N

Location :	EE Room
Equipment :	MDB
Detail :	MCCB For Branch
Comment :	Normal operation, Not found hotspot Should also keep for your future reference

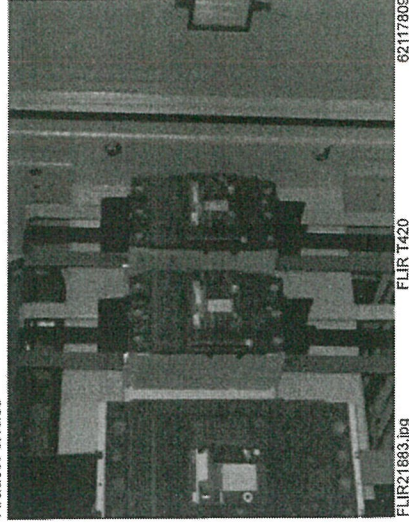
Location :	EE Room
Equipment :	MDB
Detail :	MCCB For Branch
Comment :	Normal operation, Not found hotspot Should also keep for your future reference

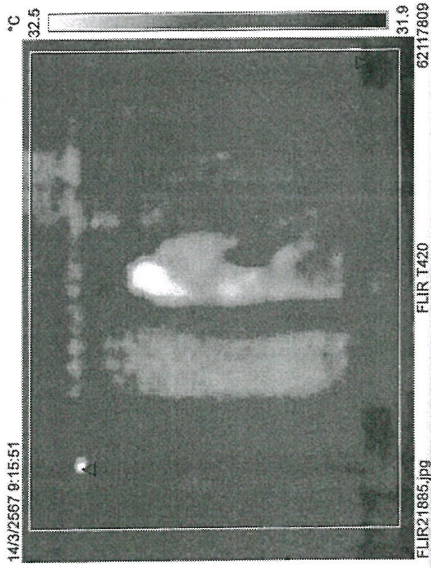
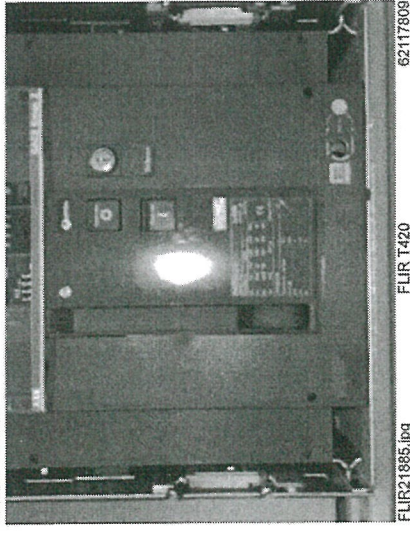
Min	31.9	
	Average	32.2	
Parameters			
Emissivity		0.92	
Ref. temp.		20 °C	
Geolocation			
Compass		N

Location :	EE Room
Equipment :	MDB
Detail :	Main ACB
Comment :	Normal operation, Not found hotspot Should also keep for your future reference

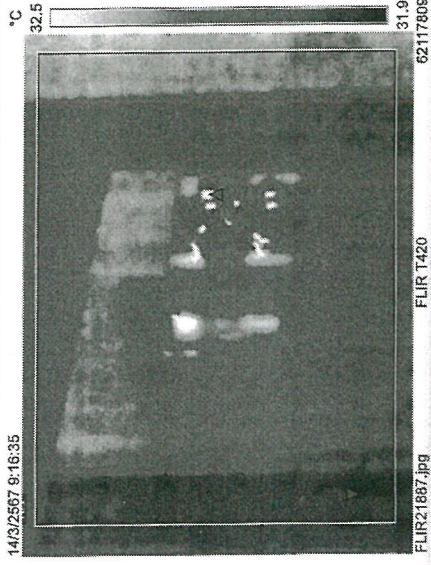
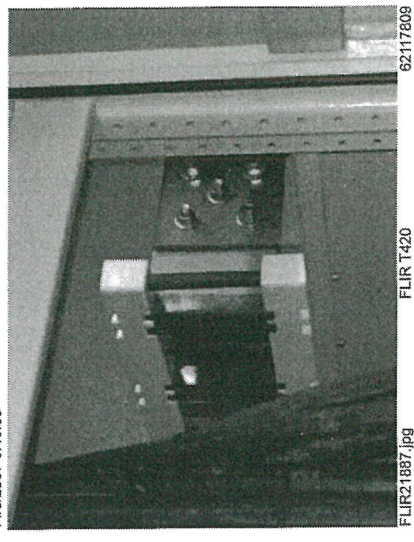
Min	31.8	
	Average	32.1	
Parameters			
Emissivity		0.92	
Ref. temp.		20 °C	
Geolocation			
Compass		SW

Location :	EE Room
Equipment :	MDB
Detail :	Main Cable and Busbar Connection
Comment :	Normal operation, Not found hotspot Should also keep for your future reference

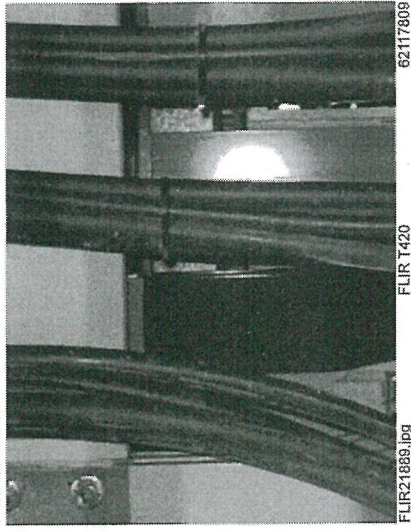
Location :	EE Room
Equipment :	MDB
Detail :	Main Cable and Busbar Connection
Comment :	Normal operation, Not found hotspot
	Should also keep for your future reference

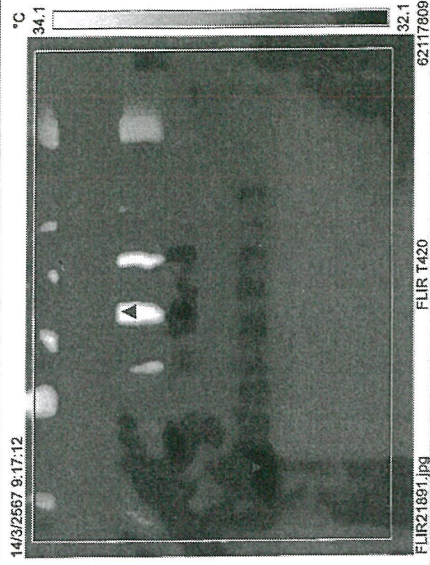
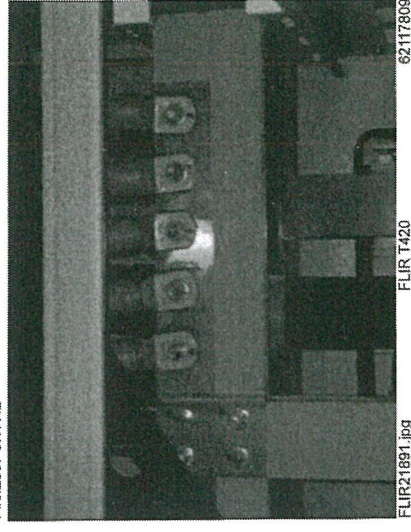
Measurements			°C
Ar1	Max	34.8	
	Min	31.9	
	Average	32.5	
Parameters			
Emissivity			0.92
Ref. temp.			20 °C
Geolocation			
Compass			S

Location :	EE Room
Equipment :	MDB
Detail :	Main Cable and Busbar Connection
Comment :	Normal operation, Not found hotspot
	Should also keep for your future reference

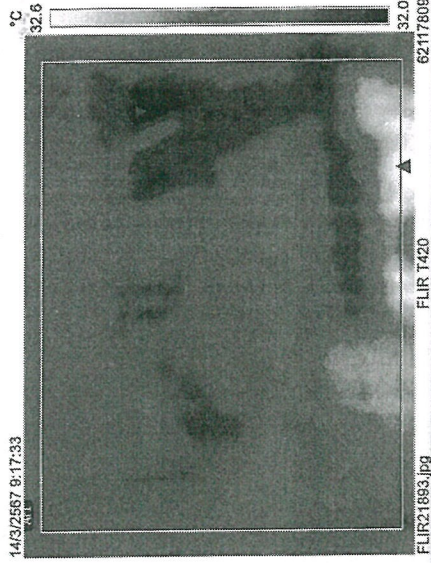
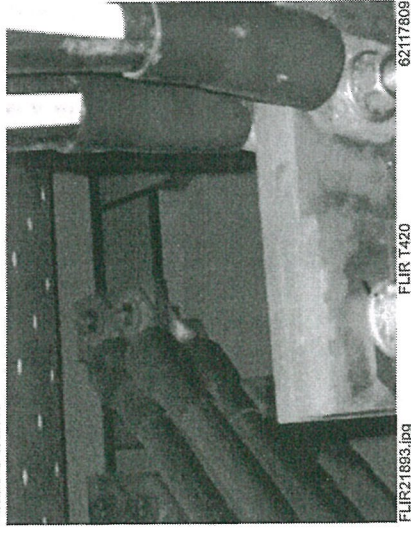
Measurements			°C
Ar1	Max	32.7	
	Min	32.0	
	Average	32.2	
Parameters			
Emissivity		0.92	
Ref. temp.		20 °C	
Geolocation			
Compass		SW

Location :	EE Room
Equipment :	MDB
Detail :	Main Cable and Busbar Connection
Comment :	Normal operation, Not found hotspot
Should also keep for your future reference

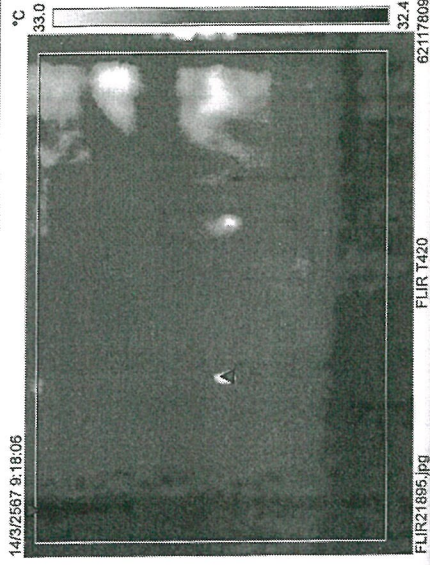
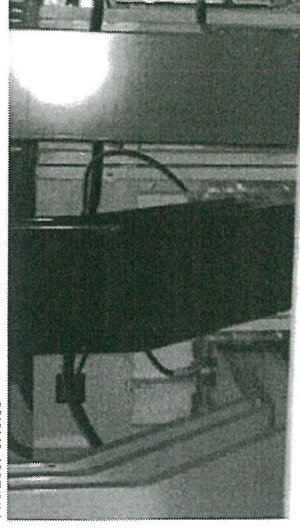
Measurements			°C
Ar1	Max	33.4	
	Min	32.3	
	Average	32.6	
Parameters			
Emissivity		0.92	
Ref. temp.		20 °C	
Geolocation			
Compass		SW

Location :	EE Room
Equipment :	MDB
Detail :	Main Cable and Busbar Connection
Comment :	Normal operation, Not found hotspot
Should also keep for your future reference

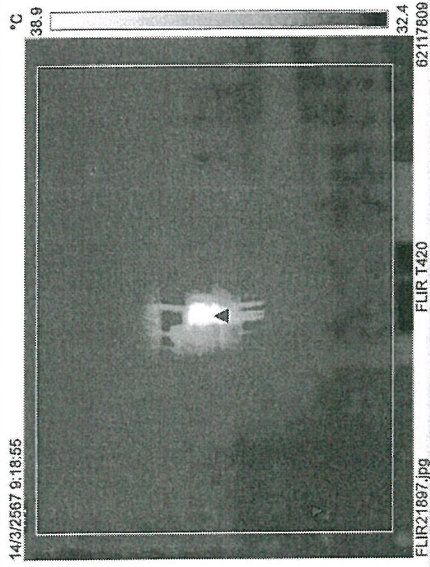
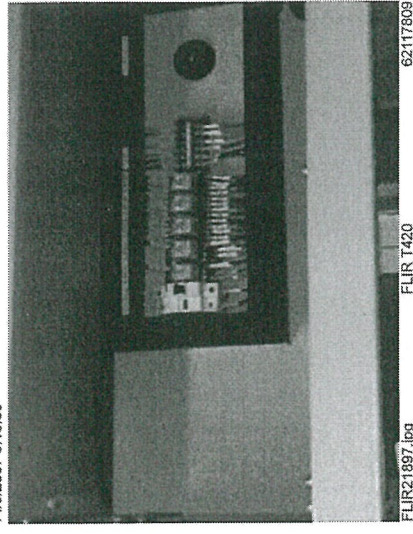
Measurements			°C
Ar1	Max	44.7	20 °C
	Min	32.6	
	Average	33.1	
Parameters			
Emissivity			0.92
Ref. temp.			
Geolocation			
Compass	N

Location :	EE Room
Equipment :	MDB
Detail :	Fuse and Relay Control
Comment :	Normal operation, Not found hotspot Should also keep for your future reference

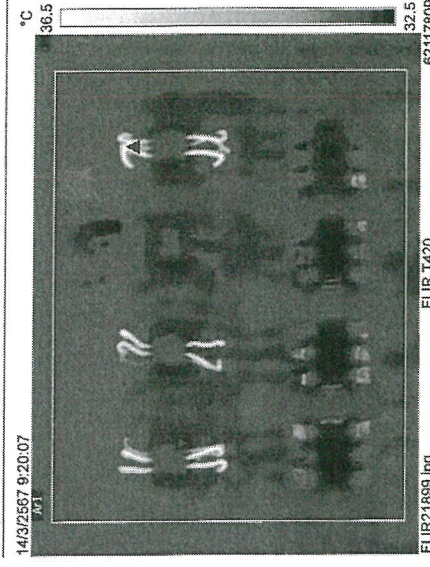
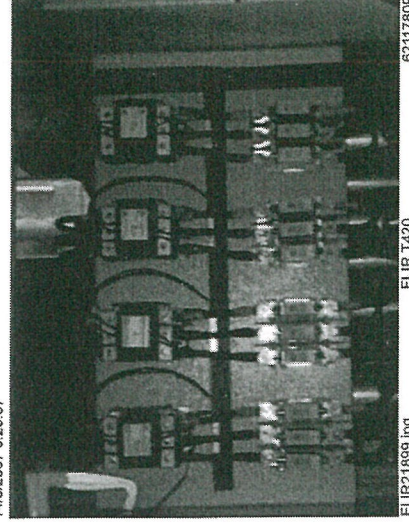
Measurements			°C
Ar1	Max	39.5	
	Min	32.4	
	Average	32.9	
Parameters			
Emissivity	0.92		
Ref. temp.	20 °C		
Geolocation			
Compass	N

Location :	EE Room
Equipment :	MDB
Detail :	HRC Fuse and Magnetic
Comment :	Normal operation, Not found hotspot Should also keep for your future reference

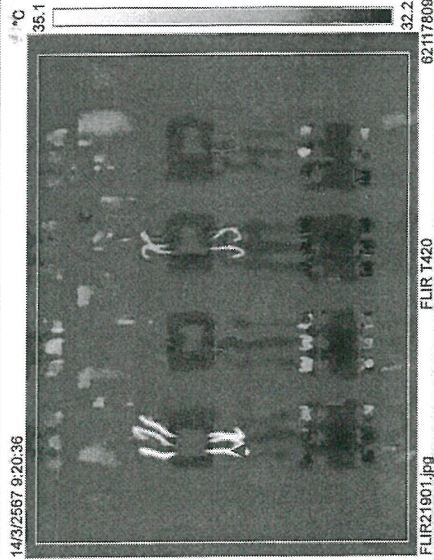
Measurements			°C
At1	Max	39.2	
	Min	31.7	
	Average	32.7	
Parameters			
Emissivity	0.92		20 °C
Ref. temp.			
Geolocation			
Compass	N

EE Room
MDB
HRC Fuse and Magnetic
Normal operation, Not found hotspot
Should also keep for your future reference

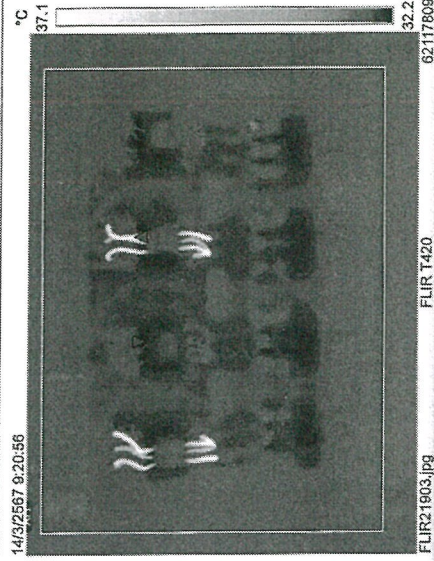
Measurements			°C
At1	Max	42.3	
	Min	32.0	
	Average	32.6	
Parameters			
Emissivity			0.92
Ref. temp.			20 °C
Geolocation			
Compass			N

EE Room
MDB
HRC Fuse and Magnetic
Normal operation, Not found hotspot
Should also keep for your future reference

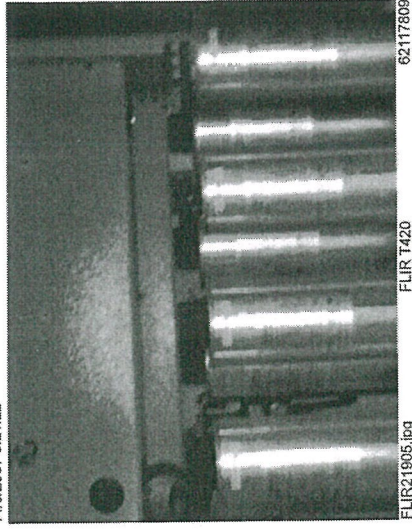
Location :	EE Room
Equipment :	MDB
Detail :	Capacitor Bank
Comment :	Normal operation, Not found hotspot Should also keep for your future reference

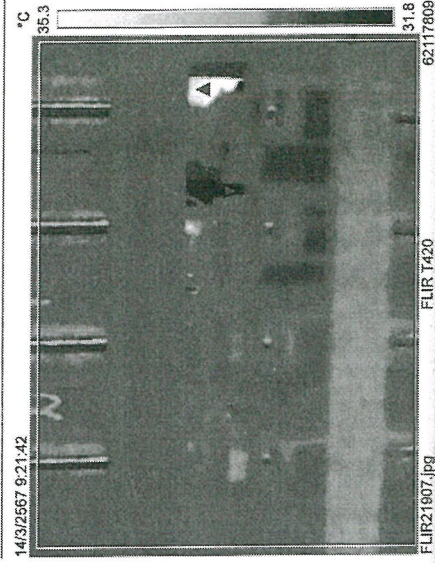
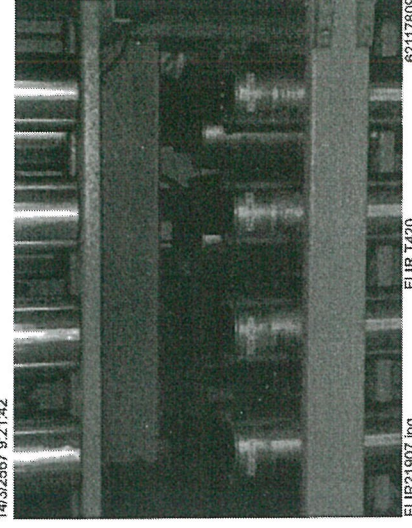
Location :	EE Room
Equipment :	MDB
Detail :	Capacitor Bank
Comment :	Normal operation, Not found hotspot Should also keep for your future reference

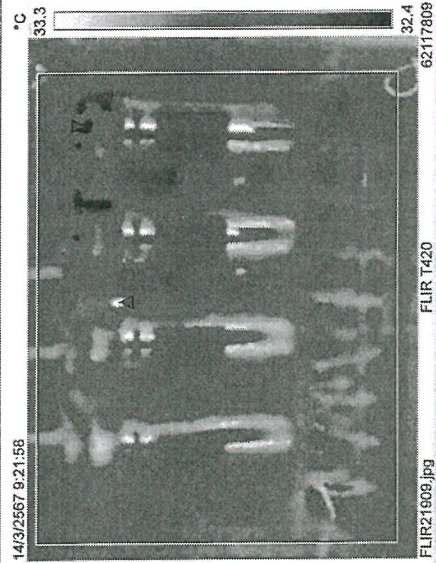
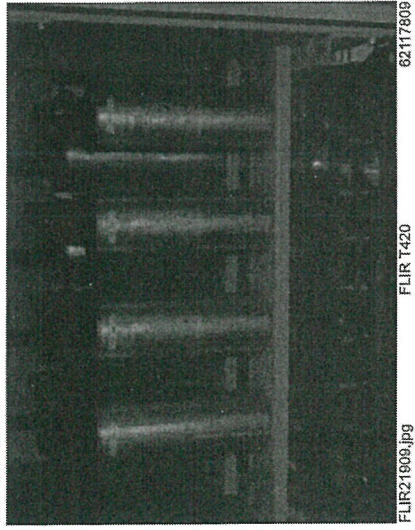
Measurements			°C
Ar1	Max	37.5	Average
	Min	31.6	
	Average	32.8	
Parameters			
Emissivity		0.92	
Ref. temp.		20 °C	
Geolocation			
Compass		S

Location :	EE Room
Equipment :	MDB
Detail :	Capacitor Bank
Comment :	Normal operation, Not found hotspot Should also keep for your future reference

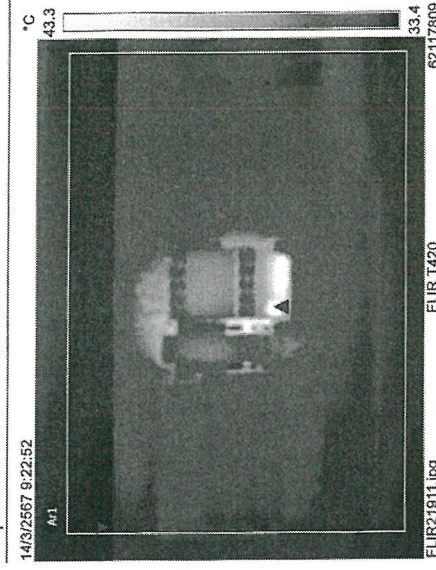
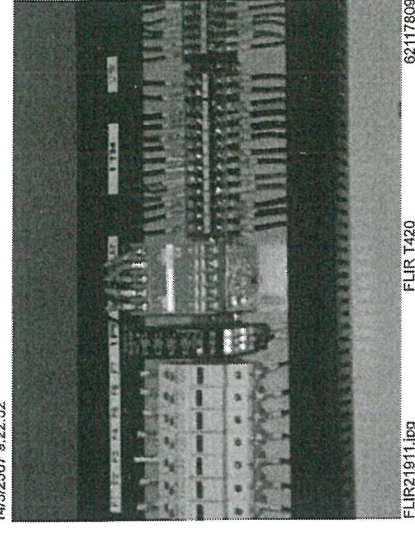
Measurements				°C
Ar1	Max	48.4	Average	34.6
	Min	33.3		
Parameters				
Emissivity		0.92		
Ref. temp.		20 °C		
Geolocation				
Compass		N

Location :	EE Room
Equipment :	MDB
Detail :	Protection Relay
Comment :	Normal operation, Not found hotspot Should also keep for your future reference

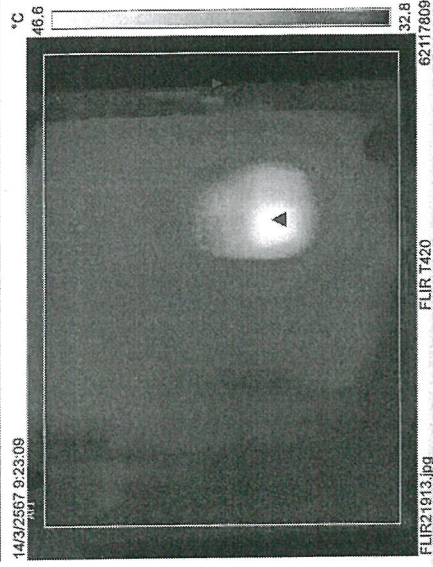
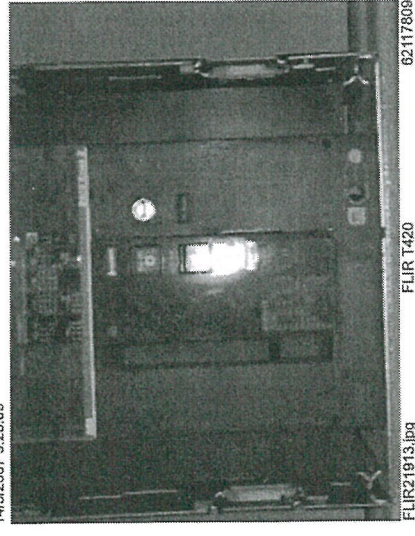
Measurements			°C
Ar1	Max	47.7	
	Min	32.7	
	Average	34.1	
Parameters			
Emissivity	0.92		20 °C
Ref. temp.			
Geolocation			
Compass	N

Location :	EE Room
Equipment :	MDB
Detail :	Main ACB
Comment :	Normal operation, Not found hotspot Should also keep for your future reference

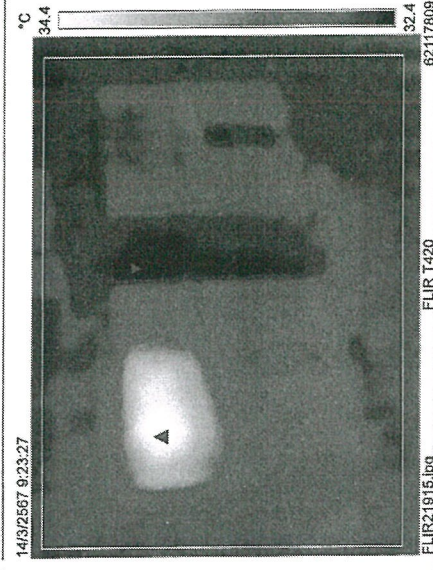
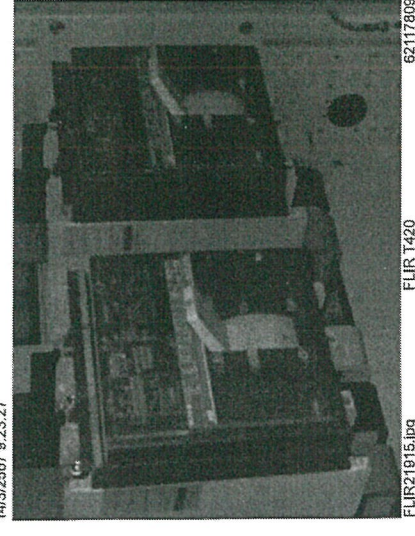
Measurements		°C
Ar1	Max	34.5
	Min	32.4
	Average	32.8
Parameters		
Emissivity	0.92	
Ref. temp.	20 °C	
Geolocation		
Compass	NE

Location :	EE Room
Equipment :	MDB
Detail :	MCCB For Branch
Comment :	Normal operation, Not found hotspot Should also keep for your future reference

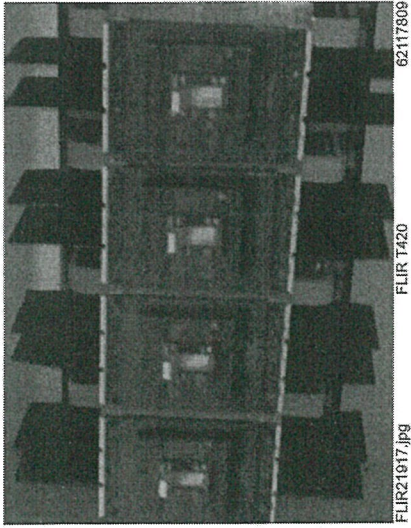
Location :	EE Room
Equipment :	MDB
Detail :	MCCB For Branch
Comment :	Normal operation, Not found hotspot Should also keep for your future reference

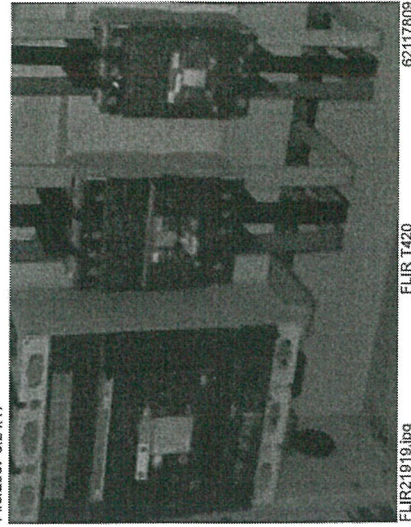
Location :	EE Room
Equipment :	MDB
Detail :	MCCB For Branch
Comment :	Normal operation, Not found hotspot Should also keep for your future reference

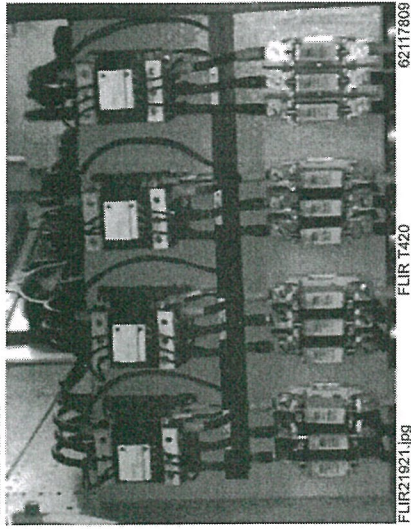
Location :	EE Room
Equipment :	MDB
Detail :	HRC Fuse and Magnetic
Comment :	Normal operation, Not found hotspot Should also keep for your future reference

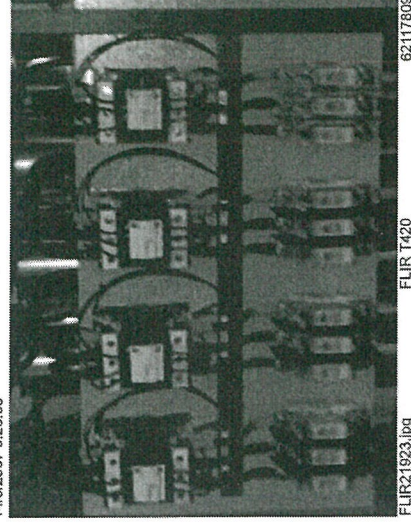
Location :	EE Room
Equipment :	MDB
Detail :	HRC Fuse and Magnetic
Comment :	Normal operation, Not found hotspot Should also keep for your future reference

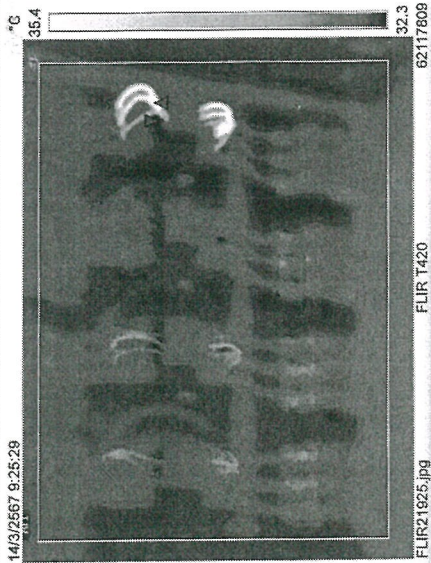
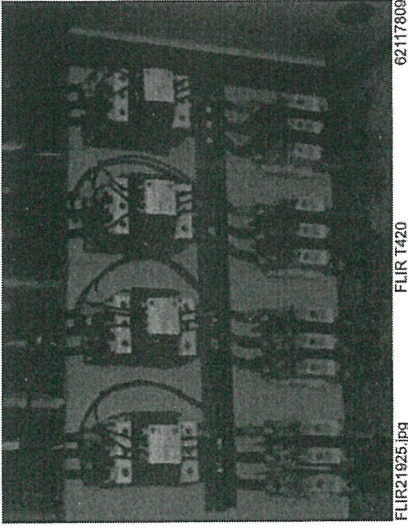
Measurements			°C
Ar1	Max	37.7	
	Min	32.1	
	Average	32.6	
Parameters			
Emissivity			0.92
Ref. temp.			20 °C
Geolocation			
Compass			N

Location :	EE Room
Equipment :	MDB
Detail :	HRC Fuse and Magnetic
Comment :	Normal operation, Not found hotspot Should also keep for your future reference

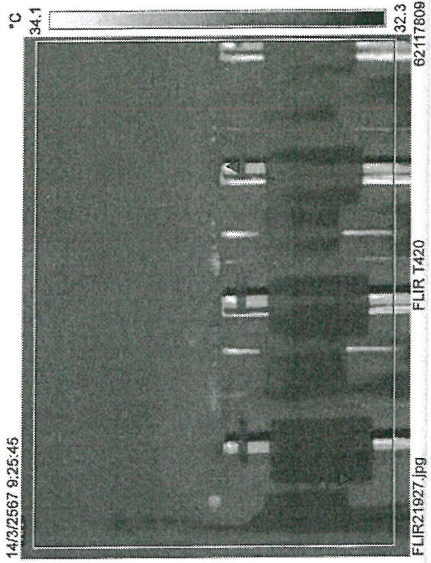
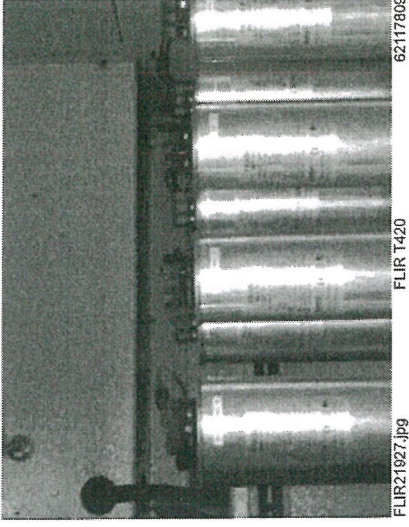
Measurements			°C
Ar1	Max	35.2	
	Min	32.0	
	Average	32.8	
Parameters			
Emissivity			0.92
Ref. temp.			20 °C
Geolocation			
Compass			S

Location :	EE Room
Equipment :	MDB
Detail :	Capacitor Bank
Comment :	Normal operation, Not found hotspot Should also keep for your future reference

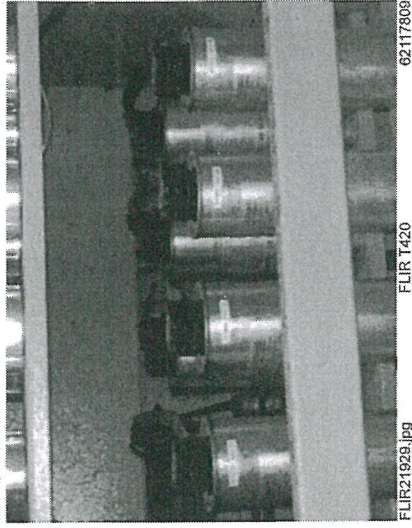
Location :	EE Room
Equipment :	MDB
Detail :	Capacitor Bank
Comment :	Normal operation, Not found hotspot Should also keep for your future reference

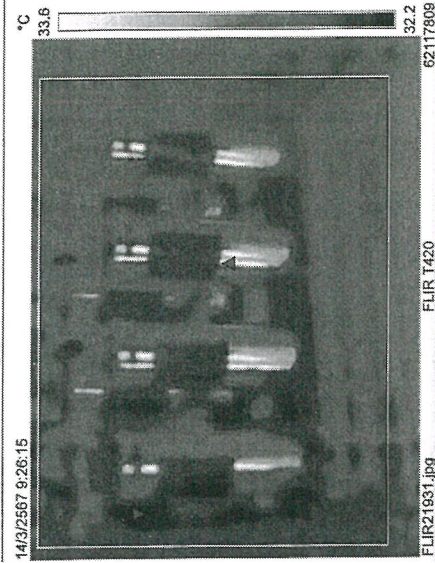
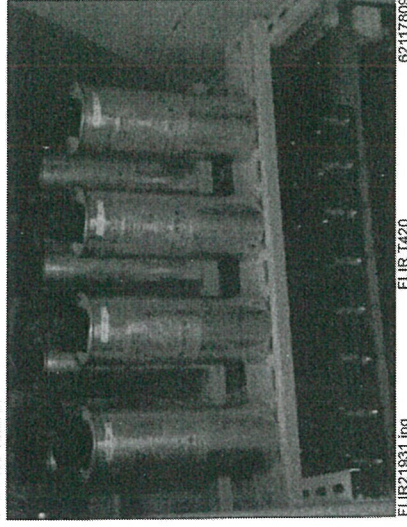
Measurements				°C
Ar1	Max	34.4		
	Min	32.1		
	Average	32.5		
Parameters				
Emissivity	0.92			
Ref. temp.	20 °C			
Geolocation				
Compass	S

Location :	EE Room
Equipment :	MDB
Detail :	Capacitor Bank
Comment :	Normal operation, Not found hotspot Should also keep for your future reference

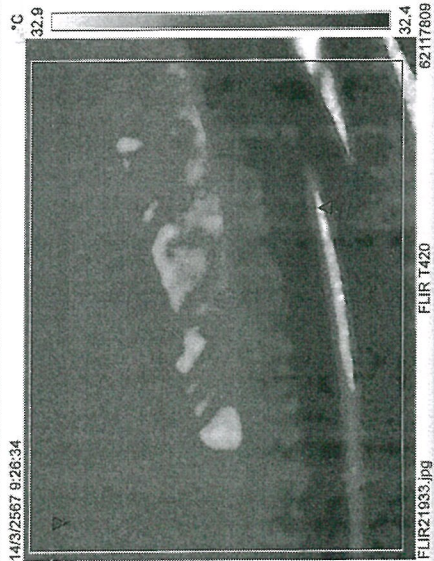
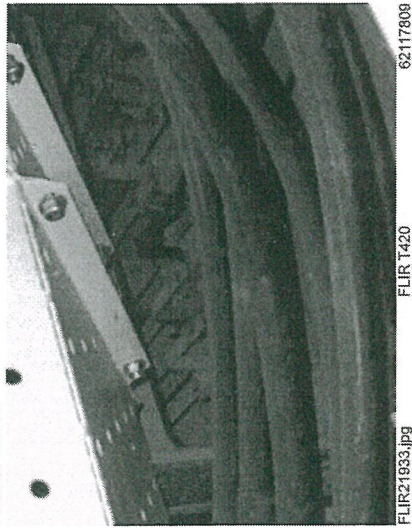
Measurements			°C
Ar1	Max	33.0	
	Min	32.3	
	Average	32.5	
Parameters			
Emissivity		0.92	
Ref. temp.		20 °C	
Geolocation			
Compass	SW

Location :	EE Room
Equipment :	MDB
Detail :	Main Cable and Busbar Connection
Comment :	Normal operation, Not found hotspot
Should also keep for your future reference

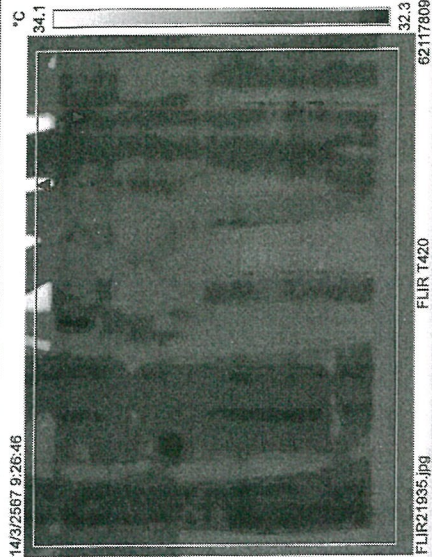
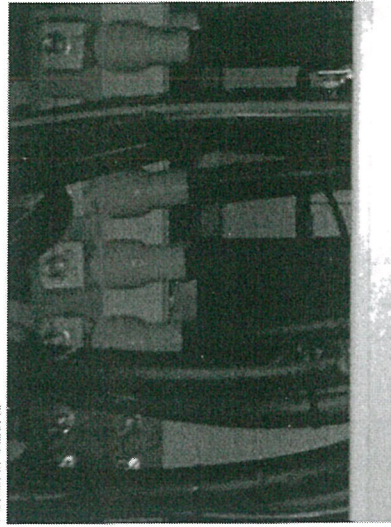
Measurements			°C
Ar1	Max	34.8	
	Min	32.0	
	Average	32.5	
Parameters			
Emissivity		0.92	
Ref. temp.		20 °C	
Geolocation			
Compass	SE

Location :	EE Room
Equipment :	MDB
Detail :	Main Cable and Busbar Connection
Comment :	Normal operation, Not found hotspot
Should also keep for your future reference

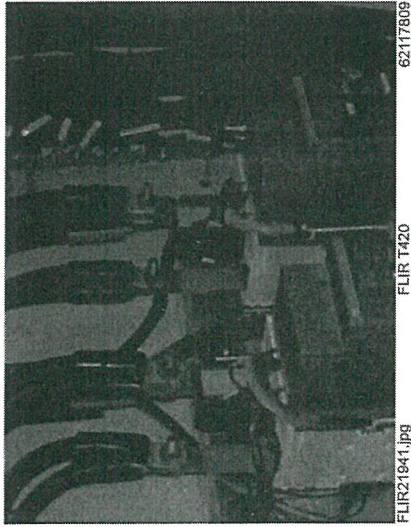
Location :	EE Room
Equipment :	MDB
Detail :	ATS Normal and Emergency
Comment :	Normal operation, Not found hotspot Should also keep for your future reference

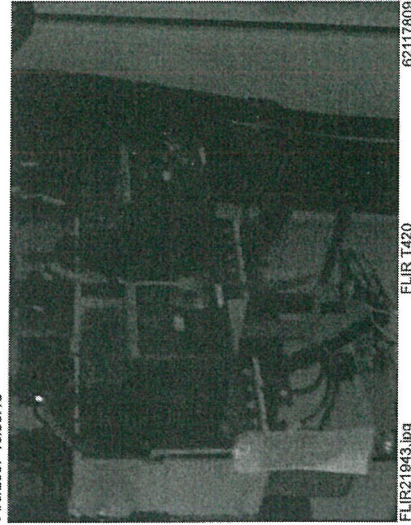
Location :	EE Room
Equipment :	MDB
Detail :	ATS Normal and Emergency
Comment :	Normal operation, Not found hotspot Should also keep for your future reference

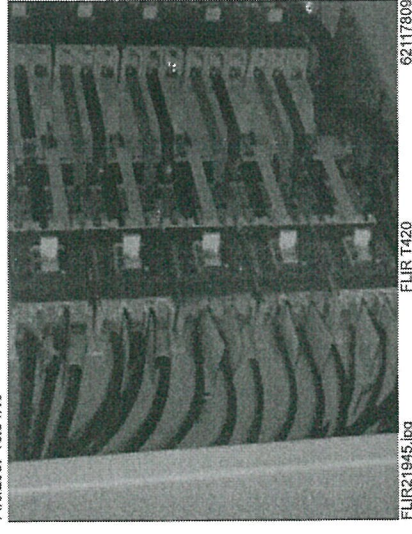
Location :	EE Room
Equipment :	MDB
Detail :	MCCB For Branch
Comment :	Normal operation, Not found hotspot Should also keep for your future reference

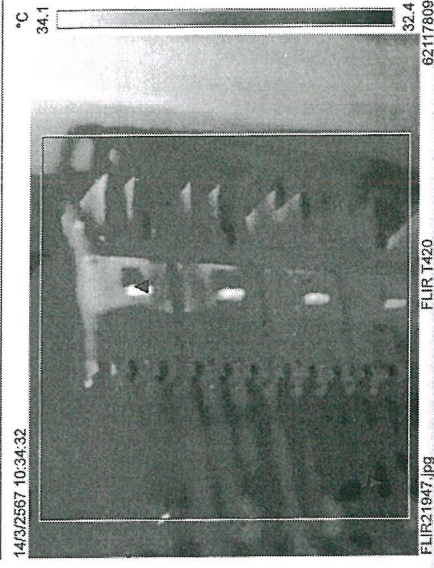
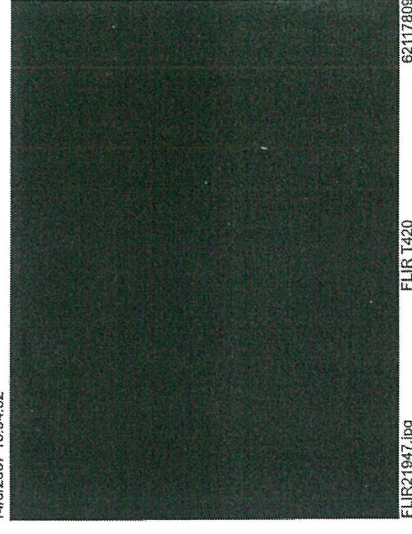
Measurements			°C
Ar1	Max	34.3	
	Min	32.1	
	Average	32.9	
Parameters			
Emissivity		0.92	
Ref. temp.		20 °C	
Geolocation			S
Compass

Location :	EE Room
Equipment :	MDB
Detail :	MCCB For Branch
Comment :	Normal operation, Not found hotspot Should also keep for your future reference

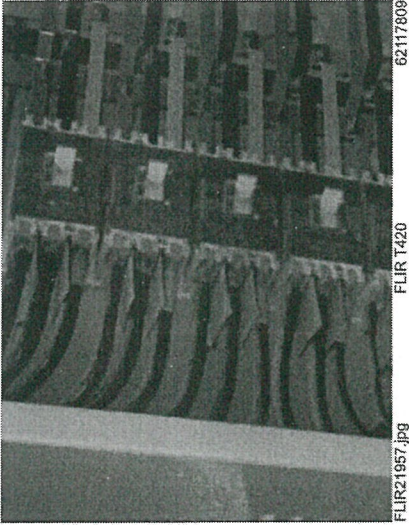
Location :	EE Room
Equipment :	MDB
Detail :	MCCB For Branch
Comment :	Normal operation, Not found hotspot Should also keep for your future reference

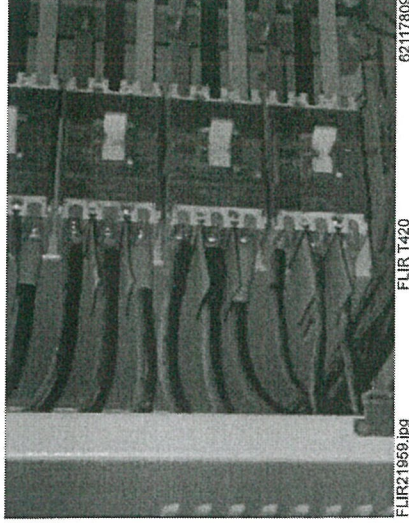
Location :	EE Room
Equipment :	MDB
Detail :	MCCB For Branch
Comment :	Normal operation, Not found hotspot Should also keep for your future reference
