รายงานการตรวจสอบสภาพและความหนาของระบบท่อ

DAICON		PIPING INSPECTION SUMMARY REPORT		Chevron		Report/ Project	Sheet
						2112012	S 1/1
STT-CC-001-02-01 (TRL 001 G-Base 95 Tank Receiving line (Jetty to Tank No.1,2,3))							
Date of inspection: 24 December 2021							
Piping data							
Line ID :	TRL 001 Tank Receiving line			Line Description :	Jetty to Tank No.3,10		
Product :	G-Base 95			Diameter/Schedule :	6 inch, Sch. STD. T nom : 7.11 mm.		
Material :	API 5L GR.B			Insulation :	N/A		
Design and calculations							
Design Pressure P :	285 psi		Tmin (measured) :	0.84 mm.			
Diameter D :	6 inch		Tmat (Table 9 API 579) :	3.3 mm.	T struc :	2.8 mm.	
Stress S (Table A1) :	20.0 ksi	Tmin = PD 2(SE+PY)	T minimum measured :	5.96 mm.			
Q factor E (Table A2 or A3) :	1		Service life (from last reading) :	1965 / 51 years			
Coefficient Y: (Table 10A, B, C) :	0.4		Corrosion Rate :	0.347 mm./year			
The estimated remaining life for this line is: 10.04 years

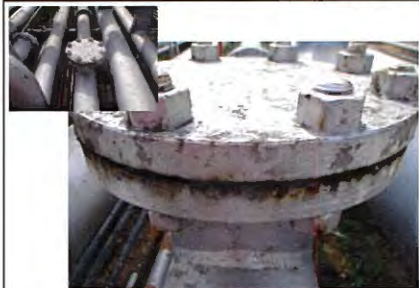
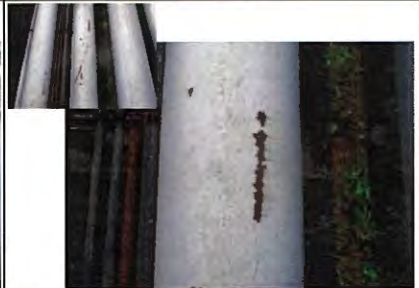
Name of part / Location	Findings	Name of part / Location	Findings
TRL 002 G-Base 91 Tank Receiving line (Jetty to Tank No.9&Tank No.2)	Slight corrosion on flange (3)	TRL 002 G-Base 91 Tank Receiving line (Jetty to Tank No.9&Tank No.2)	Painting deterioration (4)

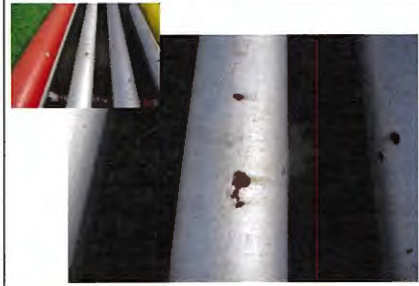
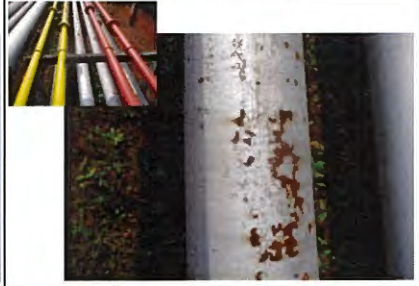
Name of part / Location	Findings	Name of part / Location	Findings
TRL 002 G-Base 91 Tank Receiving line (Jetty to Tank No.9&Tank No.2)	Painting deterioration (5)	TRL 002 G-Base 91 Tank Receiving line (Jetty to Tank No.9&Tank No.2)	Painting deterioration (6)

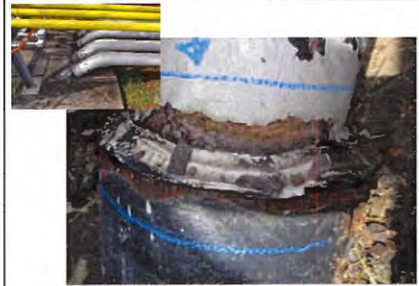
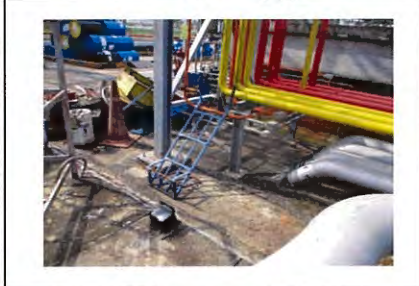
1. Sealing sleeve underground pipe was found degradation, damage and corrosion under sleeve underground pipe. Approximate corrosion depth 1.5 mm.

Name of part / Location	Findings	Name of part / Location	Findings
TRL 002 G-Base 91 Tank Receiving line (Jetty to Tank No.9&Tank No.2)	Severe corrosion under sealing&Sealing damage. (7)	TRL 002 G-Base 91 Tank Receiving line (Jetty to Tank No.9&Tank No.2)	Still in normal condition

1. Carry out alternative NDE (LRUT) to determine condition within 2 months. Then re-painting as per original design to prevention future corrosion.

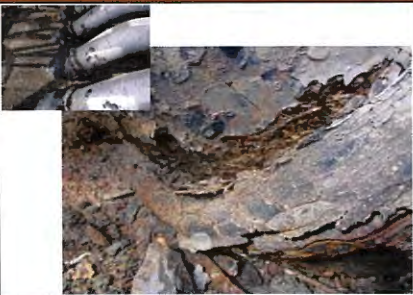
Name of part / Location		Findings		Name of part / Location		Findings
TRL 002 G-Base 91 Tank Receiving line (Jetty to Tank No.9&Tank No.2)		Severe corrosion under pipe sleeve & Sealing damage. (8)		TRL 002 G-Base 91 Tank Receiving line (Jetty to Tank No.9&Tank No.2)		Still in normal condition

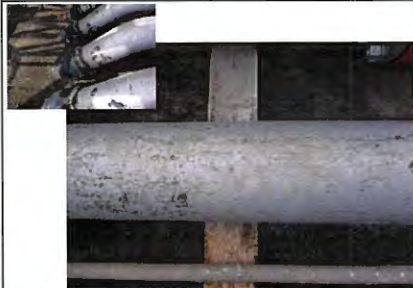
Name of part / Location		Findings		Name of part / Location		Findings
TRL 002 G-Base 91 Tank Receiving line (Jetty to Tank No.9)		Painting deterioration (10)		TRL 002 G-Base 91 Tank Receiving line (Jetty to Tank No.9)		Painting deterioration (11)
