Equipment Name : O-RISER,8"GAS(B9150) AT BEWB

Equipment No. : BE-8BEPLD1-RS-BEWB AT Receiver Tag No. ZAQ-(B9150)
Equipment Name : O-RISER,8"GAS(B9150) AT BEWB

1.1 GENERAL CONDITION

The pipeline survey of the 8in BEPLG1 from BEWA to BEWG riser tie-in flange confirmed the as-laid route with no significant deviation observed. The as-found pipeline was found to be in good general condition with no significant damage observed along the length of the pipe.

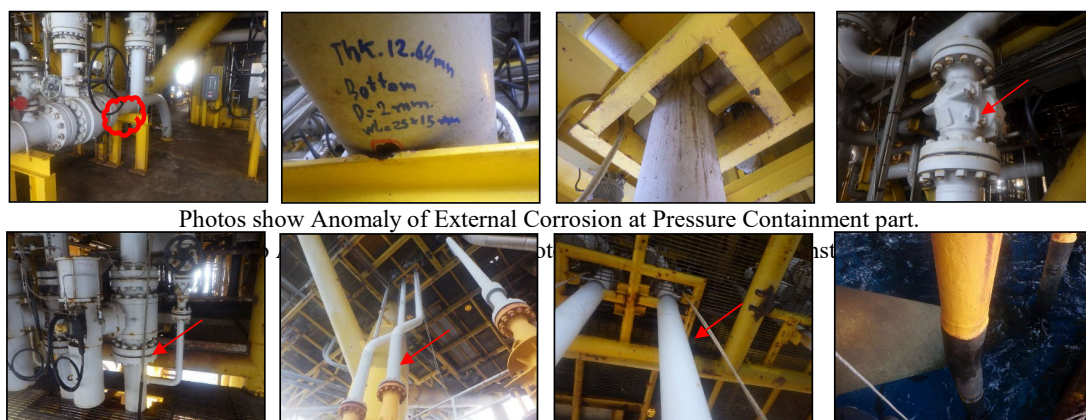
Corrosion Depth = 2 mm

Area = 25x15 mm

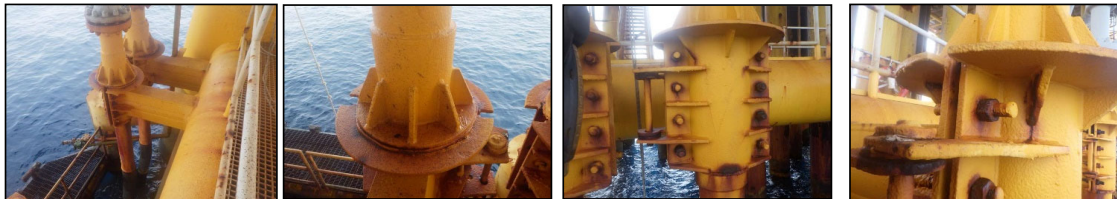
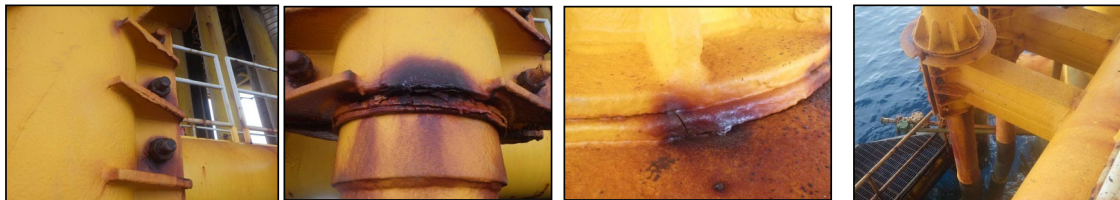
Please describe condition: Found clamp and clamp/support were still in normal condition.

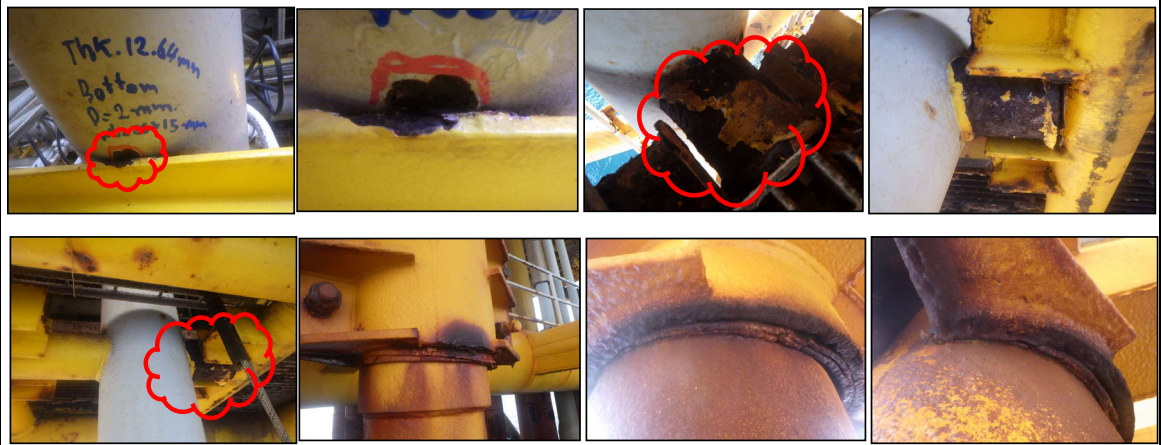
COMMENT: Found Moderate corrosion on under support, pipe riser. / Repaint
Found Moderate to severe corrosion on support. / Repaint.

Please describe condition: Found moderate to severe corrosion under support and support.

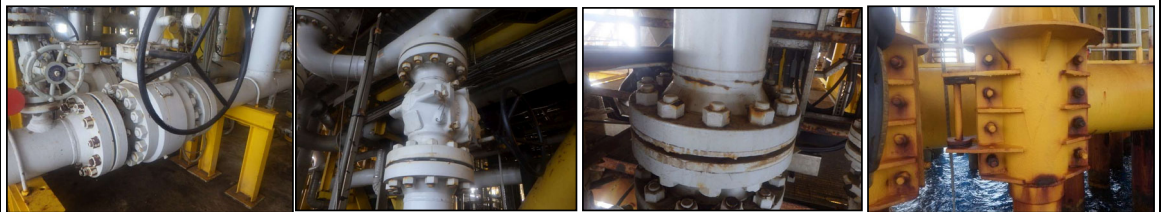
Please describe condition: Bolts/Nuts of Valve/Flange/Clamp were still in normal condition.

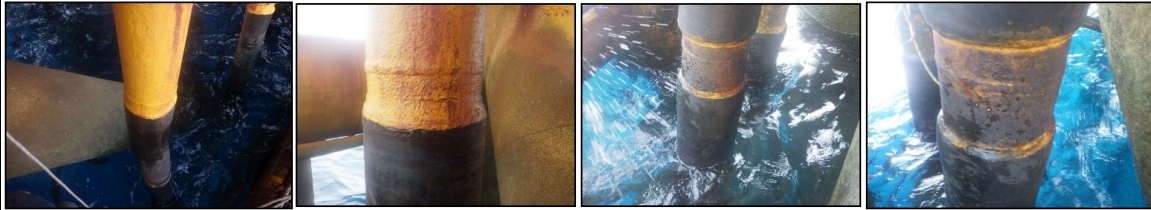
Please describe condition: Rubber were still in normal condition.

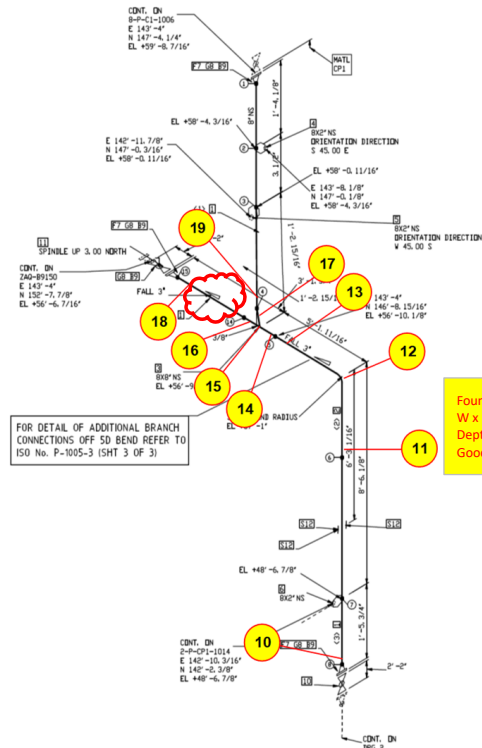
Found Point "A" moderate corrosion on under support pipe riser.

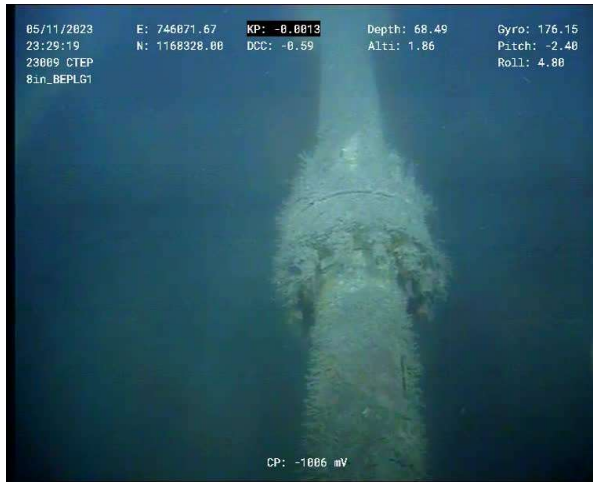
Figure 3 – BEWG Riser Tie-in Flange KP -0.001
(Top View)

The BEWG riser spool was observed in suspension after the swam neck and made contact with seabed at KP 0.021, resulting a freespan length of 23m and a maximum height of 1.1m. No movement observed. Refer to anomaly report **8"BEPLG1/004** for details.

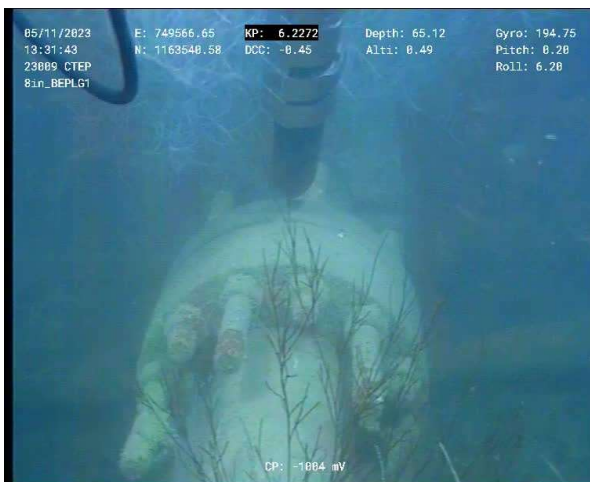
*Figure 11 – BEWA Riser Tie-in Flange KP 6.227
 (Top View)*

Contact CP potential readings acquired from the flanges of -1069 mV to -1105 mV, which are outside the acceptable range of the cathodic potential values and flagged as anomalous. No visible coating damage, blistering or cracking was observed. Refer to anomaly report **8"BEPLG1/003** in Appendix 01 and ISES's cathodic report in Appendix 06.

The BEWA riser spool was observed in contact with seabed, right after the swam neck at the riser tie-in flange. No movement observed.

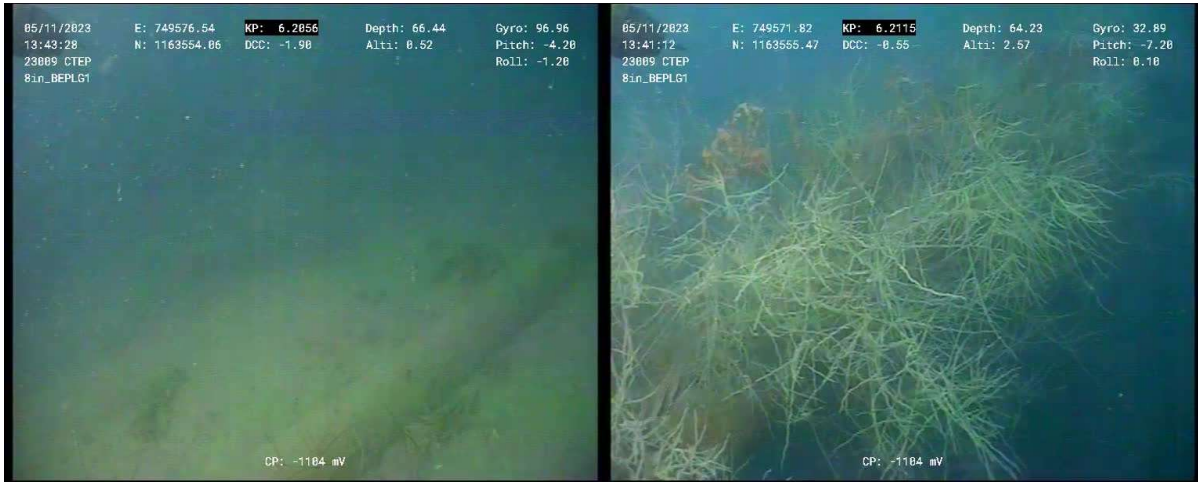
The 10” BEPLT was recorded crossing over the 8” BEPLG2 at KP 6.213, with 2.2 m clearance estimated between the bottom of pipeline BEPLT and of the top of BEPLG1 pipeline.

No movement was observed on either pipeline at the crossing point.

Figure 25 – Depth of 8” BEPLG1 pipeline at crossing point

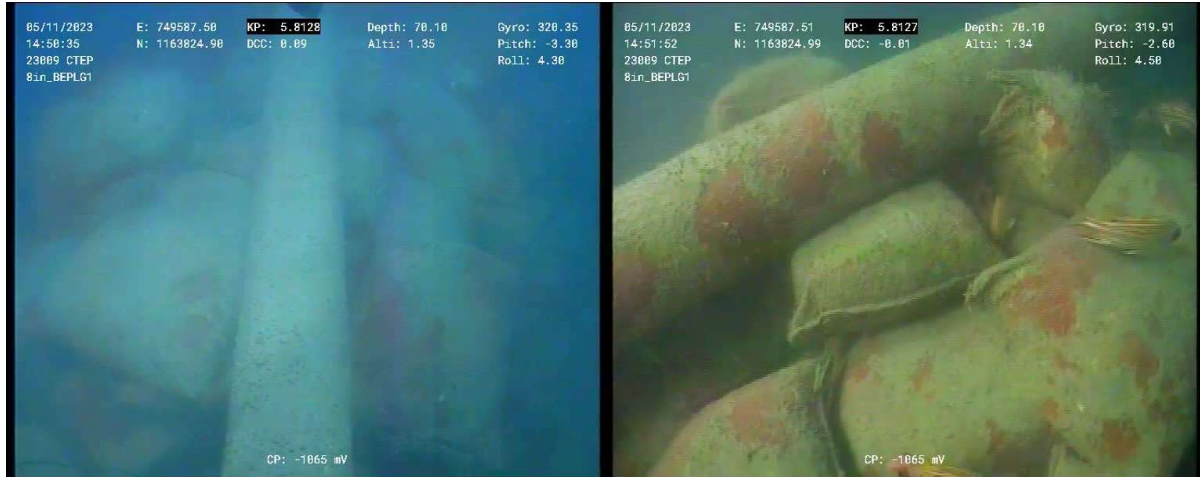
The 12" BEPLB3 was recorded crossing under the 8" BEPLG2 at KP 5.813, with Linkloc mattress and sand bags covering 12" BEPLB3 pipeline at the crossing point. The gap separation between top of BEPLB3 pipeline and of the bottom of BEPLG1 pipeline was unable to be assessed due to the presence of the Linkloc mattress and sand bags.

Figure 27 – 12" BEPLB2 pipeline Crossing under 8" BEPLG1 at KP 5.813 (View from top)

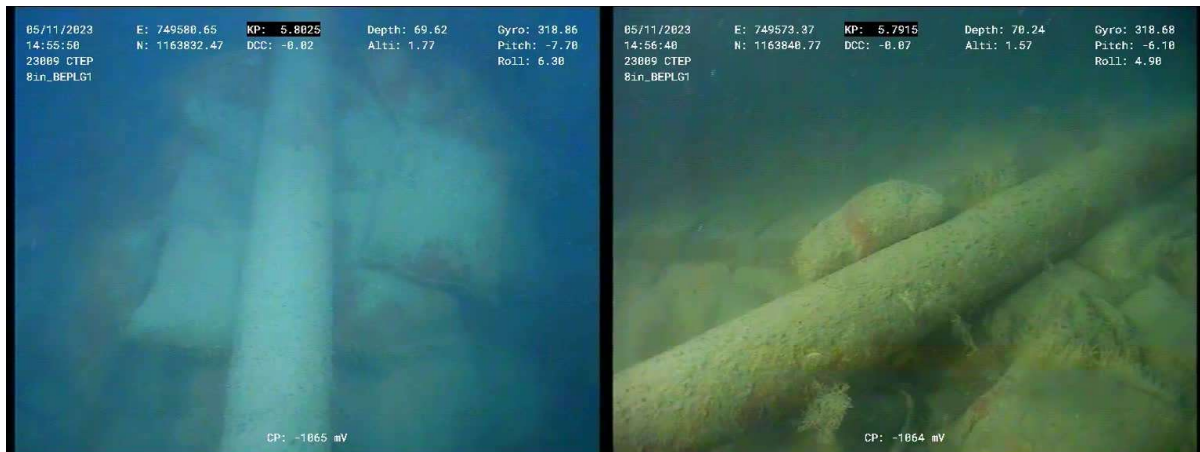
The 12" BEPLB2 was recorded crossing under the 8" BEPLG1 at KP 5.803, with Linkloc mattress and sand bags covering 12" BEPLB2 pipeline at the crossing point. The gap separation between top of BEPLB2 pipeline and of the bottom of BEPLG1 pipeline was unable to be assessed due to the presence of the Linkloc mattress and sand bags.

Figure 29 – 12" BEPLB2 pipeline Crossing under 8" BEPLG1 at KP 5.803 (View from top)

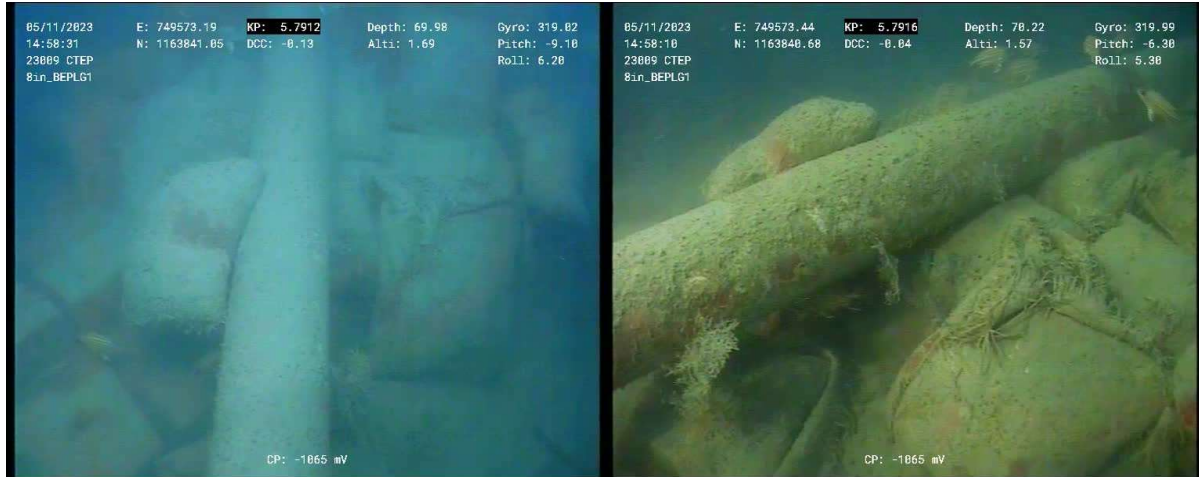
The 12" BEPLB1 was recorded crossing under the 8" BEPLG2 at KP 5.792, with Linkloc mattress and sand bags covering 12" BEPLB1 pipeline at the crossing point. The gap separation between top of BEPLB1 pipeline and of the bottom of BEPLG1 pipeline was unable to be assessed due to the presence of the Linkloc mattress and sand bags.

Figure 31 – 12" BEPLB1 pipeline Crossing under 8" BEPLG1 at KP 5.792 (View from south east)

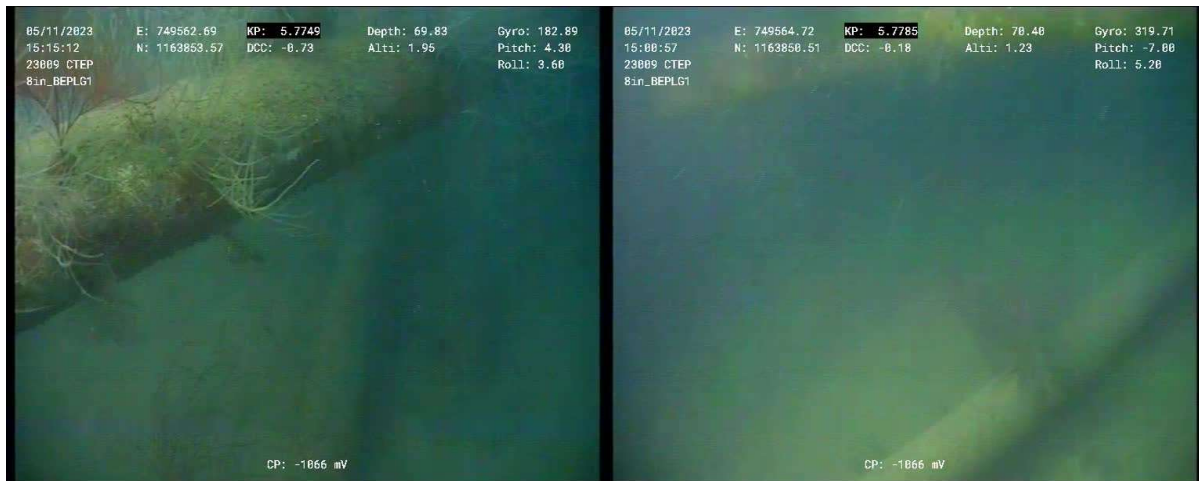
The 10" BEPLT was recorded crossing over the 8" BEPLG1 at KP 5.775, with 1.7 m clearance estimated between the bottom of BEPLT pipeline and of the top of BEPLG1 pipeline.

No movement was observed on either pipeline at the crossing point.

Figure 33 – 10" BEPLT pipeline Crossing Over 8" BEPLG1 at KP 5.775 (view from south)

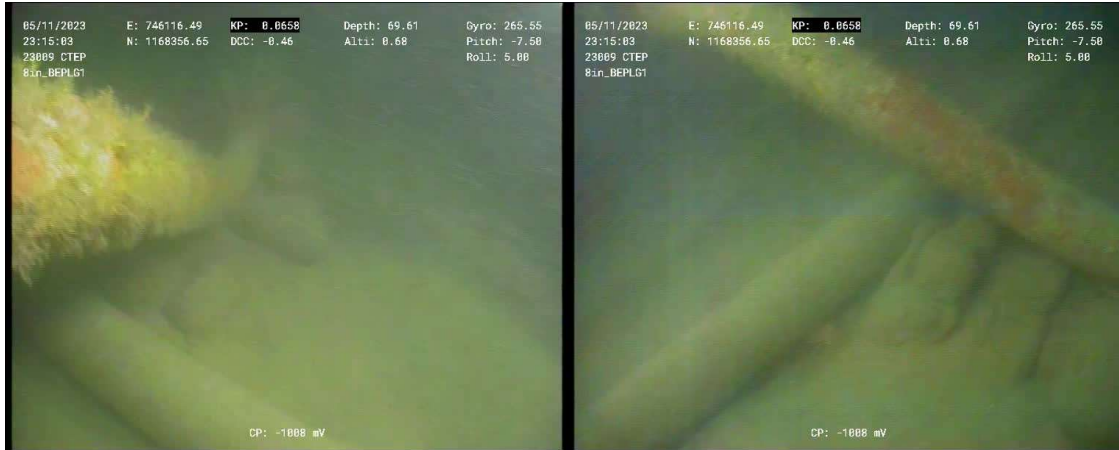
The 6" BEWLG was recorded crossing over the 8" BEPLG1 at KP 0.063, with 0.4 m clearance estimated between the bottom of BEWLG pipeline and of the top of BEPLG1 pipeline.

No movement was observed on either pipeline at the crossing point.

*Figure 35 – 6" BEWLG Crossing Over 8" BEPLG1 at KP 0.063
 (View from south)*
