Inspection Report

Subject / Title:
BD000166U02 SSUT, MO-60 KEOH, 2024, Inspection report

: SSUT Bangpoo GT12

: SGT-800

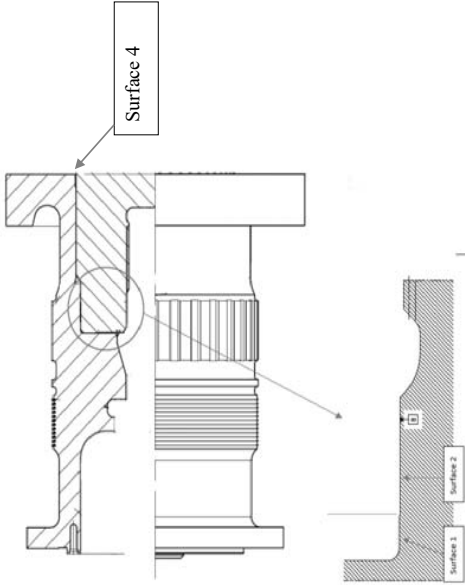
Example compressor coupling scoring condition after removal for replacement new thickness shim beg

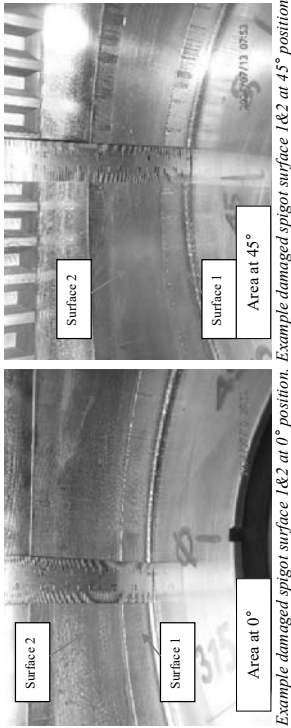
Example damaged spigot surface 1&2 at 0° position. Example damaged spigot surface 1&2 at 45° position.

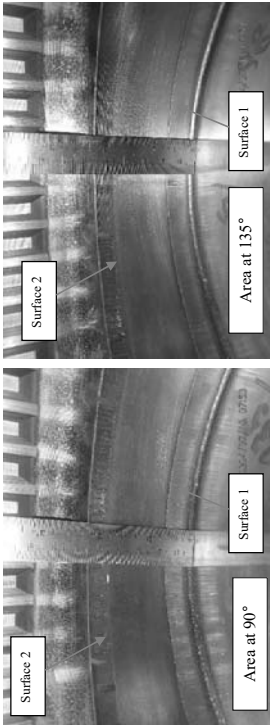
Example damaged spigot surface 1&2 at 90° position. Example damaged spigot surface 1&2 at 135° position.

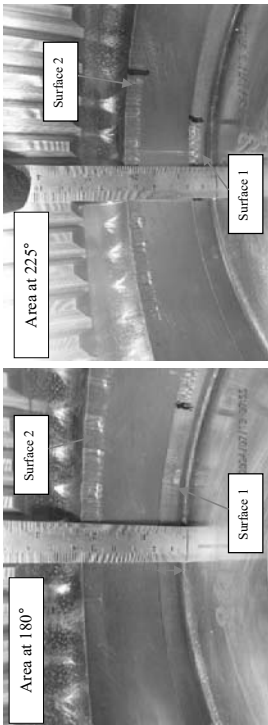
Example damaged spigot surface 1&2 at 180° position. Example damaged spigot surface 1&2 at 225° position.

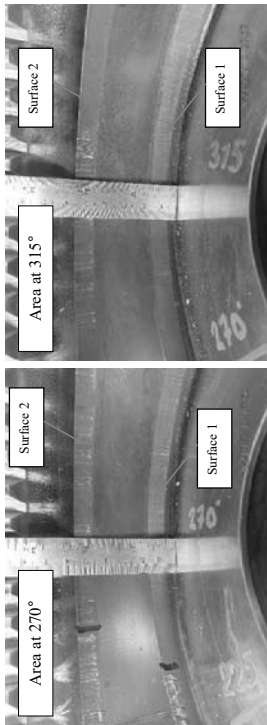
Example damaged spigot surface 1&2 at 270° position. Example damaged spigot surface 1&2 at 315° position.

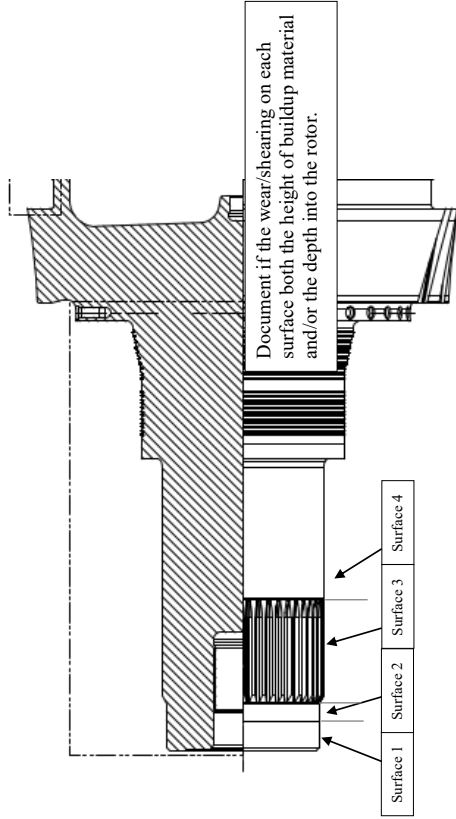
Example compressor rotor scoring condition after removal for replacement new thickness shim behind compressor bearing.

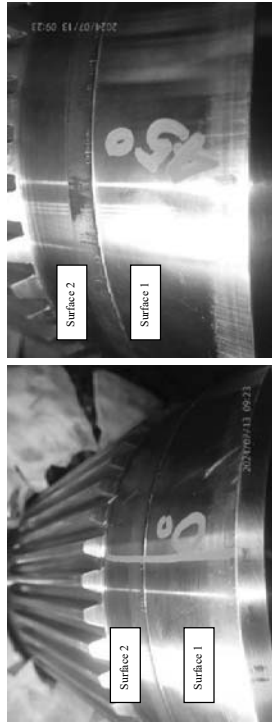
Example damaged spigot surface 1&2 at 0° position. Example damaged spigot surface 1&2 at 45° position.

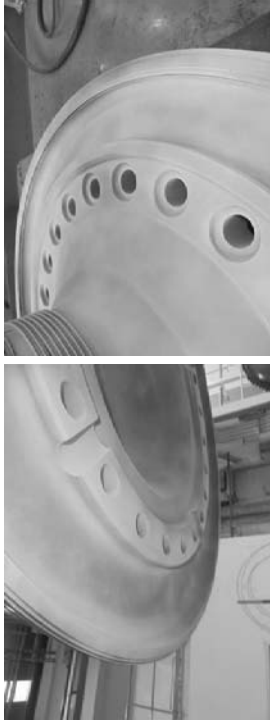
PT on rotor hub by water washable method, no relevant indication.

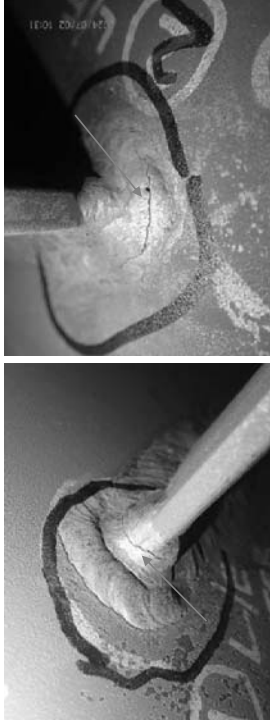
All front struts observed crack at inner/outer weld seam.

Example crack at front leading-edge struts.

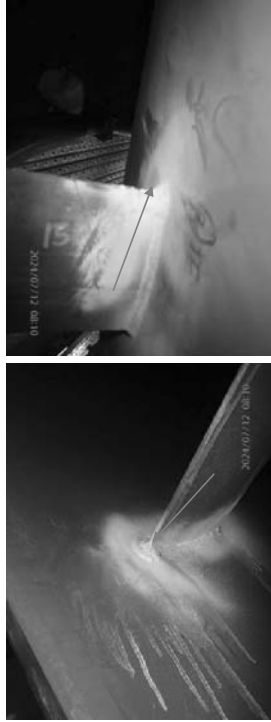
Example cracking after repaired by crack removal and re-welding.

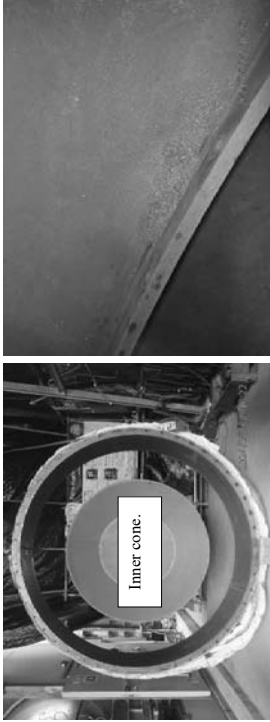
Damaged bolts and nuts inside inner cone.

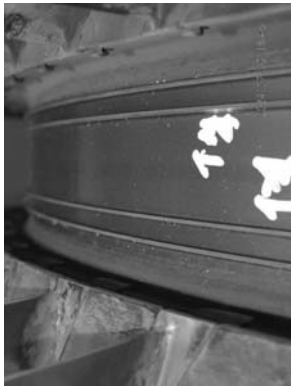
Example of corrosion found between stages 11-12.

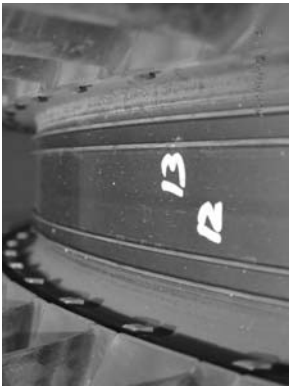
Example of corrosion found between stages 12-13.

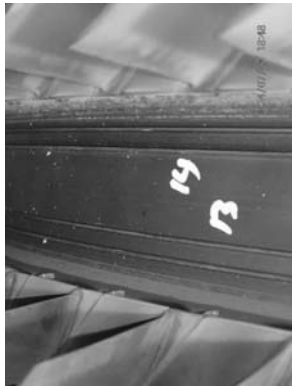
Example of corrosion found between stages 13-14.

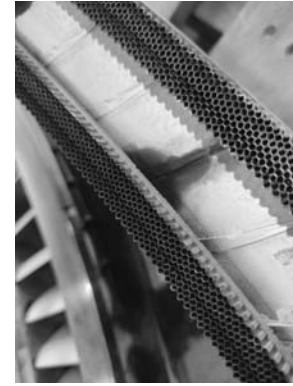
Cracks found by PT on guide vane stage #10 cold side. Cracks found by PT on guide vane stage #15.

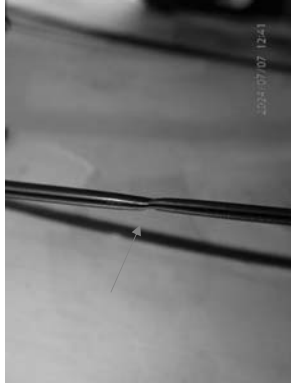
Example of deformed condition found on split e-sealing.

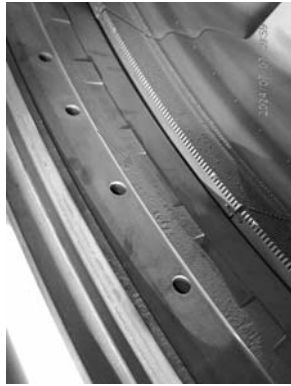
Example of fretting condition against outlet casing.

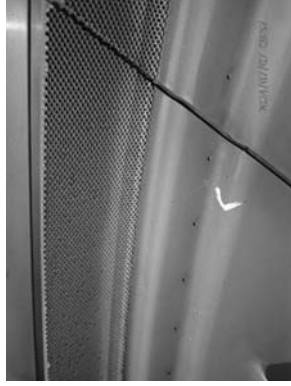
Minor contact marks found on GV3 extruded casing area.

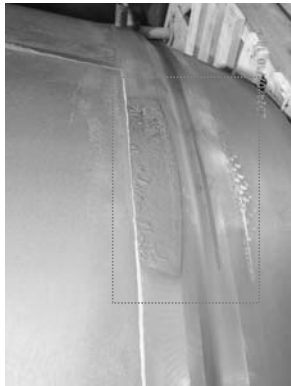
Example view for contact marks on outlet cone (Big wok).

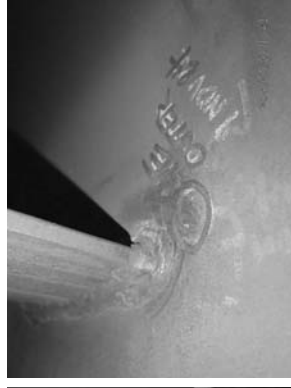
- Cracks observed on the front and rear support weld seams, noticed in previous inspection report.
- Observed bolts and nuts around exhaust diffuser and inner cone were damaged.

Example view for cracks on weld seam of front support struts.
