# **Surveying Report**

**(Condition of Property)**

## **The Andaman Cove Condominium**

### **Condition of building of The Amandaman Cove Condominium Project**

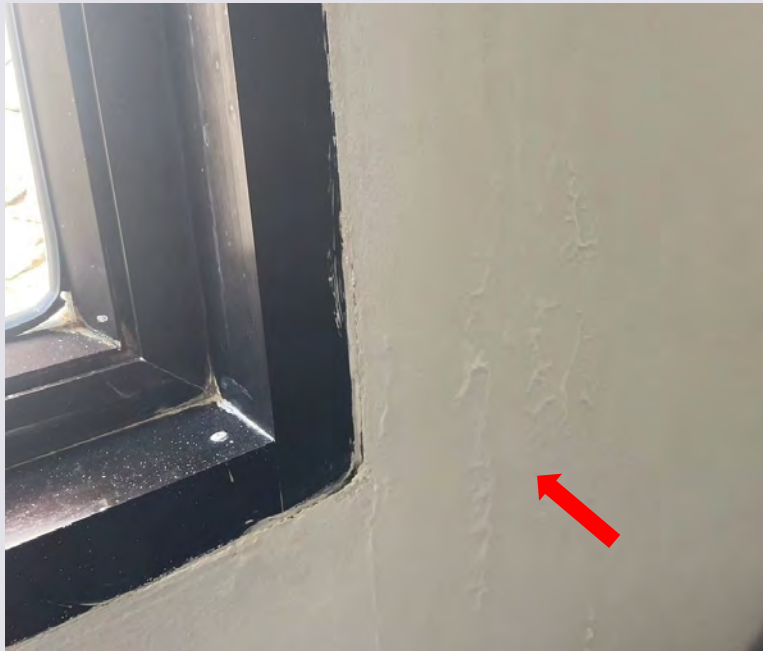
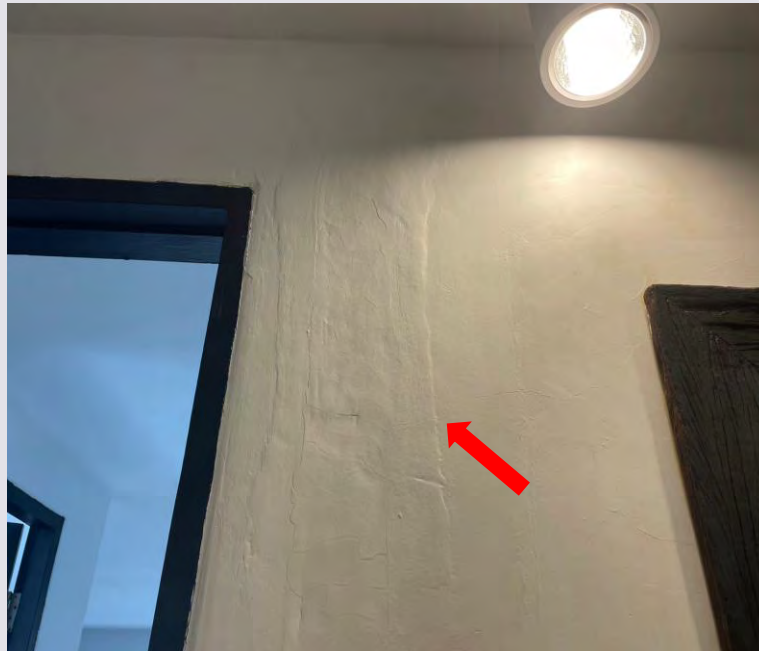
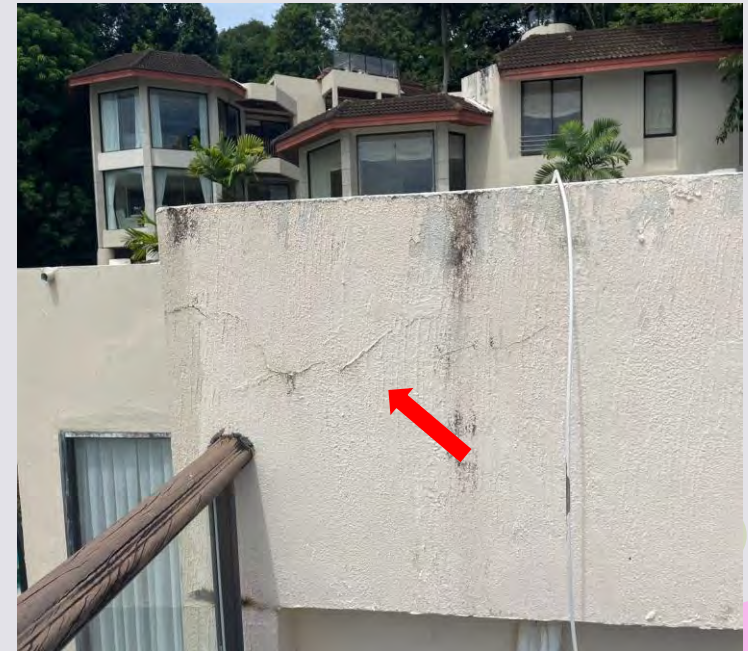
- Room No. 100/3      Living room (window)**
- Room No. 100/5      Front door**
- Room No. 100/11    Bedroom**
- Room No. 100/13    Living room / Bed room**
- Room No. 100/19    Living room**
- Room No.100/23    Bedroom / Stairs**
- Room No. 100/27    Bedroom**
- Room No. 100/29    Bedroom**
- Room No. 100/30    Storage room (office)**

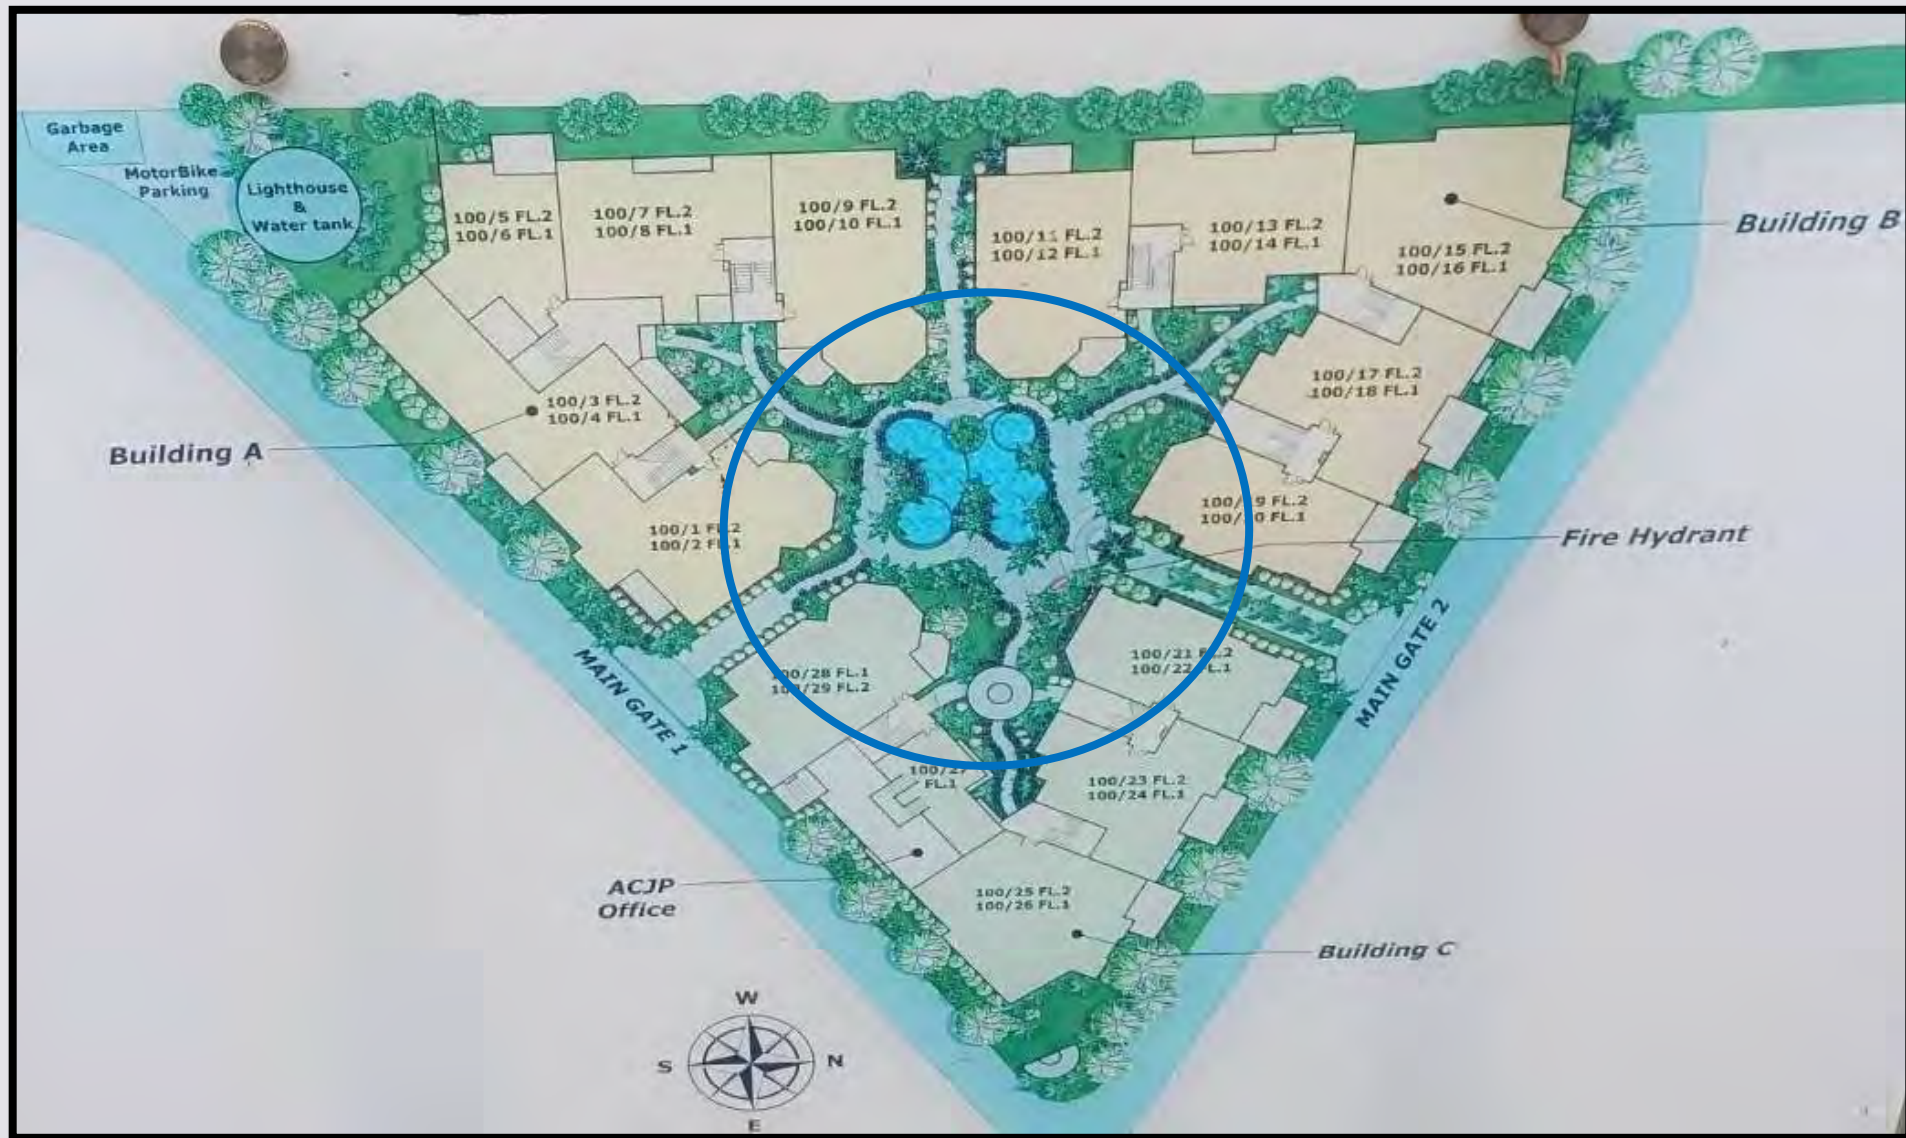
Swimming Pool

- 1. Swimming pool, retention tank septic tank and water tank no signal shown it is leakage. All area around them is dry.**
- 2. Have some room that reported in item A have water leak , on proceed to fix**
