รายงานผลการตรวจสอบท่อดูดคอนกรีตเสริมเหล็ก

CORROSION UNDER SUPPORT (CUS)
PIPELINE INTEGRITY MANAGEMENT

CHEVRON SRT TERMINAL
SURATTHANI

29 June 2023
Report No: 2305047_Rev.00

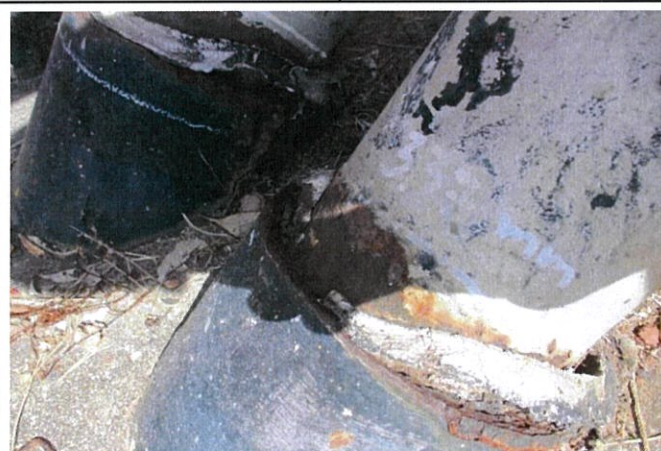
Beneath pipe sleeve

Corrosion and painting deterioration

Recommendations			
1. Visual Inspection (VT) > Re-painting and re-sealing on pipe sleeve, at the area of corrosion and deterioration were found.			
2. Long Range Ultrasonic Testing (LRUT) > Keep monitoring, as the significant indications from LRUT data log has been noticed.			
3. Ultrasonic Thickness Measurement (UTM) > Keep monitoring.			
LRU Technician Name: Mr. Pummarin P. Date: 29-Jun-23 Sign:

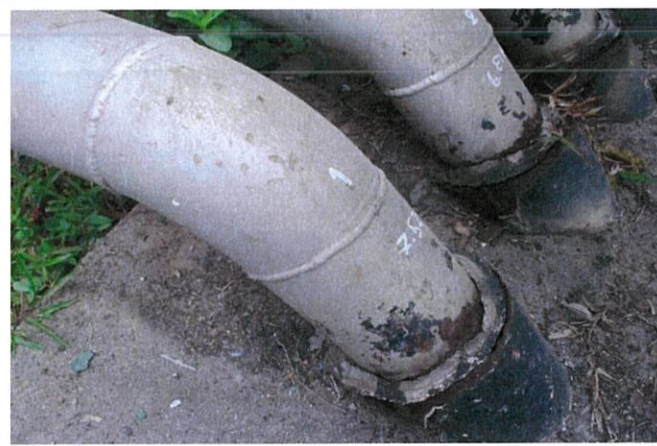
Beneath pipe sleeve

Corrosion and painting deterioration

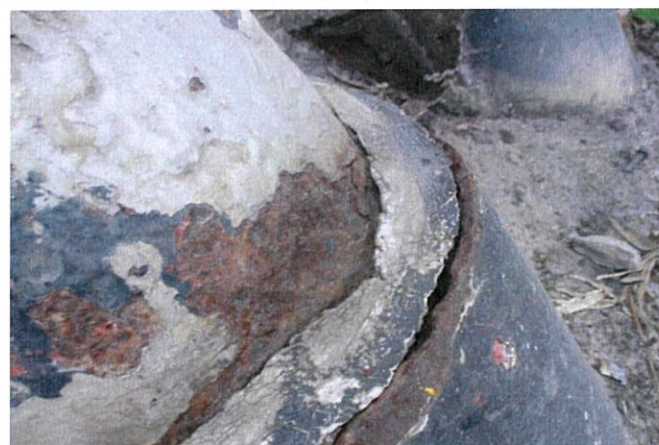
Beneath pipe sleeve

Corrosion and painting deterioration

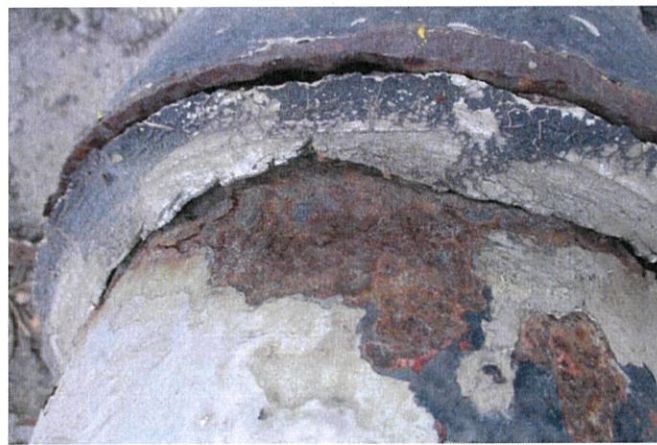
Beneath pipe sleeve

Corrosion and painting deterioration

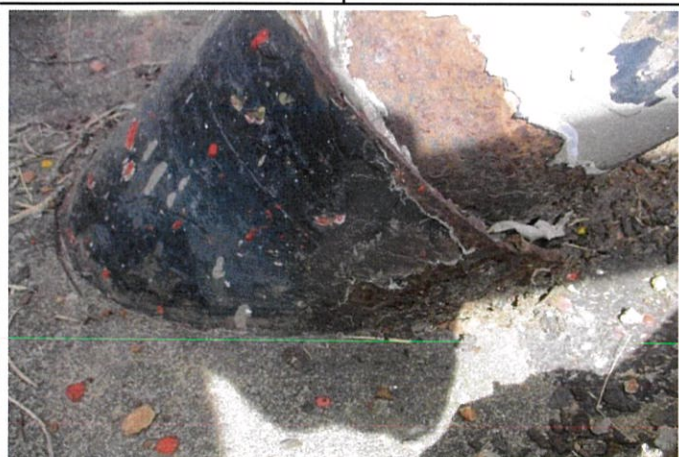
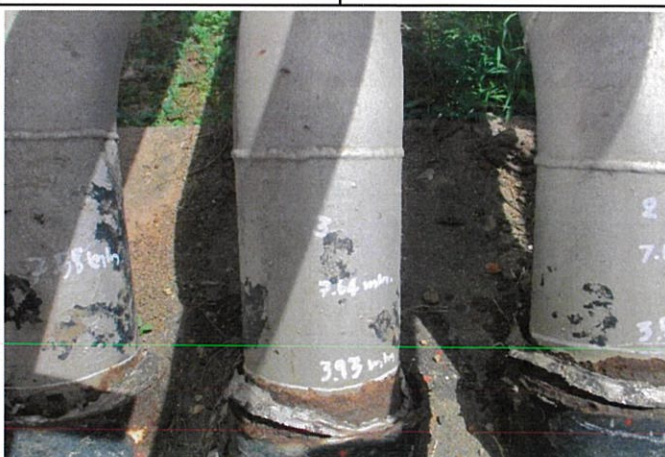
Corrosion and painting deterioration

Recommendations			
1. Visual Inspection (VT) > Re-painting and re-sealing on pipe sleeve, at the area of corrosion and deterioration were found.			
2. Long Range Ultrasonic Testing (LRUT) > Keep monitoring, as the significant indications from LRUT data log has been noticed.			
3. Ultrasonic Thickness Measurement (UTM) > Keep monitoring.			
LRUT Technician Name : Mr. Pummarin P. Date : 29-Jun-23 Sign:

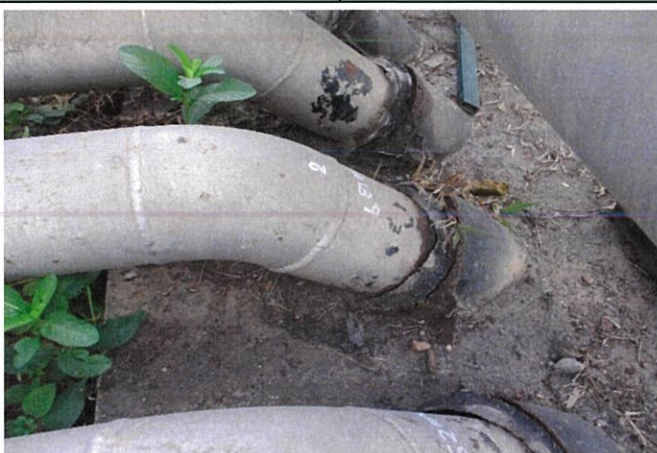
Name of part / Location	Findings	Name of part / Location	Findings
Pipe	Normal condition	Beneath pipe sleeve	Corrosion and painting deterioration

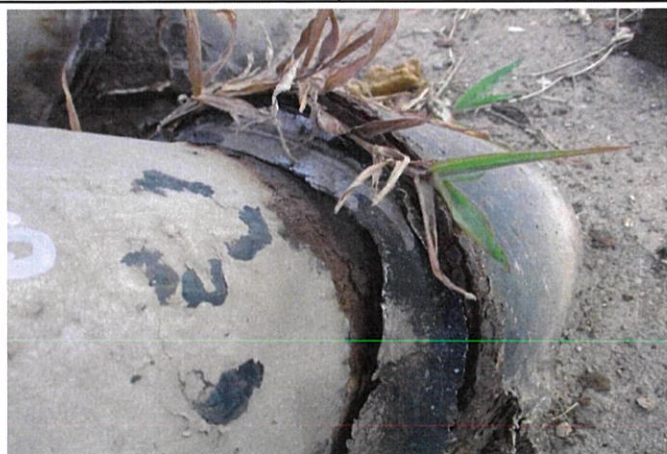
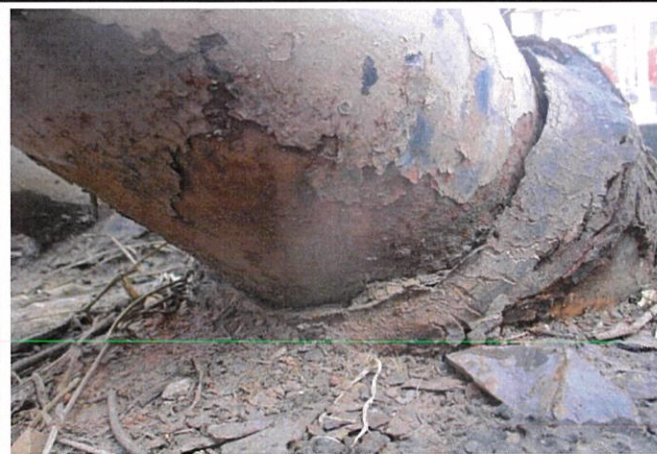
Name of part / Location	Findings	Name of part / Location	Findings
Beneath pipe sleeve	Corrosion and painting deterioration	Beneath pipe sleeve	Corrosion and painting deterioration

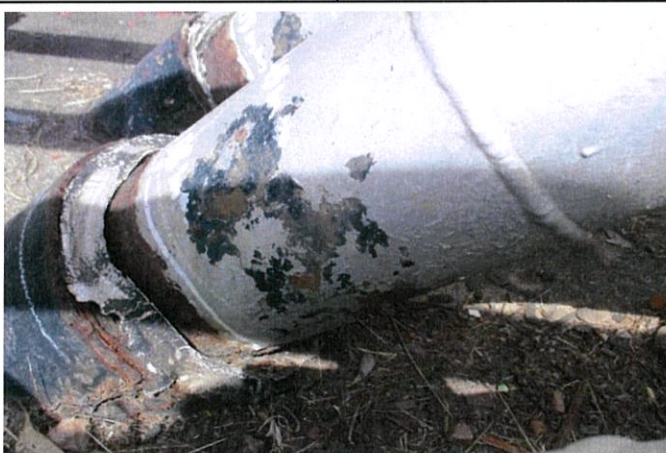
Beneath pipe sleeve

Corrosion and painting deterioration

Recommendations			
1. Visual Inspection (VT) > Re-painting and re-sealing on pipe sleeve, at the area of corrosion and deterioration were found.			
2. Long Range Ultrasonic Testing (LRUT) > Keep monitoring, as the significant indications from LRUT data log has been noticed.			
3. Ultrasonic Thickness Measurement (UTM) > Keep monitoring.			
LRUT Technician Name : Mr. Pummarin P. Date : 29-Jun-23 Sign:

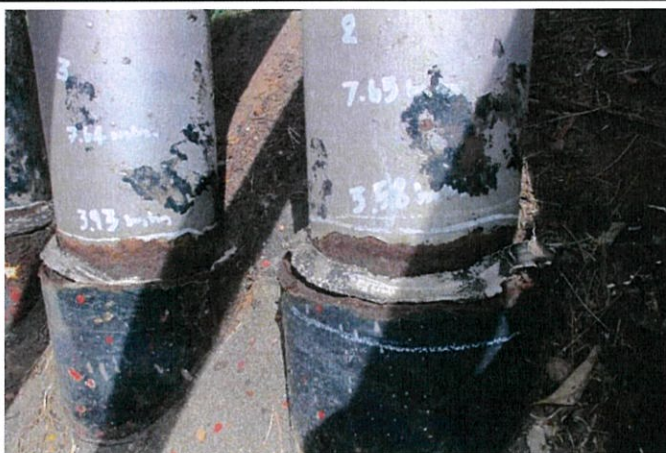
Beneath pipe sleeve

Corrosion and painting deterioration

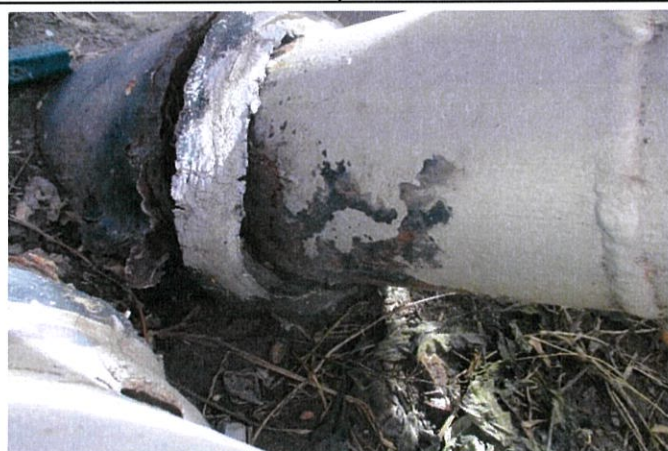
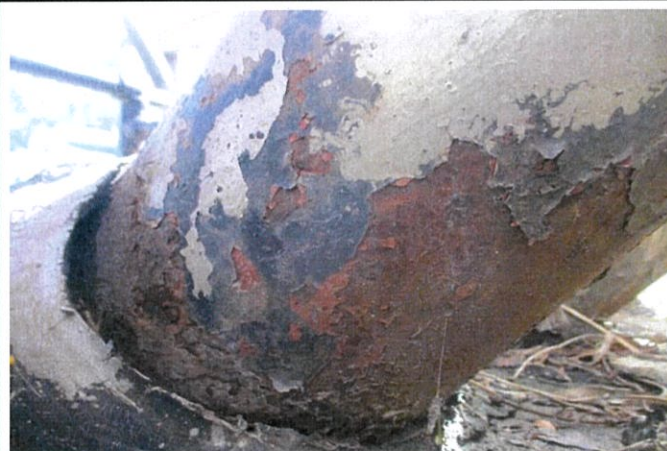
Name of part / Location	Findings	Name of part / Location	Findings
Beneath pipe sleeve	Corrosion and painting deterioration	Beneath pipe sleeve	Corrosion and painting deterioration

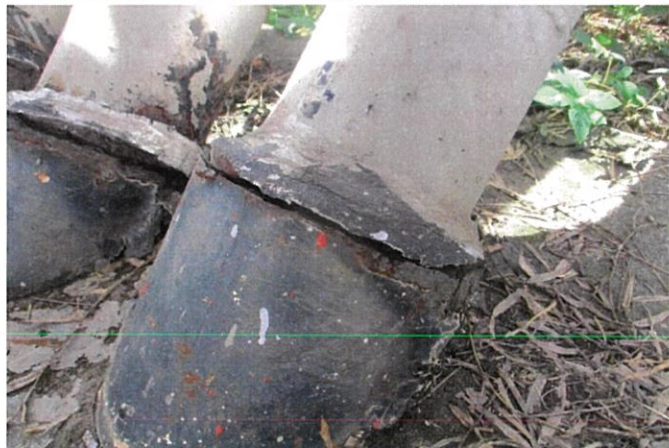
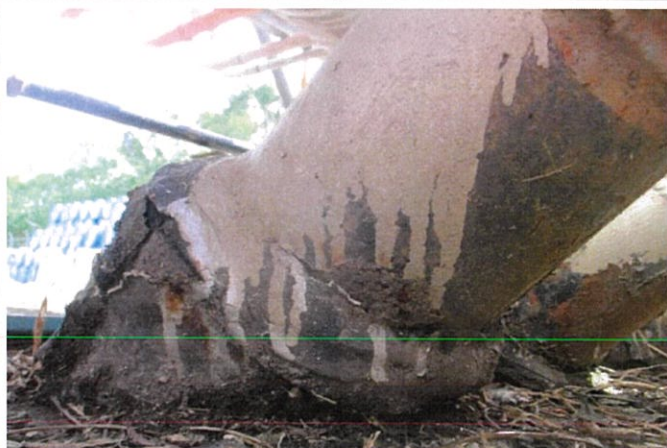
Name of part / Location	Findings	Name of part / Location	Findings	
Beneath pipe sleeve	Corrosion and painting deterioration	Beneath pipe sleeve	Corrosion and painting deterioration

> Re-painting and re-sealing on pipe sleeve, at the area of corrosion and deterioration were found.
