รายงานการตรวจสอบสภาพและความหนาของระบบท่อ

<b>PIPING INSPECTION SUMMARY REPORT</b>

Report/ Project	Sheet
			2112012	S 1/1
<b>STT-CC-001-02-01 (TRL 001 G-Base 95 Tank Receiving line (Jetty to Tank No.1,2,3))</b>

Date of inspections: 24 December 2021

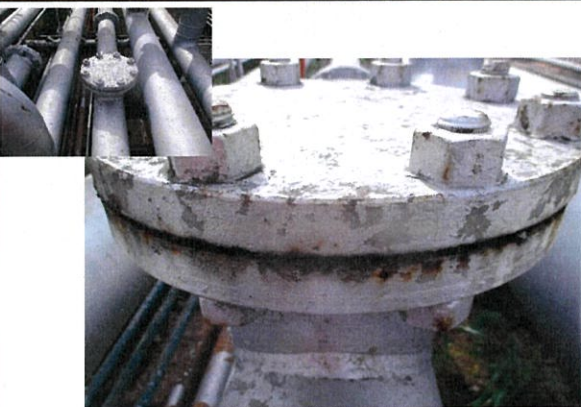
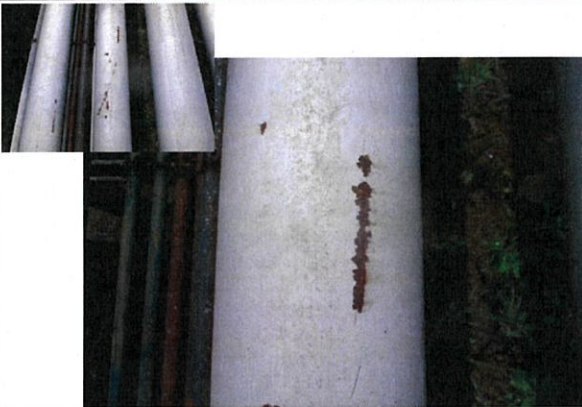
Name of part / Location		Findings			
TRL 002 G-Base 91 Tank Receiving line (Jetty to Tank No.9&Tank No.2)		Slight corrosion on flange (3)

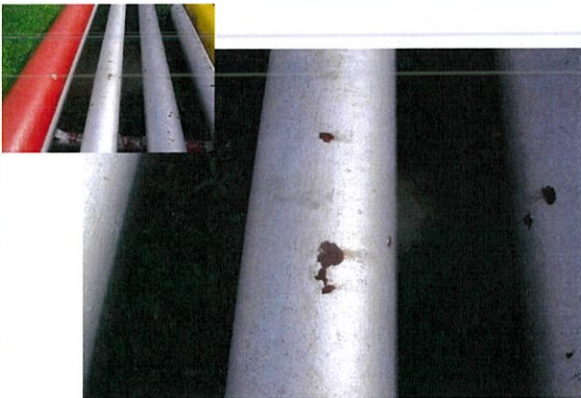
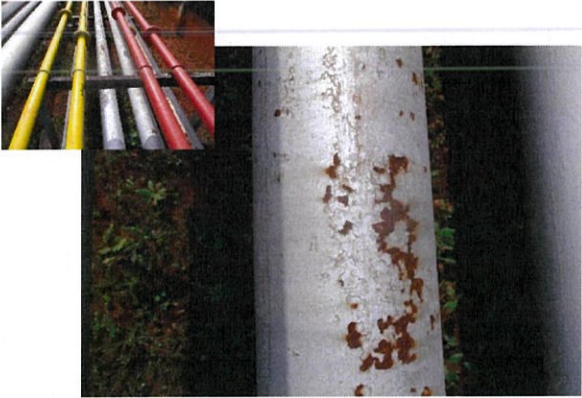
Name of part / Location		Findings			
TRL 002 G-Base 91 Tank Receiving line (Jetty to Tank No.9&Tank No.2)		Painting deterioration (5)

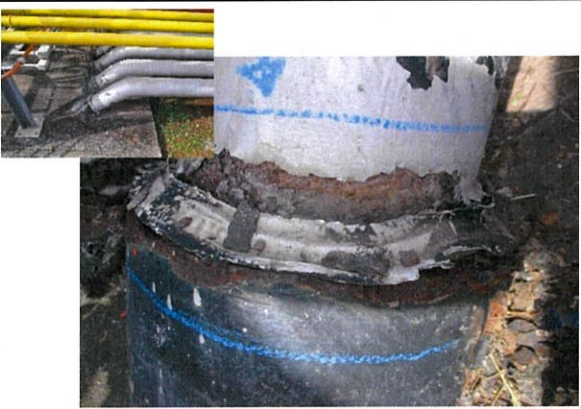
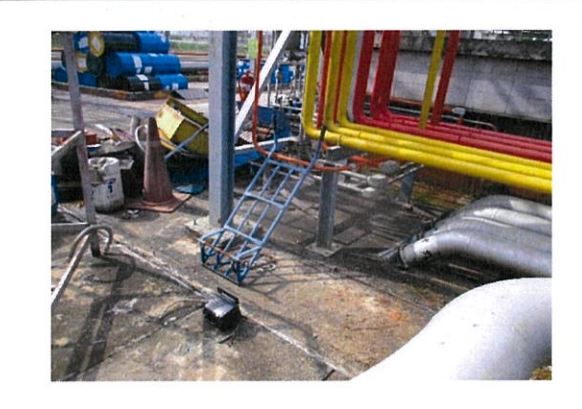
Name of part / Location		Findings			
TRL 002 G-Base 91 Tank Receiving line (Jetty to Tank No.9&Tank No.2)		Severe corrosion under sealing&Sealing damage. (7)

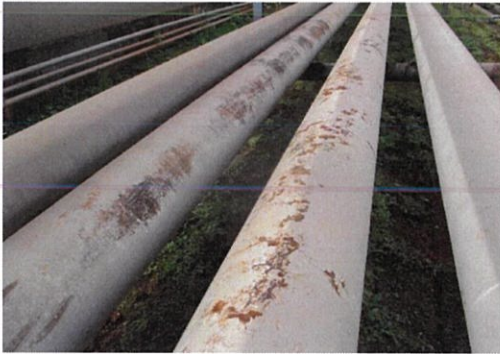
Name of part / Location		Findings		Name of part / Location		Findings	
TRL 002 G-Base 91 Tank Receiving line (Jetty to Tank No.9&Tank No.2)		Still in normal condition		TRL 002 G-Base 91 Tank Receiving line (Jetty to Tank No.9&Tank No.2)		Painting deterioration (9)

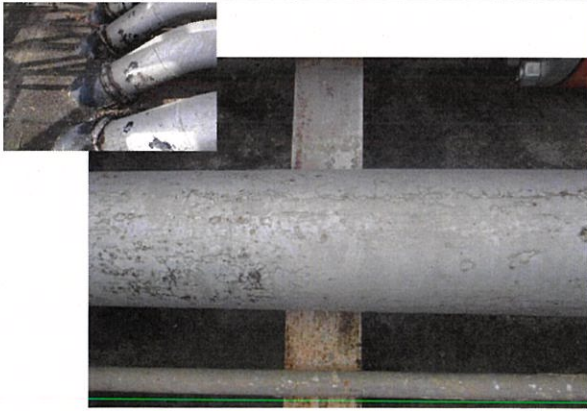
Name of part / Location		Findings		Name of part / Location		Findings	
TRL 002 G-Base 91 Tank Receiving line (Jetty to Tank No.9)		Painting deterioration (10)		TRL 002 G-Base 91 Tank Receiving line (Jetty to Tank No.9)		Painting deterioration (11)

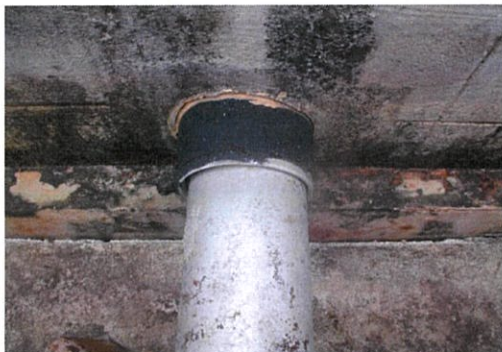
Name of part / Location		Findings		Name of part / Location		Findings	
TRL 002 G-Base 91 Tank Receiving line (Jetty to Tank No.9&Tank No.2)		Painting deterioration (13)		TRL 002 G-Base 91 Tank Receiving line (Jetty to Tank No.9&Tank No.2)		Still in normal condition

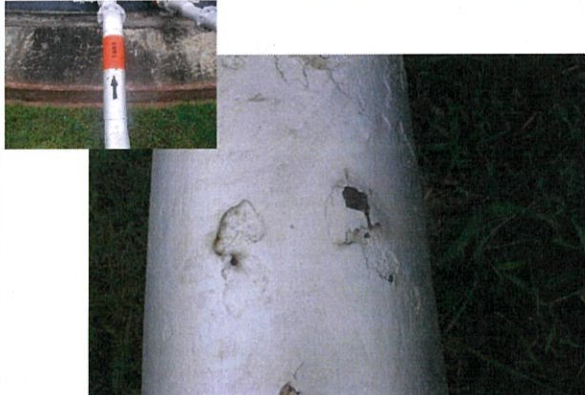
Name of part / Location		Findings		Name of part / Location		Findings	
TRL 002 G-Base 91 Tank Receiving line (Jetty to Tank No.9)		Painting deterioration (14)		TRL 002 G-Base 91 Tank Receiving line (Jetty to Tank No.9)		Still in normal condition

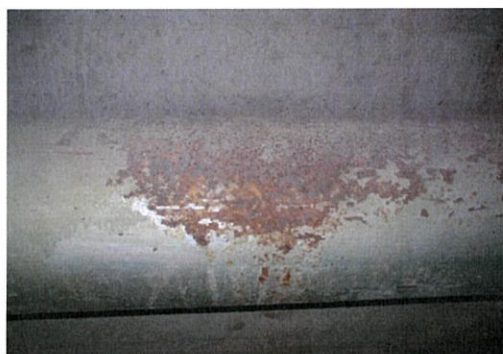
Slight corrosion on pipe. (15)

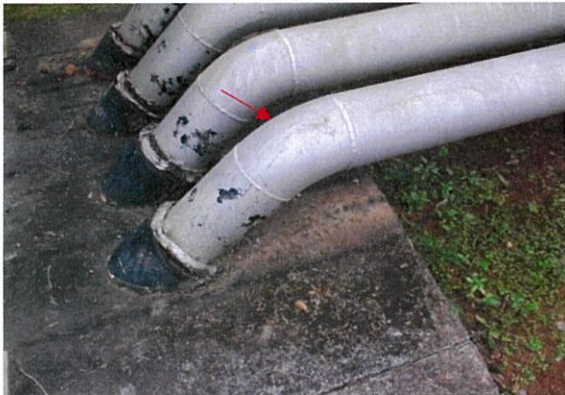
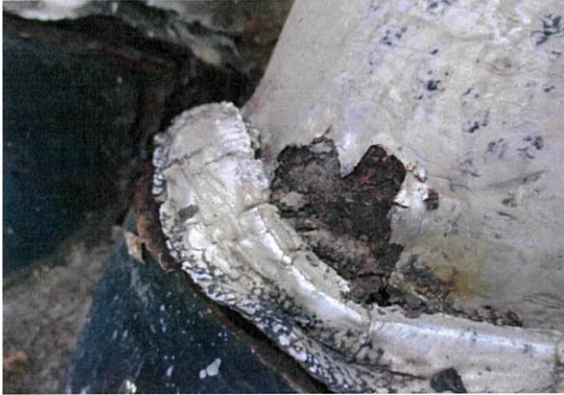
Name of part / Location	Findings	Name of part / Location	Findings	
TRL 003 Diesel Tank Receiving Line (Jetty to Tank No.6,8)	Sealing sleeve underground pipe was found degradation, damage and corrosion under sleeve underground pipe.	TRL 003 Diesel Tank Receiving Line (Jetty to Tank No.6,8)	Sealing sleeve underground pipe was found degradation, damage and corrosion under sleeve underground pipe.

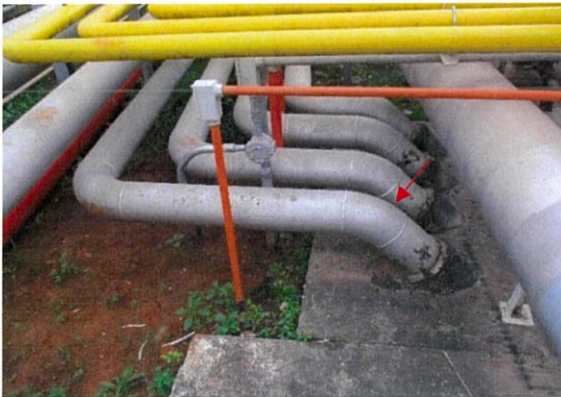
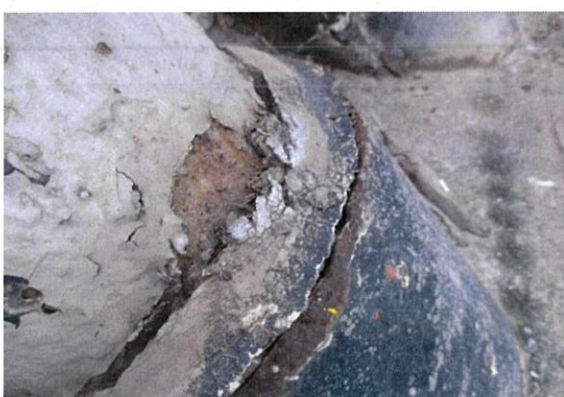
Name of part / Location	Findings	Name of part / Location	Findings	
TRL 003 Diesel Tank Receiving Line (Jetty to Tank No.6,8)	Sealing sleeve underground pipe was found degradation, damage and corrosion under sleeve underground pipe.	TRL 003 Diesel Tank Receiving Line (Jetty to Tank No.6,8)	Sealing sleeve underground pipe was found degradation, damage and corrosion under sleeve underground pipe.
