เอกสารการทบทวนเหตุการณ์อุบัติเหตุ/อุบัติภัย

แบบสอบสวนอุบัติเหตุ หรือเหตุการณ์ผิดปกติ (Incident Initial & Investigation report)

Title: PVC Leakage at PVC Loading (PVC Silo)

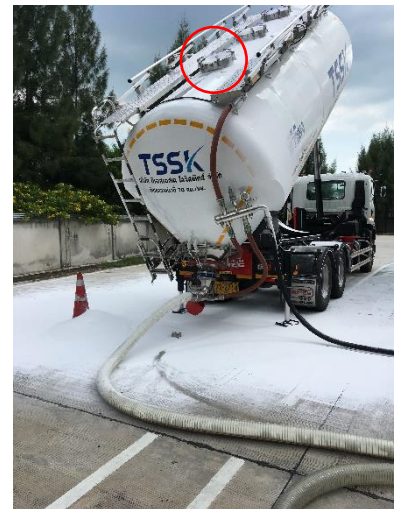
On Wednesday 23 February 2022 (02.56 PM), TSSK who is transporter to supply our R/M (PVC) does not check a cover as red circle is shown while loading of PVC.

A cover wasn't completely closed, then PVC in tank of lorry truck was leaked and spreaded out. For preliminary investigation, TSSK's Driver told that he doesn't

get a permission to interfere the condition of tank. A cover of tank which wasn't completely closed may be occurred from their loading activities at TPC. The amount of PVC was leaked about 190 kg. At our area, it already has cleaned all leakage for corrective action as pictures below;

However, TPC are during investigation to find root cause and will create prevention action in the next shipment. They will process to issue the root cause and corrective/preventive action and make an appointment for this case on 1 Mar 2022 at 10.00 AM.
