สำเนาการจัดส่งรายงานผลการปฏิบัติตามมาตรการฯ
ในระหว่างเดือนกรกฎาคม-ธันวาคม พ.ศ. 2565

เรื่อง ขอนำส่งรายงานผลการปฏิบัติตามมาตรการป้องกันและแก้ไขผลกระทบสิ่งแวดล้อม และมาตรการติดตามตรวจสอบผลกระทบสิ่งแวดล้อม โครงการทำเรือขนถ่ายถ่านหินของโรงไฟฟ้าบีแอลซีพี (ระยะดำเนินการ) ของบริษัท บีแอลซีพี เพาเวอร์ จำกัด ระหว่างเดือนกรกฎาคม-ธันวาคม พ.ศ. 2565

Coal Pile Route Inspection

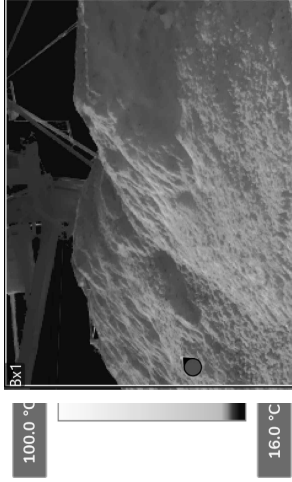
Picture 1. Captured at: Coal Pile: A2-Suek/Spot-A–North Side

Bx1	33.9 °C
Max	
Recommendation : Temperature normal condition.

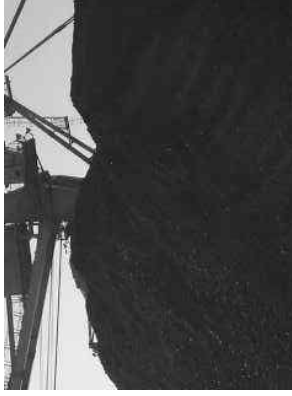
Created	1/19/2023 9:23:56 AM
File name	IR_60458.jpg
File size	291 KB
Width	320
Height	240
Minimum temp.	8.5 °C
Maximum temp.	33.9 °C

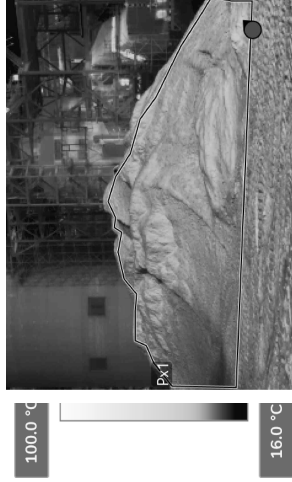
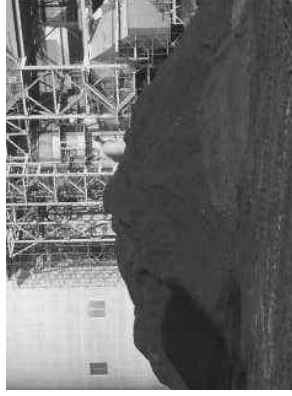
Picture 2. Captured at: Coal Pile: A2-Suek/Spot-A–South Side

Created	1/31/2023 8:36:11 AM
File name	IR_60459.jpg
File size	412 KB
Width	320
Height	240
Minimum temp.	16.9 °C
Maximum temp.	61.7 °C

Px1	51.4 °C
Max	
Recommendation : Temperature normal condition.

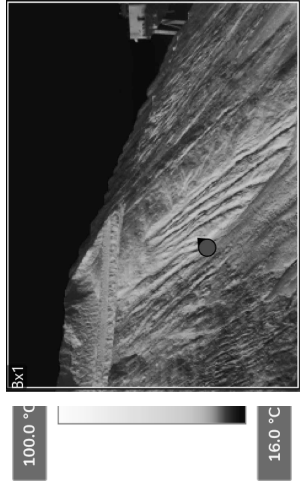
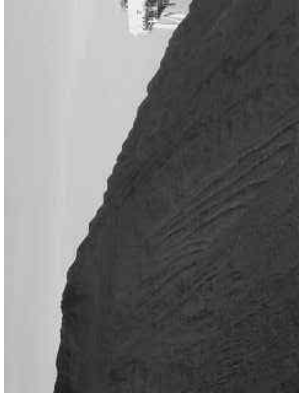
Picture 3. Captured at: Coal Pile: B1/1-Hunter Valley-North Side

Created	1/31/2023 8:41:00 AM
File name	IR_60460.jpg
File size	278 KB
Width	320
Height	240
Minimum temp.	8.5 °C
Maximum temp.	49.4 °C

Bx1	49.4 °C
Max	
Recommendation : Temperature normal condition.

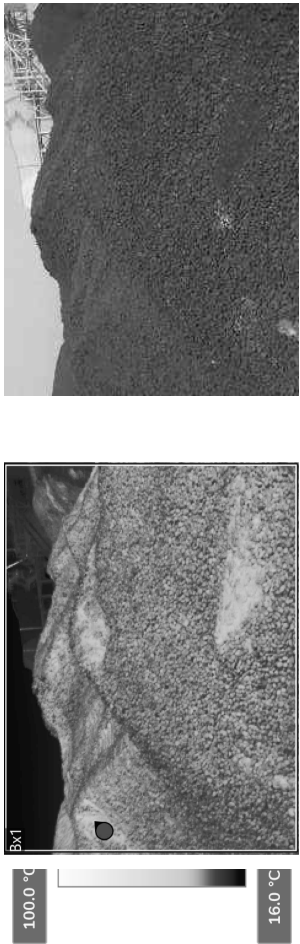
Picture 7. Captured at: Coal Pile: Reject-South Side-Pile B

File information	
Created	1/31/2023 8:46:30 AM
File name	IR_60464.jpg
File size	418 KB
Width	320
Height	240
Minimum temp.	18.6 °C
Maximum temp.	50.6 °C

Measurements	
Bx1	Max
Recommendation : Temperature normal condition.	
50.6 °C

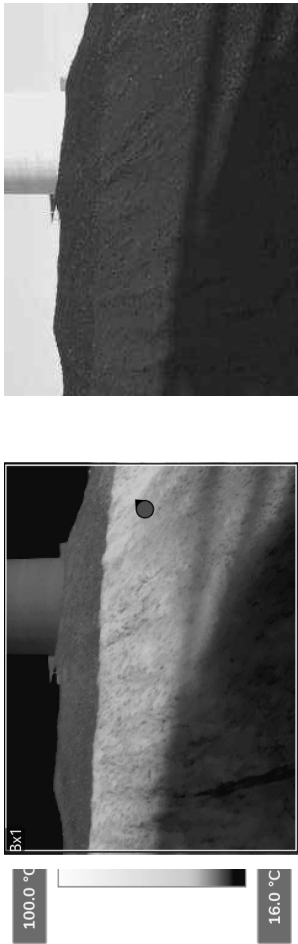
Picture 8. Captured at: Coal Pile: B2/3-Hunter Valley-South Side

File information	
Created	1/31/2023 8:47:38 AM
File name	IR_60465.jpg
File size	259 KB
Width	320
Height	240
Minimum temp.	10.1 °C
Maximum temp.	48.4 °C

Measurements	
Bx1	Max
Recommendation : Temperature normal condition.	
48.4 °C

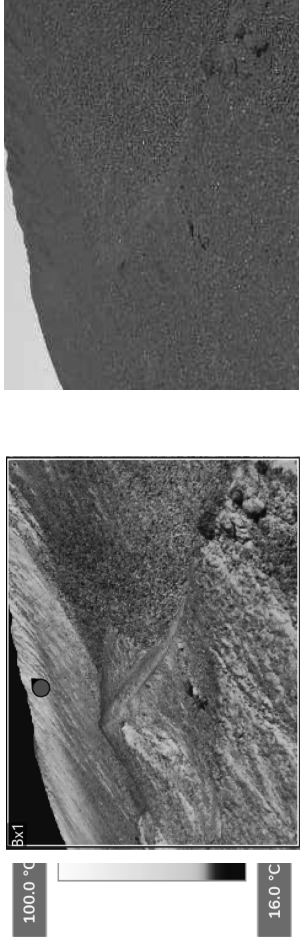
Picture 9. Captured at: Coal Pile: B2/2-Hunter Valley-South Side

File information	
Created	1/31/2023 8:48:11 AM
File name	IR_60466.jpg
File size	412 KB
Width	320
Height	240
Minimum temp.	7.7 °C
Maximum temp.	47.4 °C

Measurements	
Bx1	Max
Recommendation : Temperature normal condition.	
47.4 °C

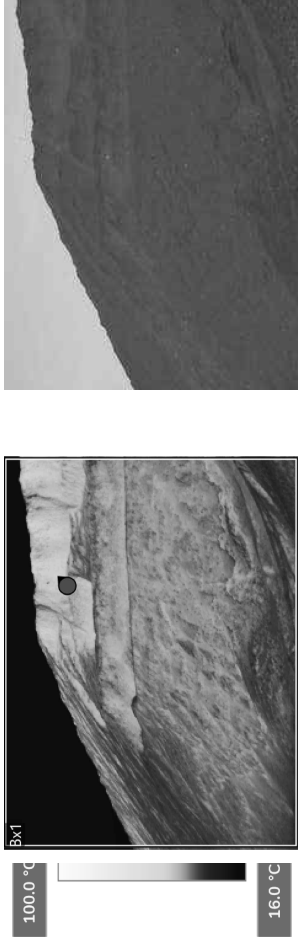
Picture 10. Captured at: Coal Pile: B2/1-Hunter Valley-South Side

File information	
Created	1/31/2023 8:50:10 AM
File name	IR_60467.jpg
File size	281 KB
Width	320
Height	240
Minimum temp.	10.2 °C
Maximum temp.	58.7 °C

Measurements	
Bx1	Max
Recommendation : Temperature normal condition.	
58.7 °C

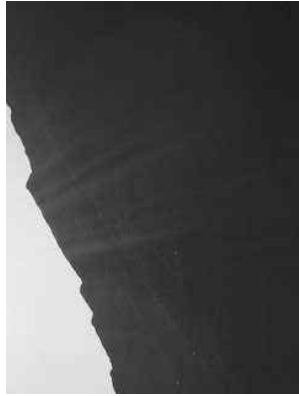
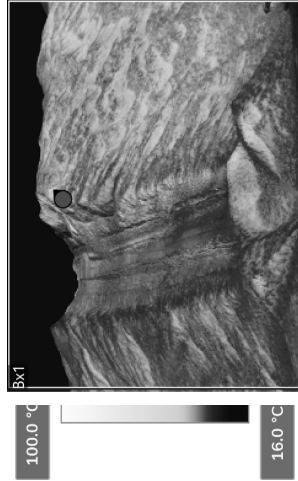
Created	1/19/2023 9:17:11 AM
File name	IR_60473.jpg
File size	323 KB
Width	320
Height	240
Minimum temp.	7.1 °C
Maximum temp.	55.2 °C

Bx1	55.2 °C
Max	
Recommendation : Temperature normal condition.

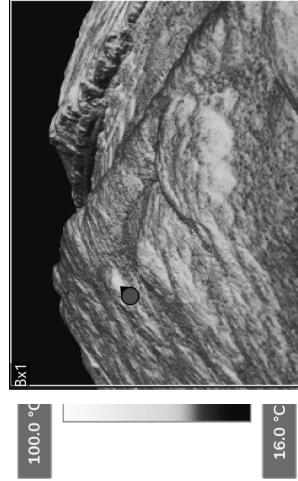
Picture 16. Captured at: Coal Pile: C1-Hunter Valley–South Side

Bx1	58.6 °C
Max	
Recommendation : Temperature normal condition.

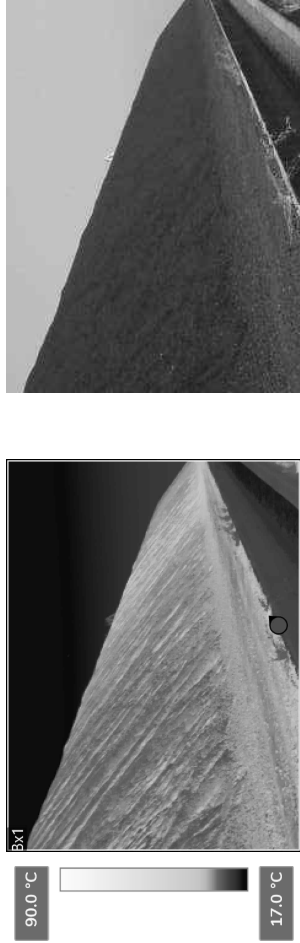
Picture 1. Captured at: Coal Pile: A1-Hunter Valley-North Side

File information	
Created	28/2/2023 8:43:37
File name	IR_60910.jpg
File size	225 KB
Width	320
Height	240
Minimum temp.	13.1 °C
Maximum temp.	43.2 °C

Measurements	
Bx1	Max
Recommendation : Temperature normal condition.	
43.2 °C

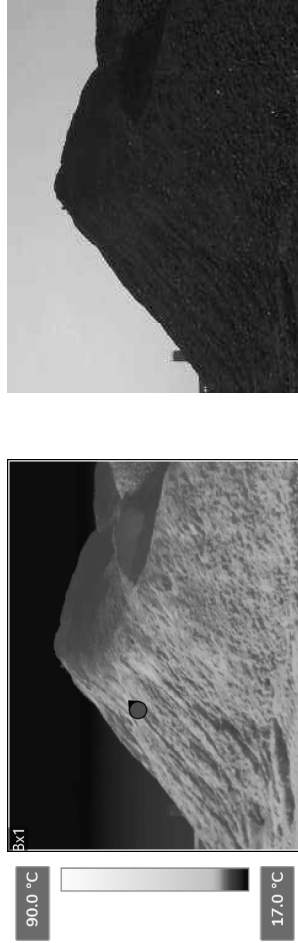
Picture 2. Captured at: Coal Pile: A2-Suek/Spot-A-North Side

File information	
Created	28/2/2566 8:44:48
File name	IR_61135.jpg
File size	278 KB
Width	320
Height	240
Minimum temp.	11.8 °C
Maximum temp.	34.7 °C

Measurements	
Bx1	Max
Recommendation : Temperature normal condition.	
34.7 °C

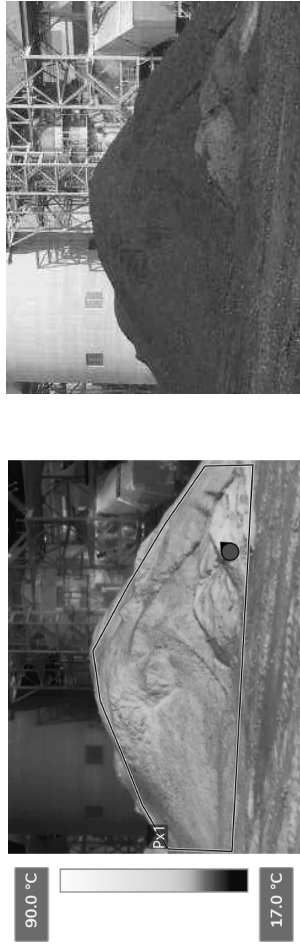
Picture 3. Captured at: Coal Pile: A2-Suek/Spot-A-South Side

File information	
Created	28/2/2566 8:48:38
File name	IR_61136.jpg
File size	380 KB
Width	320
Height	240
Minimum temp.	17.9 °C
Maximum temp.	54.4 °C

Measurements	
Px1	Max
Recommendation : Temperature normal condition.	
54.4 °C

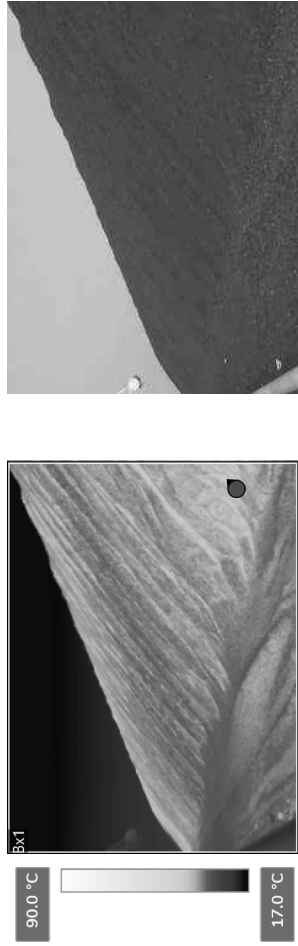
Picture 4. Captured at: Coal Pile: A1-Hunter Valley-South Side

File information	
Created	28/2/2566 8:49:13
File name	IR_61137.jpg
File size	285 KB
Width	320
Height	240
Minimum temp.	14.3 °C
Maximum temp.	49.1 °C

Measurements	
Bx1	Max
Recommendation : Temperature normal condition.	
49.1 °C

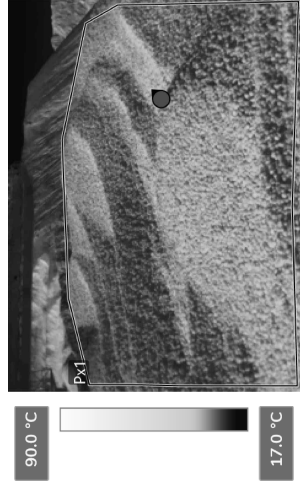
Picture 5. Captured at: Coal Pile: B1/1-Hunter Valley-North Side

Px1	
Max	45.5 °C
Recommendation : Temperature normal condition.

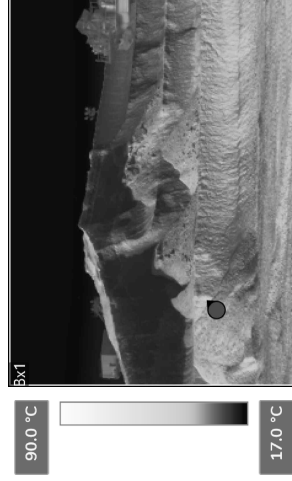
Picture 7. Captured at: Coal Pile: Reject-North Side

Created	28/2/2566 8:57:44
File name	IR_61141.jpg
File size	282 KB
Width	320
Height	240
Minimum temp.	12.6 °C
Maximum temp.	47.8 °C

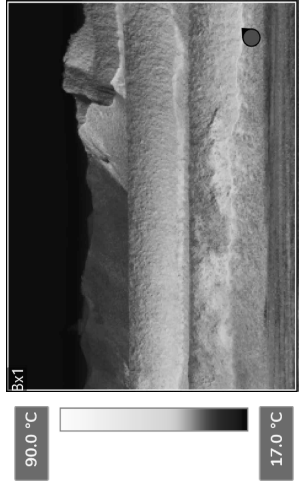
Picture 9. Captured at: Coal Pile: B2/1-Hunter Valley-South Side

Created	28/2/2566 9:06:24
File name	IR_61143.jpg
File size	278 KB
Width	320
Height	240
Minimum temp.	13.0 °C
Maximum temp.	53.2 °C

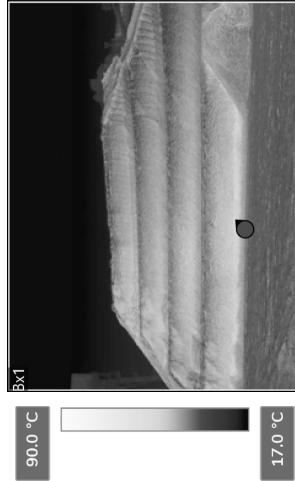
Picture 10. Captured at: Coal Pile: B2/1-Hunter Valley-South Side

Bx1	59.3 °C
Max	
Recommendation : Temperature normal condition.

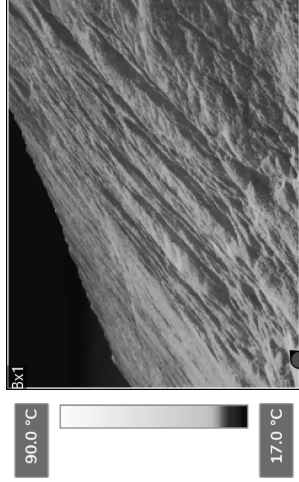
Picture 11. Captured at: Coal Pile: C1-Hunter Valley-North Side

Bx1	36.6 °C
Max	
Recommendation : Temperature normal condition.

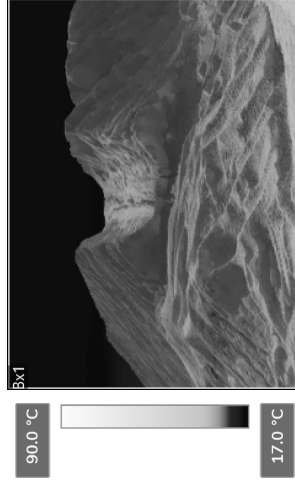
Picture 12. Captured at: Coal Pile: C3-Hunter Valley-North Side

Bx1	38.5 °C
Max	
Recommendation : Temperature normal condition.

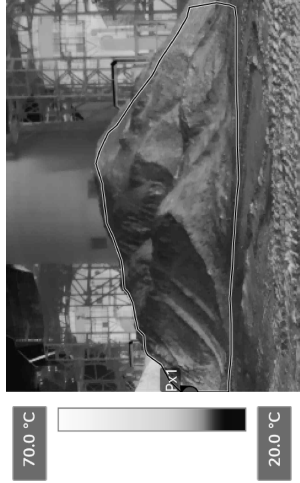
Picture 3. Captured at: Coal Pile: A2-Suek/Spot-A-South Side

Px1	38.4 °C
Max	
Recommendation : Temperature normal condition.

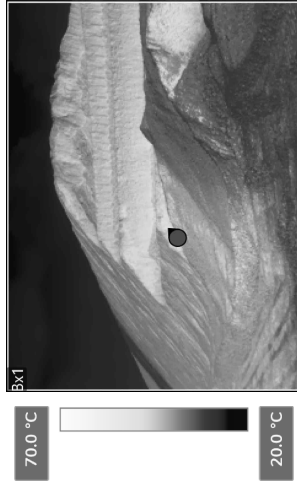
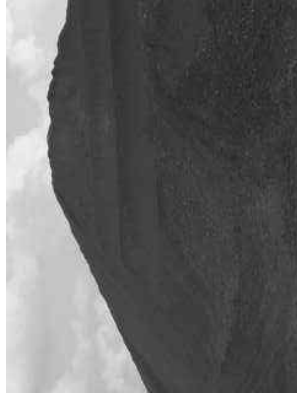
Picture 4. Captured at: Coal Pile: A1-Hunter Valley-South Side

Created	31/3/2566 8:52:50
File name	IR_62183.jpg
File size	278 KB
Width	320
Height	240
Minimum temp.	25.2 °C
Maximum temp.	53.0 °C

Bx1	53.0 °C
Max	
Recommendation : Temperature normal condition.

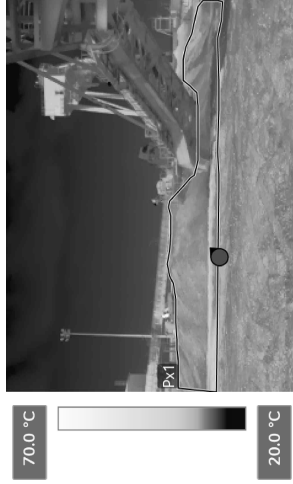
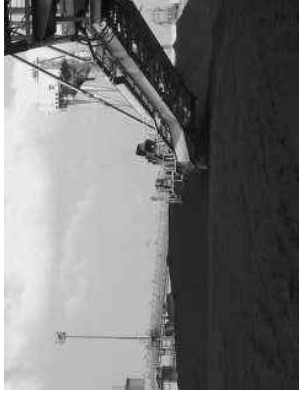
Picture 5. Captured at: Coal Pile: B1/1-Hunter Valley-North Side

Created	31/3/2566 8:56:31
File name	IR_62184.jpg
File size	273 KB
Width	320
Height	240
Minimum temp.	18.7 °C
Maximum temp.	111.9 °C

Px1	40.9 °C
Max	
Recommendation : Temperature normal condition.

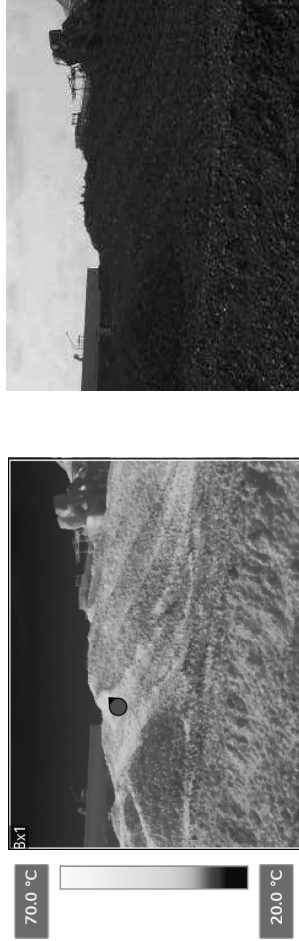
Picture 7. Captured at: Coal Pile: Reject--North Side

File information		Measurements
Created	31/3/2566 8:59:41	Bx1 Max Recommendation : Temperature normal condition. 46.0 °C
File name	IR_62186.jpg	
File size	354 KB	
Width	320	
Height	240	
Minimum temp.	26.9 °C	
Maximum temp.	46.0 °C

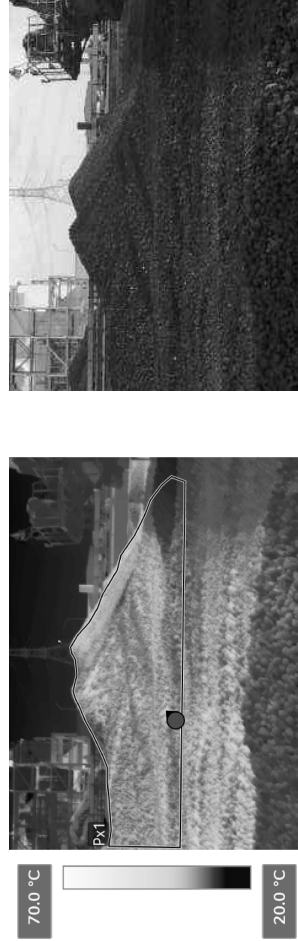
Picture 8. Captured at: Coal Pile: Reject--South Side

File information		Measurements
Created	31/3/2566 9:03:21	Px1 Max Recommendation : Temperature normal condition. 43.7 °C
File name	IR_62187.jpg	
File size	378 KB	
Width	320	
Height	240	
Minimum temp.	24.5 °C	
Maximum temp.	51.7 °C

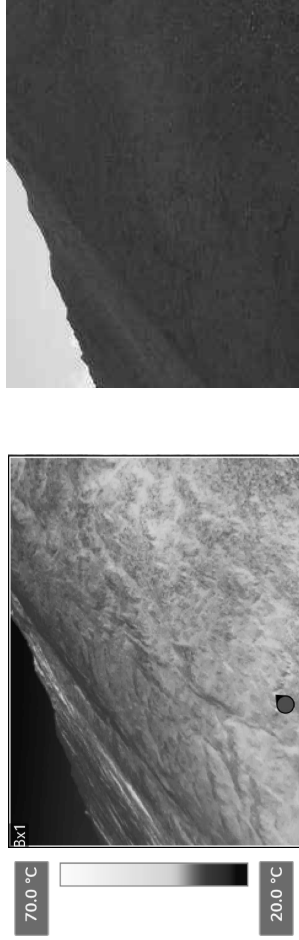
Picture 9. Captured at: Coal Pile: B2/2-Hunter Valley--South Side

File information		Measurements
Created	31/3/2566 9:03:26	Bx1 Max Recommendation : Temperature normal condition. 44.0 °C
File name	IR_62188.jpg	
File size	295 KB	
Width	320	
Height	240	
Minimum temp.	22.5 °C	
Maximum temp.	44.0 °C

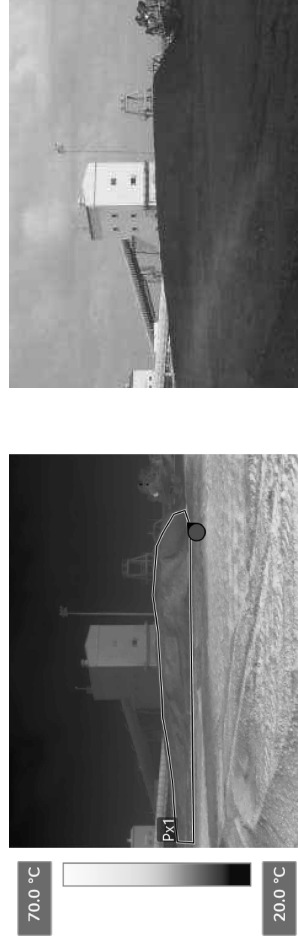
Picture 10. Captured at: Coal Pile: B2/1-Hunter Valley--South Side

File information		Measurements
Created	31/3/2566 9:06:48	Px1 Max Recommendation : Temperature normal condition. 39.6 °C
File name	IR_62189.jpg	
File size	235 KB	
Width	320	
Height	240	
Minimum temp.	25.9 °C	
Maximum temp.	56.2 °C

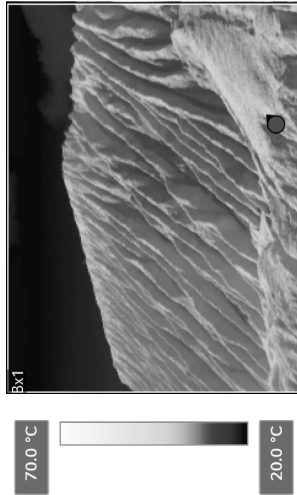
Picture 12. Captured at: Coal Pile: C2-Hunter Valley–North Side

Bx1	45.6 °C
Max	
Recommendation : Temperature normal condition.

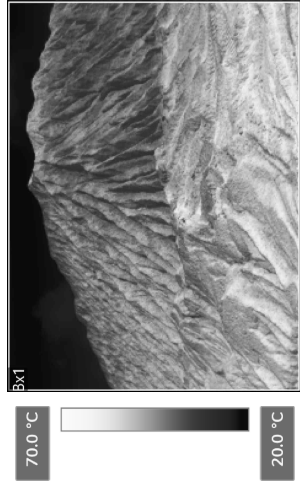
Picture 15. Captured at: Coal Pile: C2-Hunter Valley–South Side

Created	31/3/2566 9:13:39
File name	IR_62194.jpg
File size	305 KB
Width	320
Height	240
Minimum temp.	20.8 °C
Maximum temp.	63.5 °C

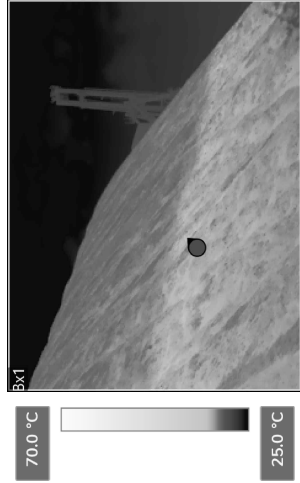
Picture 1. Captured at: Coal Pile: A1-Hunter Valley-North Side

Created	28/4/2023 8:24:43
File name	IR_62653.jpg
File size	223 KB
Width	320
Height	240
Minimum temp.	23.1 °C
Maximum temp.	36.6 °C

36.6 °C

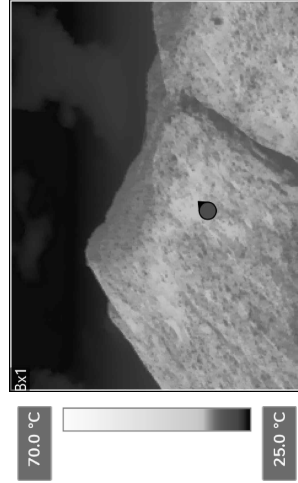
Picture 2. Captured at: Coal Pile: A2-Suek/Spot-A-North Side

Created	28/4/2023 8:29:10
File name	IR_62654.jpg
File size	241 KB
Width	320
Height	240
Minimum temp.	23.4 °C
Maximum temp.	38.5 °C

38.5 °C

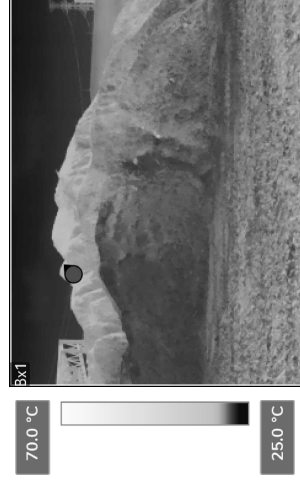
Picture 3. Captured at: Coal Pile: A2-Suek/Spot-A-South Side

Created	28/4/2023 8:45:31
File name	IR_62659.jpg
File size	294 KB
Width	320
Height	240
Minimum temp.	27.7 °C
Maximum temp.	34.7 °C

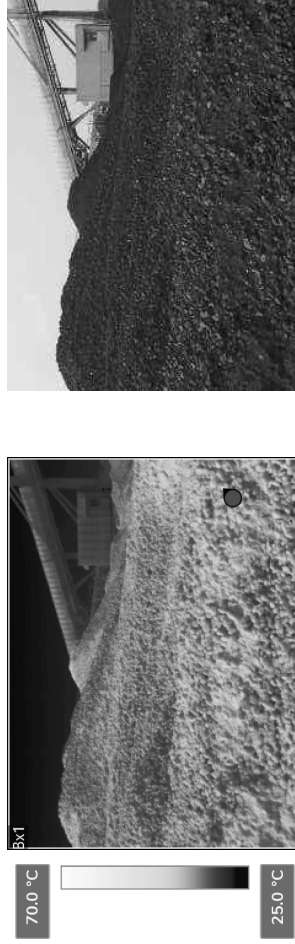
Picture 6. Captured at: Coal Pile: Reject-North Side

File information	
Created	28/4/2023 8:57:25
File name	IR_62662.jpg
File size	437 KB
Width	320
Height	240
Minimum temp.	28.0 °C
Maximum temp.	48.6 °C

Measurements	
Bx1	Max
Recommendation : Temperature normal condition.

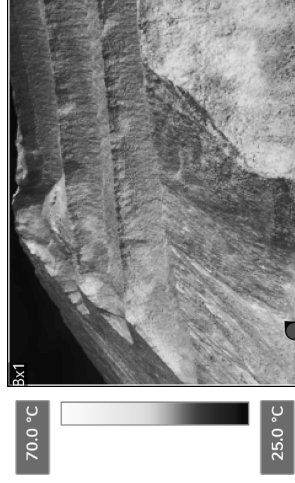
Picture 8. Captured at: Coal Pile: B2/1-Hunter Valley-South Side

File information	
Created	28/4/2023 9:05:34
File name	IR_62664.jpg
File size	340 KB
Width	320
Height	240
Minimum temp.	24.9 °C
Maximum temp.	53.2 °C

Measurements	
Bx1	Max
Recommendation : Temperature normal condition.

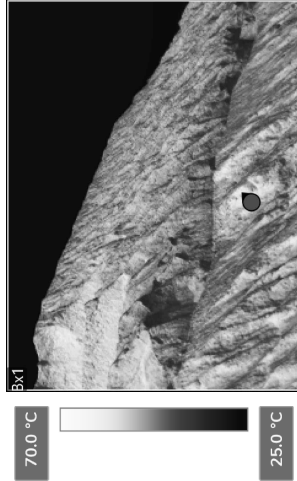
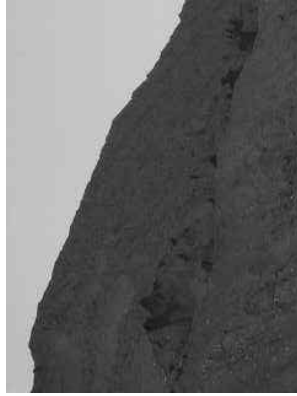
Picture 10. Captured at: Coal Pile: C2-Hunter Valley–North Side

Created	28/4/2023 9:11:59
File name	IR_62667.jpg
File size	286 KB
Width	320
Height	240
Minimum temp.	20.5 °C
Maximum temp.	61.9 °C

Bx1	61.9 °C
Max	
Recommendation : Temperature normal condition.

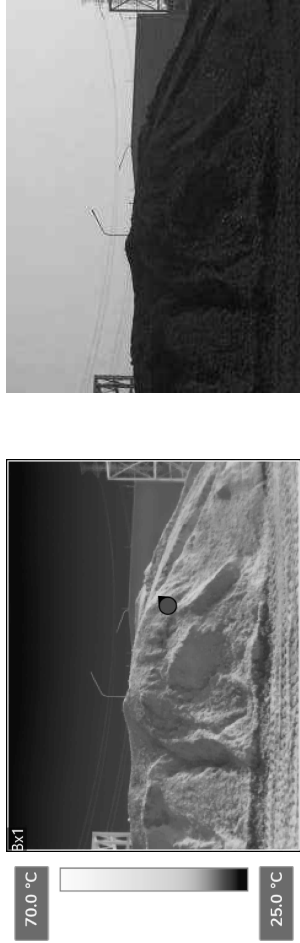
Picture 3. Captured at: Coal Pile: A2-Suek/Spot-A-South Side

Measurements	
Bx1	45.8 °C
Max	
Recommendation : Temperature normal condition.

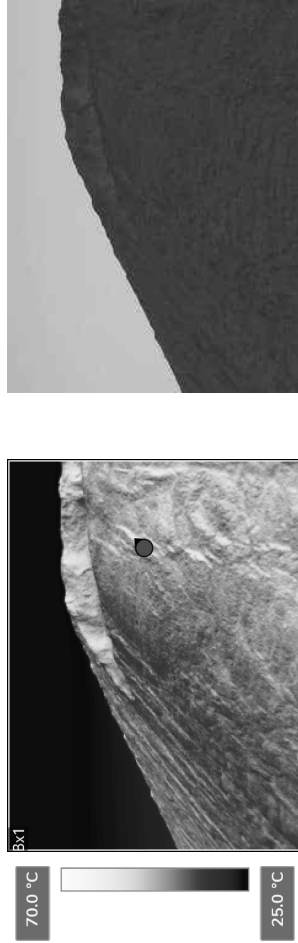
Picture 4. Captured at: Coal Pile: A1-Hunter Valley-South Side

Measurements	
Bx1	60.8 °C
Max	
Recommendation : Temperature normal condition.

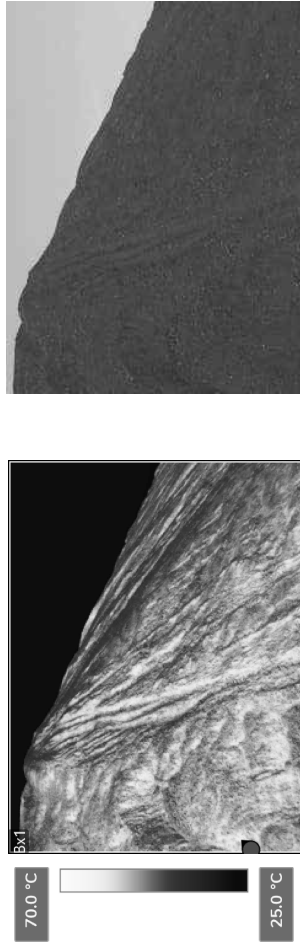
Picture 5. Captured at: Coal Pile: B1/1-Hunter Valley-North Side

Measurements	
Bx1	62.9 °C
Max	
Recommendation : Temperature normal condition.

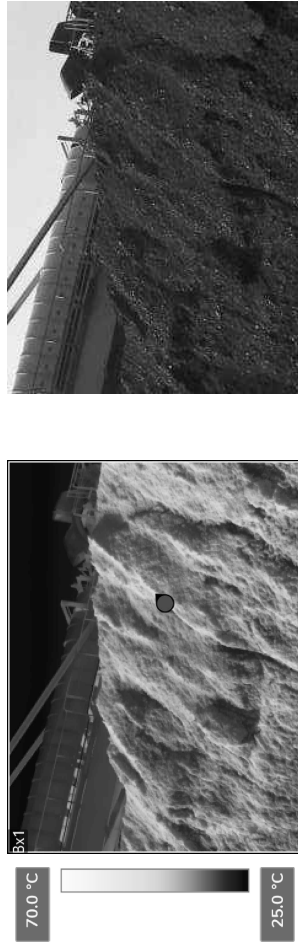
Picture 6. Captured at: Coal Pile: B1/2-Hunter Valley-North Side

Measurements	
Bx1	52.9 °C
Max	
Recommendation : Temperature normal condition.

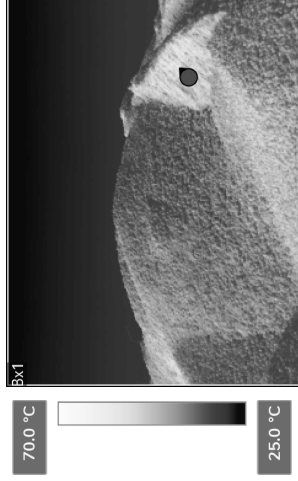
Picture 9. Captured at: Coal Pile: Reject–North Side

File information	
Created	26/5/2023 8:48:36
File name	FLUR0706.jpg
File size	316 KB
Width	320
Height	240
Minimum temp.	26.1 °C
Maximum temp.	58.9 °C

Measurements	
Bx1	Max
Recommendation : Temperature normal condition.	
58.9 °C

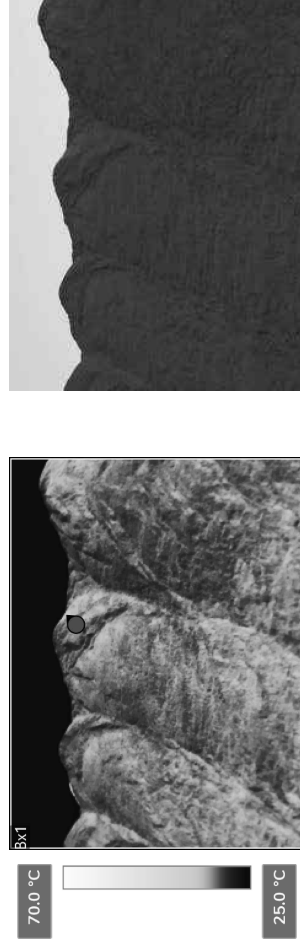
Picture 12. Captured at: Coal Pile: B2/3-Hunter Valley-South Side

File information	
Created	26/5/2023 8:54:59
File name	FLIR0710.jpg
File size	311 KB
Width	320
Height	240
Minimum temp.	22.7 °C
Maximum temp.	41.0 °C

Bx1	Max
Recommendation : Temperature normal condition.	
41.0 °C

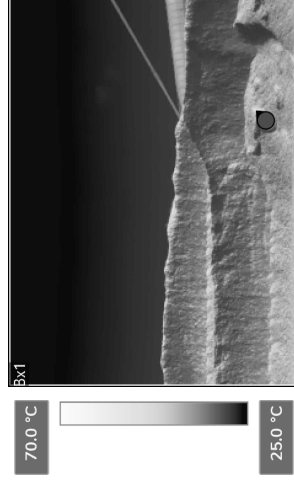
Picture 13. Captured at: Coal Pile: B2/2-Hunter Valley-South Side

File information	
Created	26/5/2023 8:56:52
File name	FLIR0711.jpg
File size	235 KB
Width	320
Height	240
Minimum temp.	23.1 °C
Maximum temp.	52.7 °C

Bx1	Max
Recommendation : Temperature normal condition.	
52.7 °C

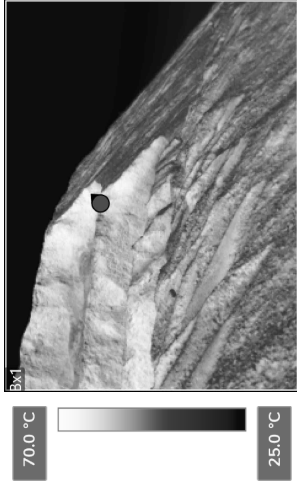
Picture 15. Captured at: Coal Pile: C1-Hunter Valley–North Side

Created	26/5/2023 9:02:05
File name	FLUR0713.jpg
File size	313 KB
Width	320
Height	240
Minimum temp.	20.5 °C
Maximum temp.	67.6 °C

Bx1	67.6 °C
Max	
Recommendation : Temperature alarm condition.	
Action :Water Spray

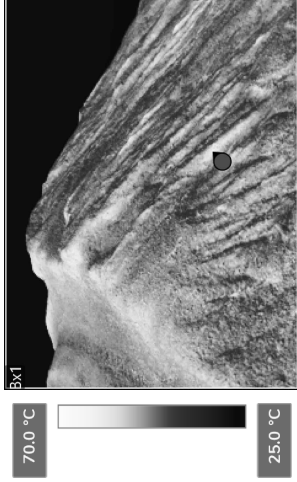
Picture 17. Captured at: Coal Pile: C3-Hunter Valley North Side

Created	26/5/2023 9:06:28
File name	FLUR0715.jpg
File size	414 KB
Width	320
Height	240
Minimum temp.	21.2 °C
Maximum temp.	62.3 °C

Bx1	62.3 °C
Max	
Recommendation : Temperature normal condition.

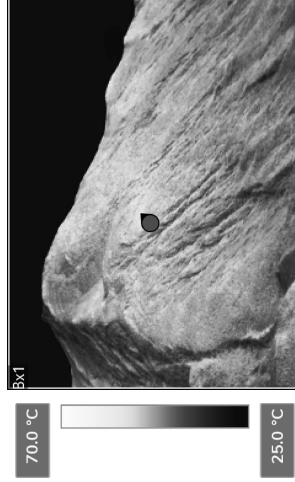
Picture 18. Captured at: Coal Pile: C3-Hunter Valley–South Side

Created	26/5/2023 9:10:38
File name	FLUR0716.jpg
File size	363 KB
Width	320
Height	240
Minimum temp.	19.3 °C
Maximum temp.	58.2 °C

Bx1	58.2 °C
Max	
Recommendation : Temperature normal condition.

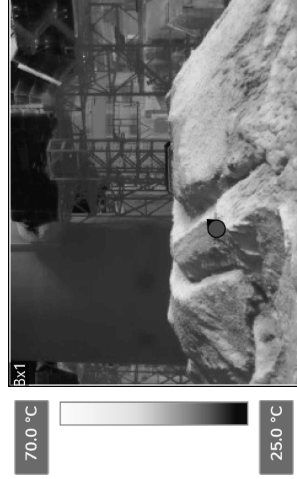
Picture 3. Captured at: Coal Pile: A2-Suek/Spot-A-South Side

Created	23/06/28 8:31:08 AM
File name	FLIR1510.jpg
File size	397 KB
Width	320
Height	240
Minimum temp.	23.0 °C
Maximum temp.	56.6 °C

Bx1	56.6 °C
Max	
Recommendation : Temperature normal condition.

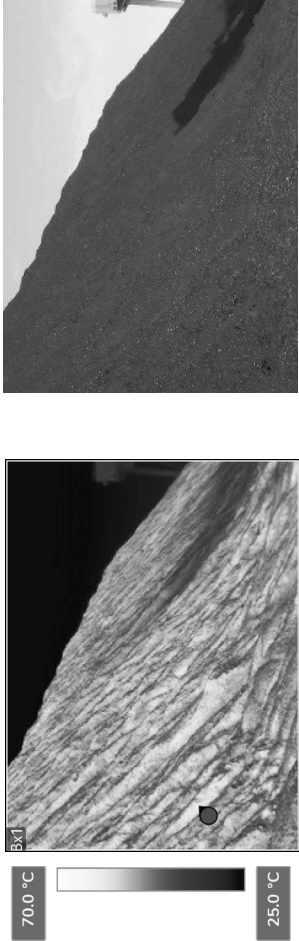
Picture 5. Captured at: Coal Pile: B1/1-Hunter Valley-North Side

File information		Measurements
Created	23/06/28 8:37:46 AM	Bx1 Max Recommendation : Temperature normal condition. 63.0 °C
File name	FLIR1512.jpg	
File size	390 KB	
Width	320	
Height	240	Minimum temp. 23.7 °C Maximum temp. 63.0 °C
Minimum temp.	23.7 °C	
Maximum temp.	63.0 °C

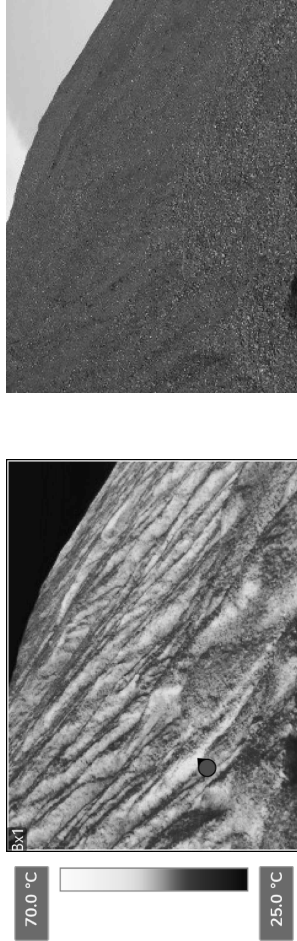
Picture 6. Captured at: Coal Pile: B1/2-Hunter Valley-North Side

File information		Measurements
Created	23/06/28 8:40:56 AM	Bx1 Max Recommendation : Temperature normal condition. 57.9 °C
File name	FLIR1513.jpg	
File size	471 KB	
Width	320	
Height	240	Minimum temp. 24.4 °C Maximum temp. 57.9 °C
Minimum temp.	24.4 °C	
Maximum temp.	57.9 °C

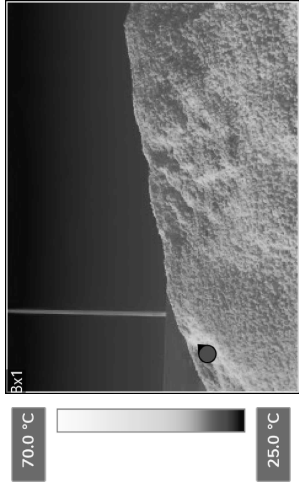
Picture 7. Captured at: Coal Pile: Reject-North Side

File information		Measurements
Created	23/06/28 8:43:08 AM	Bx1 Max Recommendation : Temperature normal condition. 47.7 °C
File name	FLIR1514.jpg	
File size	304 KB	
Width	320	
Height	240	Minimum temp. 25.2 °C Maximum temp. 47.7 °C
Minimum temp.	25.2 °C	
Maximum temp.	47.7 °C

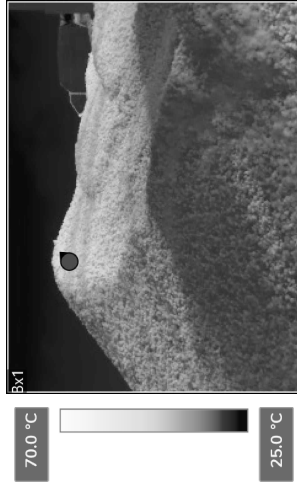
Picture 8. Captured at: Coal Pile: Reject-South Side

File information		Measurements
Created	23/06/28 8:47:22 AM	Bx1 Max Recommendation : Temperature normal condition. 53.6 °C
File name	FLIR1515.jpg	
File size	375 KB	
Width	320	
Height	240	Minimum temp. 24.4 °C Maximum temp. 53.6 °C
Minimum temp.	24.4 °C	
Maximum temp.	53.6 °C

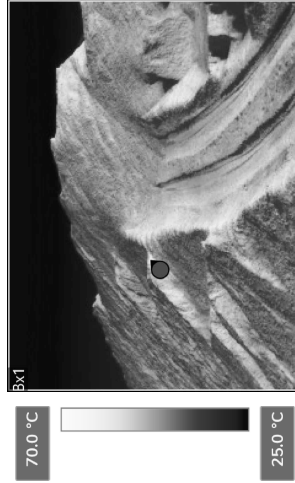
**Picture 10.** Captured at: Coal Pile: B2/1-Hunter Valley–South Side

Created	23/06/28 8:51:11 AM
File name	FLIR1517.jpg
File size	309 KB
Width	320
Height	240
Minimum temp.	24.5 °C
Maximum temp.	62.9 °C

Bx1	62.9 °C
Max	
Recommendation : Temperature normal condition.

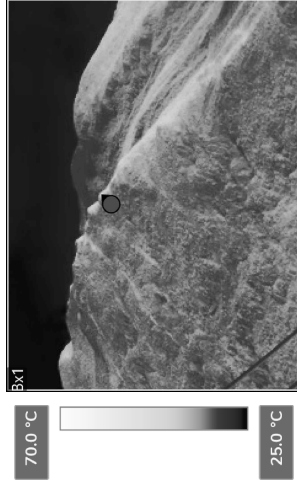
Picture 16. Captured at: Coal Pile: C1-Hunter Valley–South Side

File information	
Created	23/06/28 9:05:42 AM
File name	FLIR1524.jpg
File size	272 KB
Width	320
Height	240
Minimum temp.	22.2 °C
Maximum temp.	46.5 °C

Measurements	
Bx1	Max
Recommendation : Temperature normal condition.	
46.5 °C
