รายงานการซ่อมบำรุงระบบไฟฟ้า

ใบรายงานการตรวจเช็คเครื่องกำเนิดไฟฟ้า

Inspection date:	30/08/2023	
Report date:	3/09/2023	
Project :	Hyatt Regency Bangkok Sukhumvit	
Project Location:	Bangkok	
Type of Inspection:	Qualitative Electrical System	
Purpose of Inspection:	Maintenance IR Scan (After PM)	
Certified Thermographer:	Mr. Thirasak Nampor	
Certification Number:	Certificate Level-I No. 1-000929	
Equipment Used:	Flir E53	S/N : 84503823
No of thermograms :	78	
Comments:	The results of the examination. Measurement of electrical heat of electrical equipment according to plan of work. No defects are found that cause damage and do not cause harm to the use and maintenance of electrical equipment should be maintained in good condition.

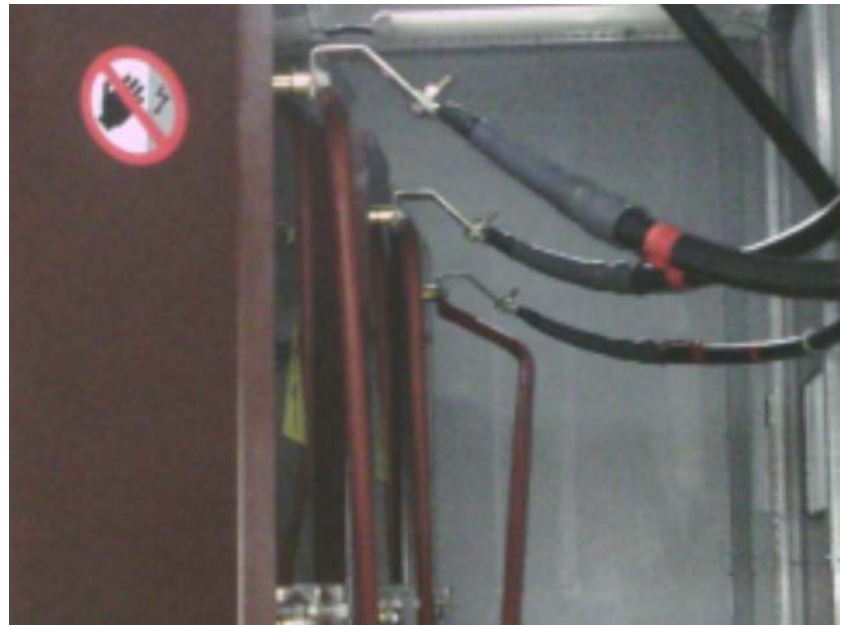
FLIR4953.jpg

Location :	MDB Room FI.3
Equipment :	TR-1
Detail :	High Volt Side Connection
Comment :	Normal operation , Not found hotspot
	Should also keep for your future reference

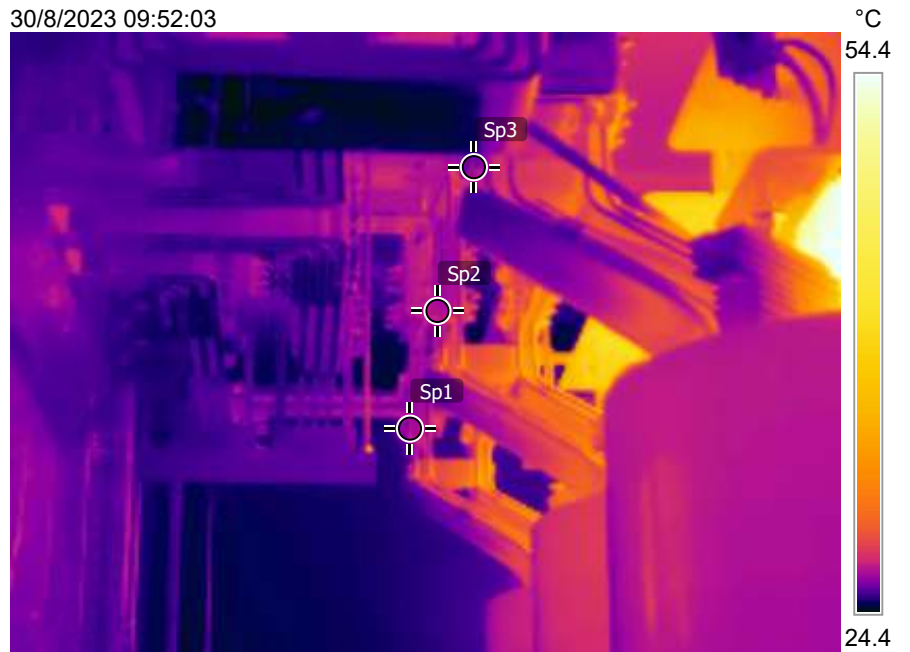
Location :	MDB Room FI.3
Equipment :	TR-1
Detail :	Low Volt Side Connection
Comment :	Normal operation , Not found hotspot
	Should also keep for your future reference

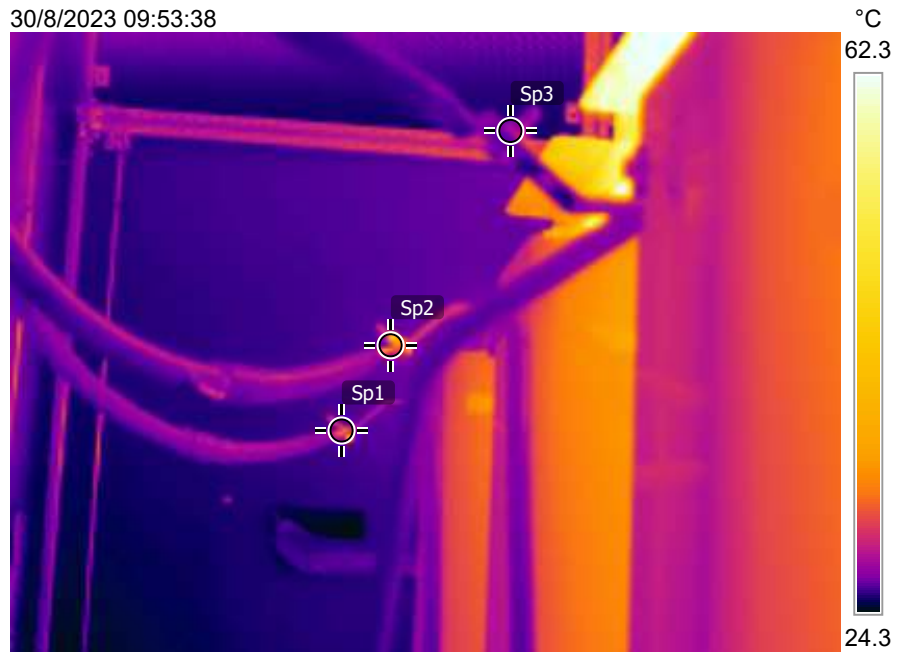
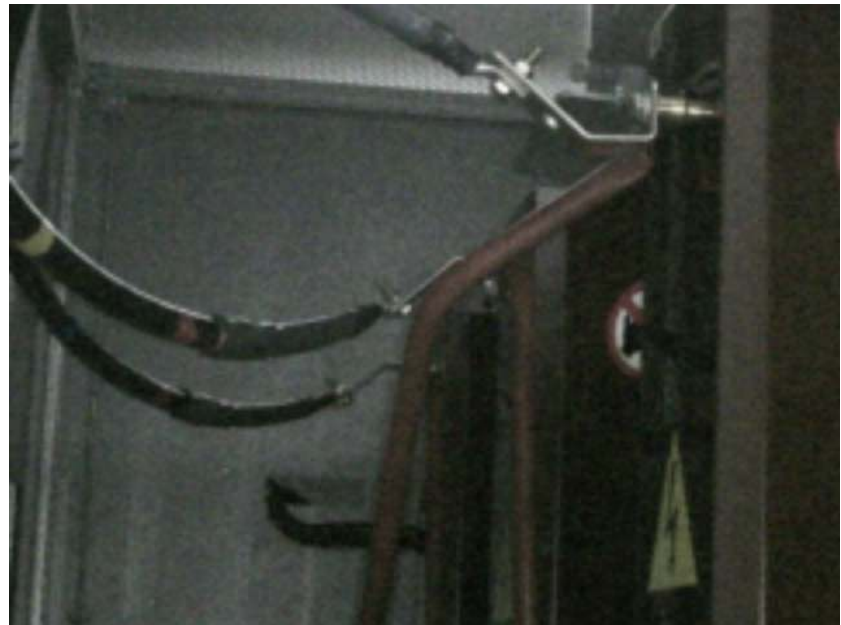
FLIR4955.jpg

Location :	MDB Room FI.3
Equipment :	TR-2
Detail :	High Volt Side Connection
Comment :	Normal operation , Not found hotspot
	Should also keep for your future reference

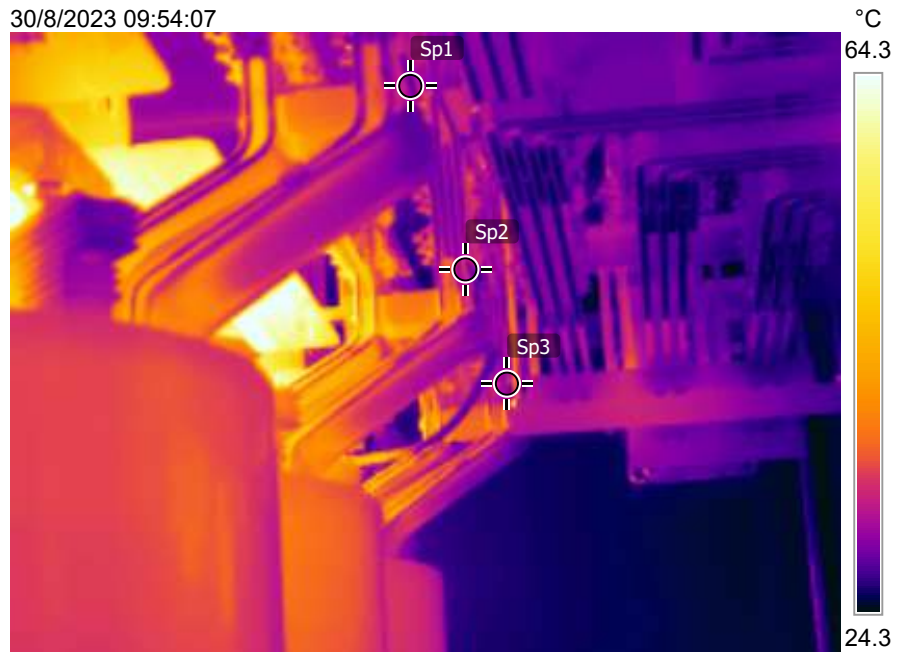
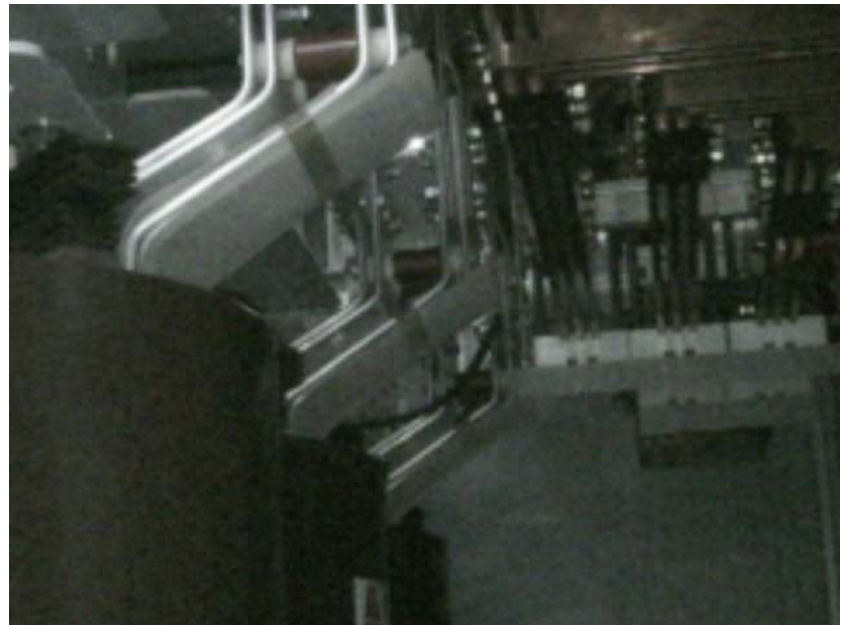
FLIR4956.jpg

Location :	MDB Room FI.3
Equipment :	TR-2
Detail :	Low Volt Side Connection
Comment :	Normal operation , Not found hotspot
	Should also keep for your future reference

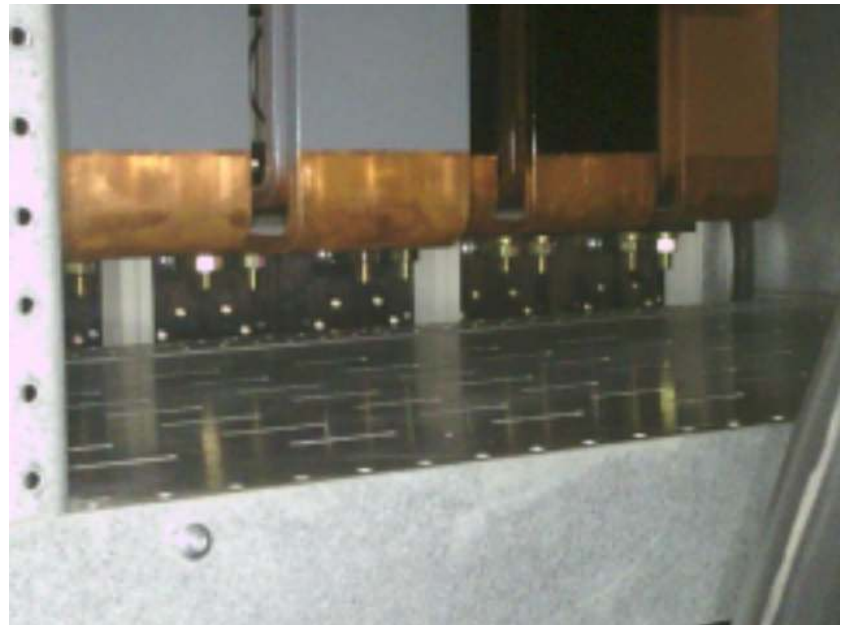
30/8/2023 09:55:21

Location :	MDB Room FI.3
Equipment :	MDB.1 Panel
Detail :	ACB Main
Comment :	Normal operation , Not found hotspot
	Should also keep for your future reference

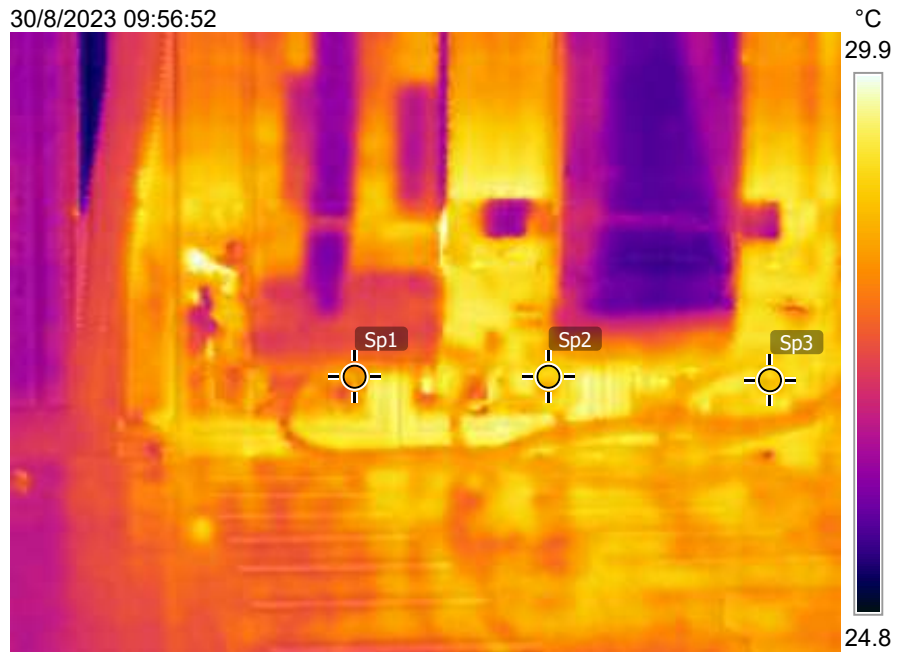
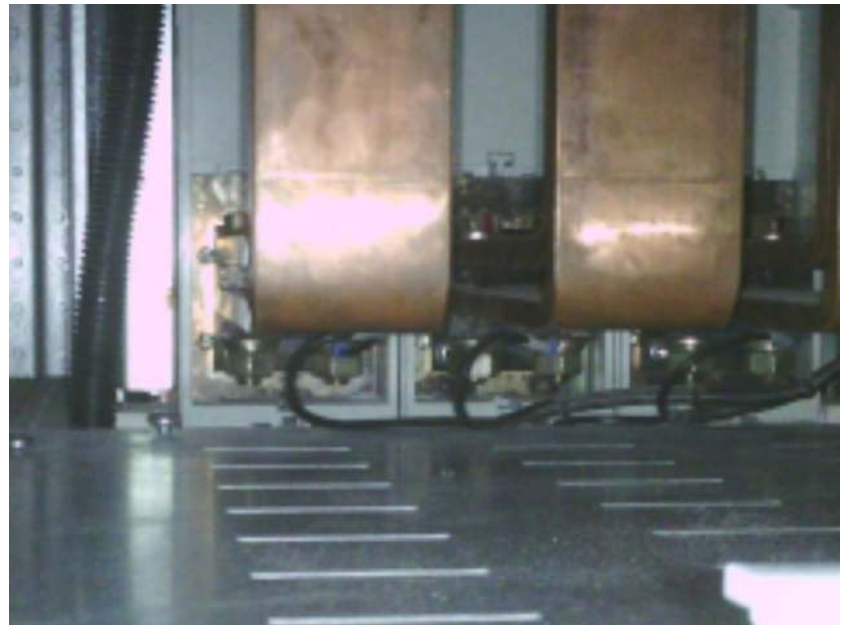
FLIR4958.jpg

Location :	MDB Room FI.3
Equipment :	MDB.1 Panel
Detail :	ACB FOR 1A 6,300 A.
Comment :	Normal operation , Not found hotspot
	Should also keep for your future reference

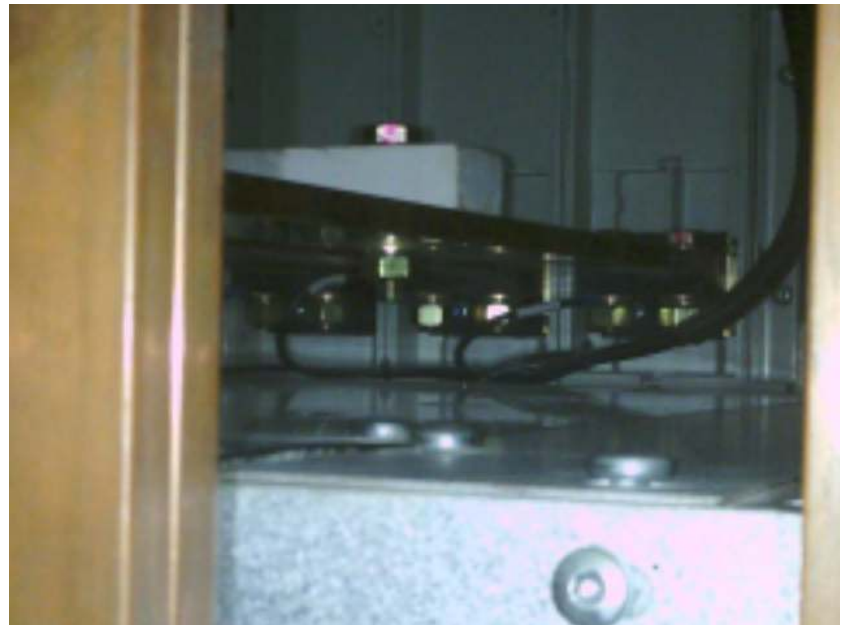
FLIR4959.jpg

Location :	MDB Room FI.3
Equipment :	MDB.1 Panel
Detail :	ACB DB.B 2,500 A.
Comment :	Normal operation , Not found hotspot
	Should also keep for your future reference

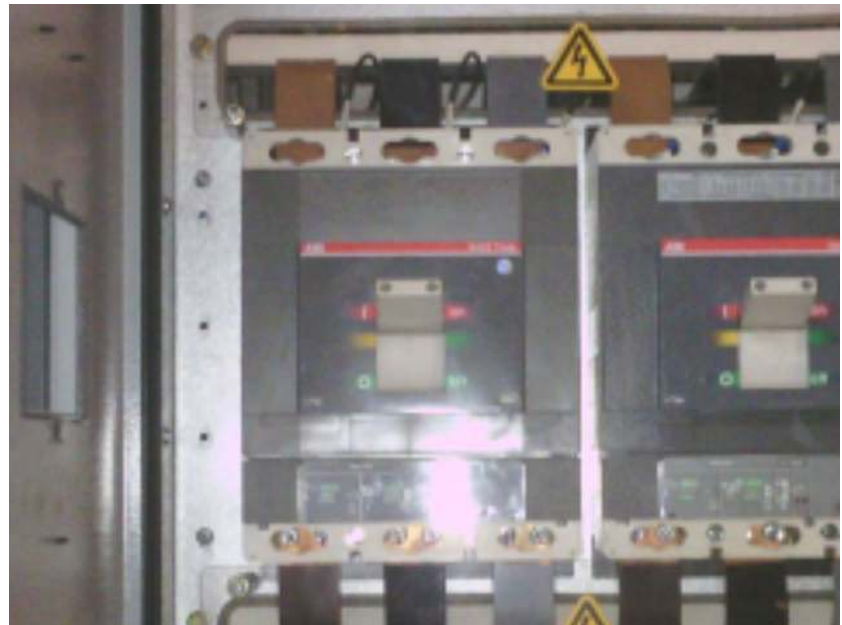
30/8/2023 09:59:26

Location :	MDB Room FI.3
Equipment :	MDB.1 Panel
Detail :	MCCB FOR ODD FLOOR 1,250 A.
Comment :	Normal operation , Not found hotspot
	Should also keep for your future reference

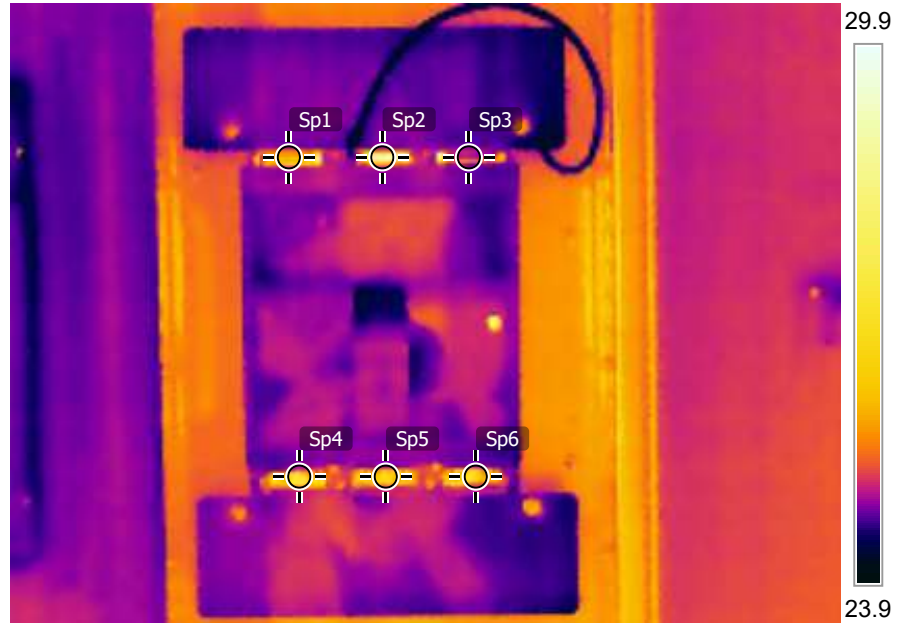
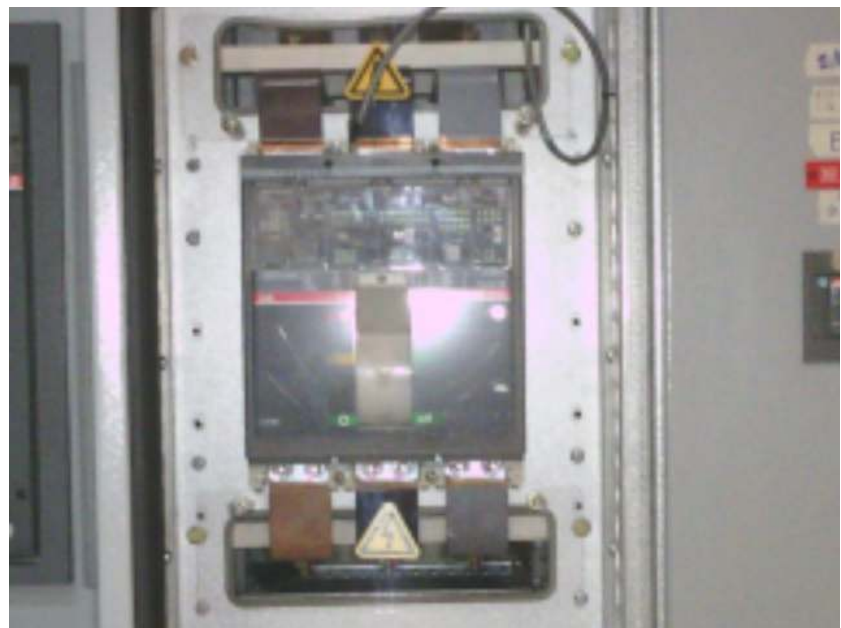
FLIR4961.jpg

Location :	MDB Room FI.3
Equipment :	MDB.1 Panel
Detail :	MCCB FDP
Comment :	Normal operation , Not found hotspot
	Should also keep for your future reference

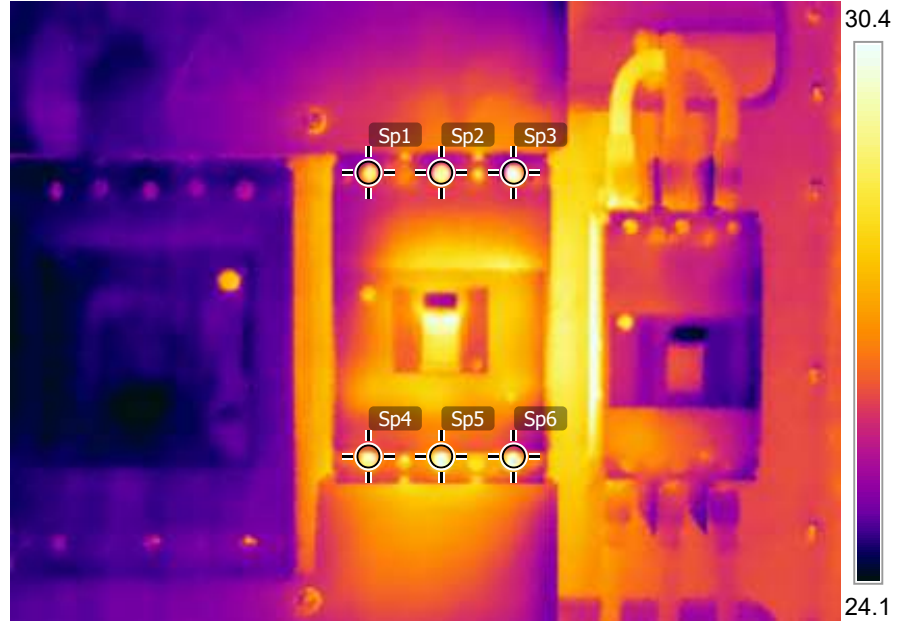
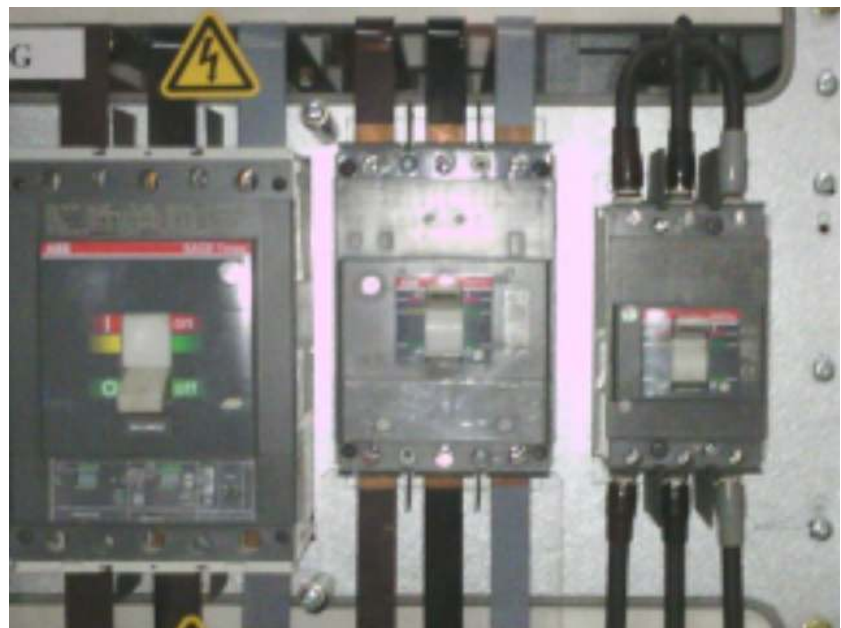
FLIR4962.jpg

Location :	MDB Room Fl.3
Equipment :	MDB.1 Panel
Detail :	MCCB CWHF
Comment :	Normal operation , Not found hotspot
	Should also keep for your future reference

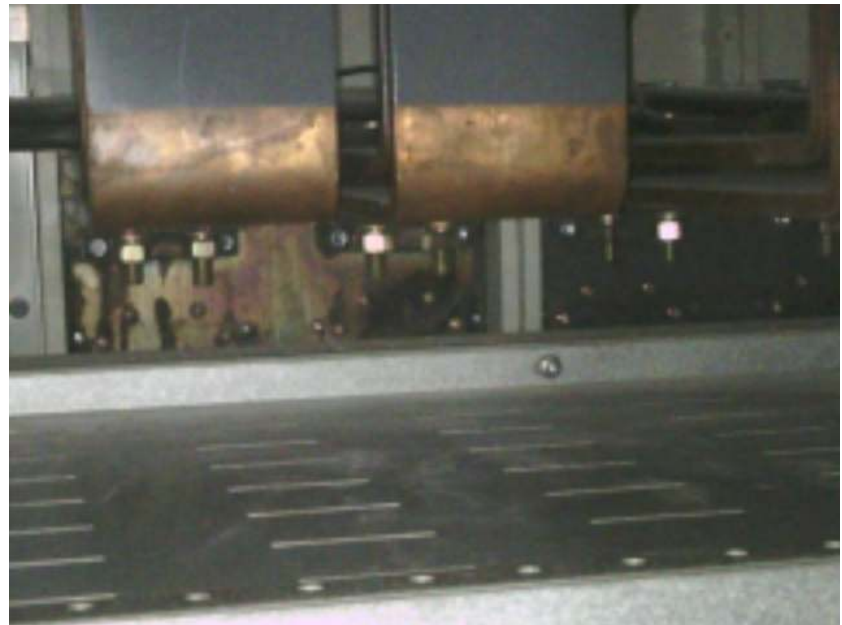
30/8/2023 10:01:11

Location :	MDB Room FI.3
Equipment :	MDB.2 Panel
Detail :	ACB Main 6,300 A.
Comment :	Normal operation , Not found hotspot
	Should also keep for your future reference

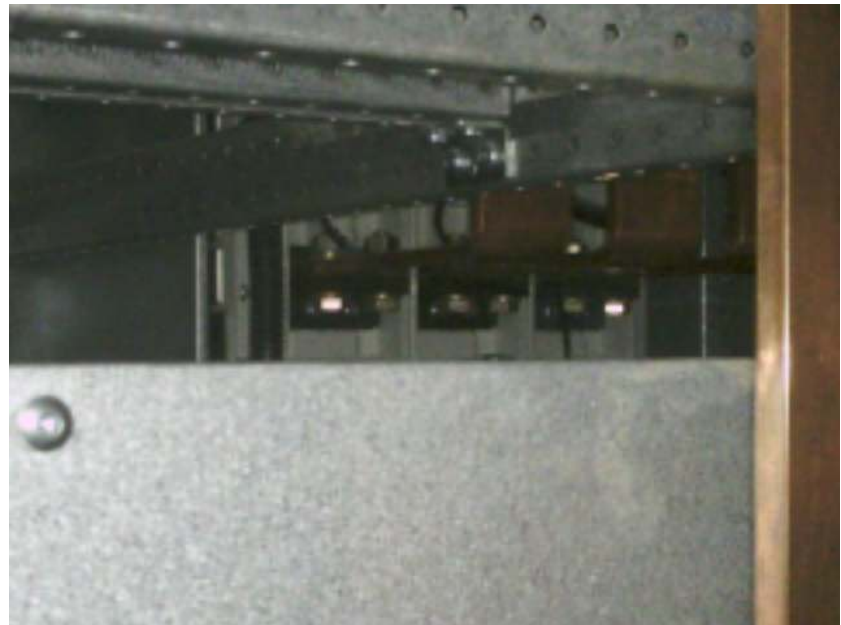
FLIR4964.jpg

Location :	MDB Room FI.3
Equipment :	MDB.2 Panel
Detail :	ACB MCC.AC1 1,250 A.
Comment :	Normal operation , Not found hotspot
	Should also keep for your future reference

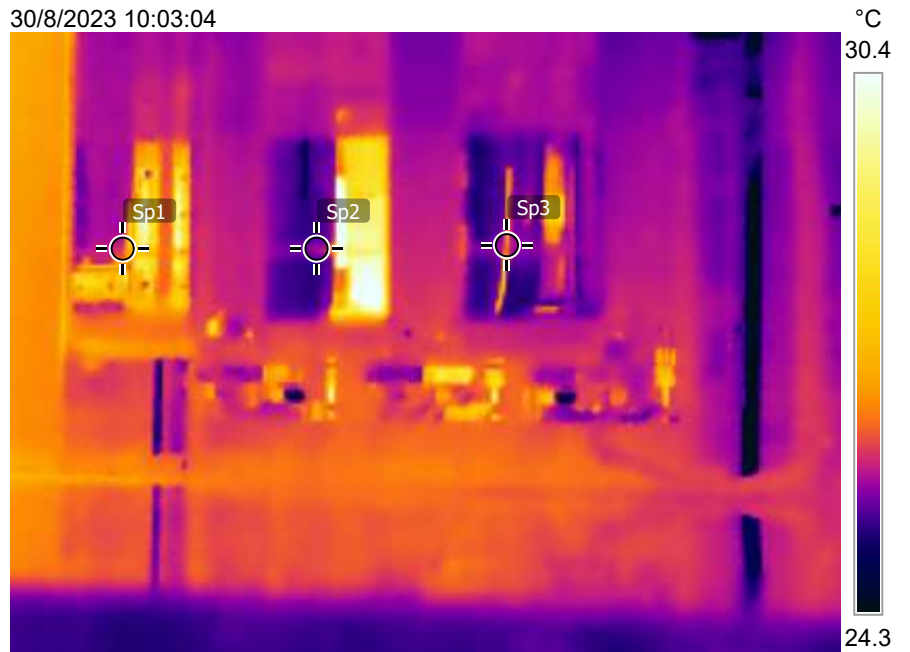
Location :	MDB Room FI.3
Equipment :	MDB.2 Panel
Detail :	ACB MCC.AC3 1,250 A.
Comment :	Normal operation , Not found hotspot
	Should also keep for your future reference

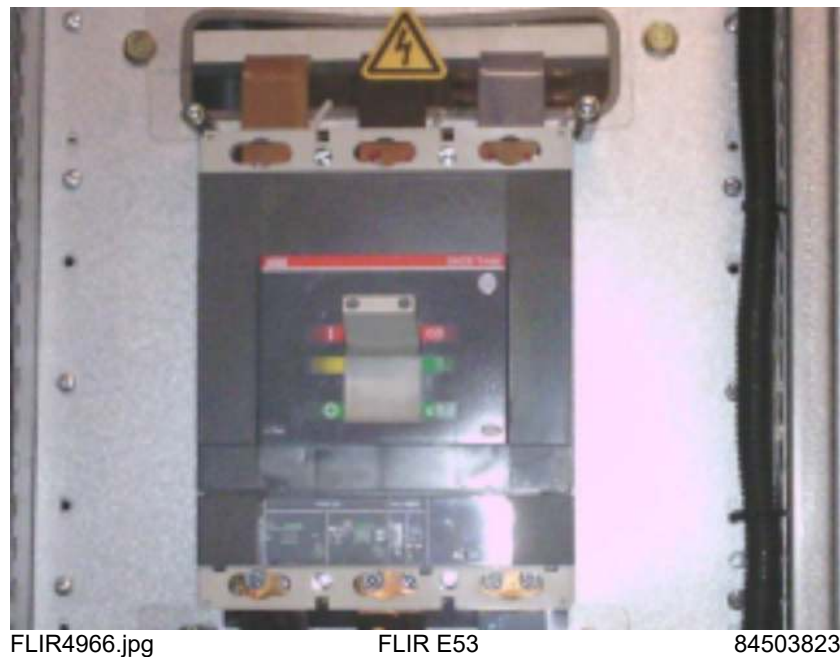
30/8/2023 10:03:58

Location :	MDB Room FI.3
Equipment :	MDB.2 Panel
Detail :	MCCB FOR EVEN FLOOR
Comment :	Normal operation , Not found hotspot
	Should also keep for your future reference

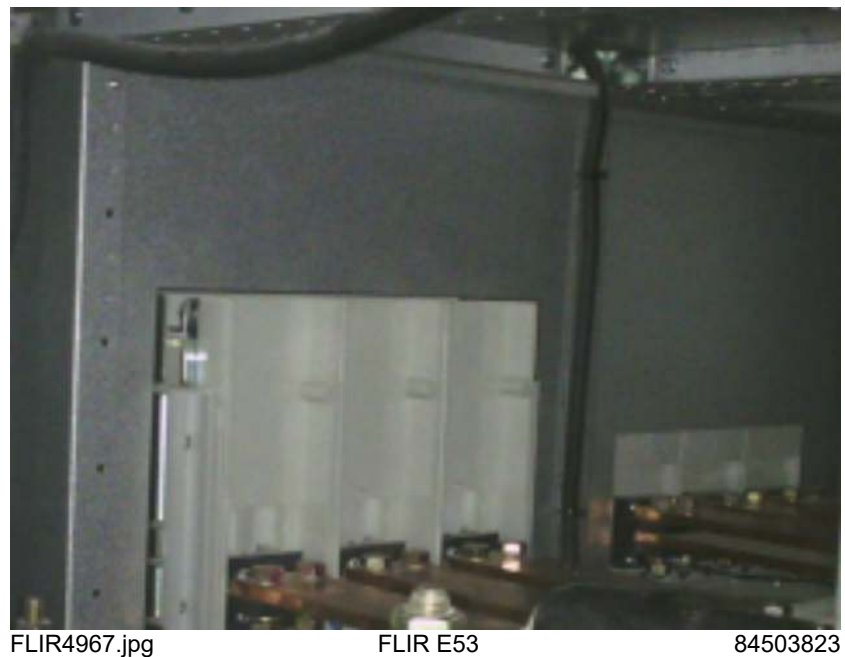
30/8/2023 10:05:22

Location :	MDB Room FI.3
Equipment :	EMDB Panel
Detail :	ACB MCC.EAC2 1,250 A.
Comment :	Normal operation , Not found hotspot
	Should also keep for your future reference

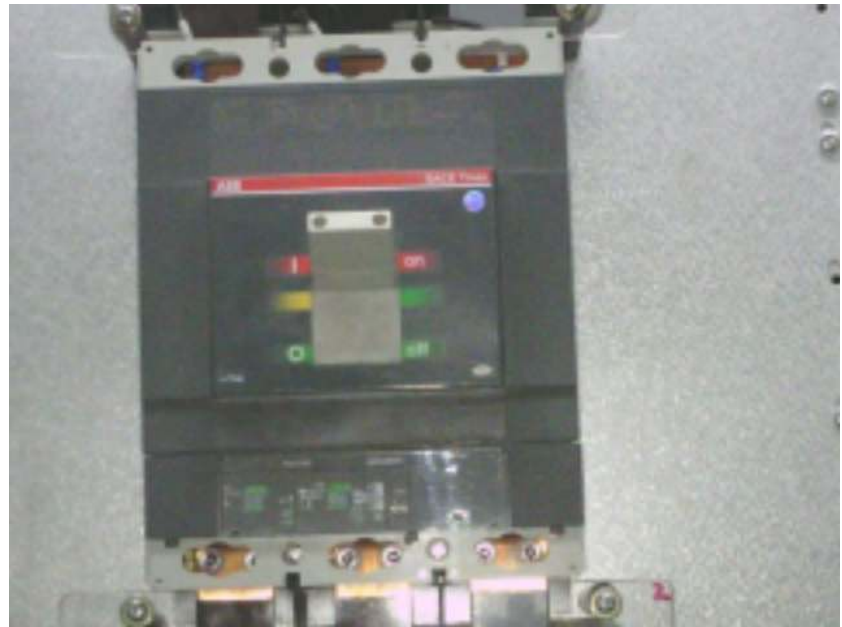
30/8/2023 10:22:18

Location :	Shaft Room FI.M
Equipment :	DB.G Panel
Detail :	MCCB Main
Comment :	Normal operation , Not found hotspot
	Should also keep for your future reference

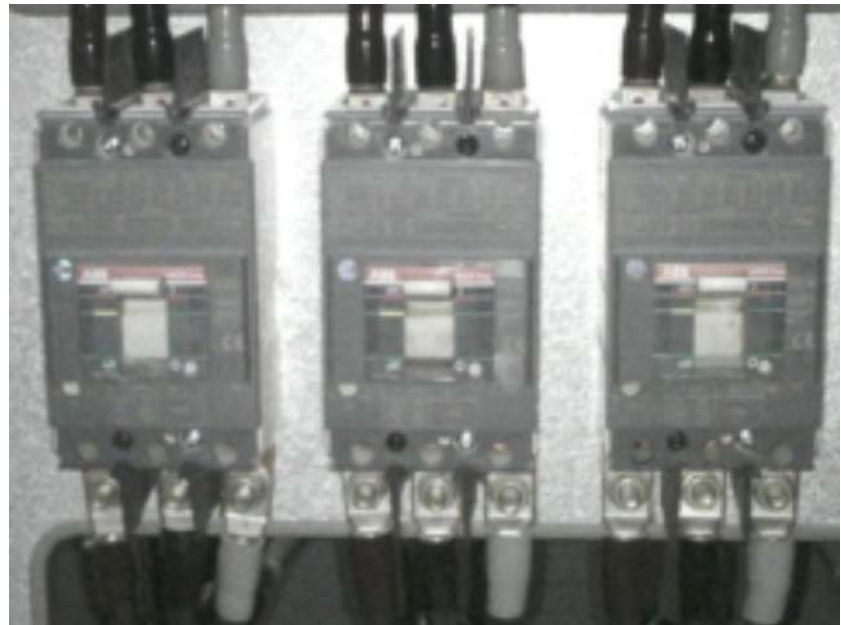
30/8/2023 10:22:34

Location :	Shaft Room FI.M
Equipment :	DB.G Panel
Detail :	MCCB LCG3
Comment :	Normal operation , Not found hotspot
	Should also keep for your future reference

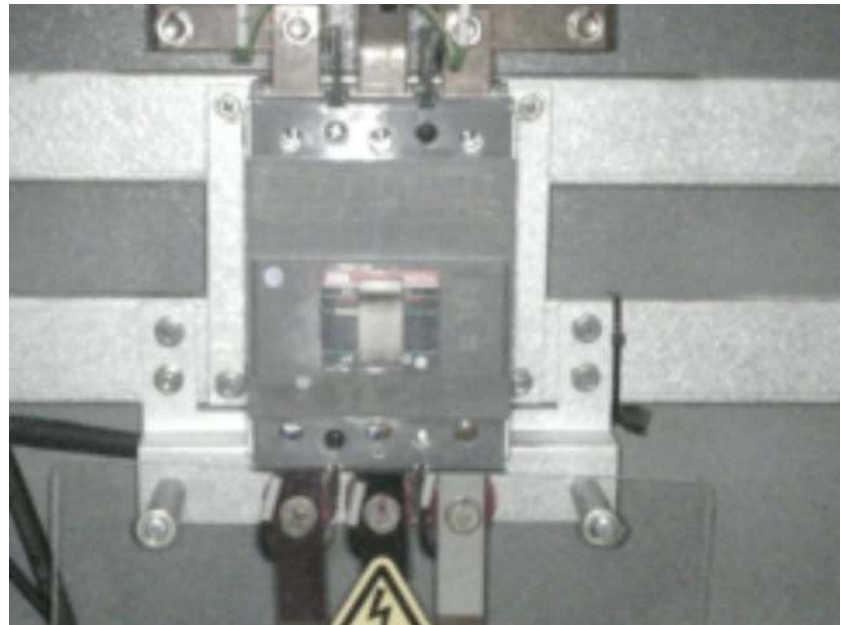
30/8/2023 10:22:43

Location :	Shaft Room FI.M
Equipment :	DB.EG Panel
Detail :	MCCB Main
Comment :	Normal operation , Not found hotspot
	Should also keep for your future reference

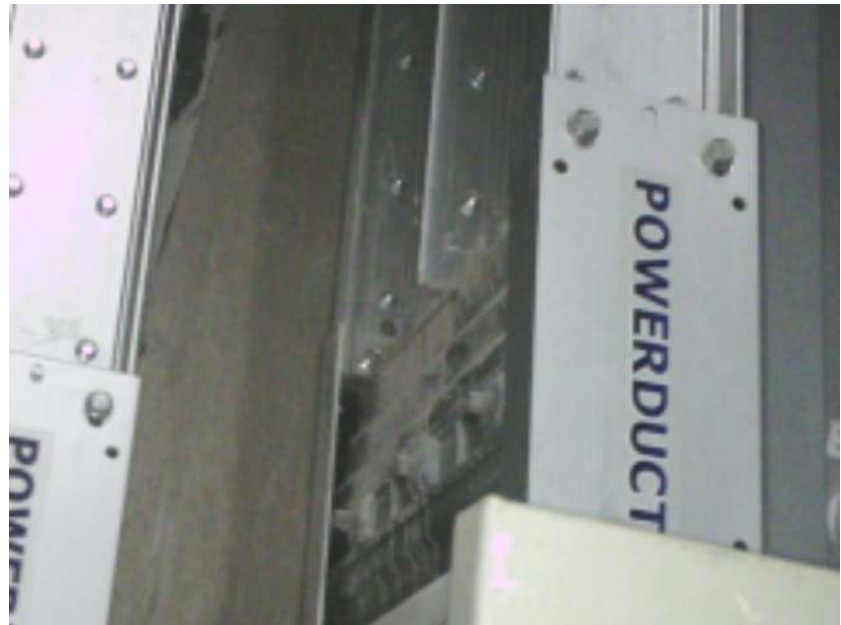
30/8/2023 11:16:18

Location :	Shaft Room FI.5
Equipment :	Busduct
Detail :	Joint Busduct
Comment :	Normal operation , Not found hotspot
	Should also keep for your future reference

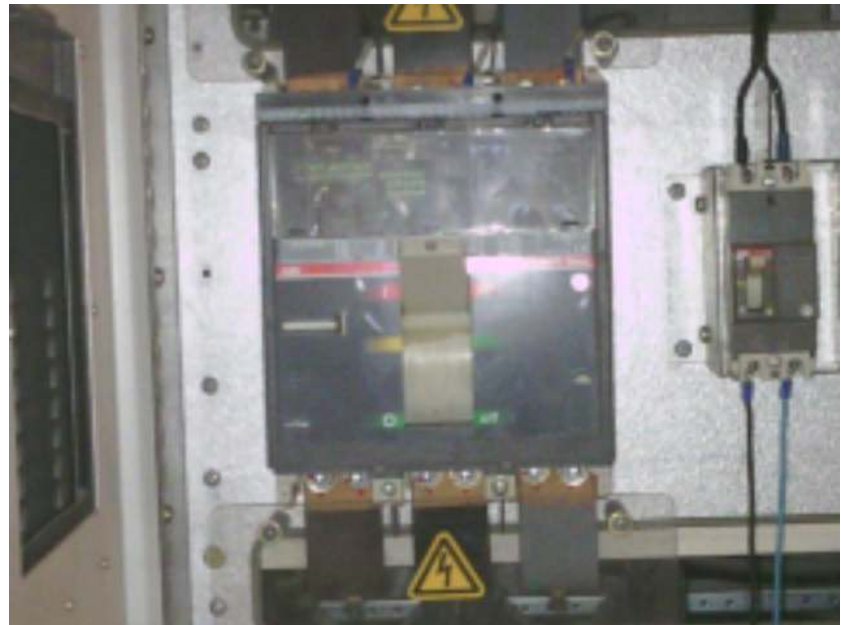
30/8/2023 11:19:45

Location :	Chiller Room FI.4
Equipment :	MCC.AC2 Panel
Detail :	MCCB CH-2
Comment :	Normal operation , Not found hotspot
	Should also keep for your future reference

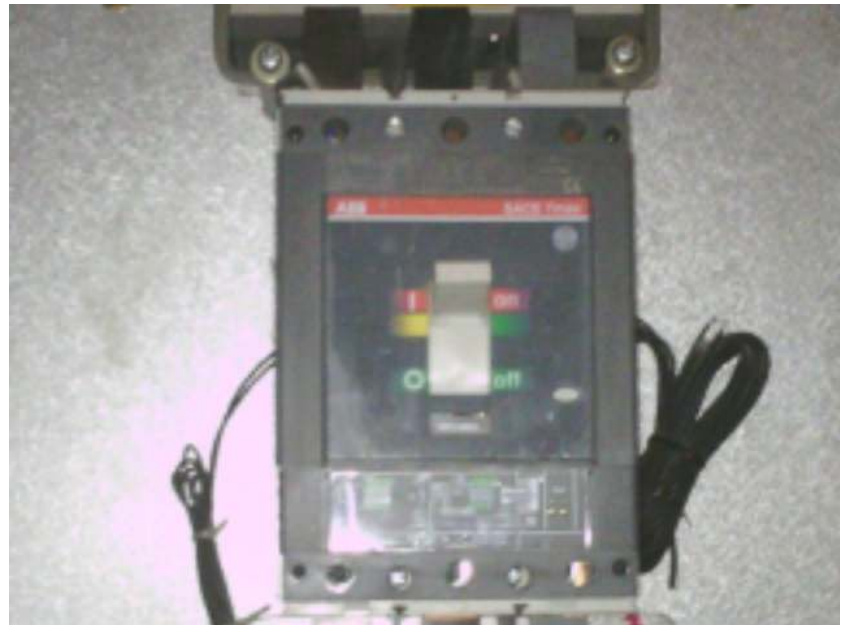
30/8/2023 11:21:36

Location :	Shaft Room FI.4
Equipment :	DB.4 Panel
Detail :	MCCB Main
Comment :	Normal operation , Not found hotspot
	Should also keep for your future reference

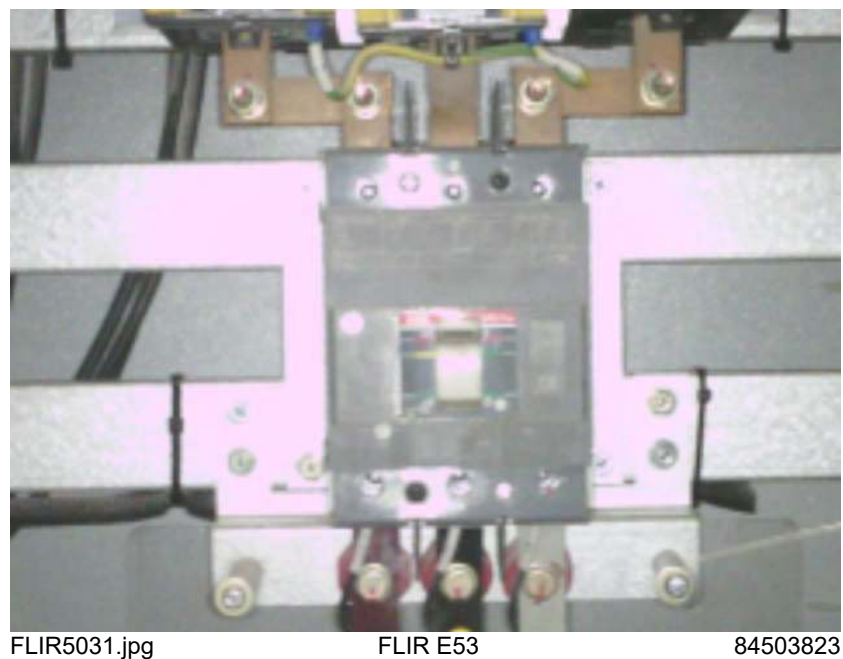
30/8/2023 11:22:15

Location :	Shaft Room FI.4
Equipment :	DB.E4 Panel
Detail :	MCCB Main
Comment :	Normal operation , Not found hotspot
	Should also keep for your future reference

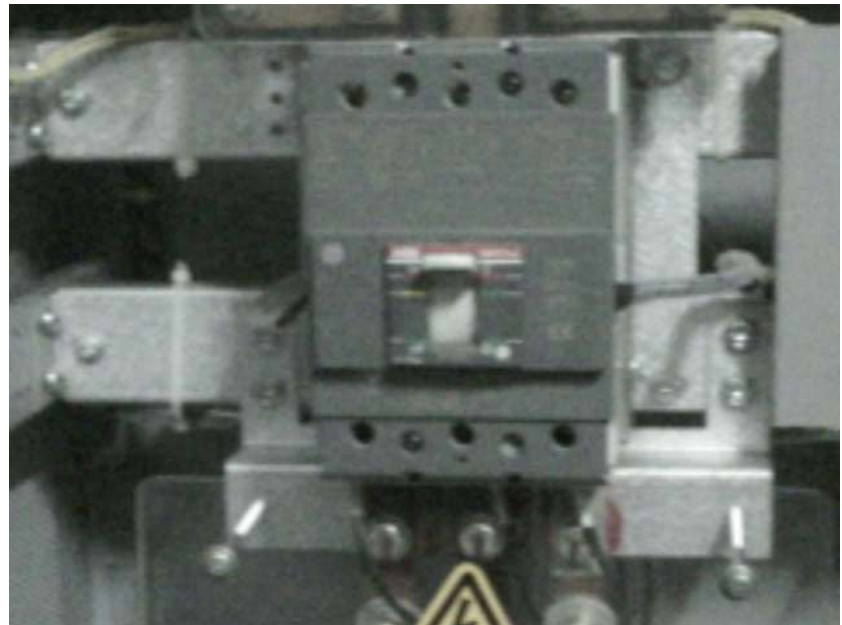
30/8/2023 10:32:45

Location :	Shaft Room FI.29
Equipment :	SDPK 28 Panel
Detail :	MCCB Main
Comment :	Normal operation , Not found hotspot
	Should also keep for your future reference

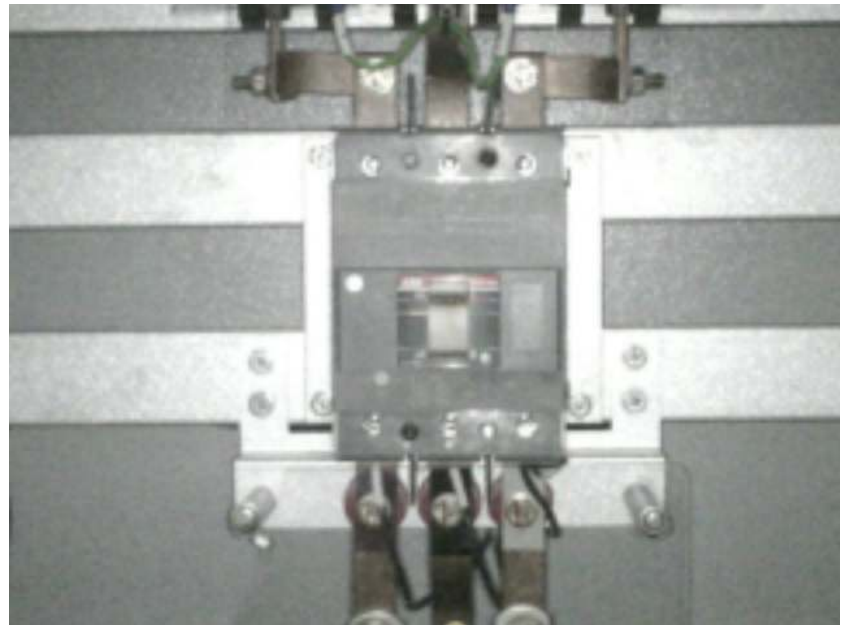
30/8/2023 10:32:59

Location :	Shaft Room FI.29
Equipment :	DB.28 Panel
Detail :	MCCB Main
Comment :	Normal operation , Not found hotspot
	Should also keep for your future reference

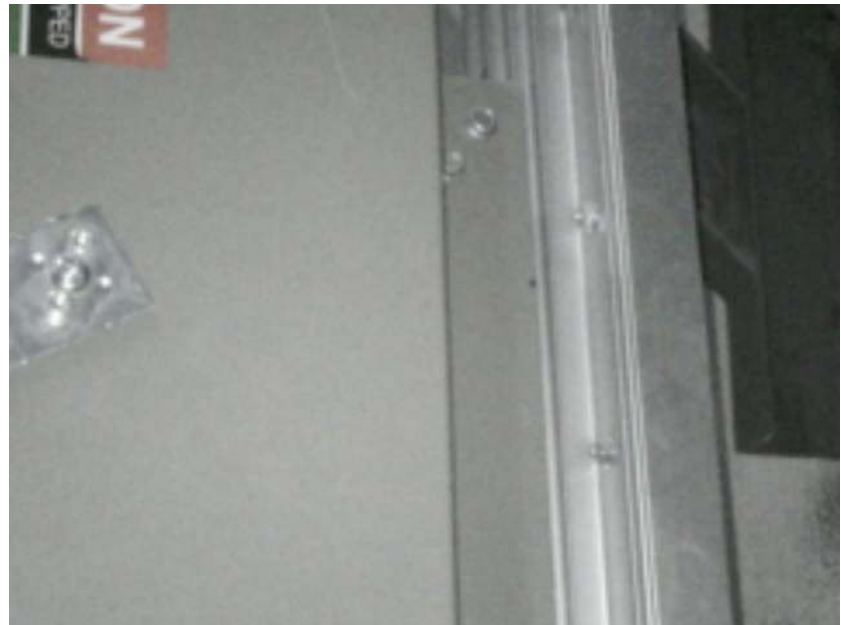
30/8/2023 10:33:10

Location :	Shaft Room FI.29
Equipment :	Plugin Unit RUN1
Detail :	Connection
Comment :	Normal operation , Not found hotspot
	Should also keep for your future reference

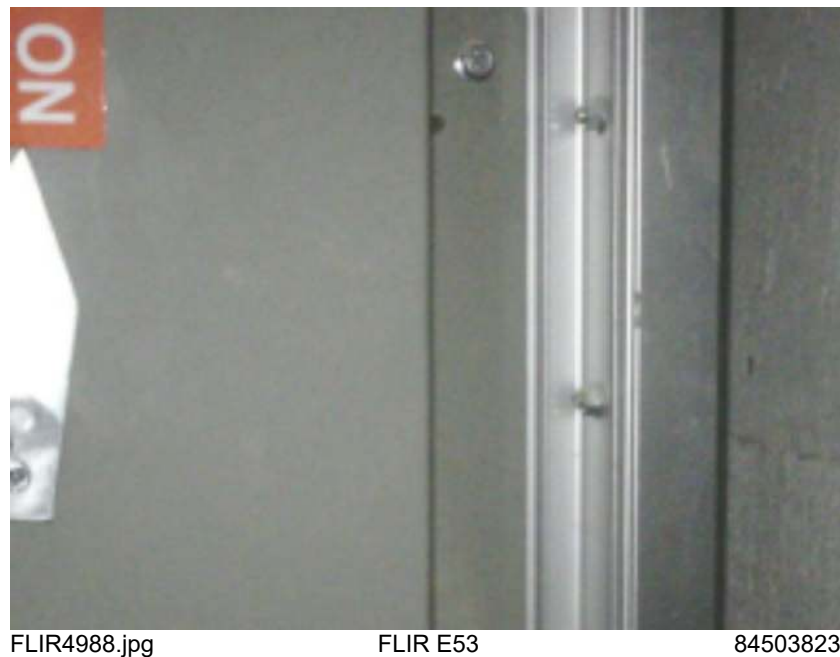
30/8/2023 10:33:22

Location :	Shaft Room FI.29
Equipment :	Plugin Unit
Detail :	Connection
Comment :	Normal operation , Not found hotspot
	Should also keep for your future reference

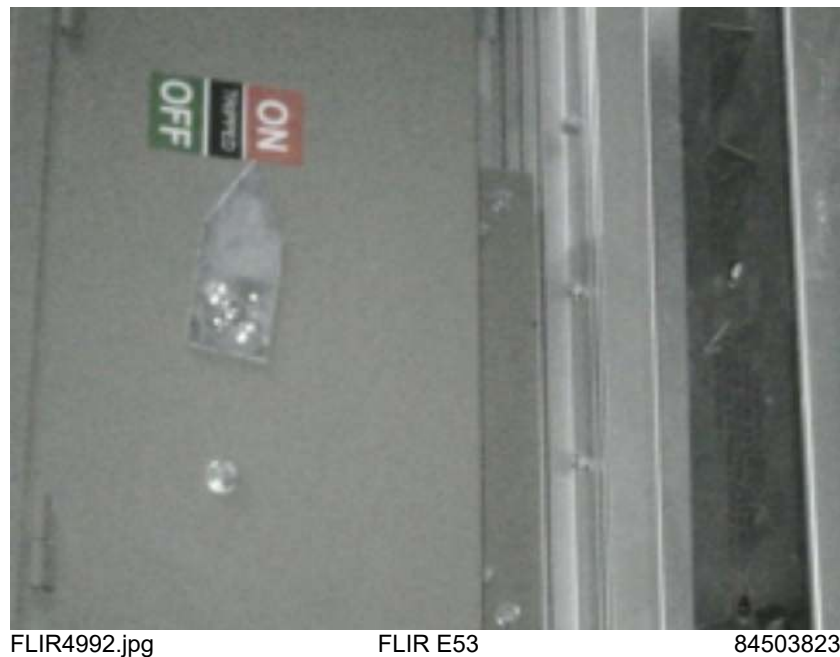
30/8/2023 10:43:12

Location :	Shaft Room FI.28
Equipment :	Plugin Unit
Detail :	Connection
Comment :	Normal operation , Not found hotspot
	Should also keep for your future reference

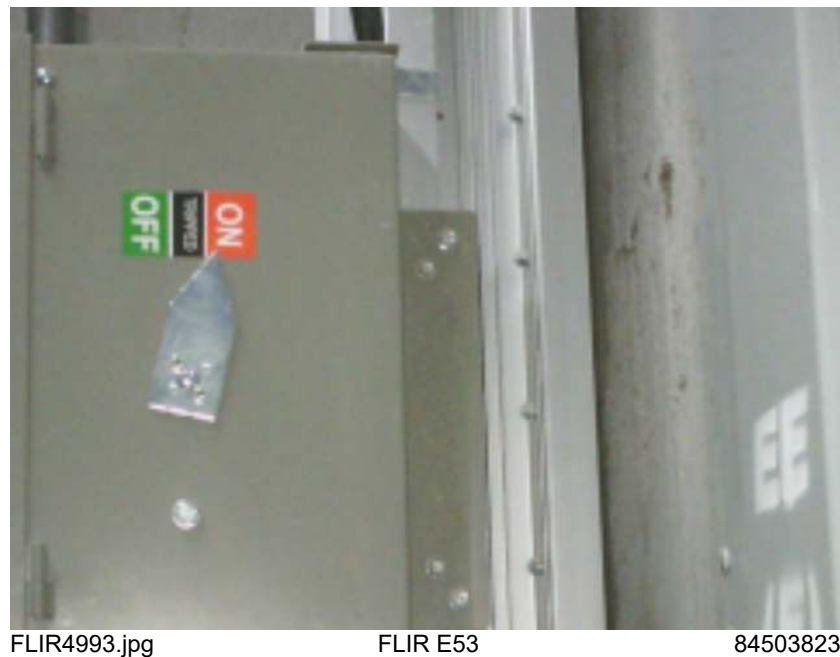
30/8/2023 10:46:05

Location :	Shaft Room FI.27
Equipment :	Plugin Unit
Detail :	Connection
Comment :	Normal operation , Not found hotspot
	Should also keep for your future reference

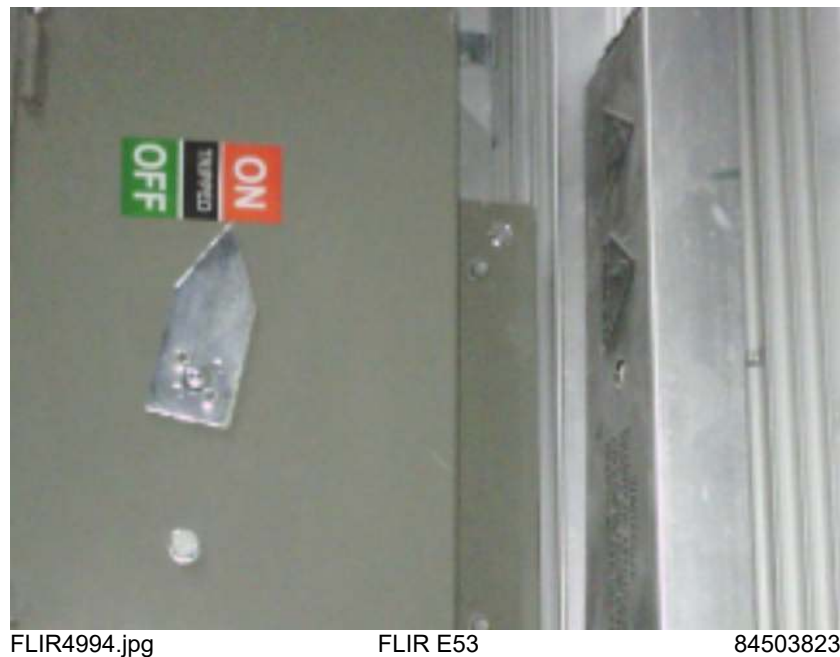
30/8/2023 10:46:50

Location :	Shaft Room FI.26
Equipment :	Plugin Unit
Detail :	Connection
Comment :	Normal operation , Not found hotspot
	Should also keep for your future reference

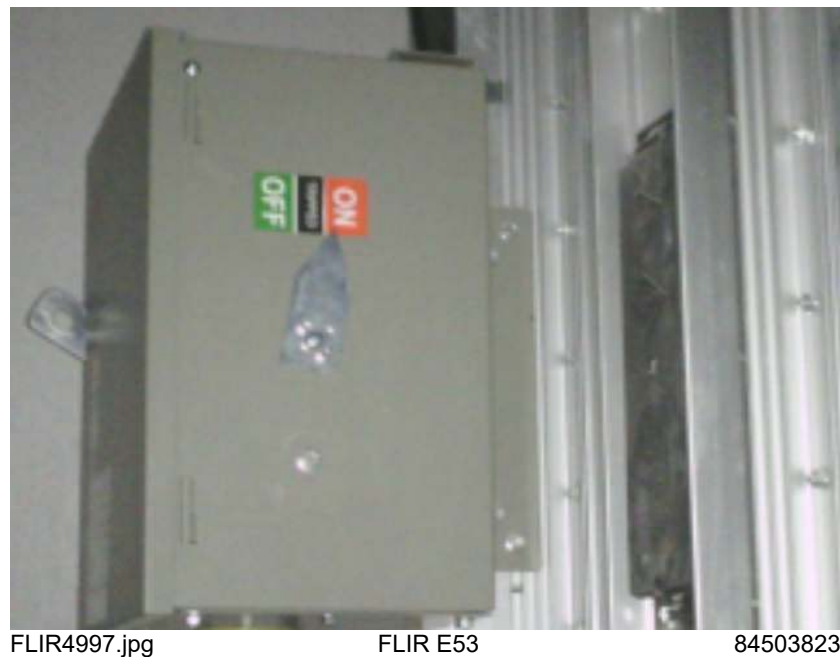
30/8/2023 10:48:31

Location :	Shaft Room FI.24
Equipment :	Plugin Unit
Detail :	Connection
Comment :	Normal operation , Not found hotspot
	Should also keep for your future reference

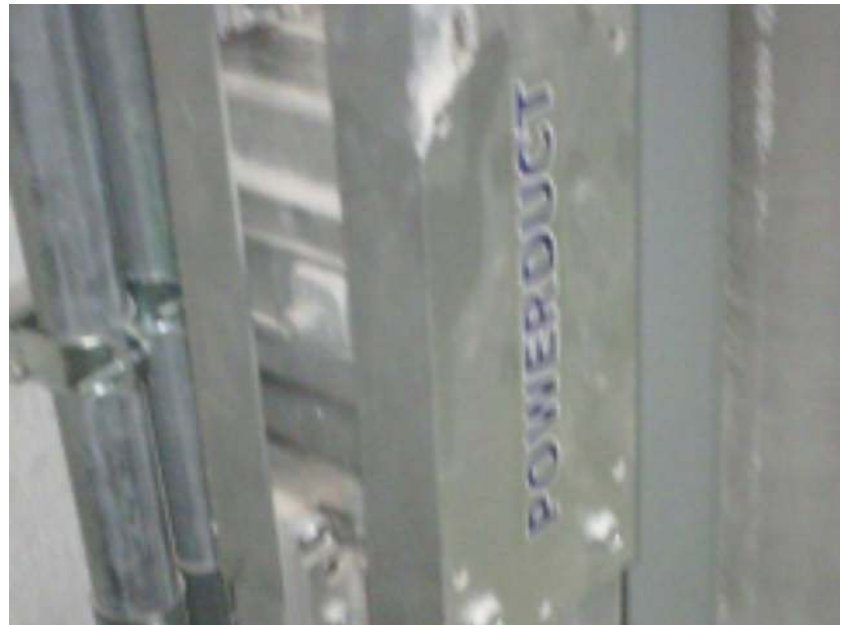
30/8/2023 10:49:26

Location :	Shaft Room FI.23
Equipment :	Busduct
Detail :	Joint Busduct
Comment :	Normal operation , Not found hotspot
	Should also keep for your future reference

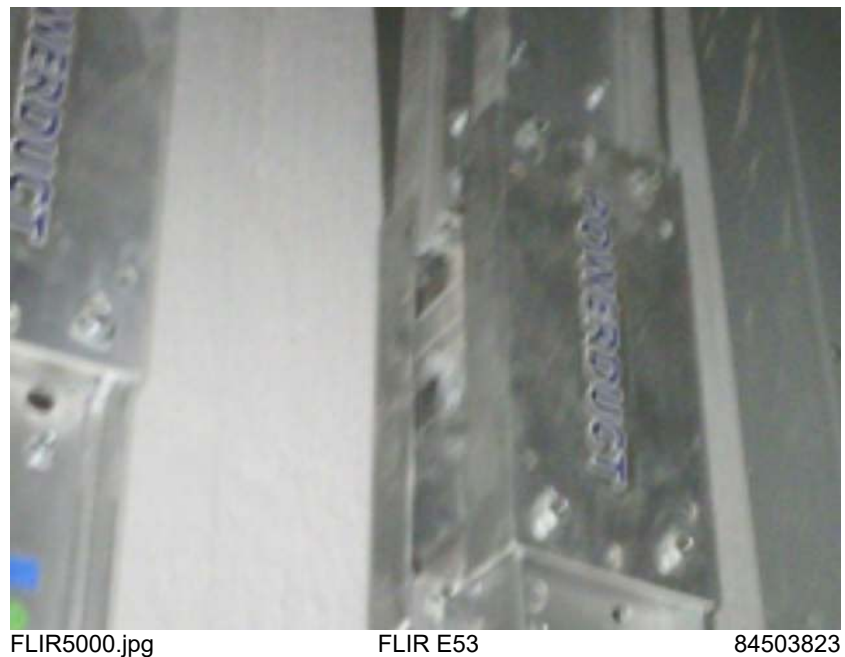
30/8/2023 10:50:31

Location :	Shaft Room FI.22
Equipment :	Busduct
Detail :	Joint Busduct
Comment :	Normal operation , Not found hotspot
	Should also keep for your future reference

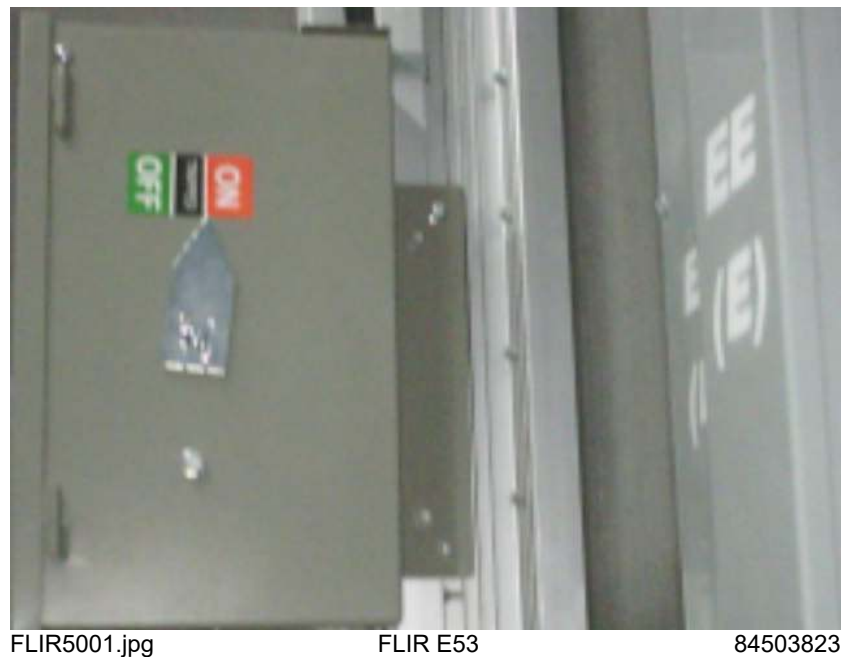
30/8/2023 10:51:12

Location :	Shaft Room FI.21
Equipment :	Plugin Unit
Detail :	Connection
Comment :	Normal operation , Not found hotspot
	Should also keep for your future reference

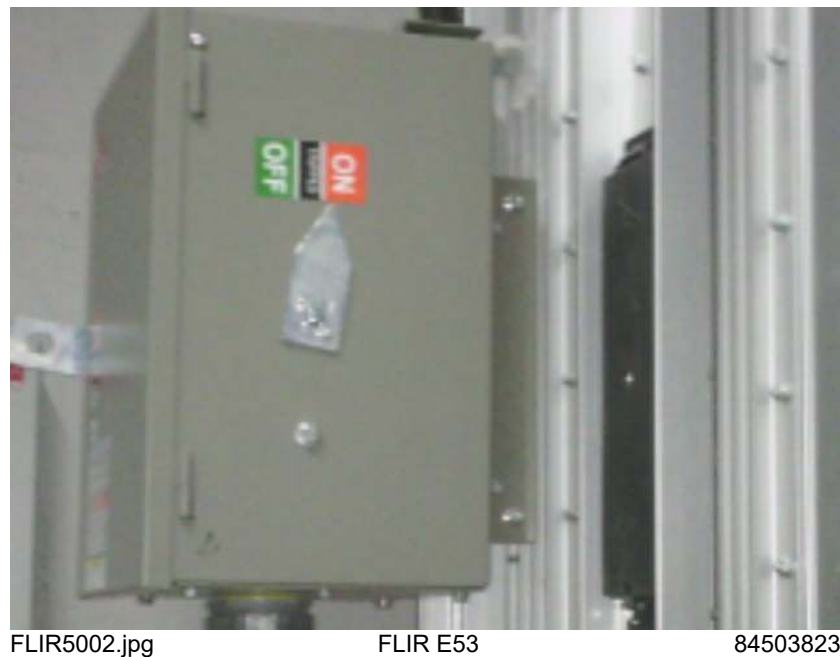
30/8/2023 10:51:56

Location :	Shaft Room FI.20
Equipment :	Plugin Unit
Detail :	Connection
Comment :	Normal operation , Not found hotspot
	Should also keep for your future reference
