รายงานการซ่อมบำรุงระบบไฟฟ้า

ใบรายงานการตรวจเช็คเครื่องกำเนิดไฟฟ้า

Inspection date:	30/08/2023	
Report date:	3/09/2023	
Project :	Hyatt Regency Bangkok Sukhumvit	
Project Location:	Bangkok	
Type of Inspection:	Qualitative Electrical System	
Purpose of Inspection:	Maintenance IR Scan (After PM)	
Certified Thermographer:	Mr. Thirasak Nampor	
Certification Number:	Certificate Level-I No. 1-000929	
Equipment Used:	Flir E53	S/N : 84503823
No of thermograms :	78	
Comments:	The results of the examination. Measurement of electrical heat of electrical equipment according to plan of work. No defects are found that cause damage and do not cause harm to the use and maintenance of electrical equipment should be maintained in good condition.

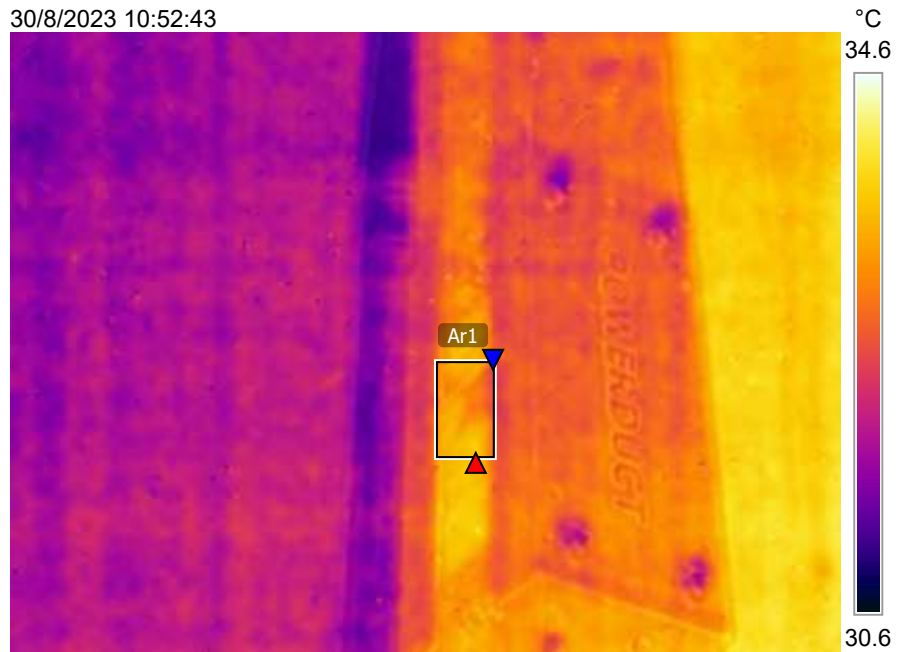
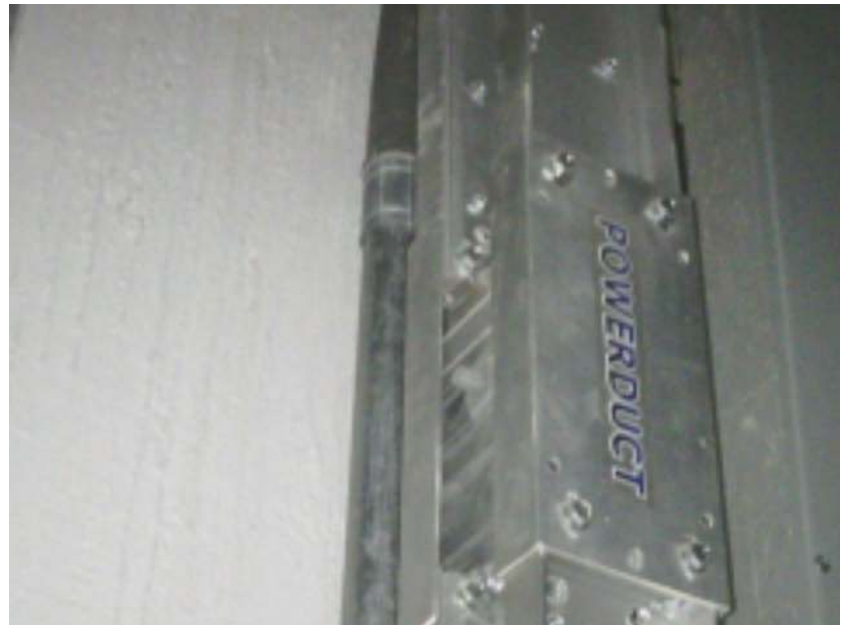
FLIR5003.jpg

Location :	Shaft Room Fl.19
Equipment :	Busduct
Detail :	Joint Busduct
Comment :	Normal operation , Not found hotspot
	Should also keep for your future reference

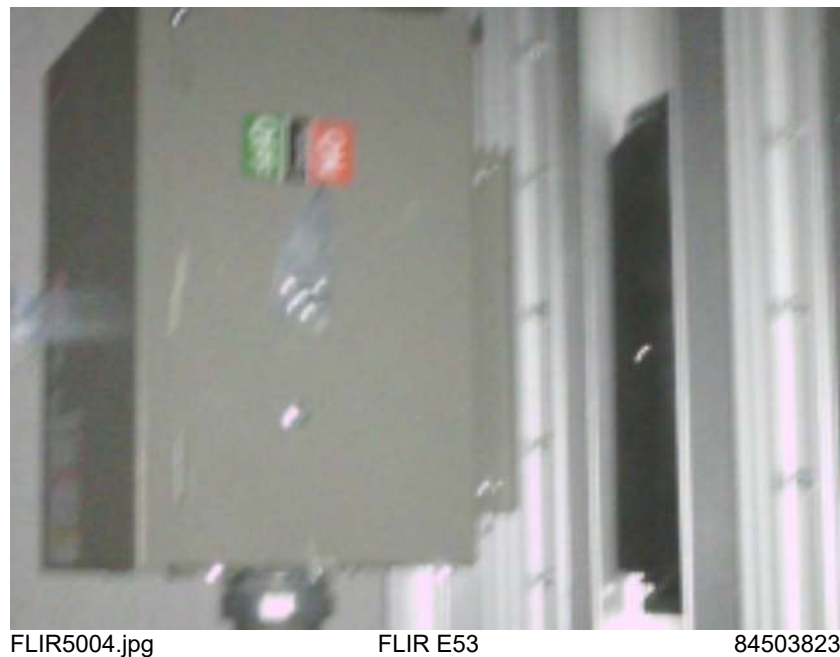
30/8/2023 10:53:47

Location :	Shaft Room Fl.18
Equipment :	Plugin Unit
Detail :	Connection
Comment :	Normal operation , Not found hotspot
	Should also keep for your future reference

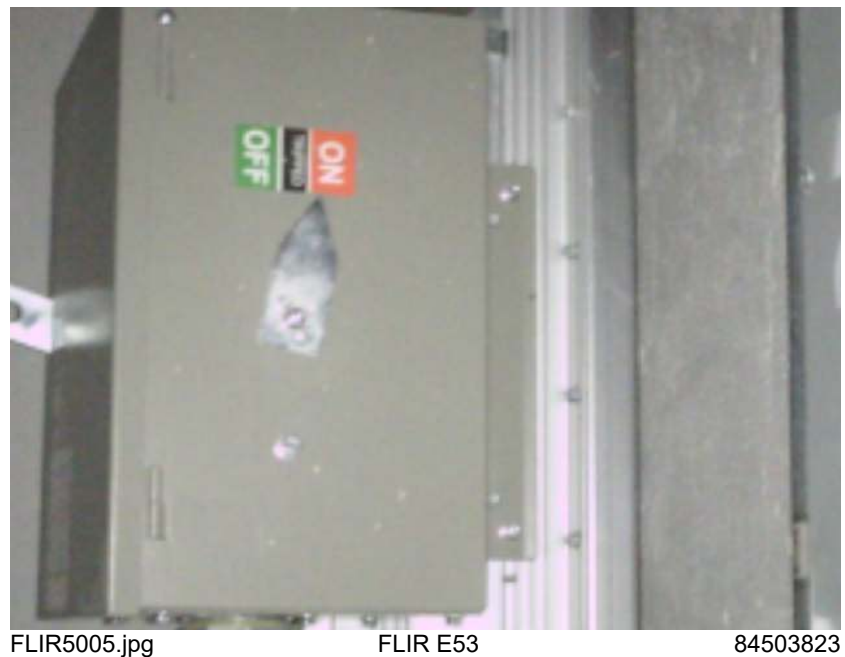
30/8/2023 10:54:33

Location :	Shaft Room Fl.17
Equipment :	Plugin Unit
Detail :	Connection
Comment :	Normal operation , Not found hotspot
	Should also keep for your future reference

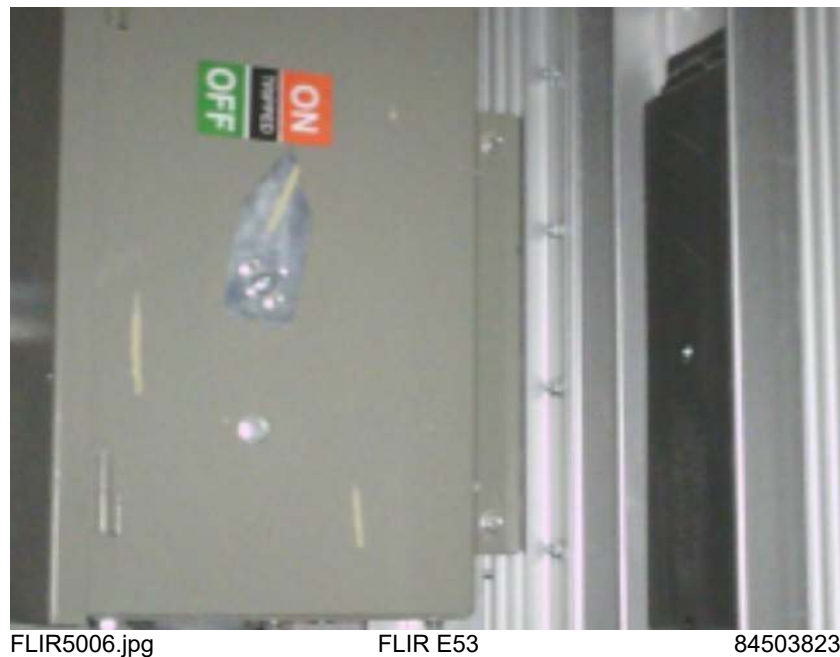
30/8/2023 10:55:12

Location :	Shaft Room Fl.16
Equipment :	Plugin Unit
Detail :	Connection
Comment :	Normal operation , Not found hotspot
	Should also keep for your future reference

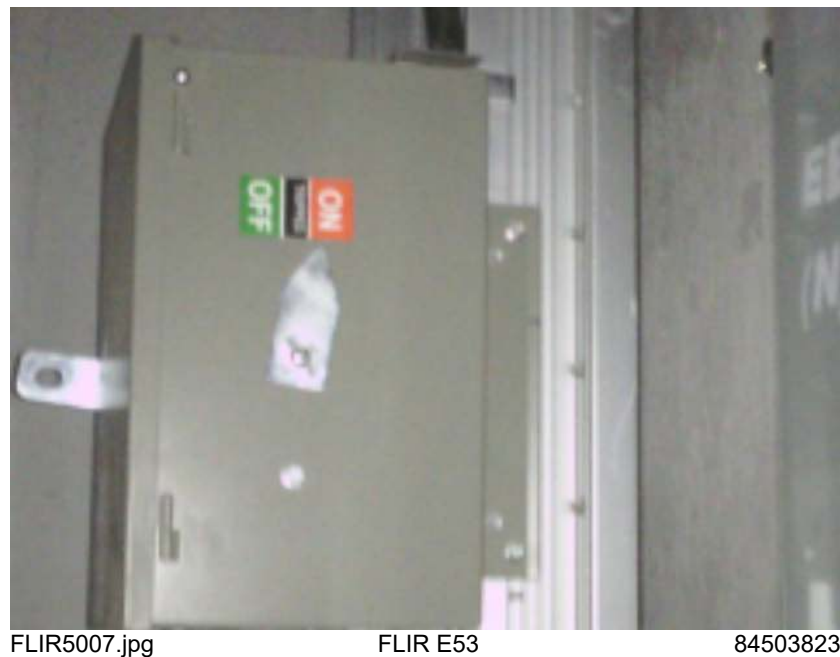
30/8/2023 10:55:56

Location :	Shaft Room Fl.15
Equipment :	Plugin Unit
Detail :	Connection
Comment :	Normal operation , Not found hotspot
	Should also keep for your future reference

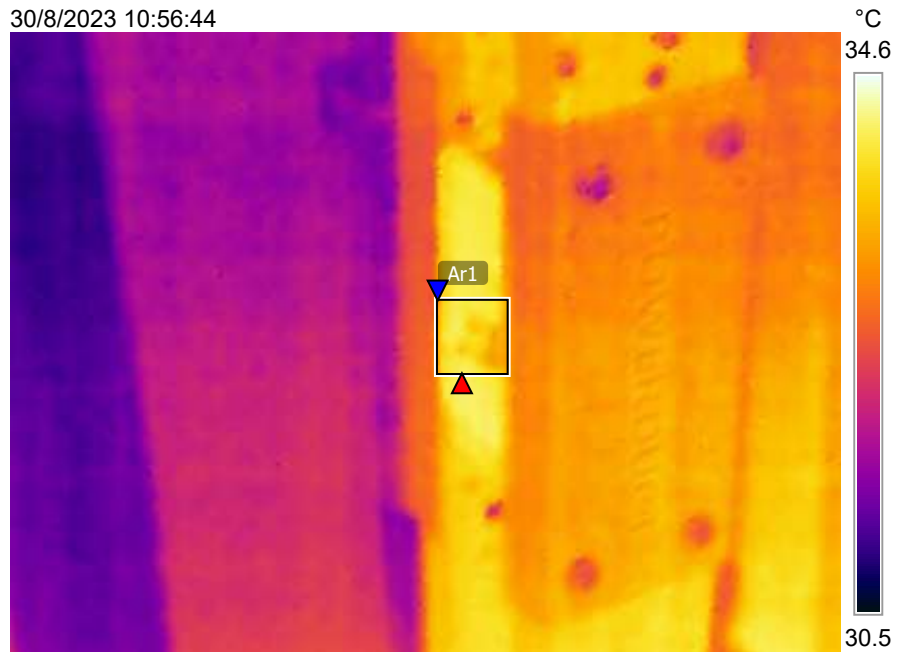
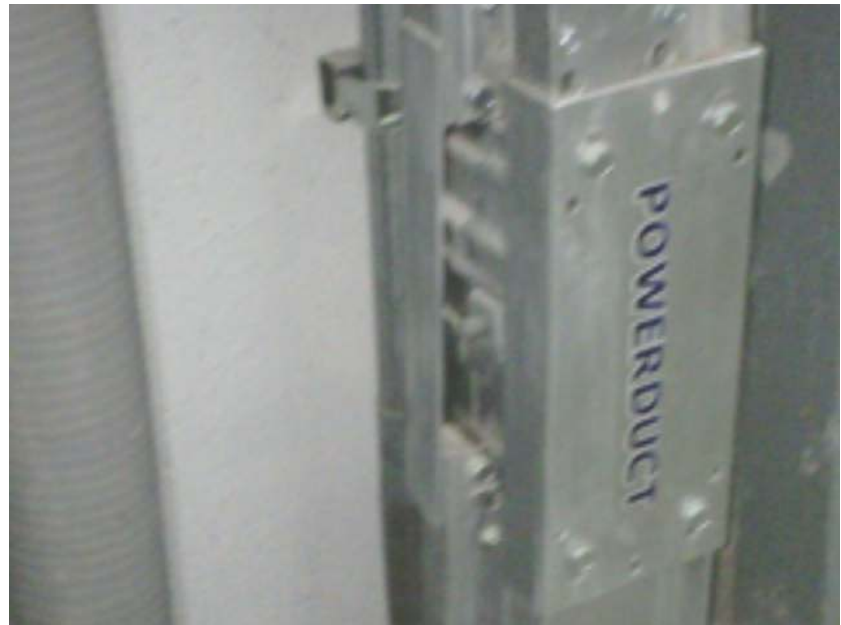
FLIR5008.jpg

Location :	Shaft Room Fl.14
Equipment :	Busduct
Detail :	Joint Busduct
Comment :	Normal operation , Not found hotspot
	Should also keep for your future reference

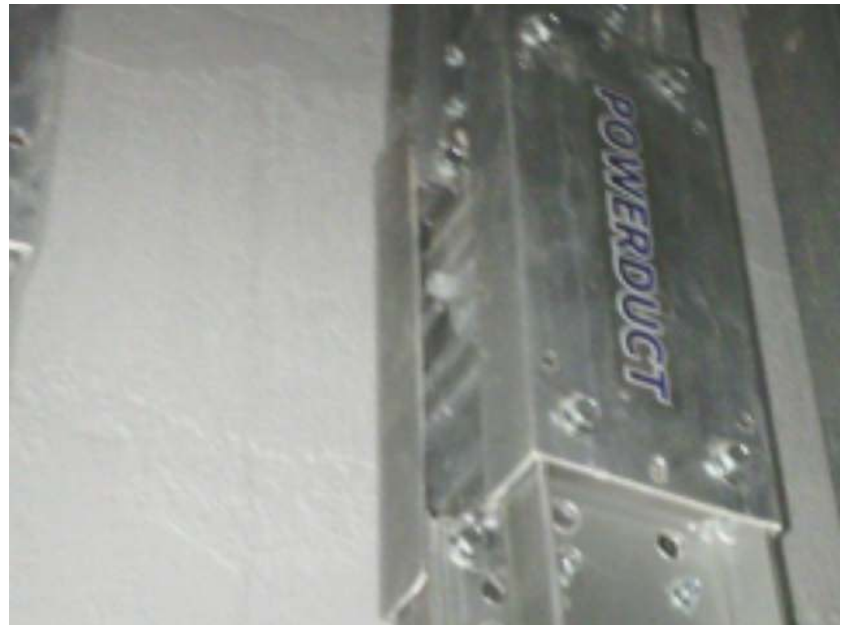
Location :	Shaft Room Fl.12
Equipment :	Busduct
Detail :	Joint Busduct
Comment :	Normal operation , Not found hotspot
	Should also keep for your future reference

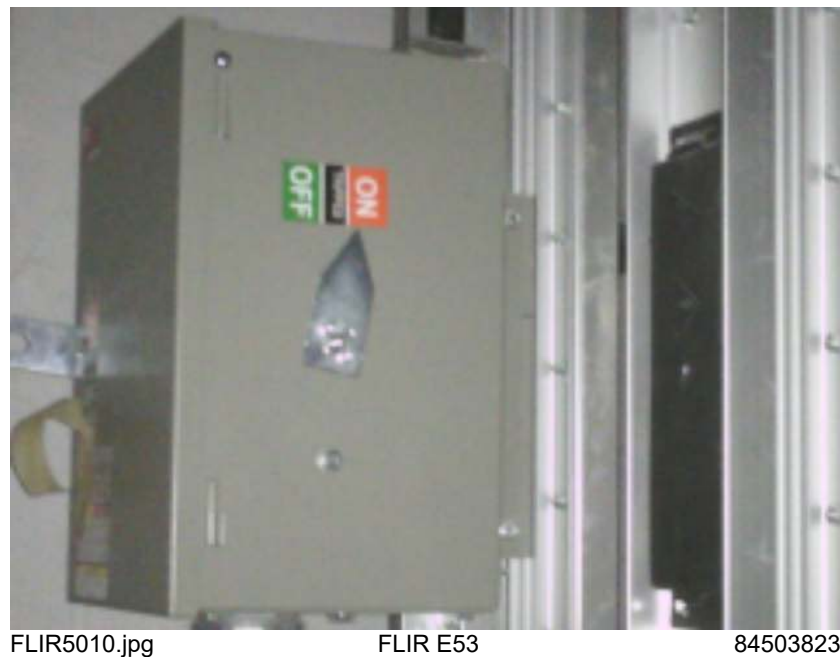
30/8/2023 10:58:17

Location :	Shaft Room Fl.11
Equipment :	Plugin Unit
Detail :	Connection
Comment :	Normal operation , Not found hotspot
	Should also keep for your future reference

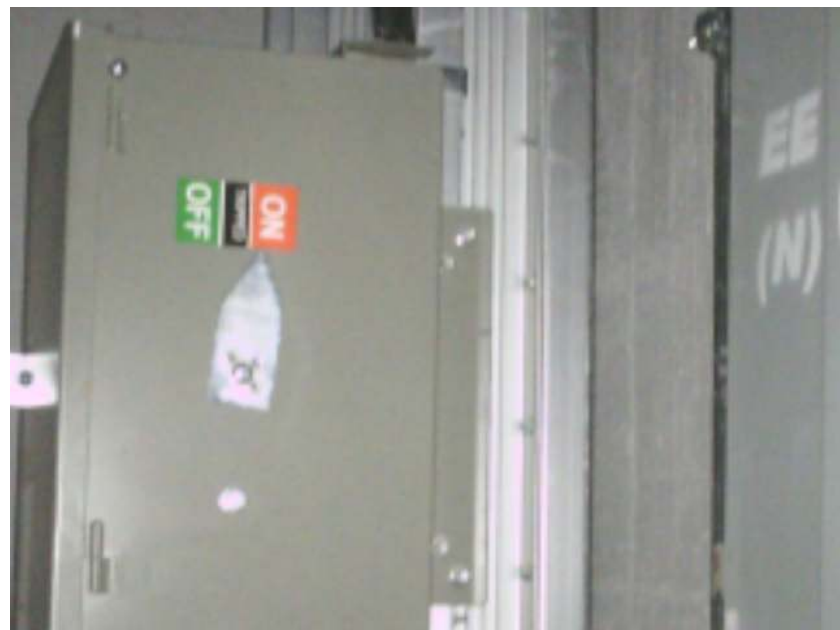
30/8/2023 10:58:58

Location :	Shaft Room FI.10
Equipment :	Plugin Unit
Detail :	Connection
Comment :	Normal operation , Not found hotspot
	Should also keep for your future reference

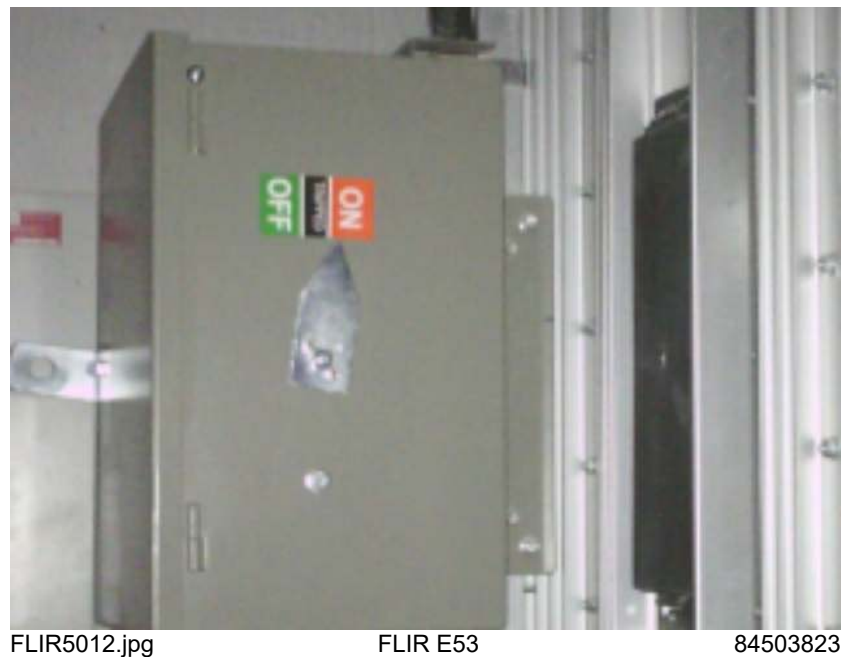
30/8/2023 11:00:06

Location :	Shaft Room FI.9
Equipment :	Plugin Unit
Detail :	Connection
Comment :	Normal operation , Not found hotspot
	Should also keep for your future reference

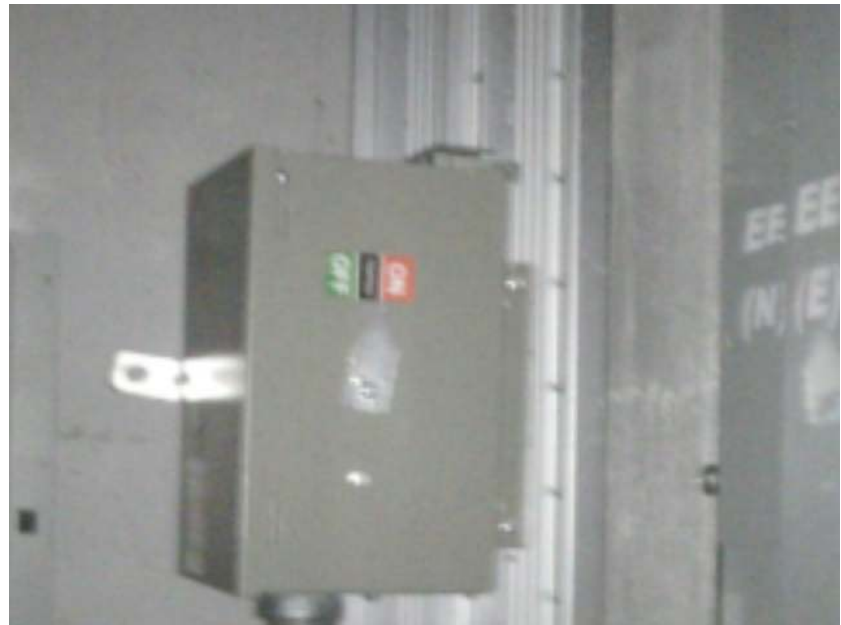
FLIR5013.jpg

Location :	Shaft Room FI.8
Equipment :	Plugin Unit
Detail :	Connection
Comment :	Normal operation , Not found hotspot
	Should also keep for your future reference

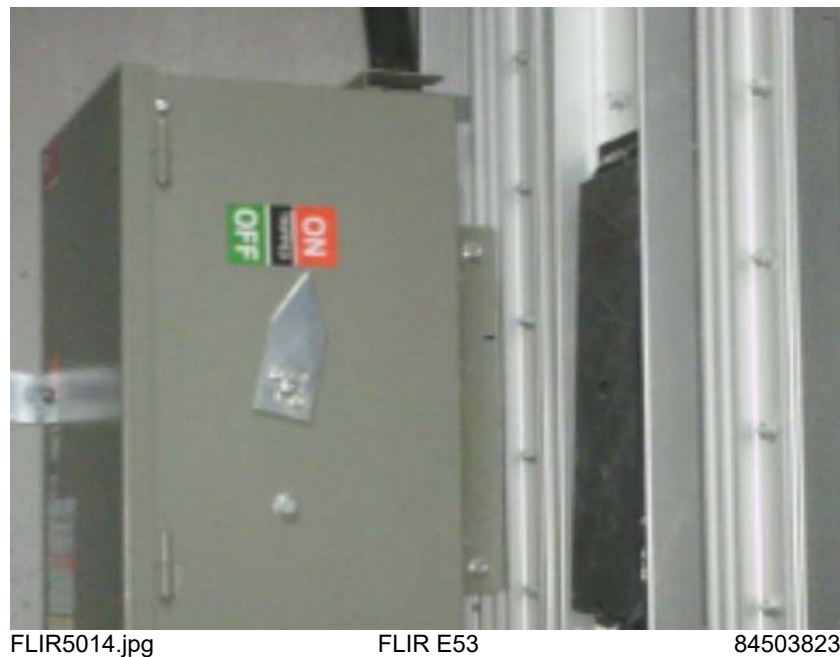
30/8/2023 11:05:08

Location :	Shaft Room FI.7
Equipment :	Plugin Unit
Detail :	Connection
Comment :	Normal operation , Not found hotspot
	Should also keep for your future reference

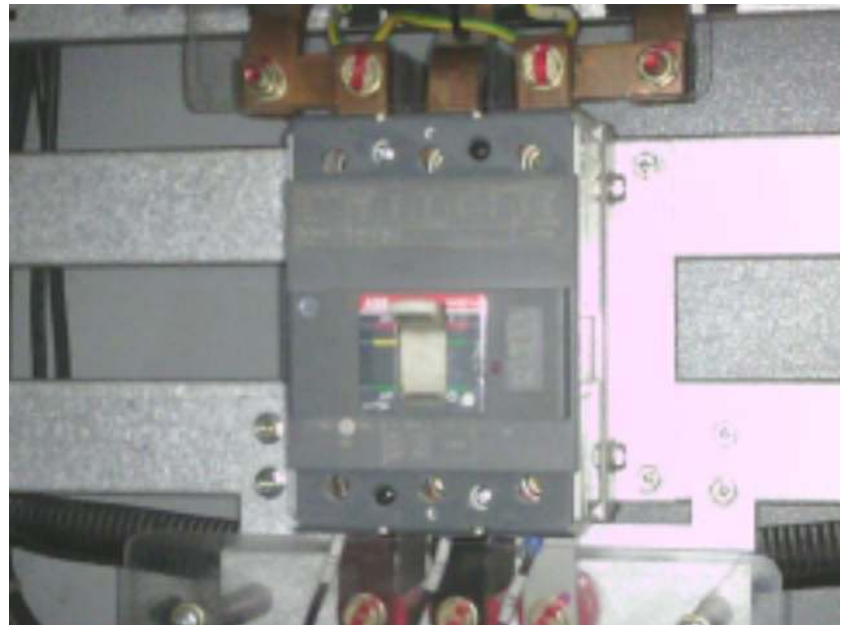
FLIR5015.jpg

Location :	Shaft Room FI.7
Equipment :	DB.E7 Panel
Detail :	MCCB Main
Comment :	Normal operation , Not found hotspot
	Should also keep for your future reference

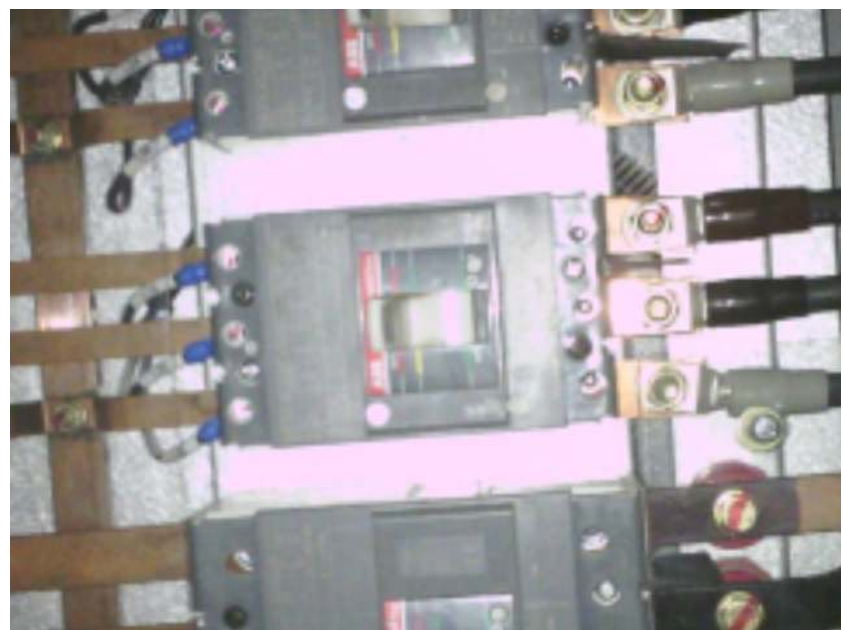
30/8/2023 11:11:31

Location :	Shaft Room FI.6
Equipment :	DB.6 Panel
Detail :	MCCB LC-62
Comment :	Normal operation , Not found hotspot
	Should also keep for your future reference

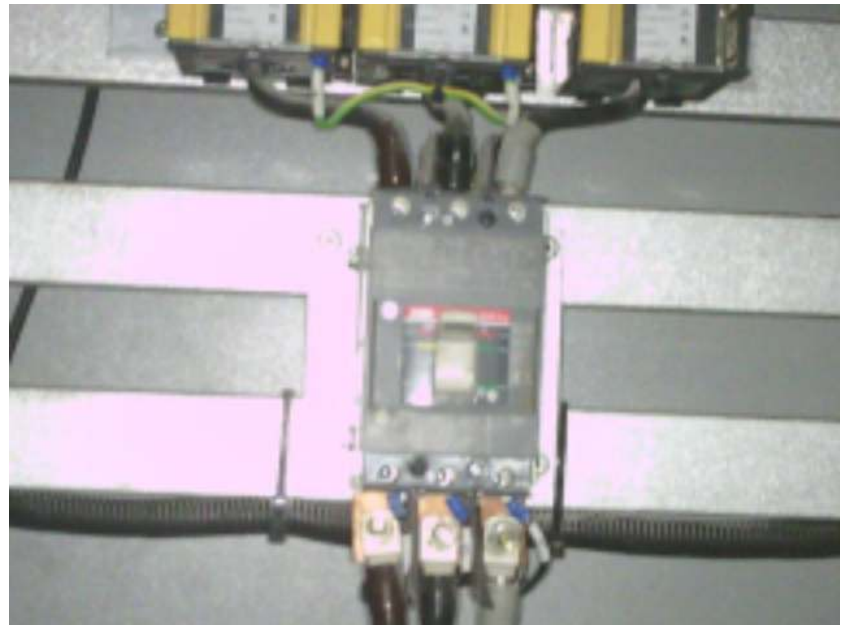
30/8/2023 11:11:59

Location :	Shaft Room FI.6
Equipment :	DB.E6 Panel
Detail :	MCCB Main
Comment :	Normal operation , Not found hotspot
	Should also keep for your future reference

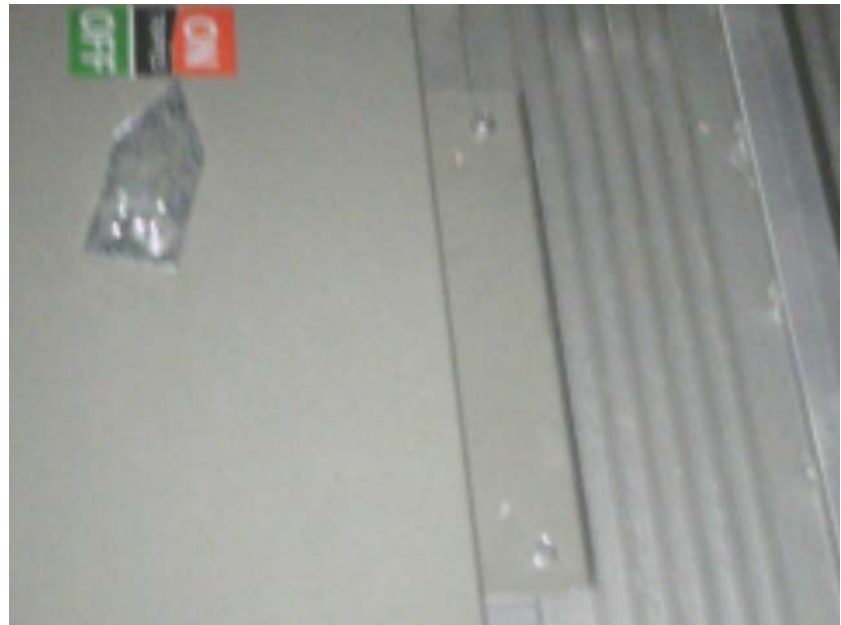
Location :	Shaft Room FI.6
Equipment :	Plugin Unit
Detail :	Connection
Comment :	Normal operation , Not found hotspot
	Should also keep for your future reference

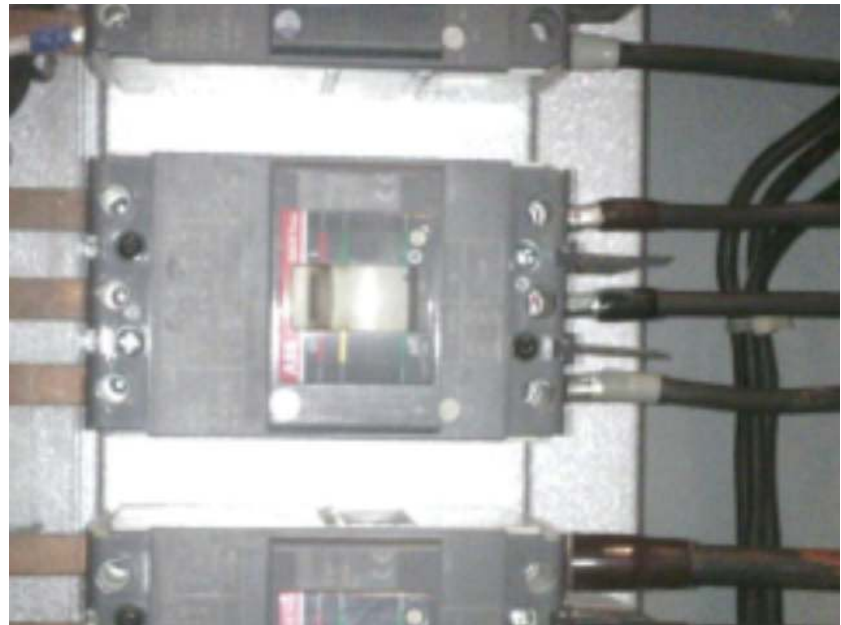
Location :	Shaft Room FI.3
Equipment :	DB.3 Panel
Detail :	MCCB LC-33
Comment :	Normal operation , Not found hotspot
	Should also keep for your future reference

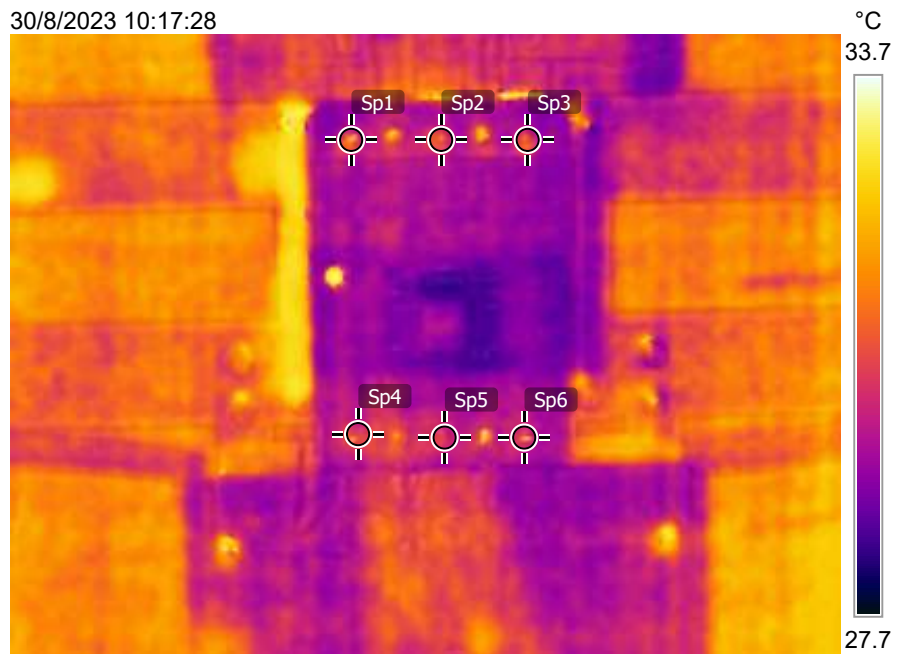
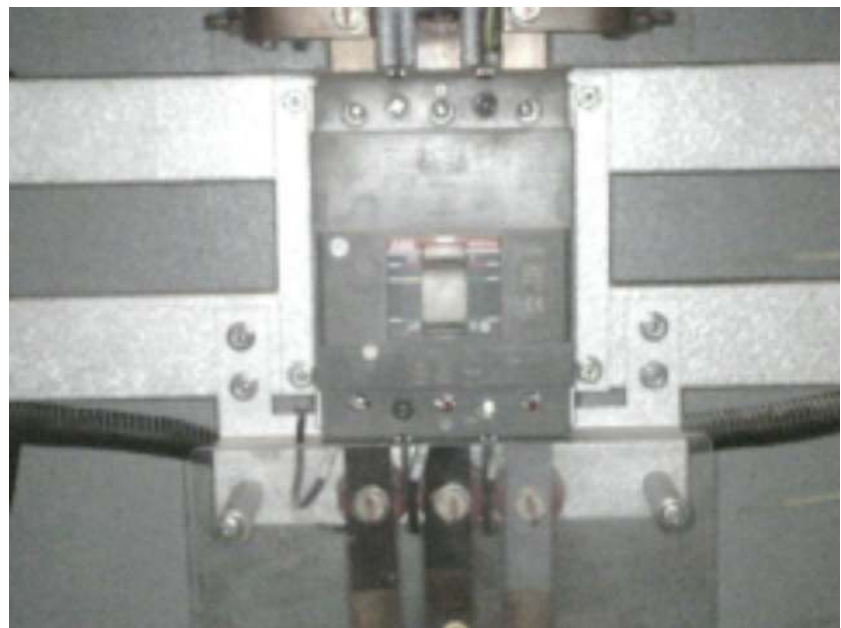
FLIR4974.jpg

Location :	Shaft Room FI.3
Equipment :	DB.E3 Panel
Detail :	MCCB Main
Comment :	Normal operation , Not found hotspot
	Should also keep for your future reference

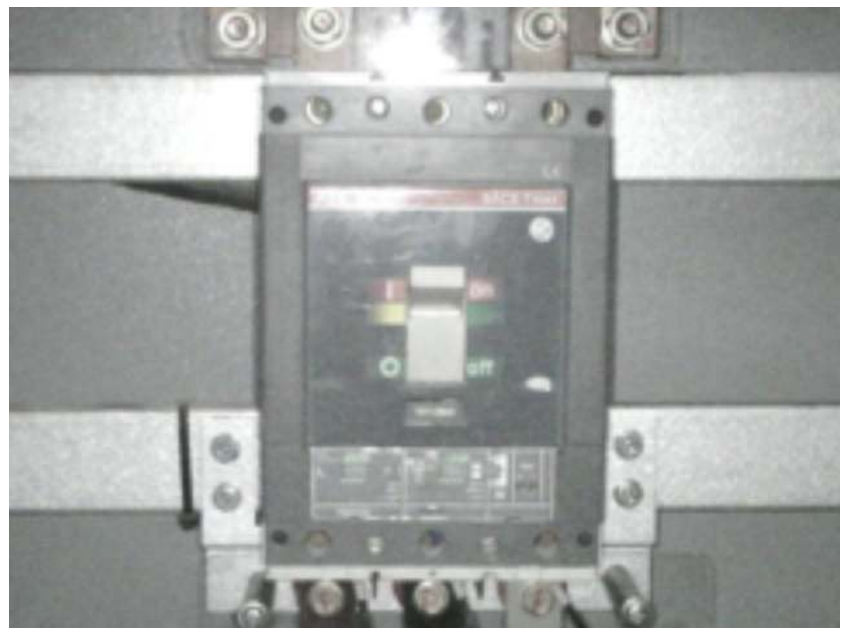
FLIR4976.jpg

Location :	Shaft Room Fl.2
Equipment :	DB.2 Panel
Detail :	MCCB Main
Comment :	Normal operation , Not found hotspot
	Should also keep for your future reference

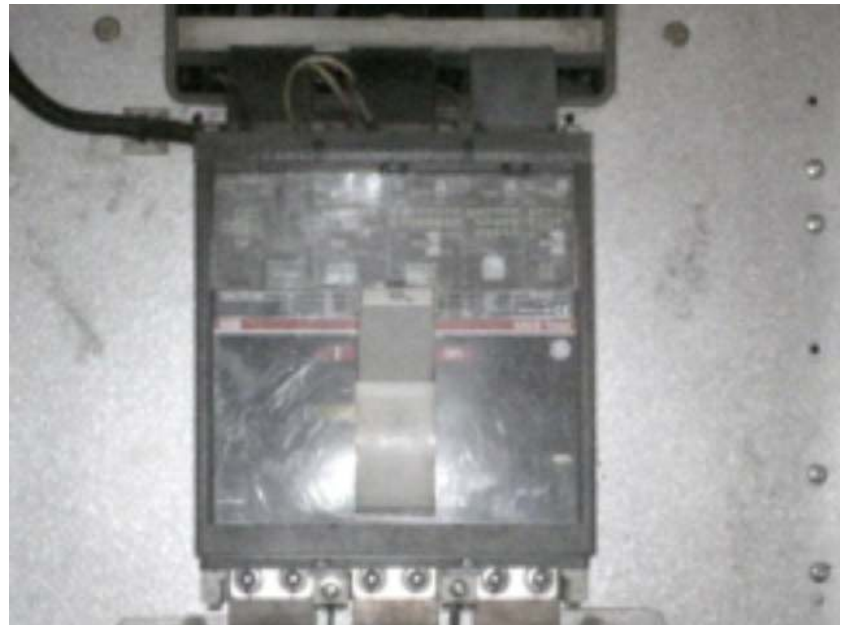
30/8/2023 10:26:44

Location :	Shaft Room FI.B
Equipment :	DB.B Panel
Detail :	MCCB Main
Comment :	Normal operation , Not found hotspot
	Should also keep for your future reference

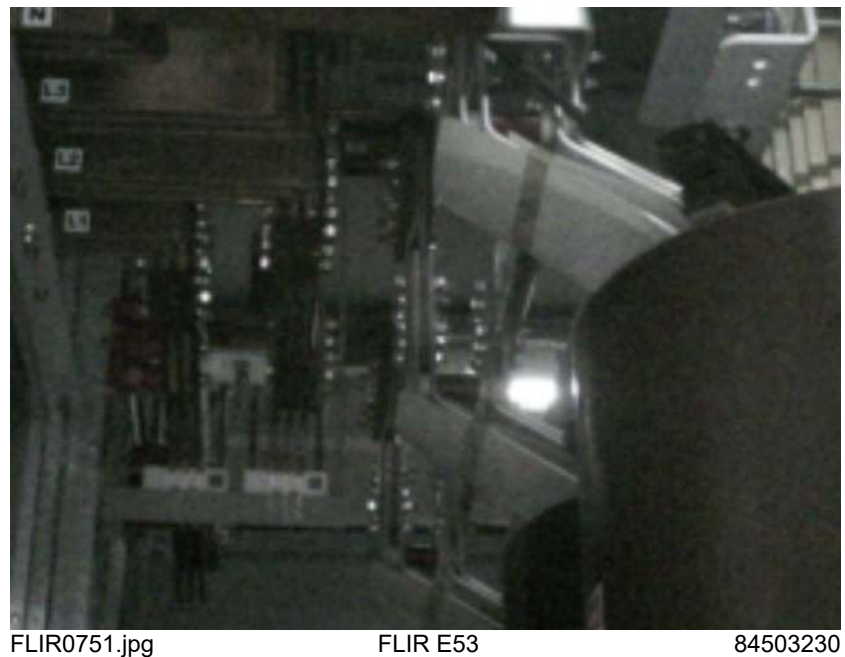
21/7/2023 13:21:34

Location :	MDB Room FI.3
Equipment :	TR-1
Detail :	Low Volt Side Connection
Comment :	Normal operation , Not found hotspot
	Should also keep for your future reference

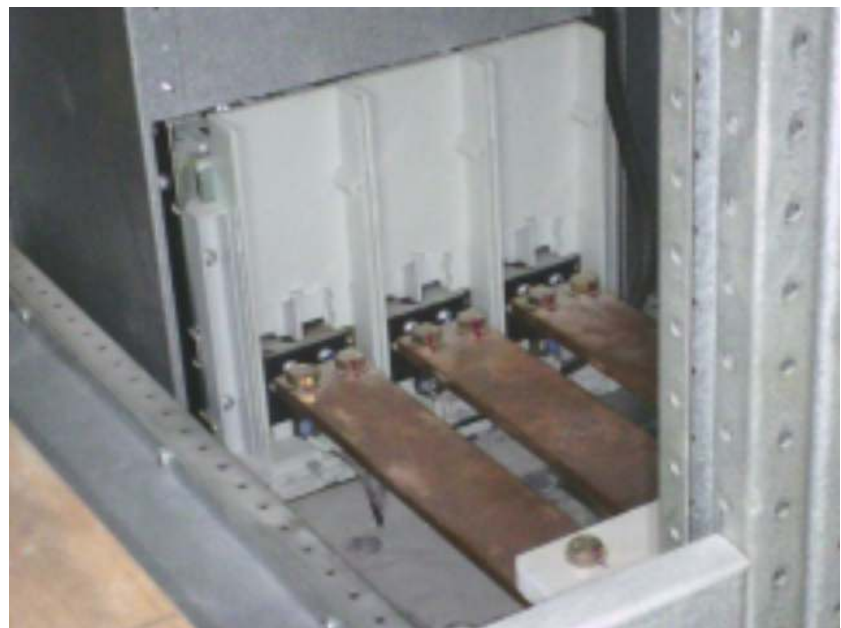
21/7/2023 13:26:48

Location :	MDB Room FI.3
Equipment :	MDB.1 Panel
Detail :	ACB DB.B 2,500 A.
Comment :	Normal operation , Not found hotspot
	Should also keep for your future reference

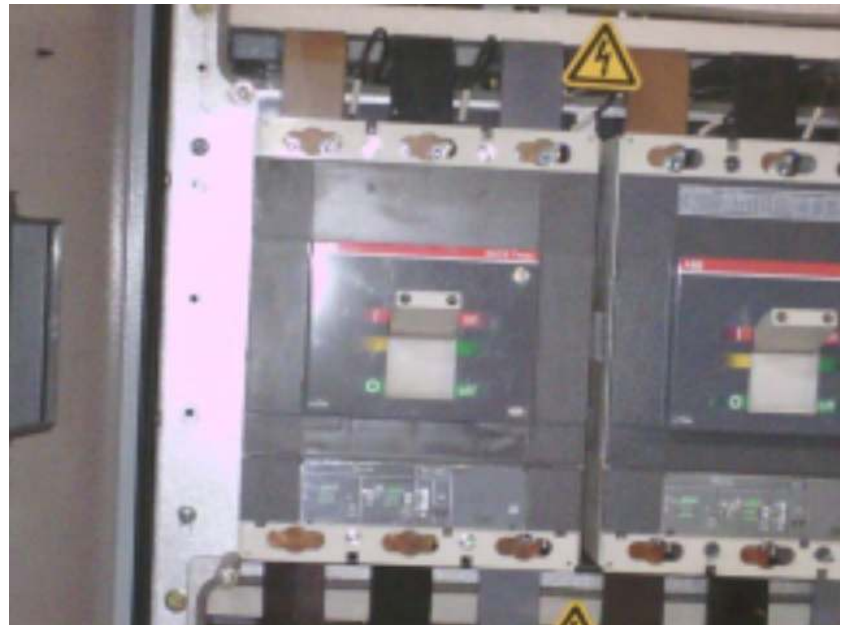
Location :	MDB Room FI.3
Equipment :	MDB.1 Panel
Detail :	MCCB FOR ODD FLOOR 1,250 A.
Comment :	Normal operation , Not found hotspot
	Should also keep for your future reference

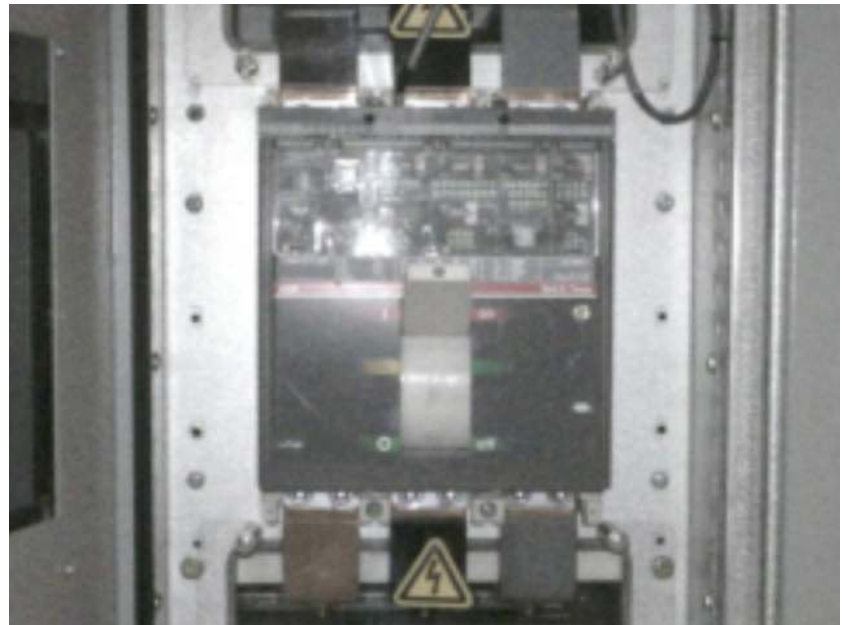
21/7/2023 13:31:34

Location :	MDB Room FI.3
Equipment :	MDB.1 Panel
Detail :	MCCB FDP
Comment :	Normal operation , Not found hotspot
	Should also keep for your future reference

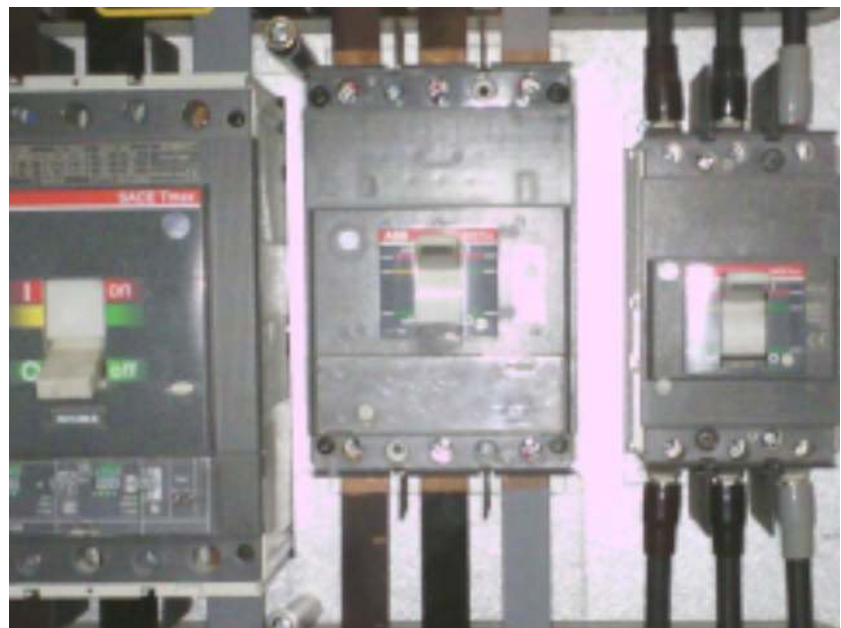
21/7/2023 13:32:11

Location :	MDB Room FI.3
Equipment :	MDB.1 Panel
Detail :	MCCB CWHF
Comment :	Normal operation , Not found hotspot
	Should also keep for your future reference

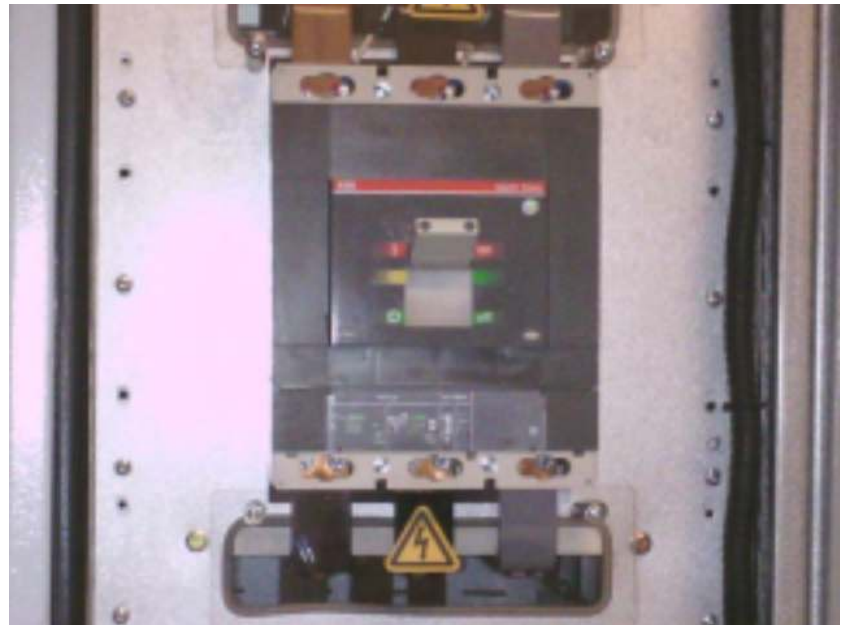
21/7/2023 13:39:03

Location :	MDB Room FI.3
Equipment :	MDB.2 Panel
Detail :	MCCB FOR EVEN FLOOR
Comment :	Normal operation , Not found hotspot
	Should also keep for your future reference

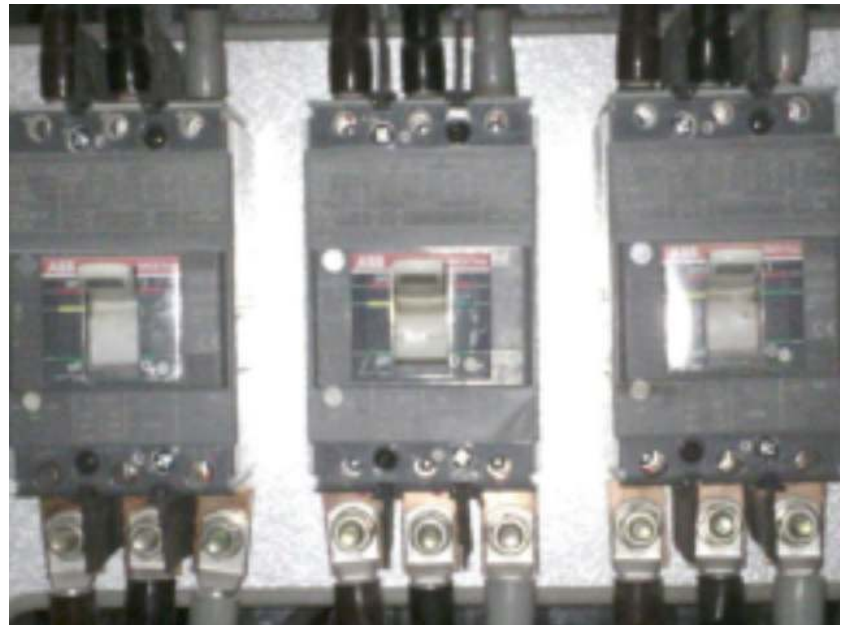
21/7/2023 14:03:06

Location :	Shaft Room FI.M
Equipment :	DB.G Panel
Detail :	MCCB LCG3
Comment :	Normal operation , Not found hotspot
	Should also keep for your future reference

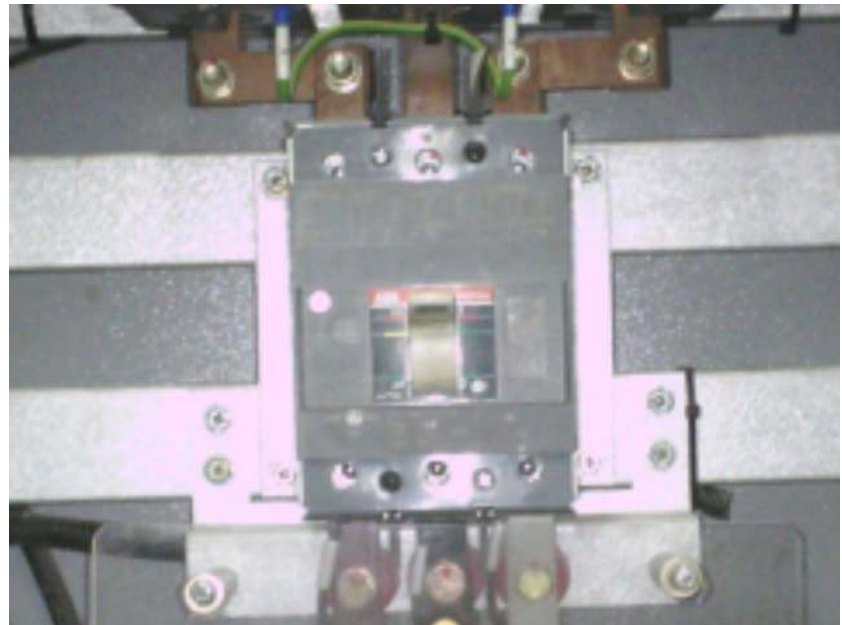
21/7/2023 14:04:05

Location :	Shaft Room FI.M
Equipment :	DB.EG Panel
Detail :	MCCB Main
Comment :	Normal operation , Not found hotspot
	Should also keep for your future reference

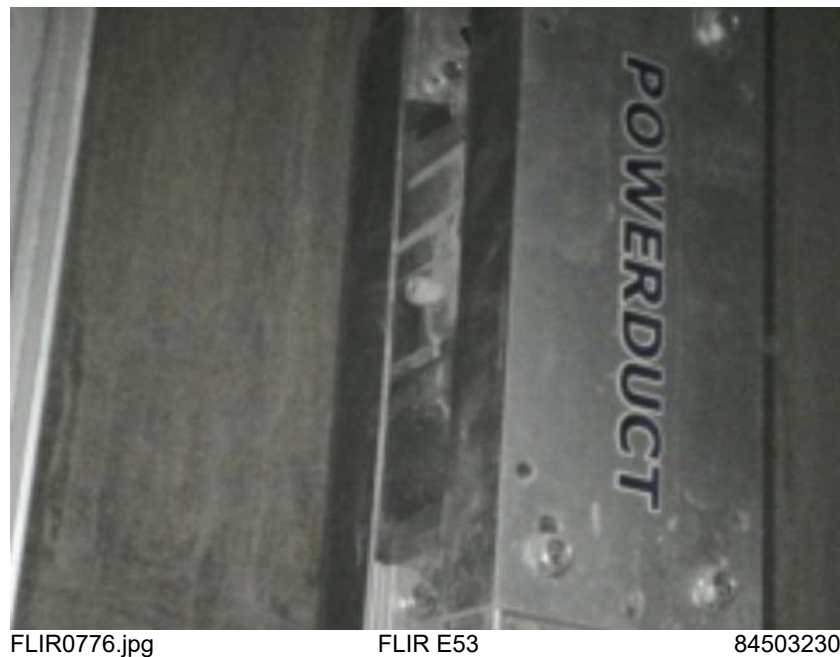
21/7/2023 14:04:27

Location :	Shaft Room FI.M
Equipment :	Busduct
Detail :	Joint Busduct
Comment :	Normal operation , Not found hotspot
	Should also keep for your future reference

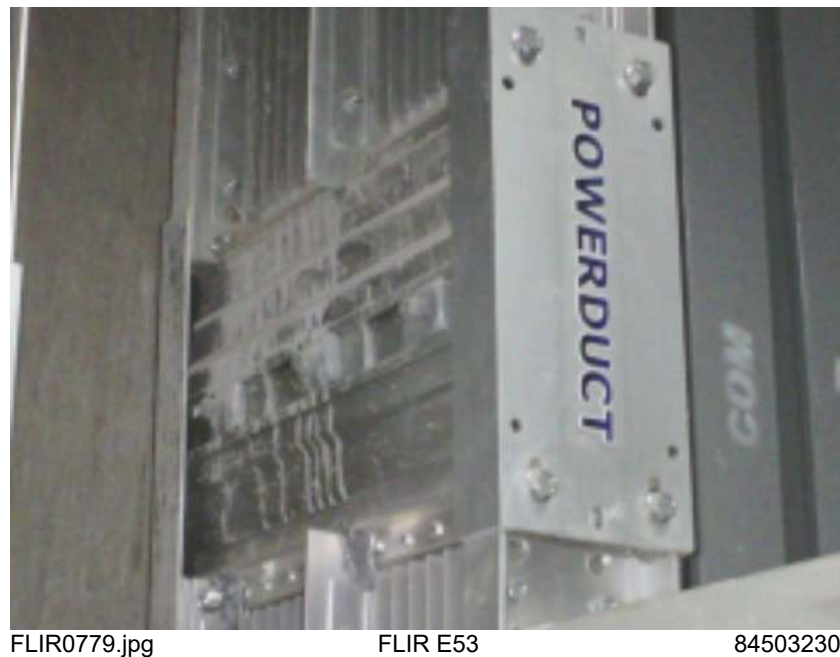
21/7/2023 14:11:51

Location :	Shaft Room FI.5
Equipment :	Busduct
Detail :	Joint Busduct
Comment :	Normal operation , Not found hotspot
	Should also keep for your future reference

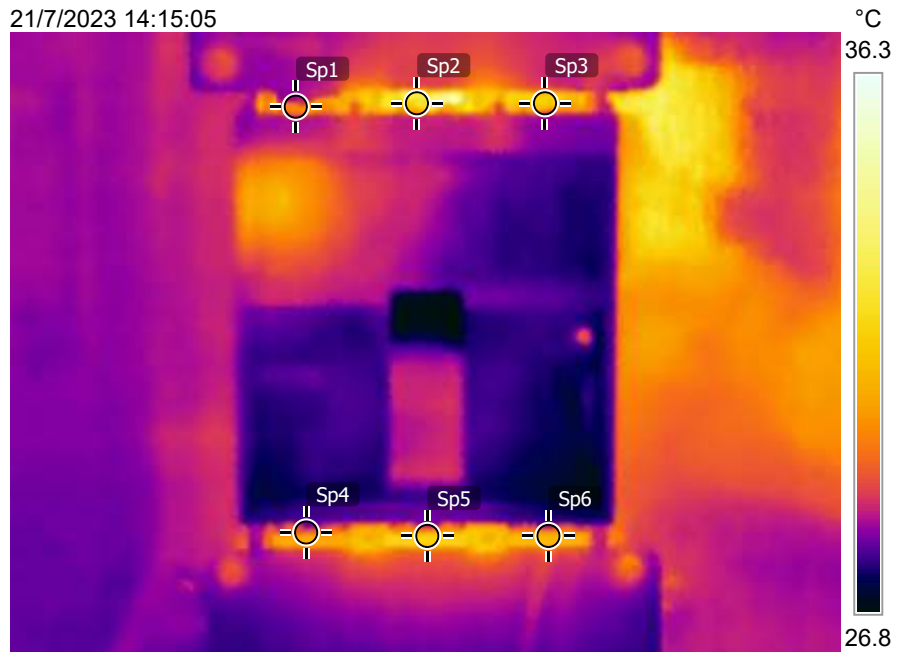
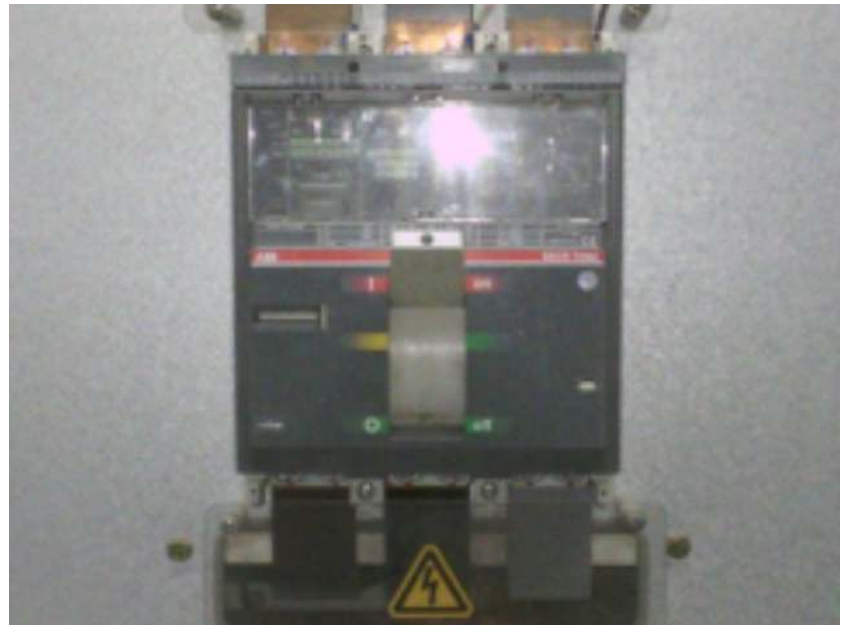
FLIR0780.jpg

Location :	Chiller Room FI.4
Equipment :	MCC.A3 Panel
Detail :	MCCB Main
Comment :	Normal operation , Not found hotspot
	Should also keep for your future reference

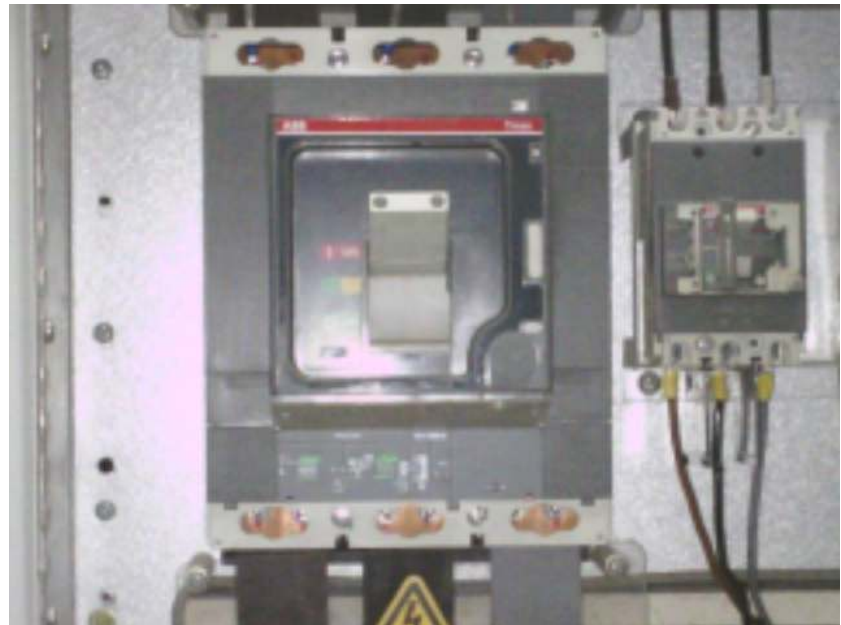
Location :	Chiller Room FI.4
Equipment :	MCC.A3 Panel
Detail :	MCCB CH-3
Comment :	Normal operation , Not found hotspot
	Should also keep for your future reference

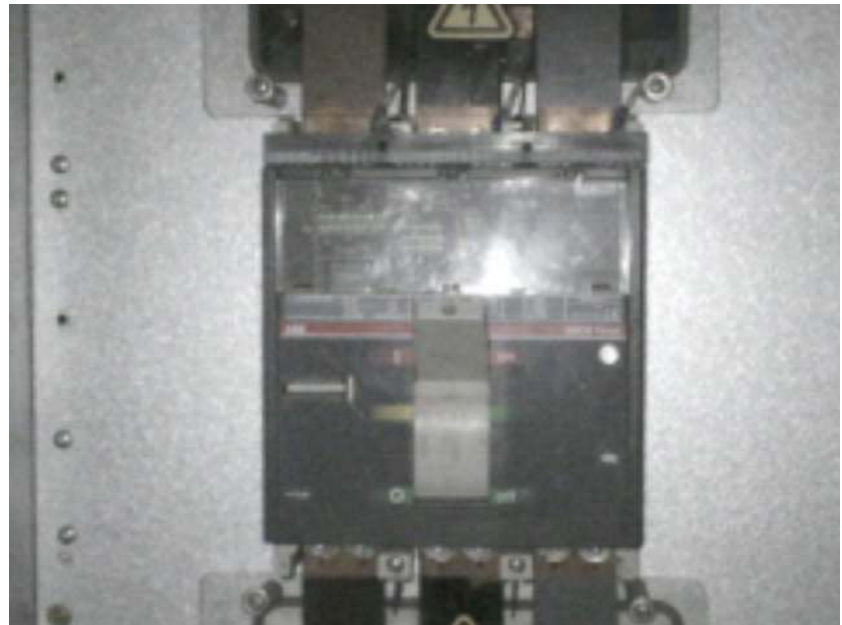
21/7/2023 14:16:36

Location :	Chiller Room FI.4
Equipment :	MCC.AC2 Panel
Detail :	MCCB Main
Comment :	Normal operation , Not found hotspot
	Should also keep for your future reference

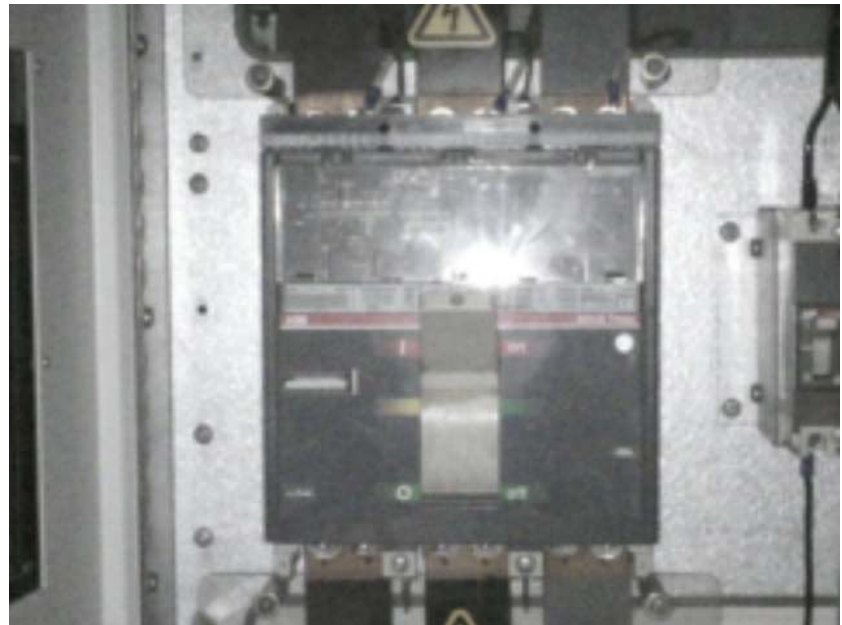
21/7/2023 14:16:51

Location :	Chiller Room FI.4
Equipment :	MCC.AC2 Panel
Detail :	MCCB CH-2
Comment :	Normal operation , Not found hotspot
	Should also keep for your future reference

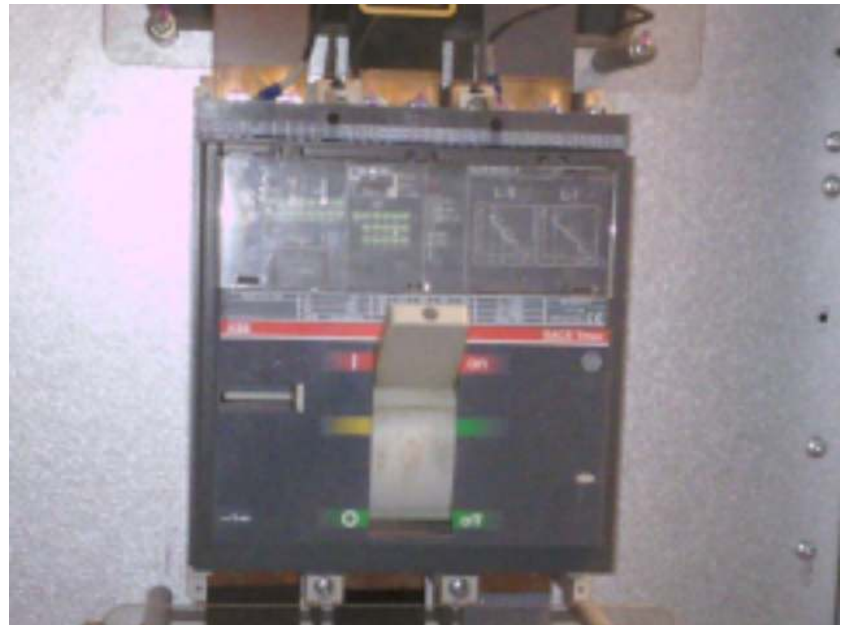
FLIR0784.jpg

Location :	Chiller Room FI.4
Equipment :	MCC.AC1 Panel
Detail :	MCCB Main
Comment :	Normal operation , Not found hotspot
	Should also keep for your future reference
