รายงานการซ่อมบำรุงระบบไฟฟ้า

ใบรายงานการตรวจเช็คเครื่องกำเนิดไฟฟ้า

Inspection date:	30/08/2023	
Report date:	3/09/2023	
Project :	Hyatt Regency Bangkok Sukhumvit	
Project Location:	Bangkok	
Type of Inspection:	Qualitative Electrical System	
Purpose of Inspection:	Maintenance IR Scan (After PM)	
Certified Thermographer:	Mr. Thirasak Nampor	
Certification Number:	Certificate Level-I No. 1-000929	
Equipment Used:	Flir E53	S/N : 84503823
No of thermograms :	78	
Comments:	The results of the examination. Measurement of electrical heat of electrical equipment according to plan of work. No defects are found that cause damage and do not cause harm to the use and maintenance of electrical equipment should be maintained in good condition.

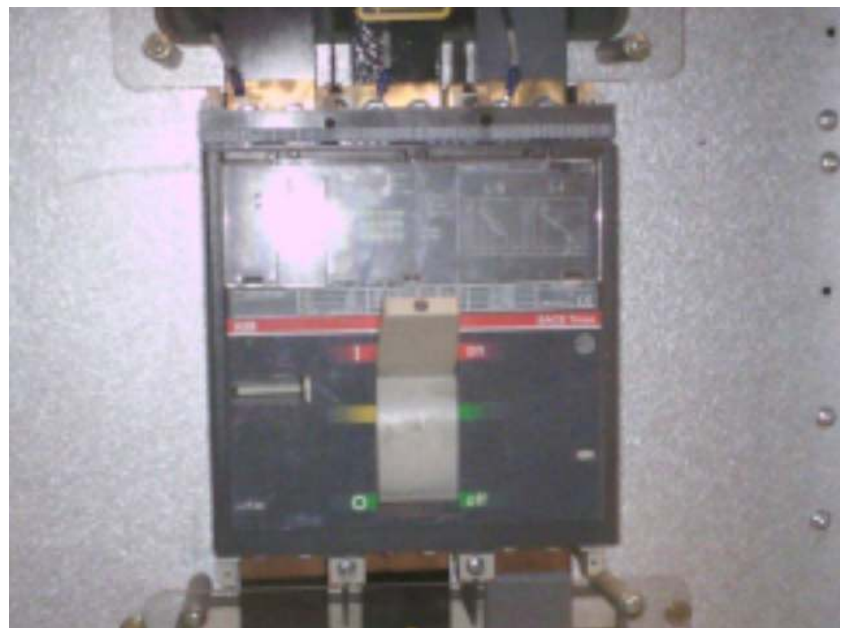
FLIR0785.jpg

Location :	Chiller Room FI.4
Equipment :	MCC.AC1 Panel
Detail :	MCCB CH-1
Comment :	Normal operation , Not found hotspot
	Should also keep for your future reference

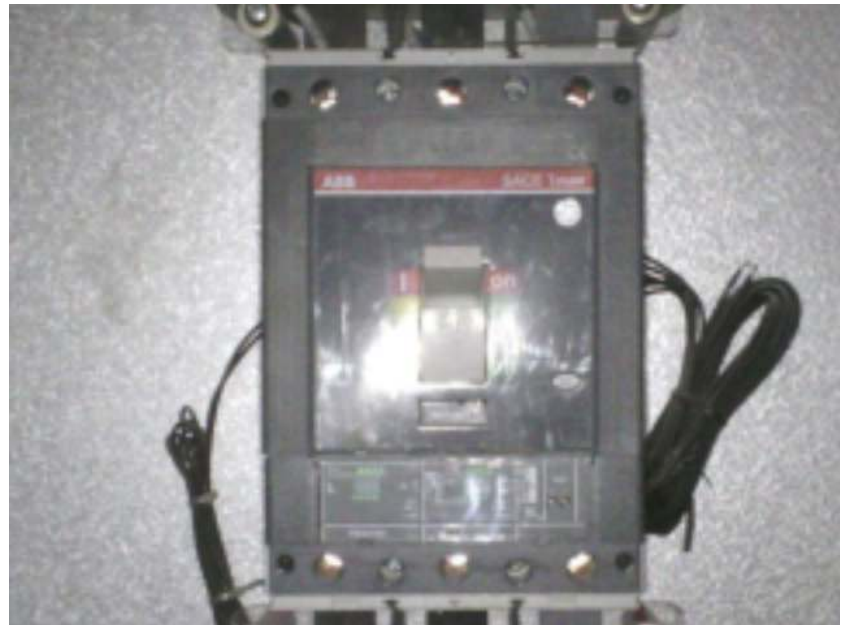
FLIR0786.jpg

Location :	Shaft Room Fl.4
Equipment :	DB.4 Panel
Detail :	MCCB Main
Comment :	Normal operation , Not found hotspot
	Should also keep for your future reference

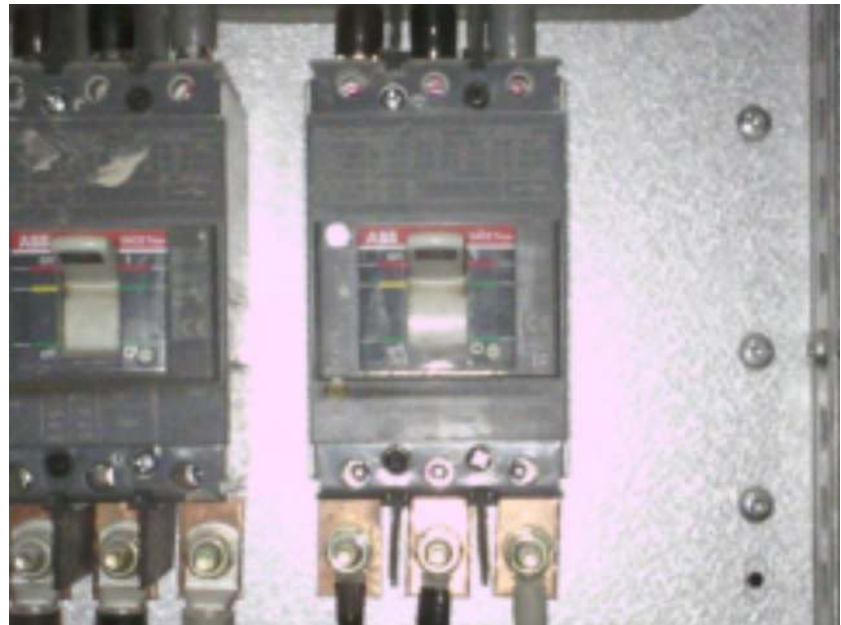
FLIR0787.jpg

Location :	Shaft Room FI.4
Equipment :	DB.4 Panel
Detail :	MCCB LC4A
Comment :	Normal operation , Not found hotspot
	Should also keep for your future reference

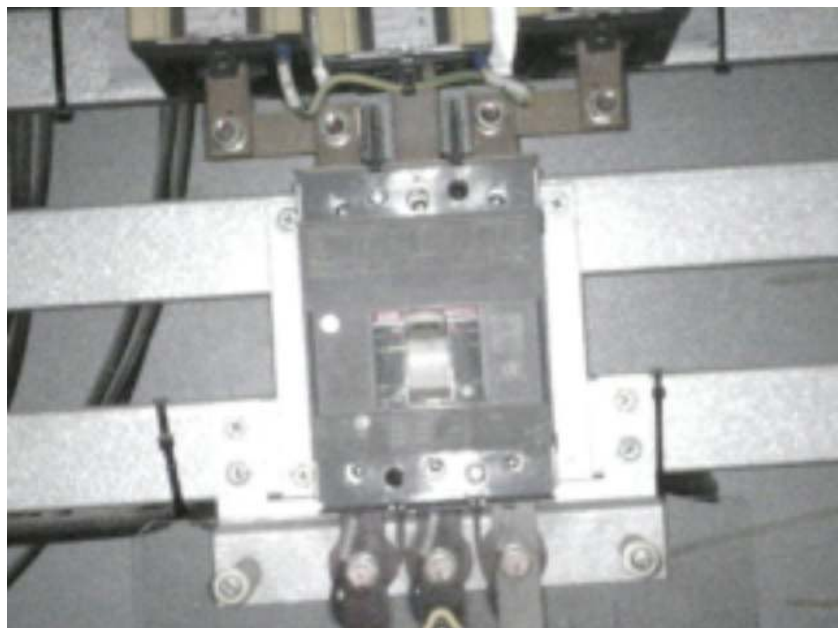
21/7/2023 14:22:19

Location :	Shaft Room FI.4
Equipment :	DB.E4 Panel
Detail :	MCCB Main
Comment :	Normal operation , Not found hotspot
	Should also keep for your future reference

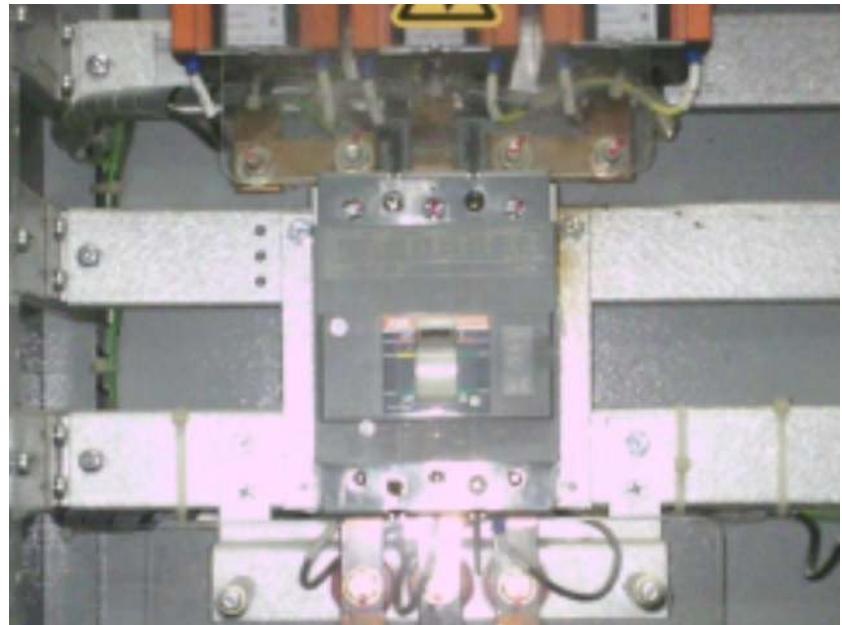
21/7/2023 14:26:42

Location :	Shaft Room FI.29
Equipment :	DB.28A Panel
Detail :	MCCB Main
Comment :	Normal operation , Not found hotspot
	Should also keep for your future reference

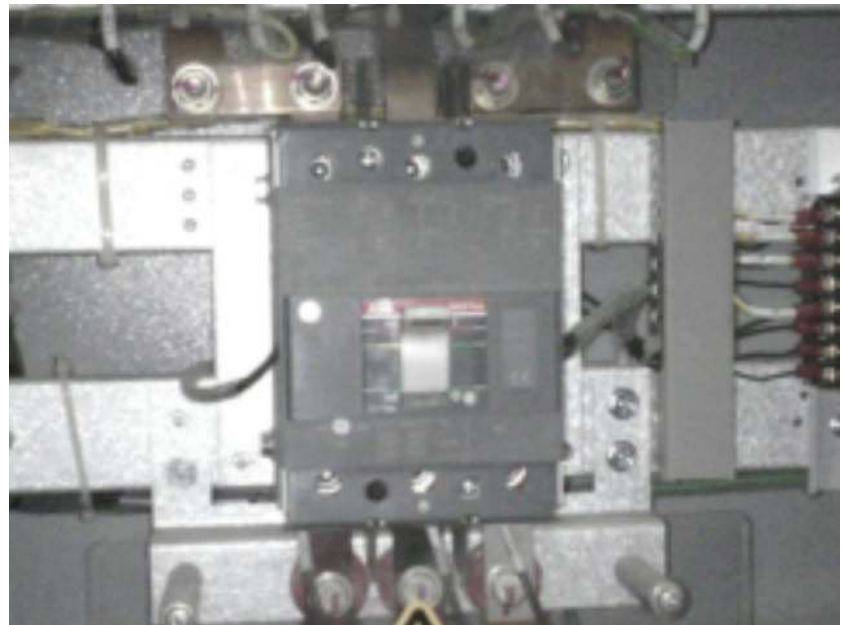
21/7/2023 14:27:01

Location :	Shaft Room FI.29
Equipment :	SDPK 28 Panel
Detail :	MCCB Main
Comment :	Normal operation , Not found hotspot
	Should also keep for your future reference

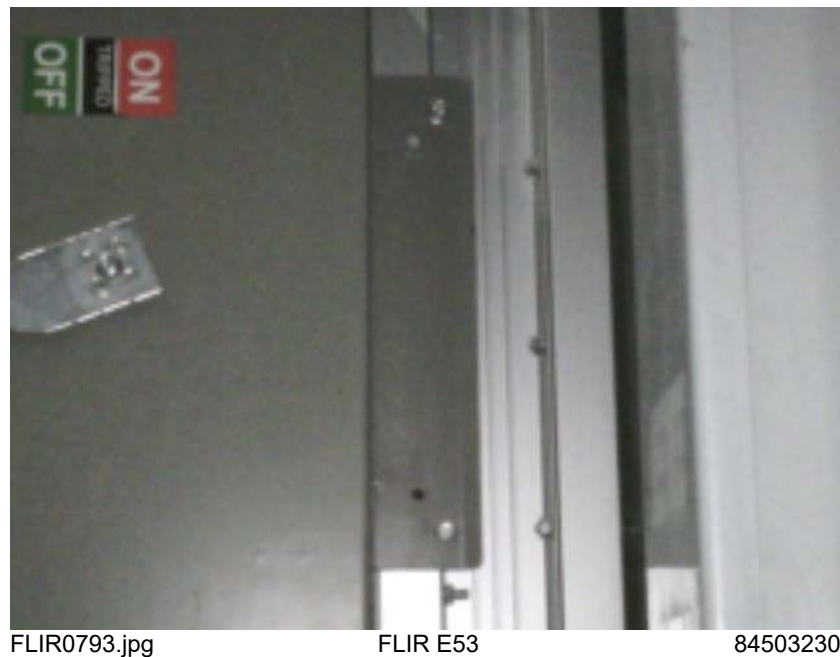
21/7/2023 14:29:09

Location :	Shaft Room FI.29
Equipment :	Plugin Unit RUN1
Detail :	Connection
Comment :	Normal operation , Not found hotspot
	Should also keep for your future reference

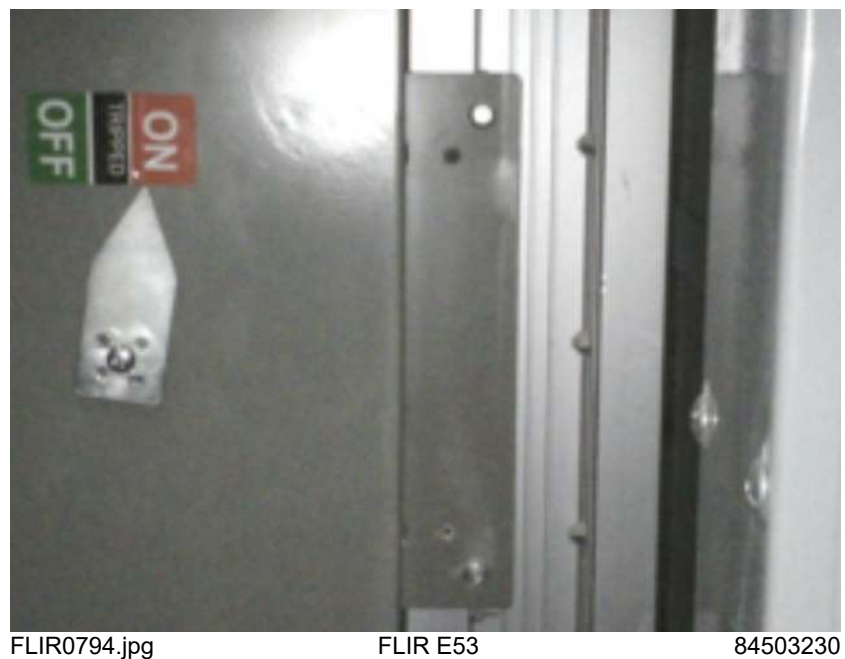
21/7/2023 14:29:15

Location :	Shaft Room FI.29
Equipment :	Plugin Unit
Detail :	Connection
Comment :	Normal operation , Not found hotspot
	Should also keep for your future reference

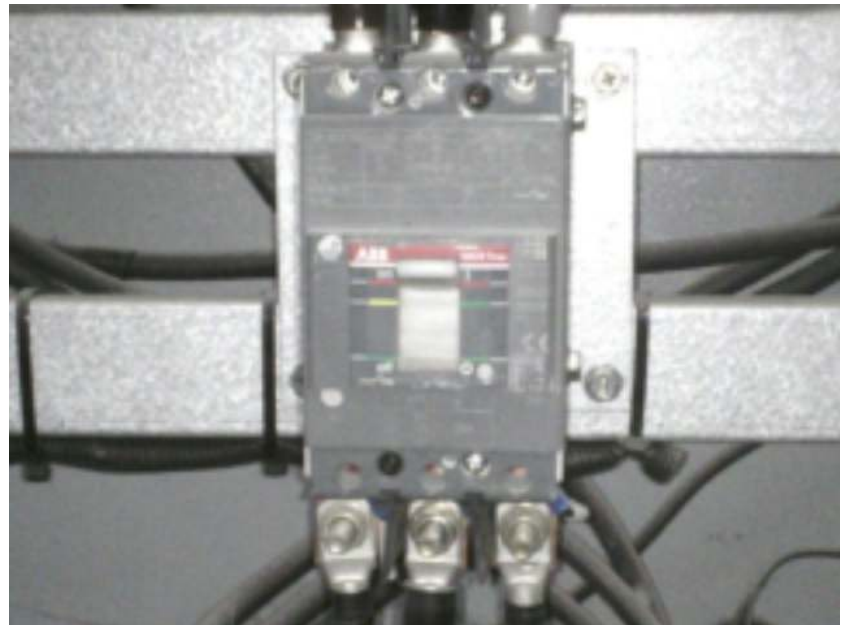
Location :	Lift Room FI.29
Equipment :	DBEL V4.1 Panel
Detail :	MCCB Main
Comment :	Normal operation , Not found hotspot
	Should also keep for your future reference

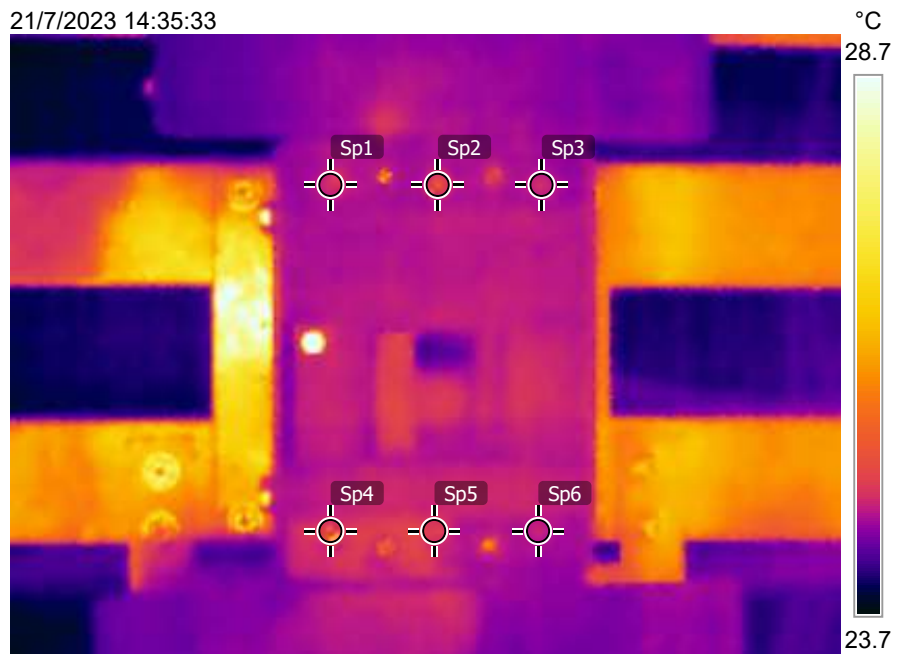
FLIR0796.jpg

Location :	Lift Room FI.30
Equipment :	DBEL V4 Panel
Detail :	MCCB Main
Comment :	Normal operation , Not found hotspot
	Should also keep for your future reference

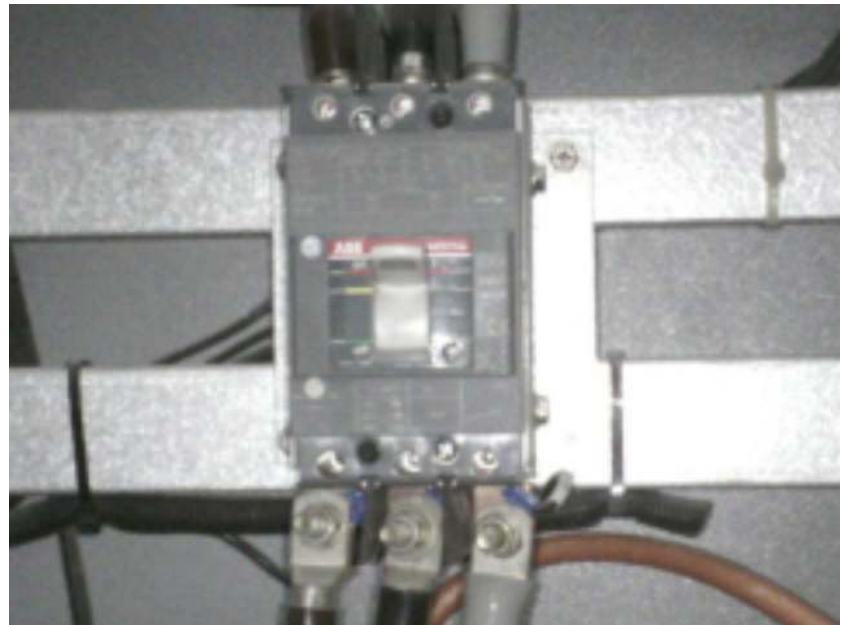
Location :	Lift Room FI.30
Equipment :	DBEL V5 Panel
Detail :	MCCB Main
Comment :	Normal operation , Not found hotspot
	Should also keep for your future reference

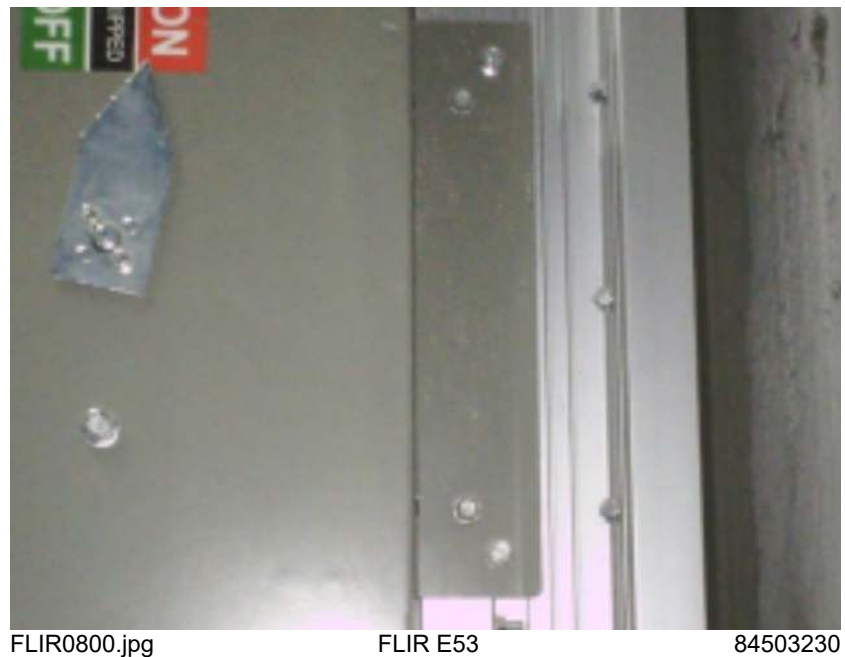
Location :	Shaft Room FI.27
Equipment :	Plugin Unit
Detail :	Connection
Comment :	Normal operation , Not found hotspot
	Should also keep for your future reference

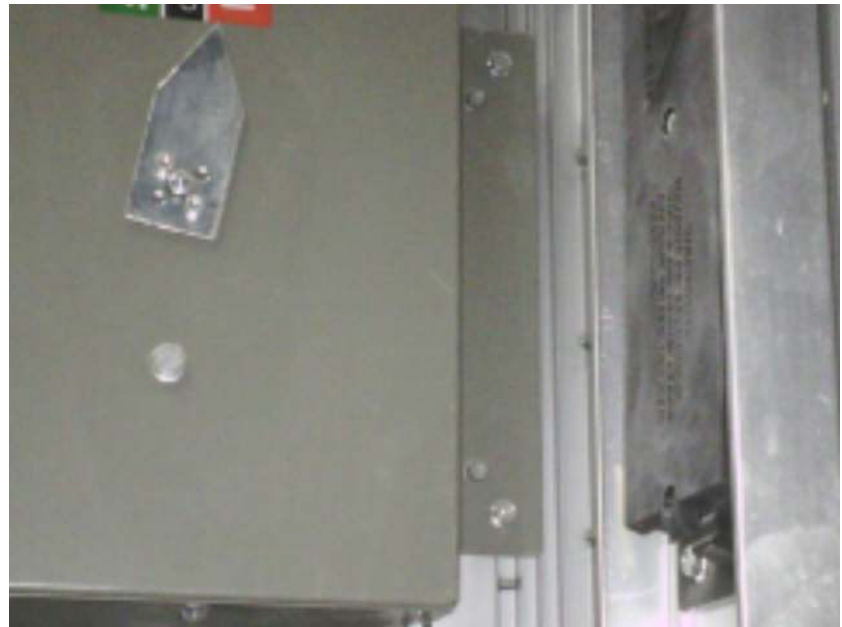
FLIR0801.jpg

Location :	Shaft Room FI.26
Equipment :	Plugin Unit
Detail :	Connection
Comment :	Normal operation , Not found hotspot
	Should also keep for your future reference

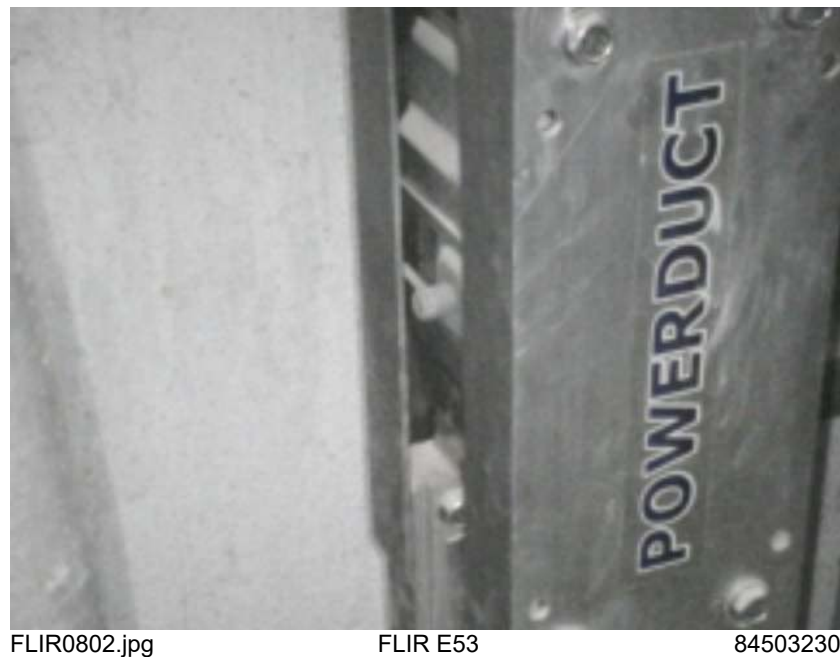
Location :	Shaft Room FI.26
Equipment :	Busduct
Detail :	Joint Busduct
Comment :	Normal operation , Not found hotspot
	Should also keep for your future reference

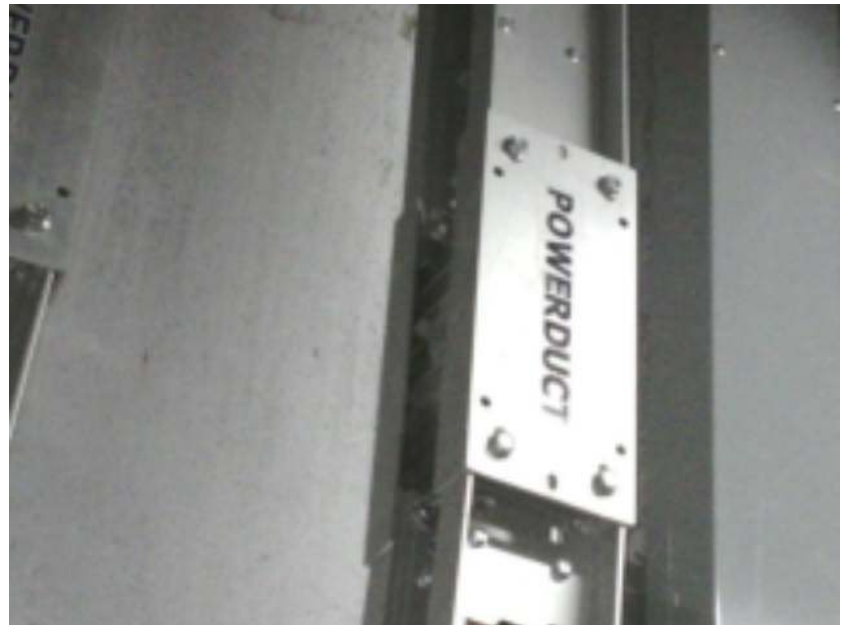
Location :	Shaft Room Fl.25
Equipment :	Busduct
Detail :	Joint Busduct
Comment :	Normal operation , Not found hotspot
	Should also keep for your future reference

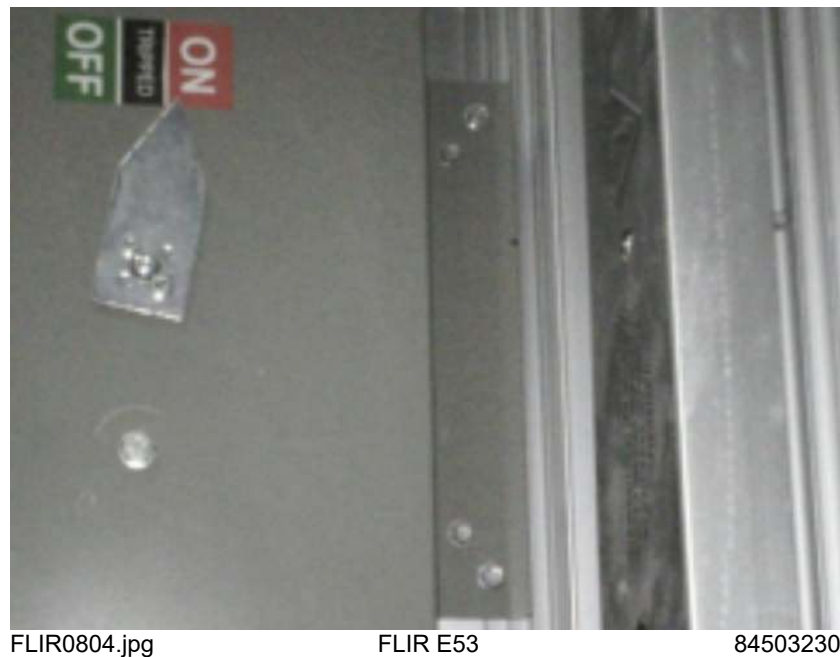
Location :	Shaft Room FI.24
Equipment :	Plugin Unit
Detail :	Connection
Comment :	Normal operation , Not found hotspot
	Should also keep for your future reference

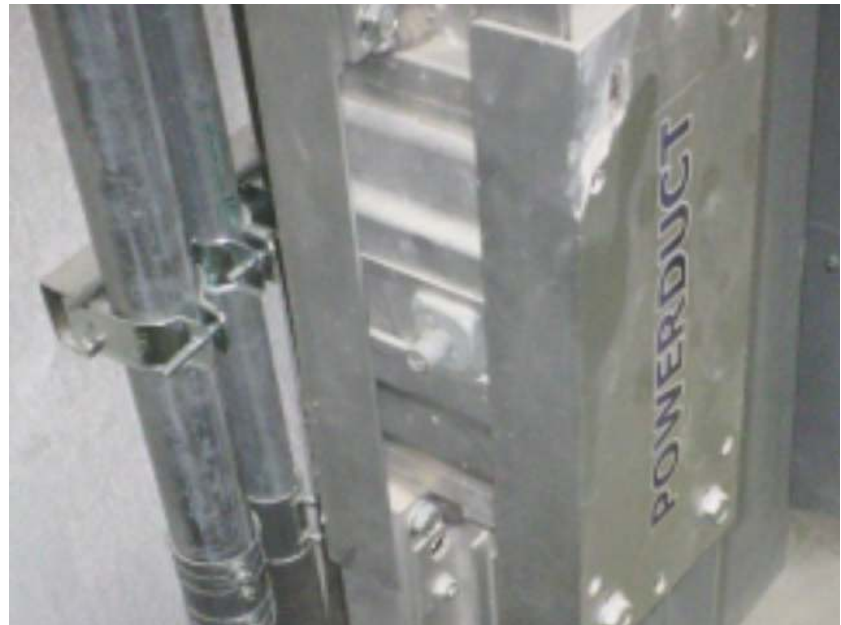
Location :	Shaft Room FI.23
Equipment :	Busduct
Detail :	Joint Busduct
Comment :	Normal operation , Not found hotspot
	Should also keep for your future reference

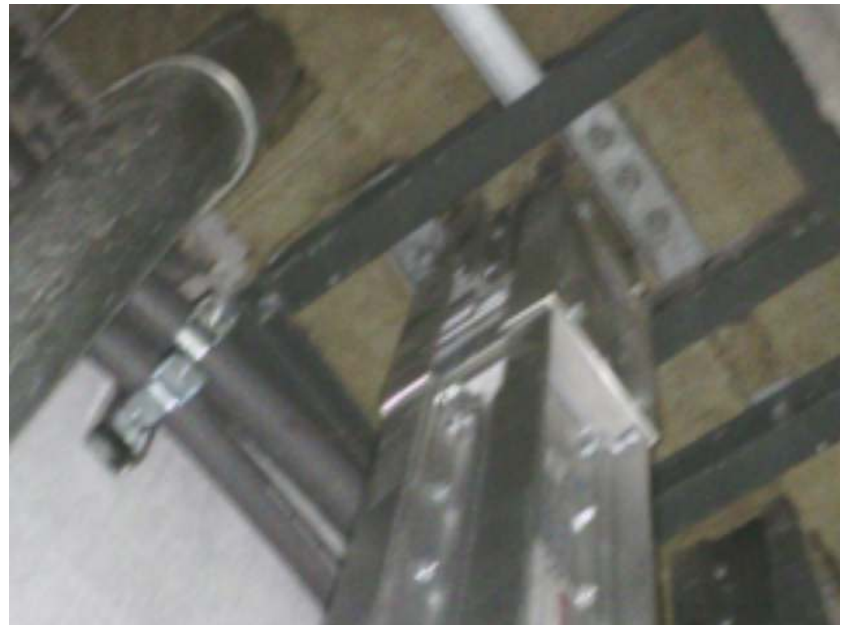
FLIR0806.jpg

Location :	Shaft Room FI.23
Equipment :	Busduct
Detail :	Joint Busduct
Comment :	Normal operation , Not found hotspot
	Should also keep for your future reference

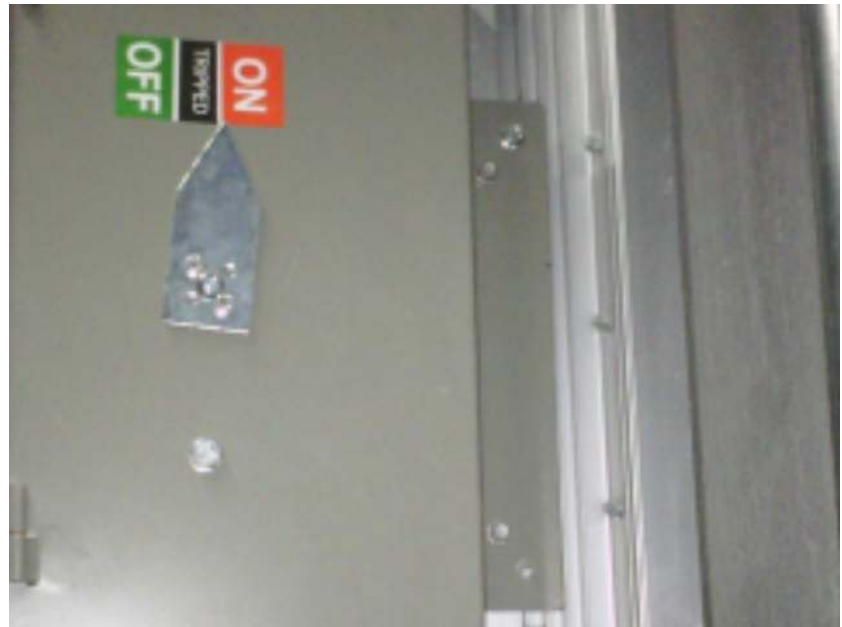
FLIR0808.jpg

Location :	Shaft Room FI.21
Equipment :	Plugin Unit
Detail :	Connection
Comment :	Normal operation , Not found hotspot
	Should also keep for your future reference

Measurements °C		
Ar1	Max	33.0
	Min	32.7
	Average	32.8

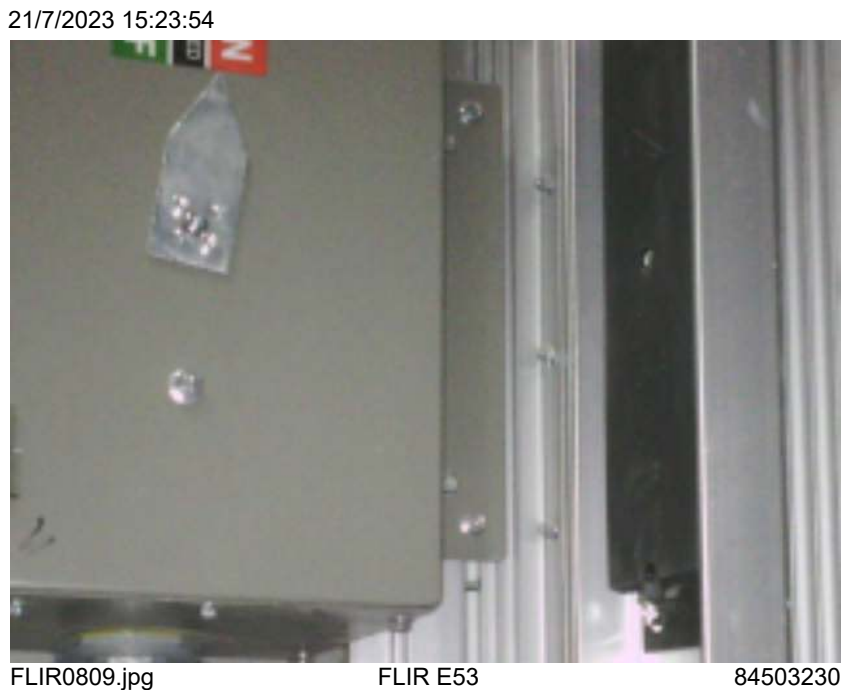
Location :	Shaft Room FI.20
Equipment :	Plugin Unit
Detail :	Connection
Comment :	Normal operation , Not found hotspot
	Should also keep for your future reference

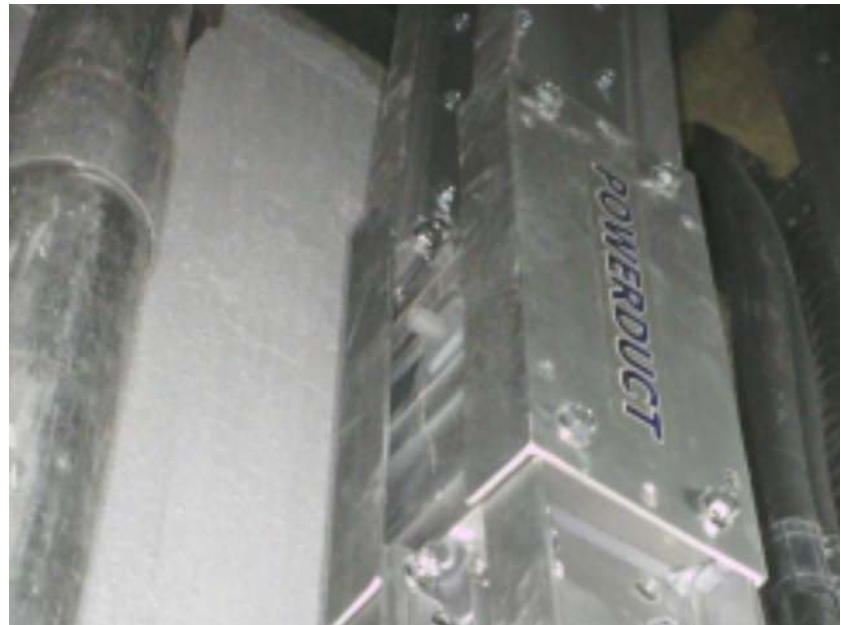
Location :	Shaft Room Fl.19
Equipment :	Busduct
Detail :	Joint Busduct
Comment :	Normal operation , Not found hotspot
	Should also keep for your future reference

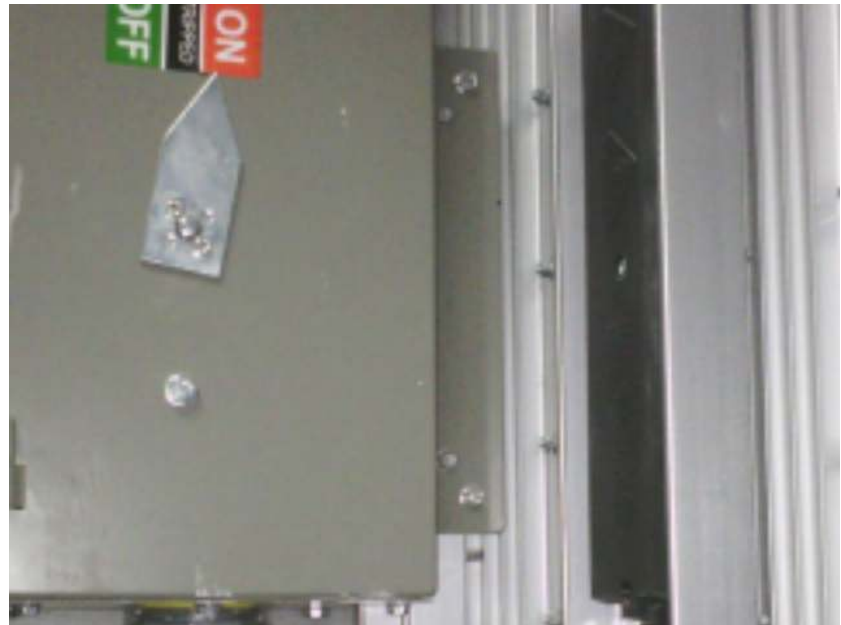
Location :	Shaft Room Fl.18
Equipment :	Plugin Unit
Detail :	Connection
Comment :	Normal operation , Not found hotspot
	Should also keep for your future reference

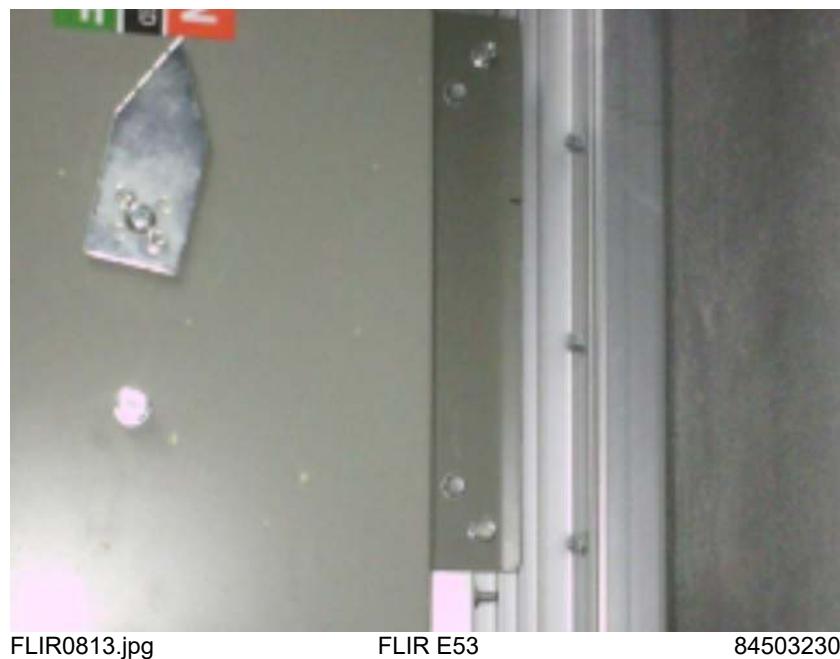
Location :	Shaft Room Fl.17
Equipment :	Plugin Unit
Detail :	Connection
Comment :	Normal operation , Not found hotspot
	Should also keep for your future reference

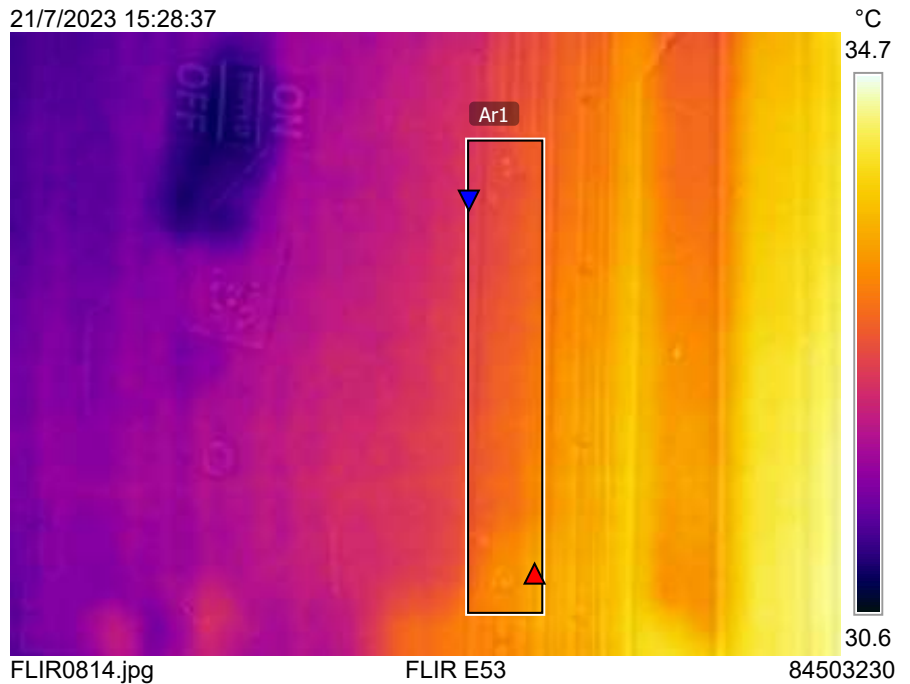
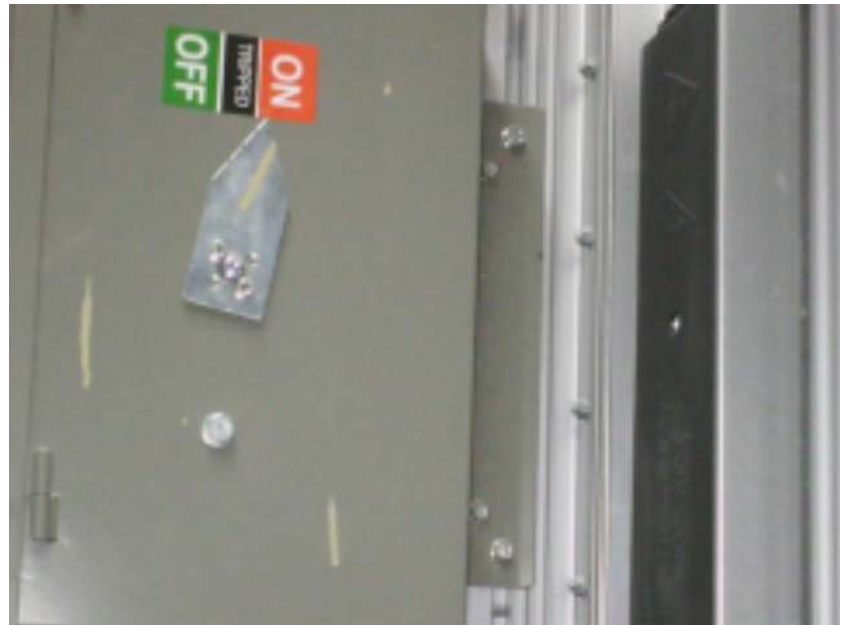
Location :	Shaft Room Fl.16
Equipment :	Plugin Unit
Detail :	Connection
Comment :	Normal operation , Not found hotspot
	Should also keep for your future reference

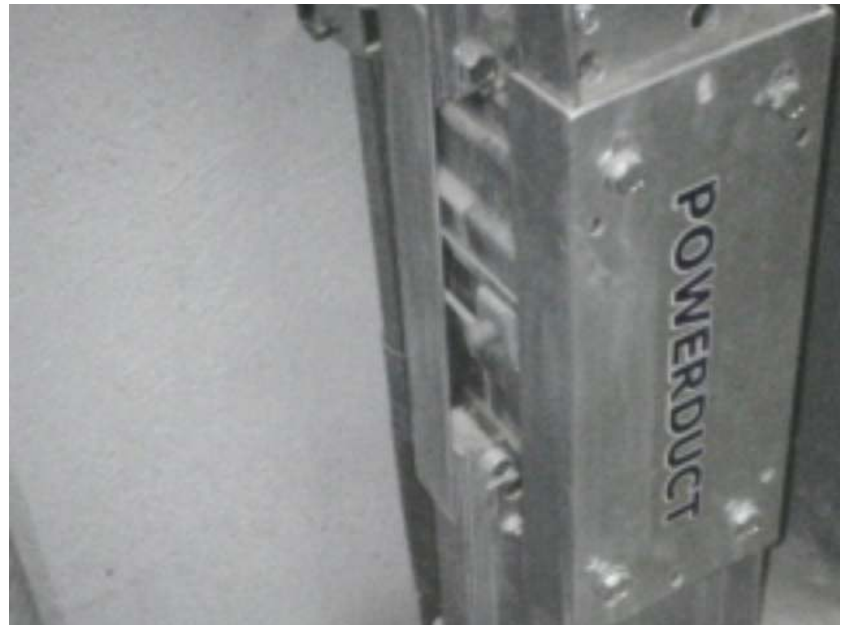
FLIR0816.jpg

Location :	Shaft Room Fl.14
Equipment :	Busduct
Detail :	Joint Busduct
Comment :	Normal operation , Not found hotspot
	Should also keep for your future reference

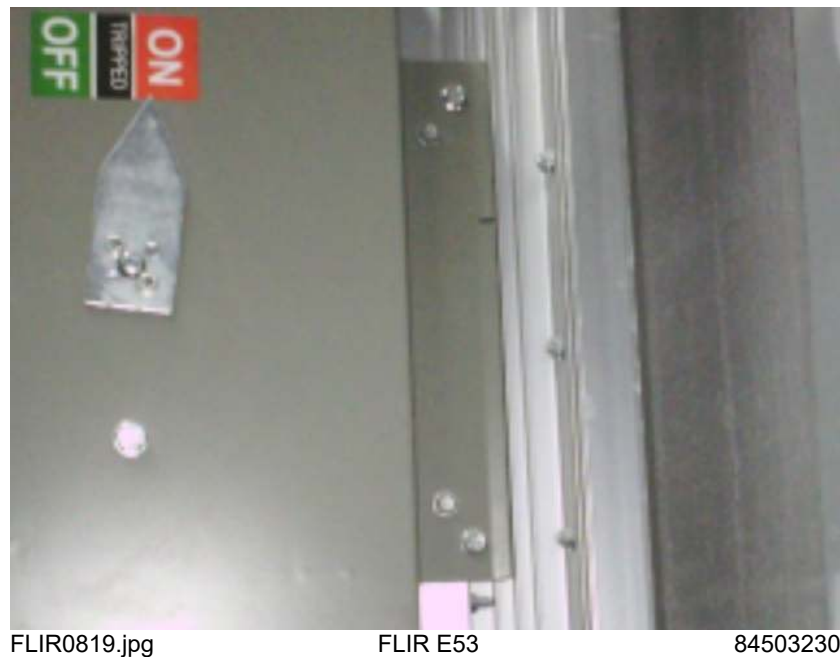
Location :	Shaft Room FI.10
Equipment :	Plugin Unit
Detail :	Connection
Comment :	Normal operation , Not found hotspot
	Should also keep for your future reference

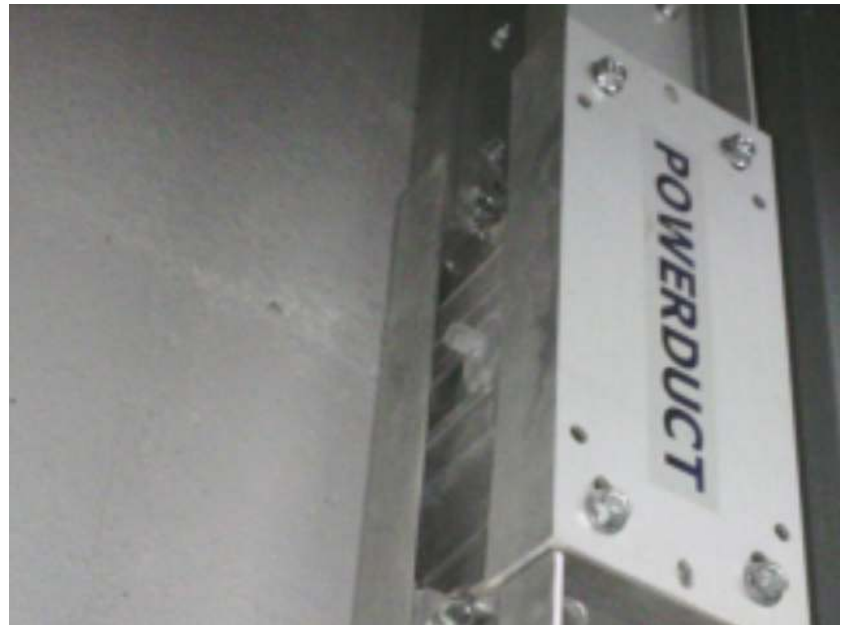
Location :	Shaft Room FI.9
Equipment :	Busduct
Detail :	Joint Busduct
Comment :	Normal operation , Not found hotspot
	Should also keep for your future reference

Measurements °C		
Ar1	Max	34.8
	Min	33.3
	Average	33.9

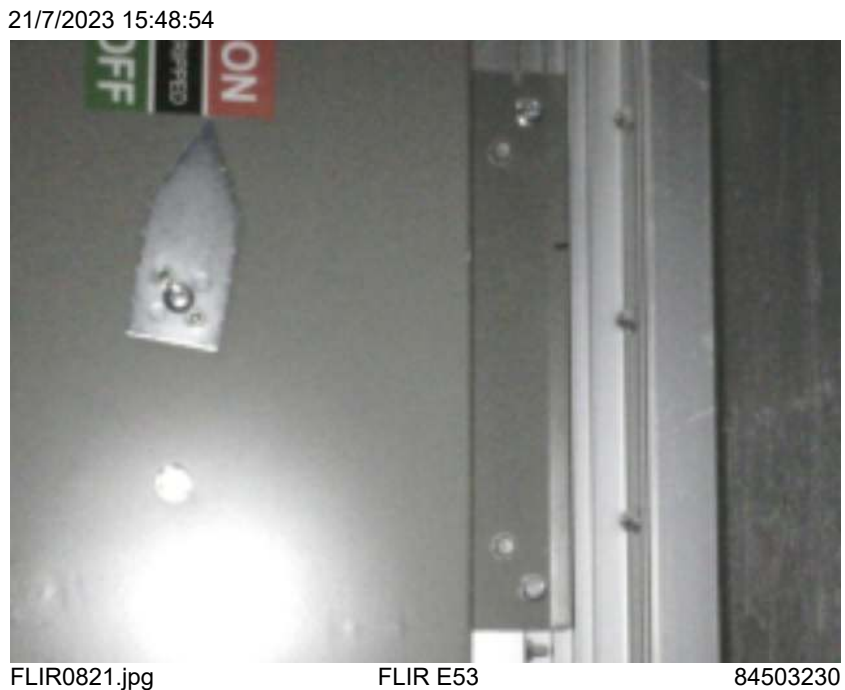
Location :	Shaft Room Fl.8
Equipment :	Plugin Unit
Detail :	Connection
Comment :	Normal operation , Not found hotspot
	Should also keep for your future reference

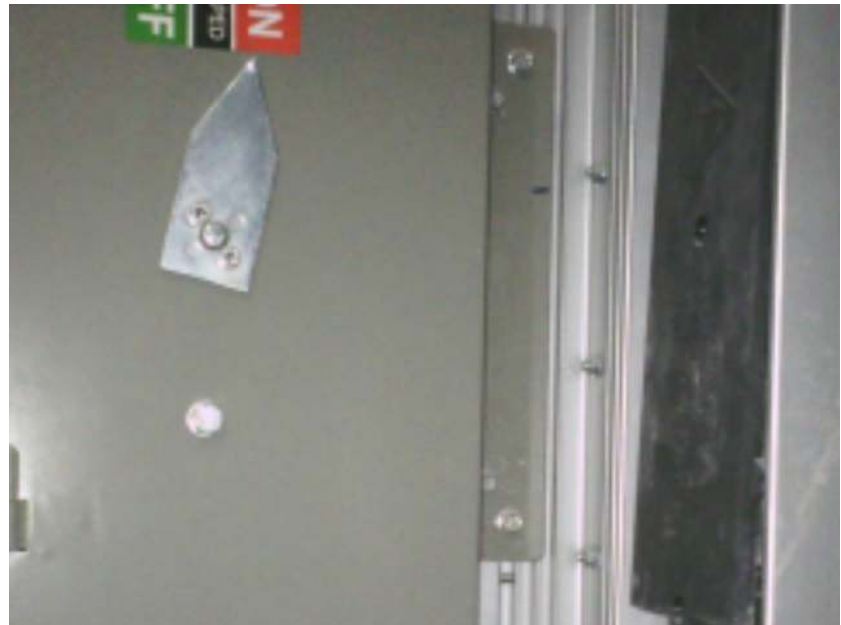
Location :	Shaft Room FI.7
Equipment :	Plugin Unit
Detail :	Connection
Comment :	Normal operation , Not found hotspot
	Should also keep for your future reference

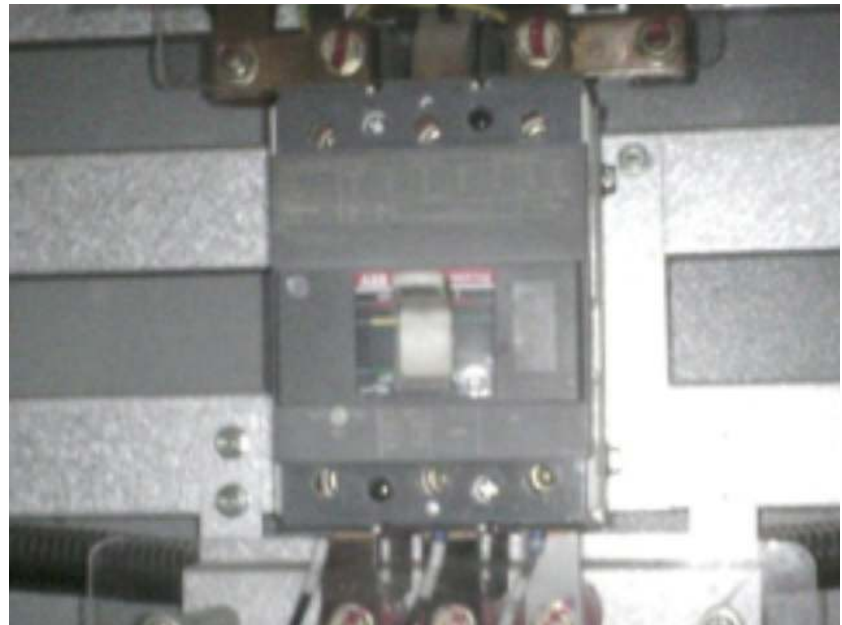
FLIR0823.jpg

Location :	Shaft Room FI.7
Equipment :	DB.E7 Panel
Detail :	MCCB Main
Comment :	Normal operation , Not found hotspot
	Should also keep for your future reference

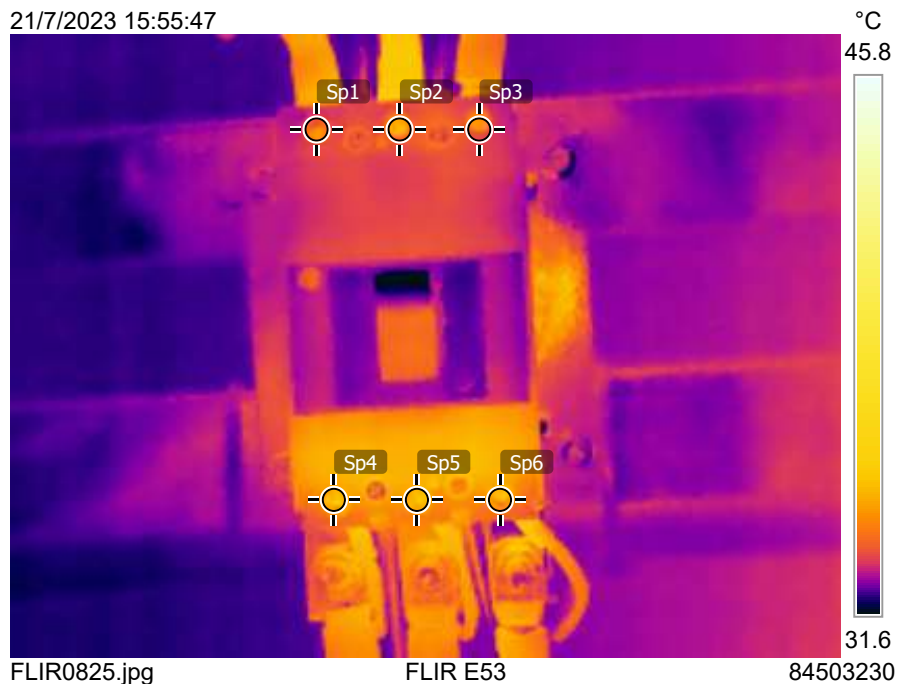
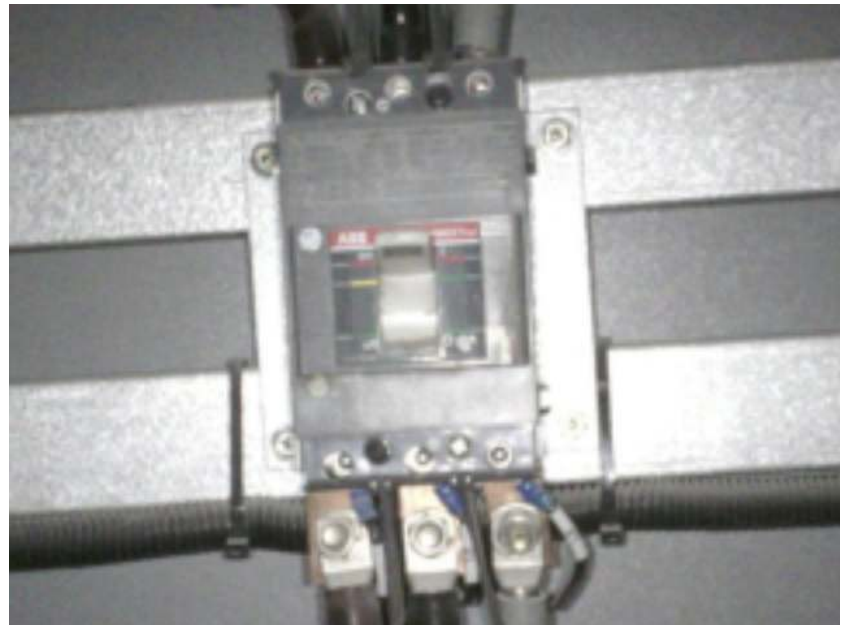
FLIR0825.jpg

Location :	Shaft Room FI.6
Equipment :	DB.E6 Panel
Detail :	MCCB Main
Comment :	Normal operation , Not found hotspot
	Should also keep for your future reference

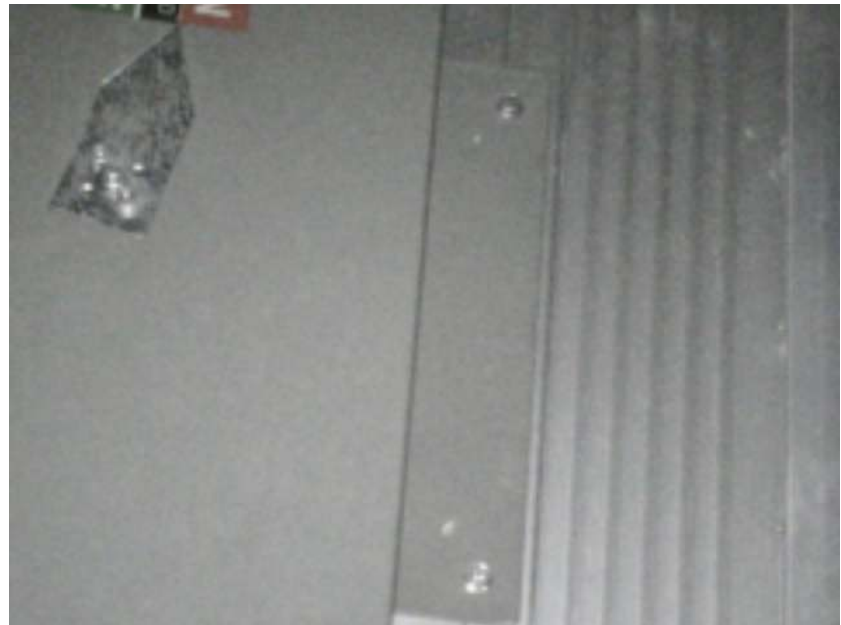
Location :	Shaft Room FI.6
Equipment :	Plugin Unit
Detail :	Connection
Comment :	Normal operation , Not found hotspot
	Should also keep for your future reference

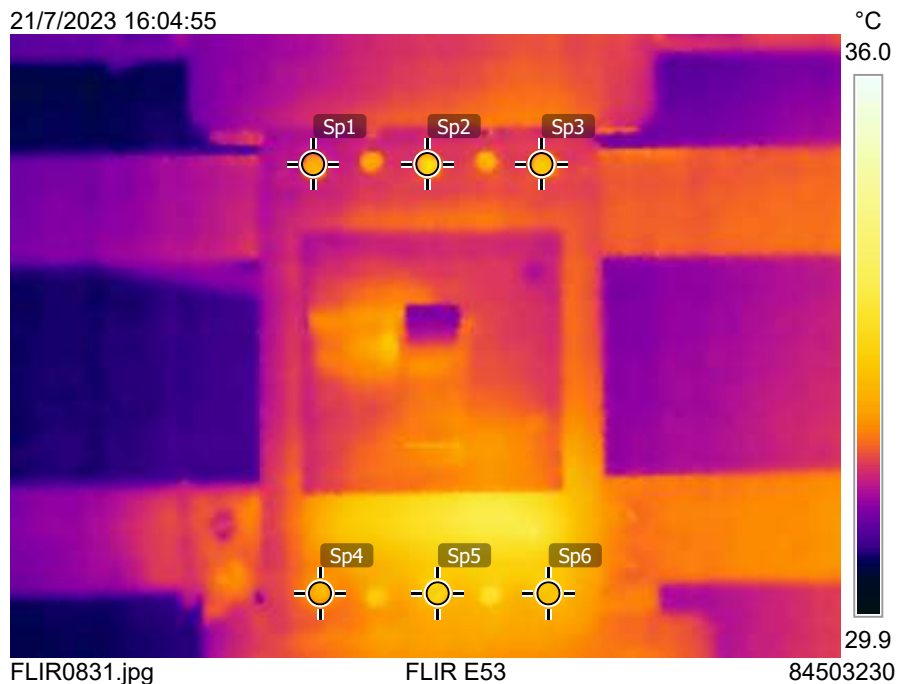
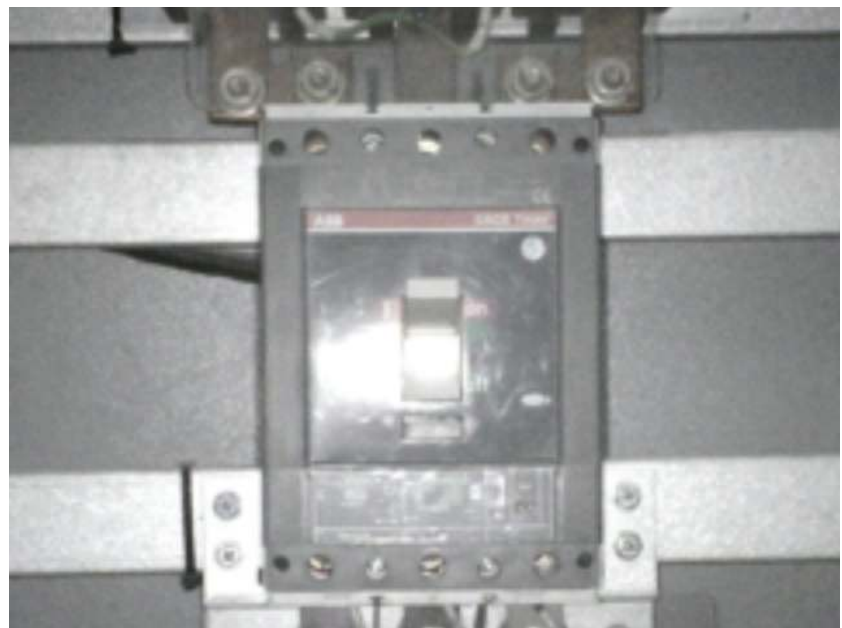
Location :	Shaft Room FI.2
Equipment :	DB.2 Panel
Detail :	MCCB Main
Comment :	Normal operation , Not found hotspot
	Should also keep for your future reference

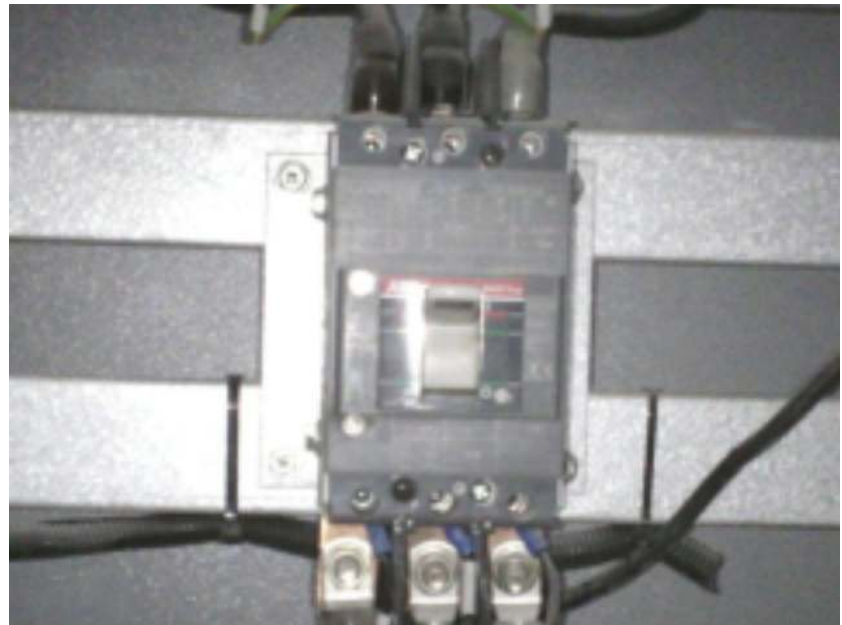
FLIR0832.jpg

Location :	Shaft Room FI.2
Equipment :	DB.E2 Panel
Detail :	MCCB Main
Comment :	Normal operation , Not found hotspot
	Should also keep for your future reference

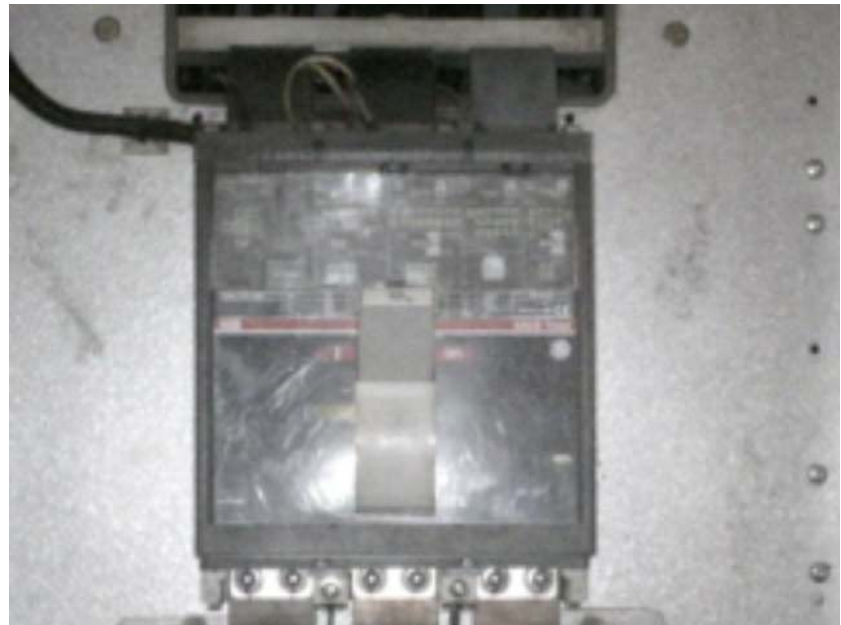
FLIR0833.jpg

Location :	Shaft Room FI.B
Equipment :	DB.B Panel
Detail :	MCCB Main
Comment :	Normal operation , Not found hotspot
	Should also keep for your future reference

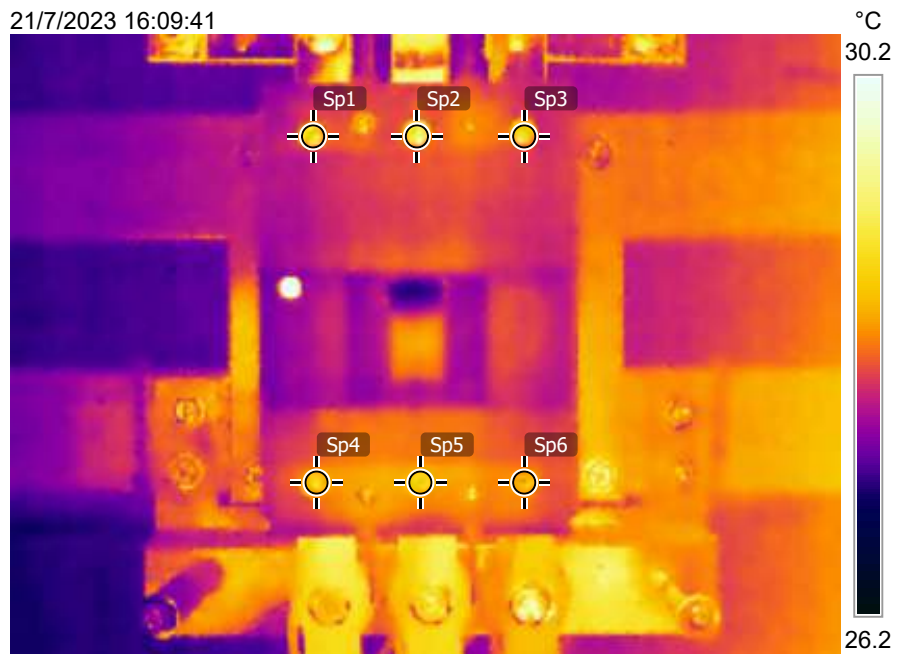
Location :	Shaft Room FI.B
Equipment :	DB.EB Panel
Detail :	MCCB Main
Comment :	Normal operation , Not found hotspot
	Should also keep for your future reference
