รายงานการซ่อมบำรุงระบบไฟฟ้า

ใบรายงานการตรวจเช็คเครื่องกำเนิดไฟฟ้า

Inspection date:	30/08/2023	
Report date:	3/09/2023	
Project :	Hyatt Regency Bangkok Sukhumvit	
Project Location:	Bangkok	
Type of Inspection:	Qualitative Electrical System	
Purpose of Inspection:	Maintenance IR Scan (After PM)	
Certified Thermographer:	Mr. Thirasak Nampor	
Certification Number:	Certificate Level-I No. 1-000929	
Equipment Used:	Flir E53	S/N : 84503823
No of thermograms :	78	
Comments:	The results of the examination. Measurement of electrical heat of electrical equipment according to plan of work. No defects are found that cause damage and do not cause harm to the use and maintenance of electrical equipment should be maintained in good condition.

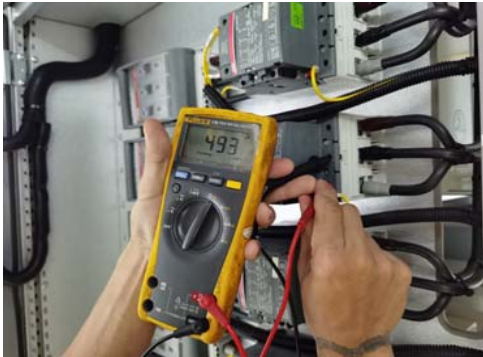
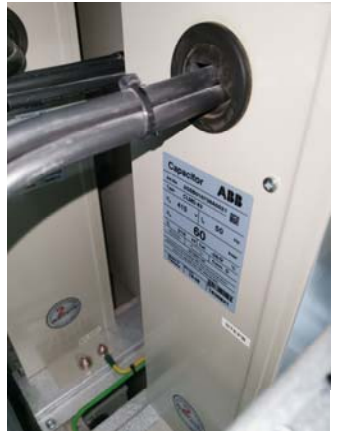
Item	Equipments	Status	Faulty list	Corrective Action	Remark
1	<ul style="list-style-type: none"> ● CAP. BANK2 / Capacitor / Brand : ABB Type : CLMD63 Qn: 60 kVar Un : 415 V 	Abnormal	- Capacitor step no.2 เสื่อมสภาพ

ควรทำการเปลี่ยน Capacitor ใหม่ <input type="checkbox"/> แก้ไขโดยเร่งด่วน <input type="checkbox"/> แก้ไขภายใน.....เดือน <input checked="" type="checkbox"/> ควรวางแผนเปลี่ยนอุปกรณ์ <input type="checkbox"/> ตรวจสอบอุปกรณ์เป็นระยะ	รุ่นที่ใช้งาน :

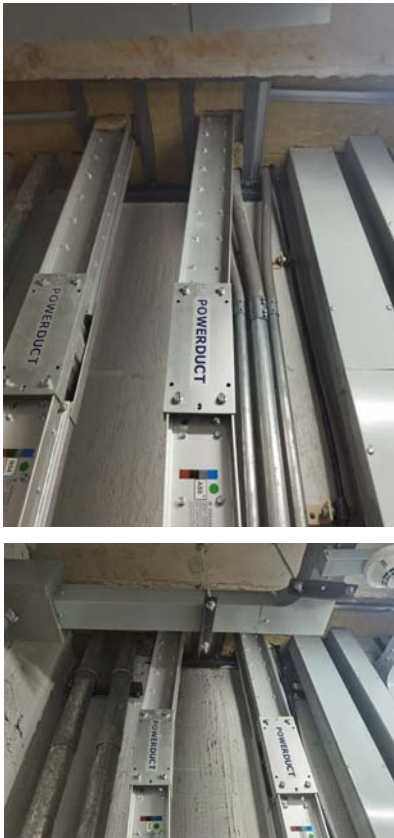
Item	Description	Detail	Suggestion/Recommendation
2	<ul style="list-style-type: none"> BUSDUCT: Brand: POWERDUCT 	<p>ลักษณะของการติดตั้ง Jointing Busduct ตามชั้นต่างๆ Alignment ไม่ตรง (ตัวอย่างเช่นชั้น12,18,19,20,21,22,23,25) ซึ่งคู่มือการติดตั้งใช้งานของบัสดักได้แสดงให้เห็นว่าควรจะติดตั้งให้ Alignment ตรง</p>

<p>แนะนำให้ทำการแก้ไข Alignment ของบัสดักให้ตรง ซึ่งการติดตั้งที่เอียงแบบนี้จะส่งผลให้บัสดักมีปัญหาความร้อนที่จุดต่อได้และอาจส่งผลให้เกิดการ Short circuit ของบัสดักในอนาคตได้</p>

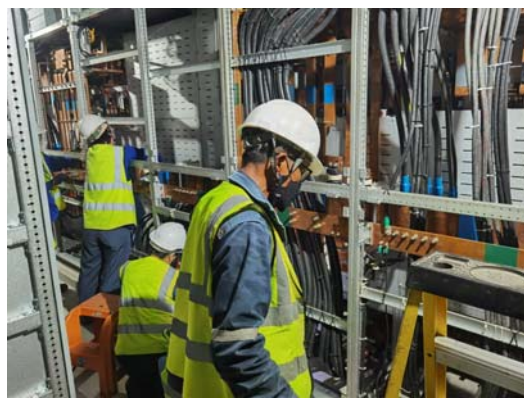
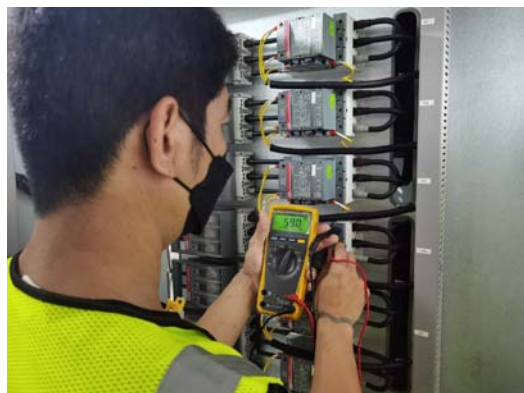
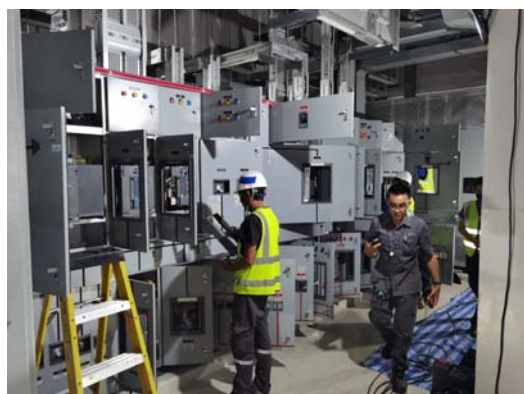
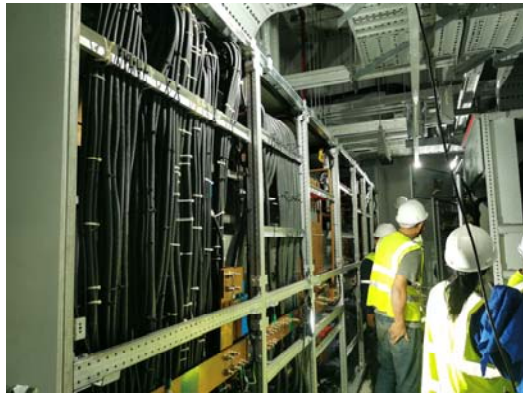
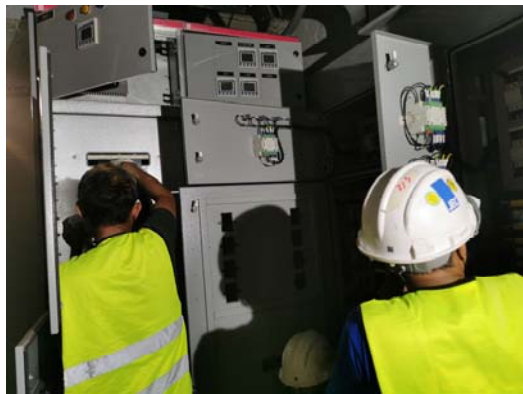
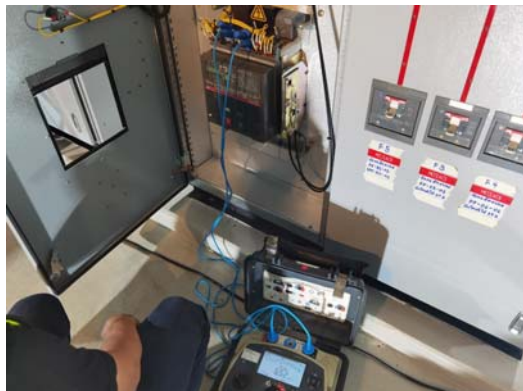
Photo 20-21-22-23-24-25-26-27 : ภาพแสดงการทำ

Preventive Maintenance ตู้ LV MDB, EMDB, Cap. Bank,
MCCB โดยการ Inspection, Cleaning, Tightening torque,
Insulation resistance test
