Suphanburi asset Emergency Flow Chart

CHEMICAL SPILL RESPONSE PLAN FOR
PTTEP SUPHANBURI ASSET PROCEDURE

13250-PDR-SSHE-501/03-R02

MINUTE OF SUPHANBURI SSHE & OPERATION MONTHLY MEETING

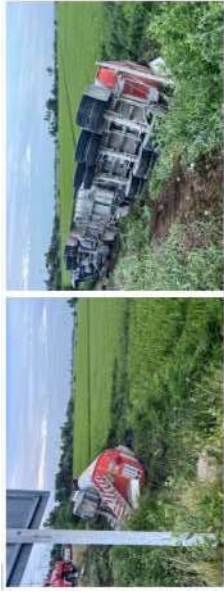
- 1) Recovered the spillage
- 2) Met & discussed with the paddy field owner

The overturned road tanker on the paddy field

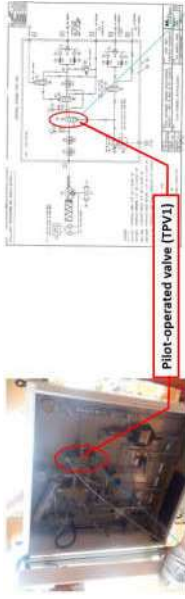
Incident Description At 2100 hrs, the QP2 control room observed the depletion of hyd. oil from the unmanned WP2 reservoir tank. CCR reported the site management and tested the related SDVs for the initial troubleshooting process. The oil level still continued to decrease. The next

morning, the maintenance team was sent to WP2 to investigate and found the leak from the pilot-operated valve (TPV1) inside the local control panel of BDV-20007, due to an internal seal defect. The defective valve was replaced and no further oil leak.

Consequence : 540 liters of hydraulic oil spill on water

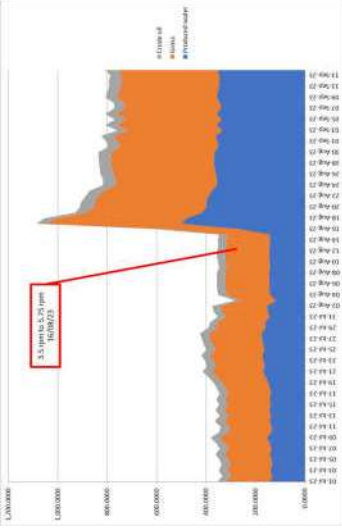
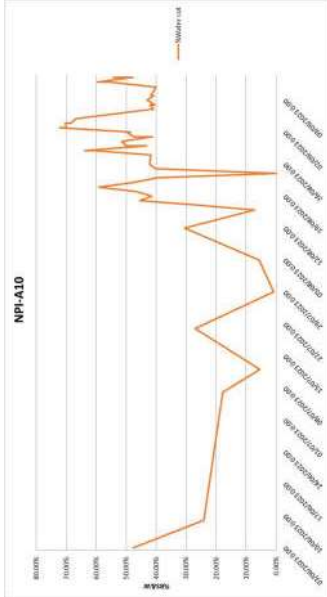
<ul style="list-style-type: none"> Stopped all pumping unit for monthly P.M. D/T = 0.17 hrs.(21/08/2023) <p>Main Highlight Activities:</p> <ul style="list-style-type: none"> Change motor sheave of beam pump at NPI-A10 <table border="1"> <thead> <tr> <th>Well</th><th>Before Speed per minute (RPM)</th><th>After Speed per minute (RPM)</th></tr> </thead> <tbody> <tr> <td>NPI-A10</td><td>3.5</td><td>5.75</td></tr> </tbody> </table> <p>Result each wells : NPI-A10</p>

<p>Result each wells :</p>
