MAINTENANCE REPORT

FOR OVERHAUL VALVE BOILER 21

บริษัท มิตรผล ไบโอ-เพาเวอร์ จำกัด
(อุเวียง)

INK VALVE & SERVICE CO., LTD.
64/9 THOET THAI MUSLIM RD., TAMBON
MAPTAPHUT AMPHUR MUANGRAYONG,
RAYONG 21150 THAILAND
TEL. (66-38) 692-319, 692-326 FAX (66-38) 692-224
E-mail: centerink@inkgroup2005.com

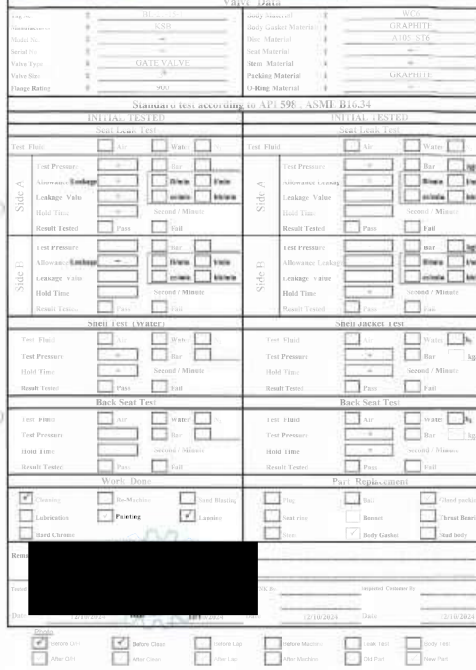
TNK VALVE SERVICE		Test Report For Manual Valve		Page 1
CUSTOMER : (Sri Lanka Air Force Engineering Unit Colombo)		JOB NO. : 0524110001

TNK VALVE SERVICE		PICTURE INSPECTION REPORT		Page 3
CUSTOMER : (Sri Lanka Air Force Engineering Unit Colombo)		TAG NO. : BL-21-14		
  <p>The condition of the globe valve before maintenance.</p>				
  <p>The condition of the globe valve after maintenance.</p>				
  <p>The condition of body valve was dirty before clean and inspection.</p>				
  <p>The inner of body valve is good condition after clean.</p>

TNK VALVE SERVICE		PICTURE INSPECTION REPORT		Page 4
CUSTOMER : (Sri Lanka Air Force Engineering Unit Colombo)		TAG NO. : BL-21-14		
  <p>The metal touch surface of the plug & seat was scratch by before wearing & re-machine.</p>				
  <p>The metal touch surface of the plug & seat is good repaired after wearing & re-machine.</p>				
  <p>The metal touch surface of the plug & seat was scratch by before lapping.</p>				
  <p>The metal touch surface of the plug & seat is good repaired after lapping.</p>				
  <p>The condition of the part gland packing and body gasket after disassembly valve.</p>				
  <p>The change new of gland packing and body gasket before assembling the valve.</p>
