Diamond Condominium – MDB PM2024

Maintenance Report

Date of work : 25 July 2024

Preventive maintenance of MDB

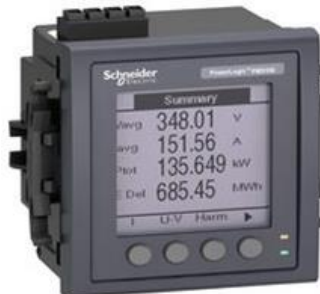
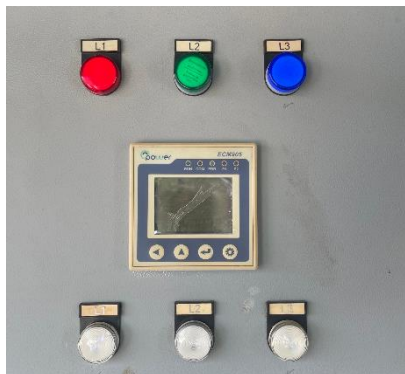
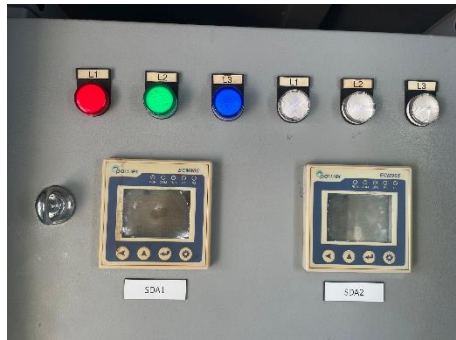
Item	Equipments	Status	Faulty list	Corrective Action	Remark
Diamond Condominium (EE Substation – MDB-1, MDB-4)					
1.	"Power Meter" Panel name : MDB-1, MDB-4 Load name : (Main MDB-1, SDA1, SDA2, EMER), (Main MDB-4, SDD1, SDD2 ,EMER) Brand : Power Type : ECM095	No Comply / Minor	ตรวจพบ Power Logic เลื่อนราง แสดงผลไม่ชัดเจน <u>อุปกรณ์ทดแทน</u> - Power Logic PM5350 <u>Damages list</u> Total : 8 EA

ควรทำการเปลี่ยน Power Logic ให้เป็นรุ่นใหม่เนื่องจากอุปกรณ์ดังกล่าวได้เลิกผลิตไปแล้ว (Obsolete) <div style="display: flex; flex-direction: column; gap: 5px;"> <div><input type="checkbox"/> แก้ไขโดยเร่งด่วน</div> <div><input type="checkbox"/> แก้ไขภายใน.....เดือน</div> <div><input checked="" type="checkbox"/> ควรวางแผนเปลี่ยนอุปกรณ์</div> <div><input type="checkbox"/> ตรวจสอบอุปกรณ์เป็นระยะ</div> </div>

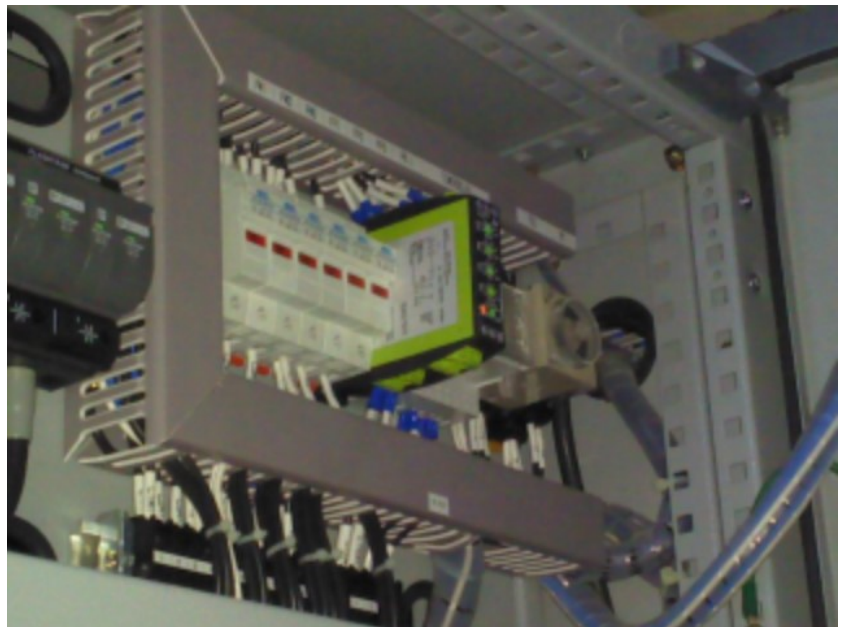
Location :	EE ROOM
Equipment :	MDB
Detail :	Fuse and Relay Control
Comment :	Normal operation, Not found hotspot
	Should also keep for your future reference

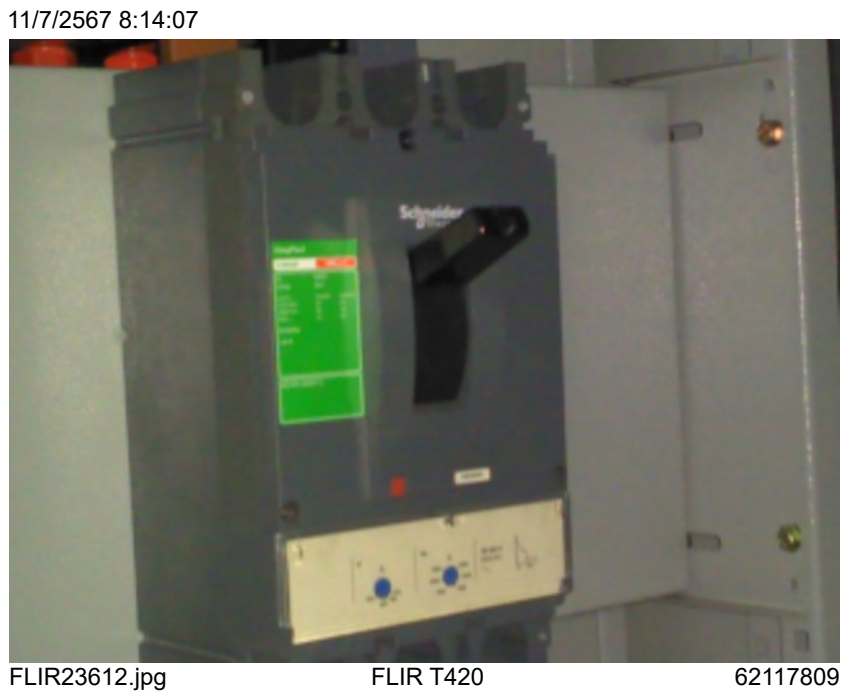
Location :	EE ROOM
Equipment :	MDB
Detail :	MCCB For Branch
Comment :	Normal operation, Not found hotspot
	Should also keep for your future reference

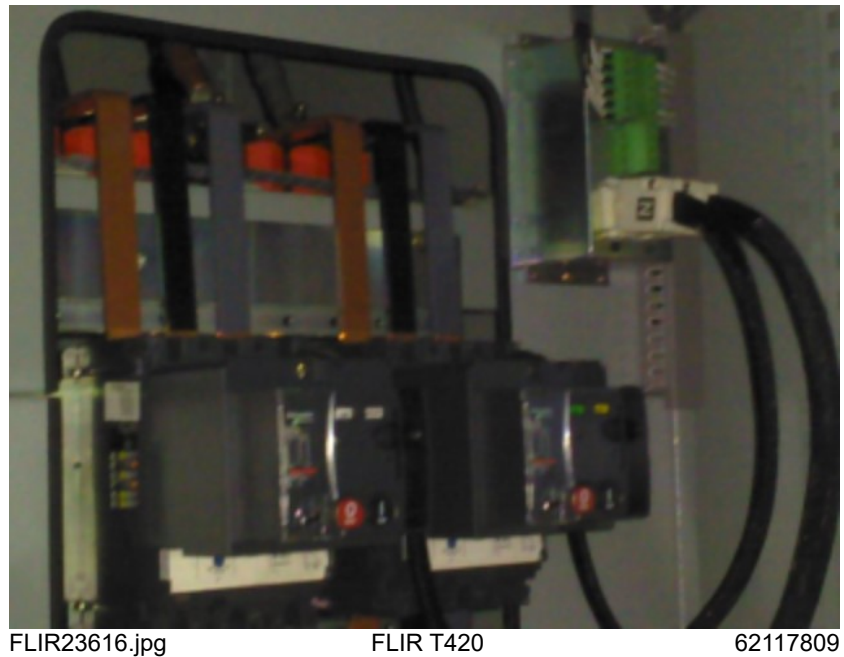
11/7/2567 8:15:01

Location :	EE ROOM
Equipment :	MDB
Detail :	MCCB For Branch
Comment :	Normal operation, Not found hotspot
	Should also keep for your future reference

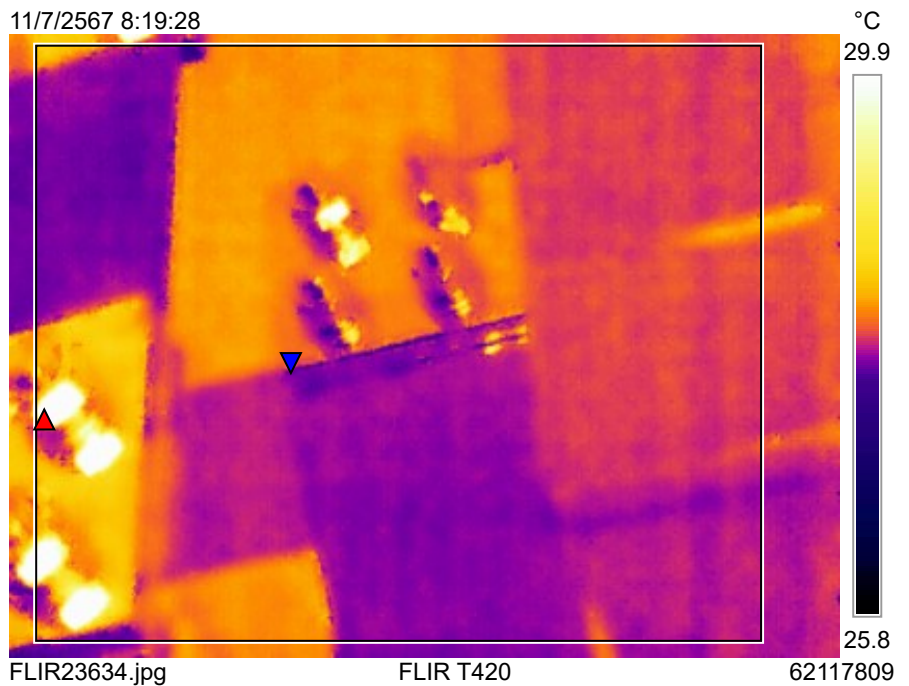
Location :	EE ROOM
Equipment :	MDB
Detail :	Main Cable and Busbar Connection
Comment :	Normal operation, Not found hotspot
	Should also keep for your future reference

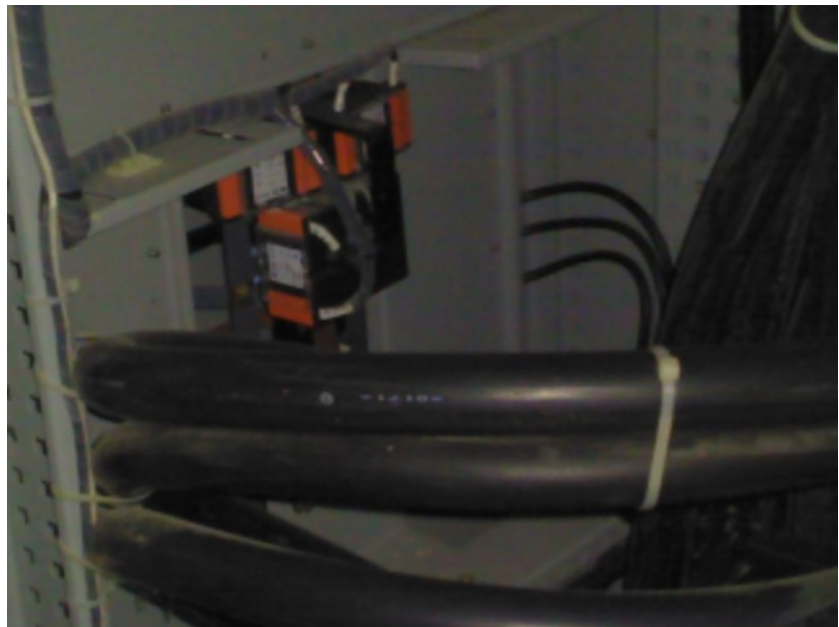
FLIR23640.jpg

Measurements °C		
Ar1	Max	31.6
	Min	26.0
	Average	26.5

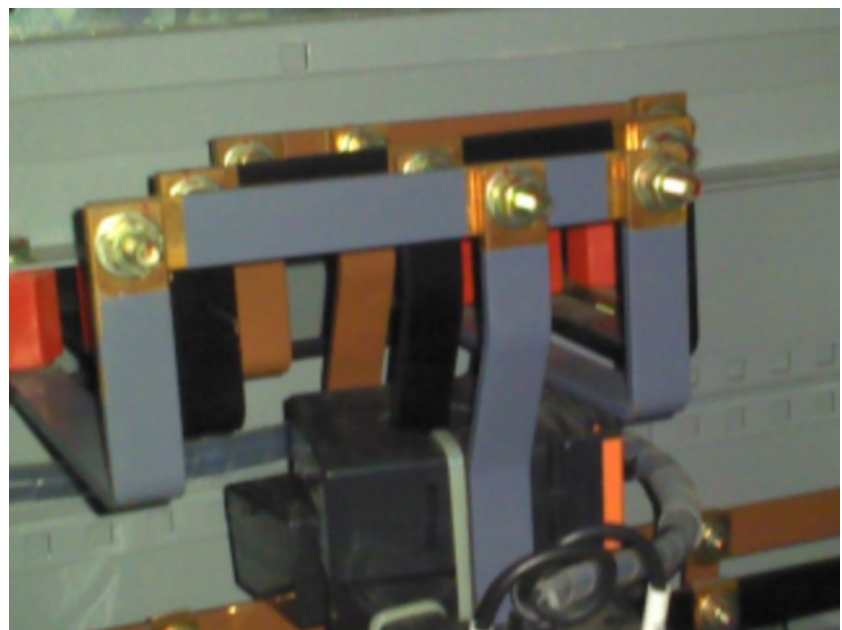
Location :	EE ROOM
Equipment :	MDB
Detail :	Main Cable and Busbar Connection
Comment :	Normal operation, Not found hotspot
	Should also keep for your future reference

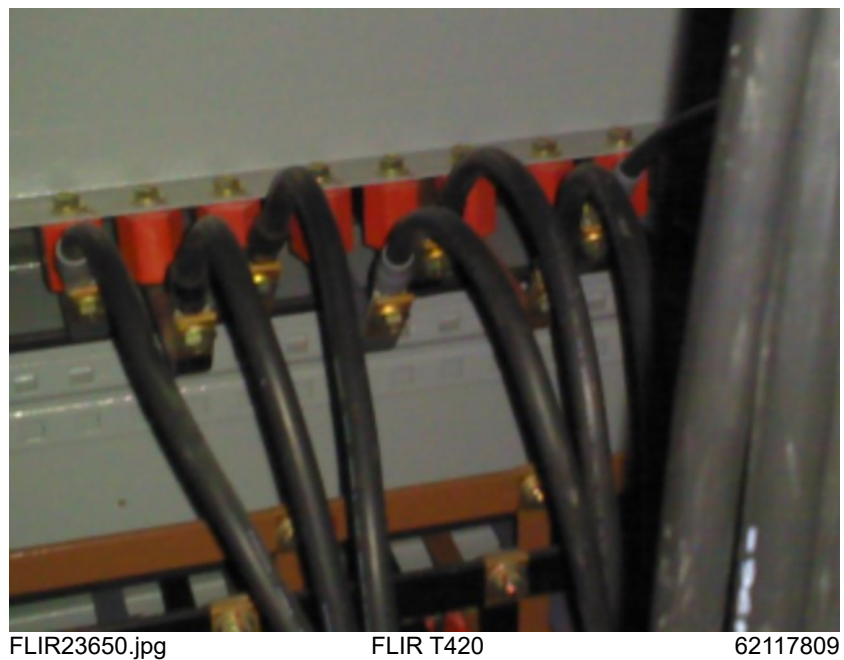
11/7/2567 8:22:19

Location :	EE ROOM
Equipment :	MDB
Detail :	Main Cable and Busbar Connection
Comment :	Normal operation, Not found hotspot
	Should also keep for your future reference

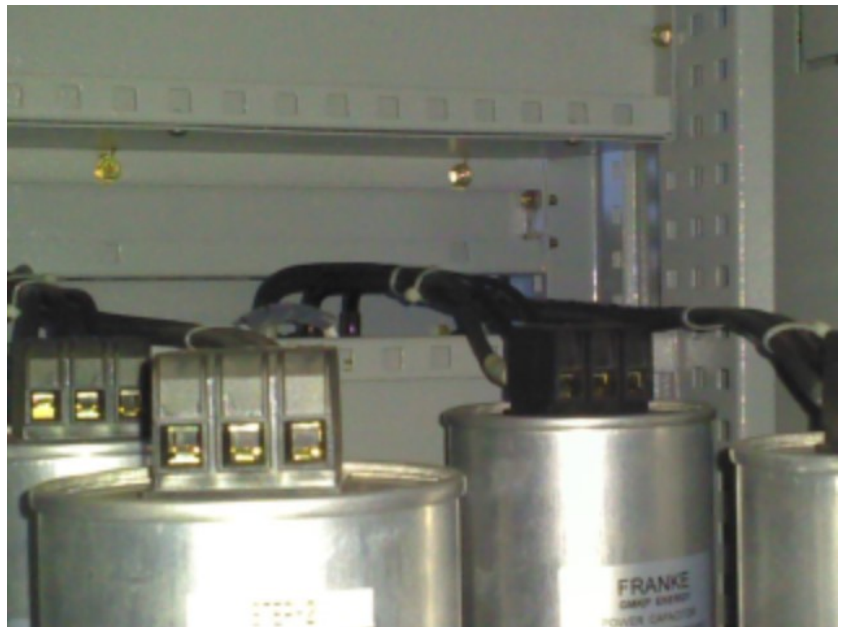
Location :	EE ROOM
Equipment :	MDB
Detail :	Capacitor Bank
Comment :	Normal operation, Not found hotspot
	Should also keep for your future reference

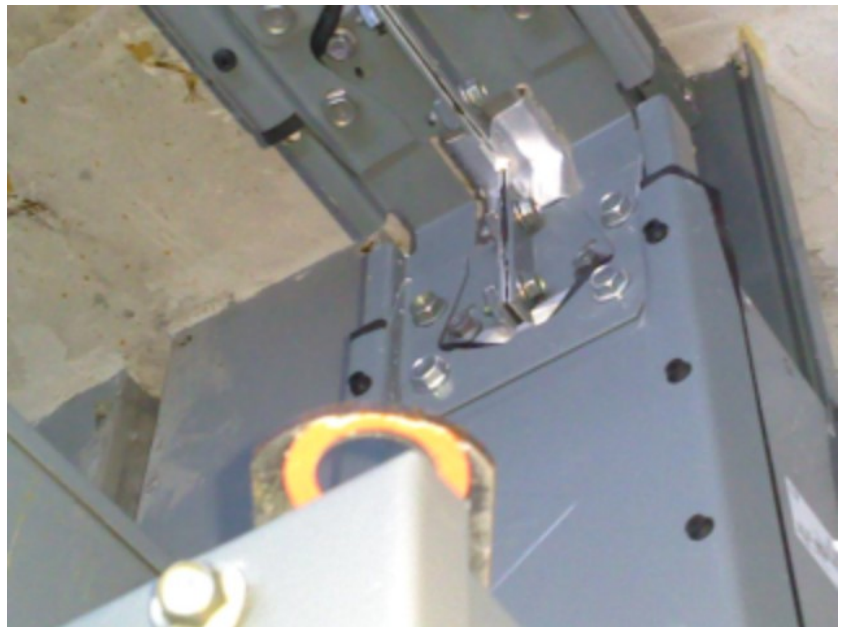
Location :	EE ROOM
Equipment :	Busduct
Detail :	Main Cable and Busbar Connection
Comment :	Normal operation, Not found hotspot
	Should also keep for your future reference

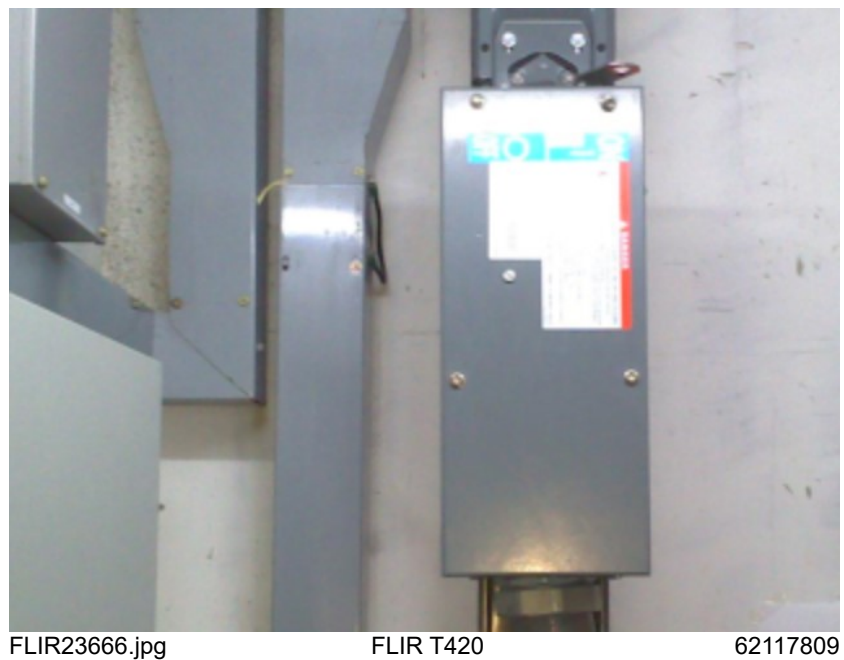
11/7/2567 8:39:33

Location :	EE ROOM
Equipment :	Busduct
Detail :	Main Cable and Busbar Connection
Comment :	Normal operation, Not found hotspot
	Should also keep for your future reference

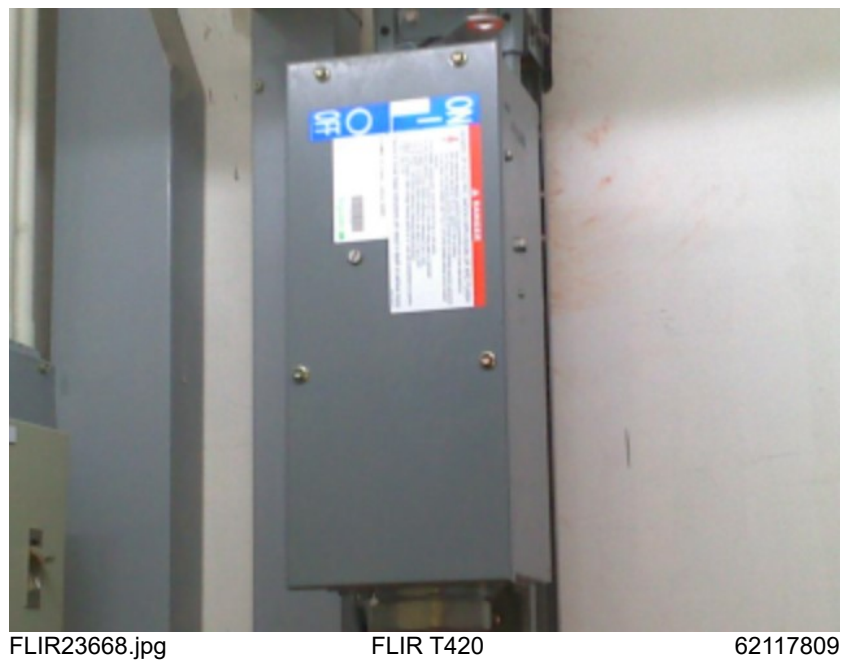
11/7/2567 8:44:23

Location :	EE ROOM
Equipment :	Busduct
Detail :	Main Cable and Busbar Connection
Comment :	Normal operation, Not found hotspot
	Should also keep for your future reference

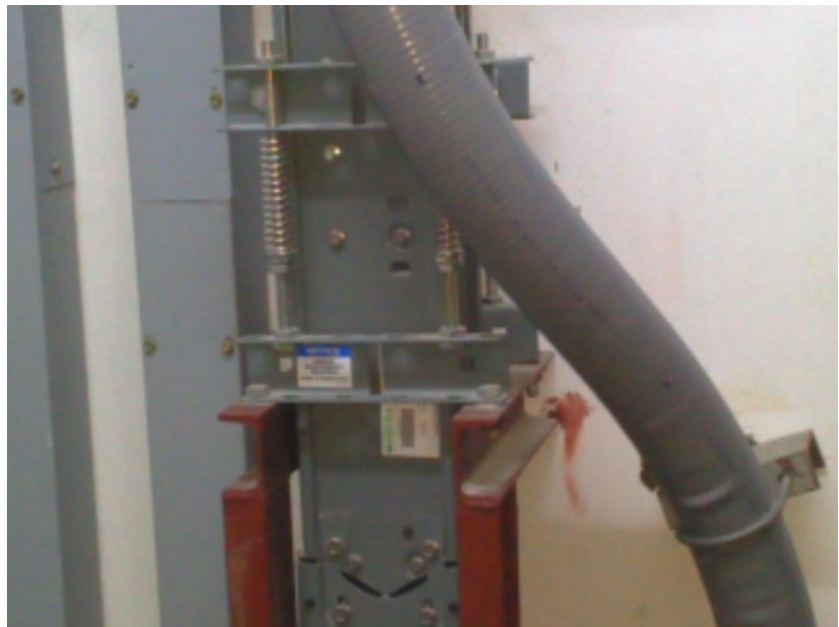
Location :	EE ROOM
Equipment :	Busduct
Detail :	Main Cable and Busbar Connection
Comment :	Normal operation, Not found hotspot
	Should also keep for your future reference

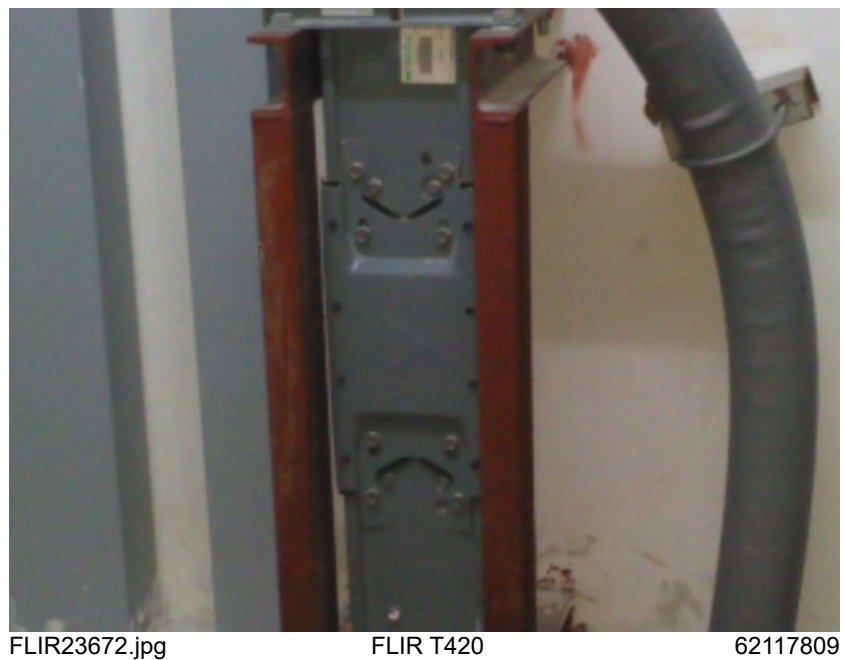
11/7/2567 8:45:48

Location :	EE ROOM
Equipment :	Busduct
Detail :	Main Cable and Busbar Connection
Comment :	Normal operation, Not found hotspot
	Should also keep for your future reference

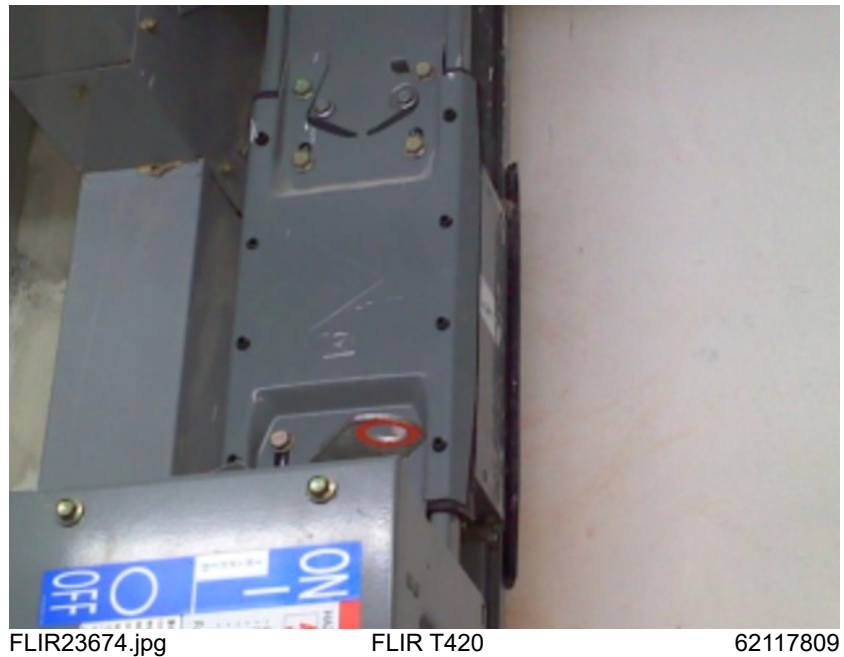
11/7/2567 8:47:42

Location :	EE ROOM
Equipment :	Busduct
Detail :	Main Cable and Busbar Connection
Comment :	Normal operation, Not found hotspot
	Should also keep for your future reference

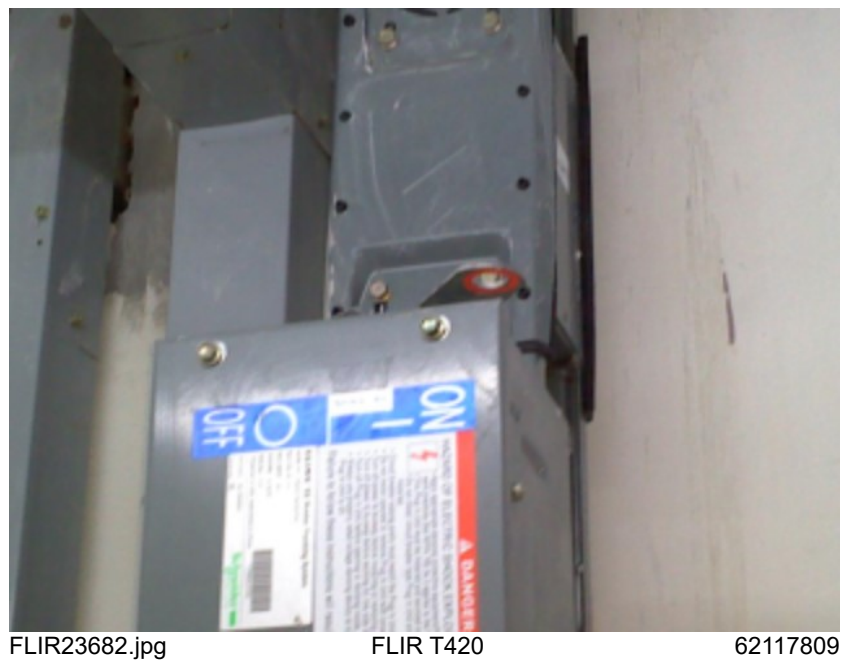
11/7/2567 8:50:09

Location :	EE ROOM
Equipment :	Busduct
Detail :	Main Cable and Busbar Connection
Comment :	Normal operation, Not found hotspot
	Should also keep for your future reference

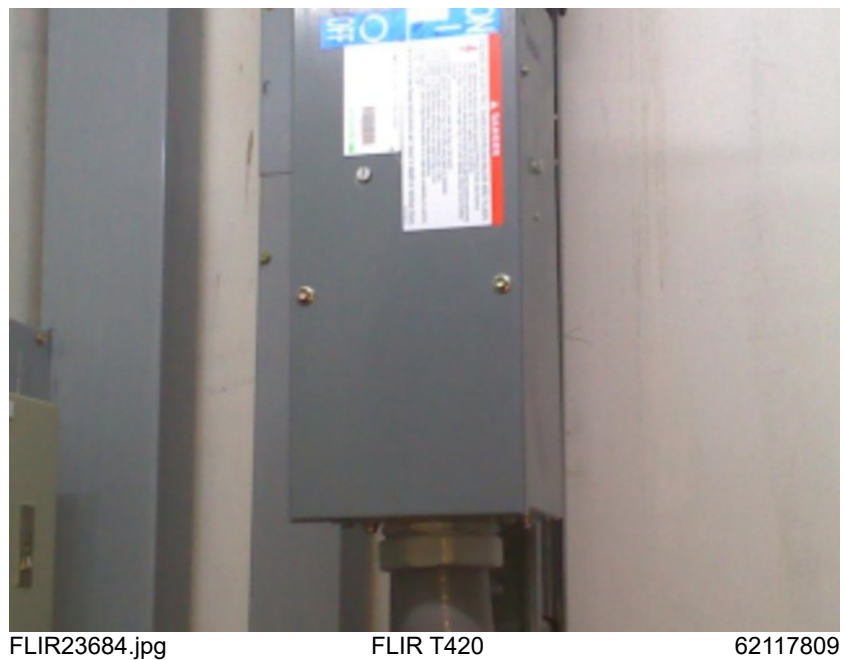
11/7/2567 8:50:25

Location :	EE ROOM
Equipment :	Busduct
Detail :	Main Cable and Busbar Connection
Comment :	Normal operation, Not found hotspot
	Should also keep for your future reference

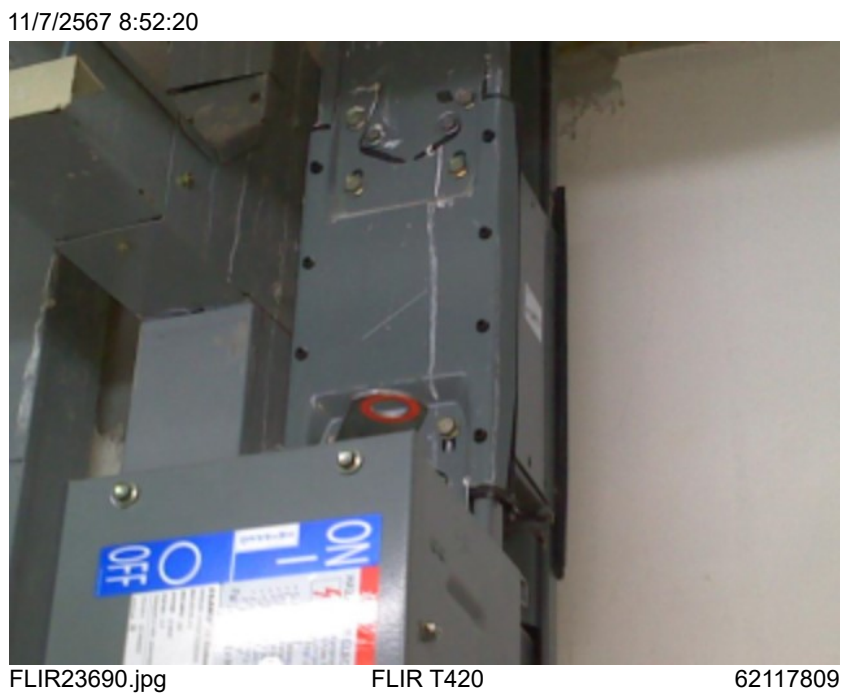
Location :	EE ROOM
Equipment :	Busduct
Detail :	Main Cable and Busbar Connection
Comment :	Normal operation, Not found hotspot
	Should also keep for your future reference

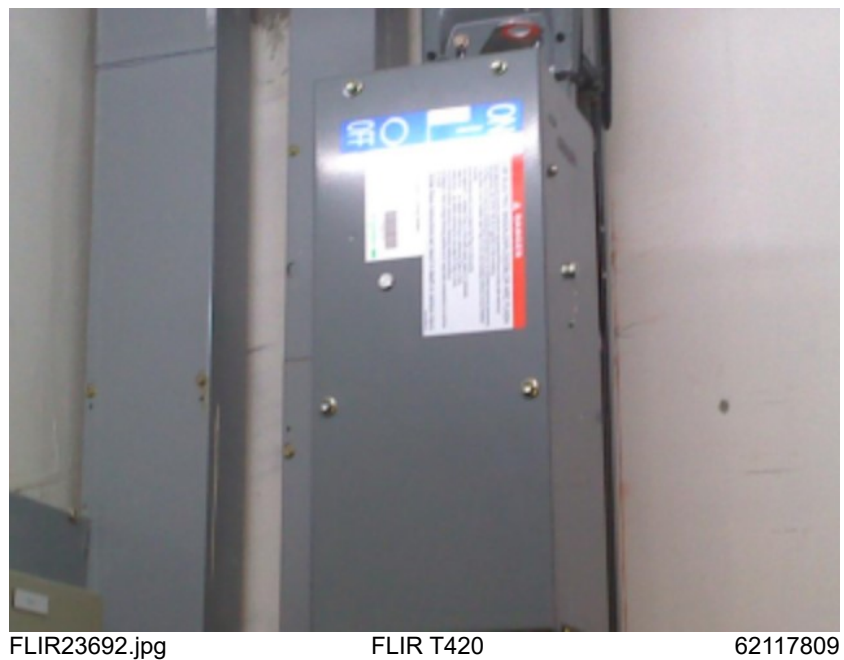
11/7/2567 8:52:31

Location :	EE ROOM
Equipment :	Busduct
Detail :	Main Cable and Busbar Connection
Comment :	Normal operation, Not found hotspot
	Should also keep for your future reference

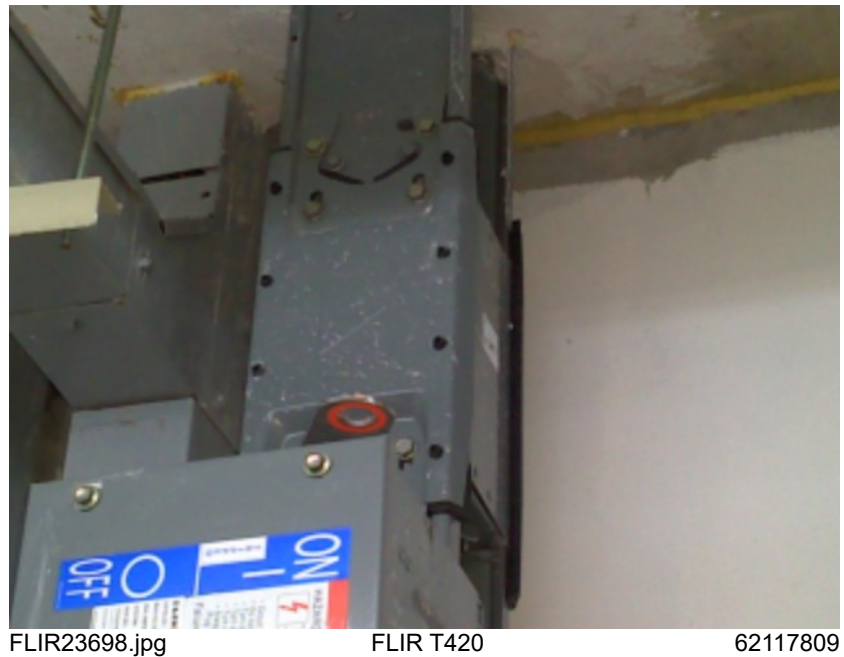
11/7/2567 8:54:36

Location :	EE ROOM
Equipment :	Busduct
Detail :	Main Cable and Busbar Connection
Comment :	Normal operation, Not found hotspot
	Should also keep for your future reference

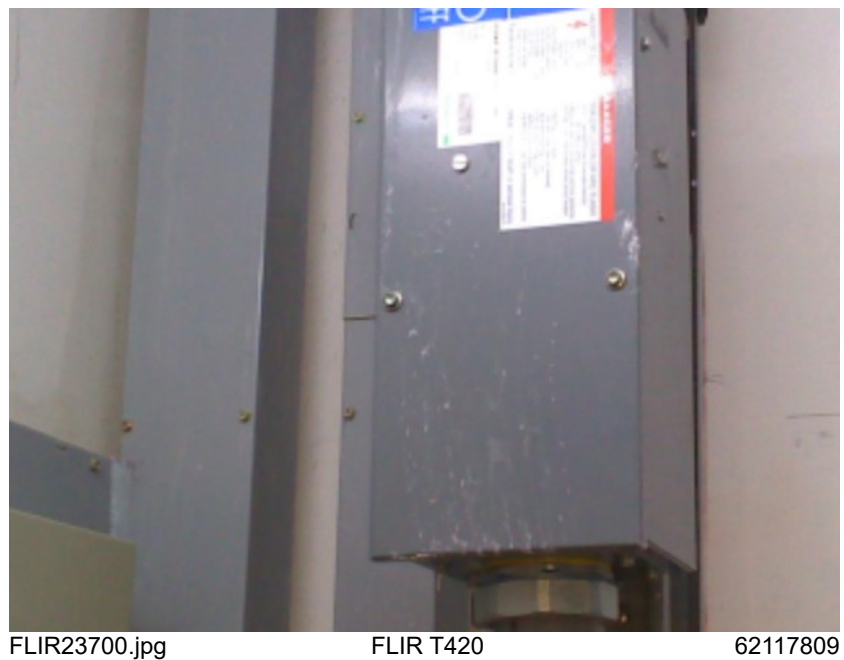
11/7/2567 8:54:48

Location :	EE ROOM
Equipment :	Busduct
Detail :	Main Cable and Busbar Connection
Comment :	Normal operation, Not found hotspot
	Should also keep for your future reference

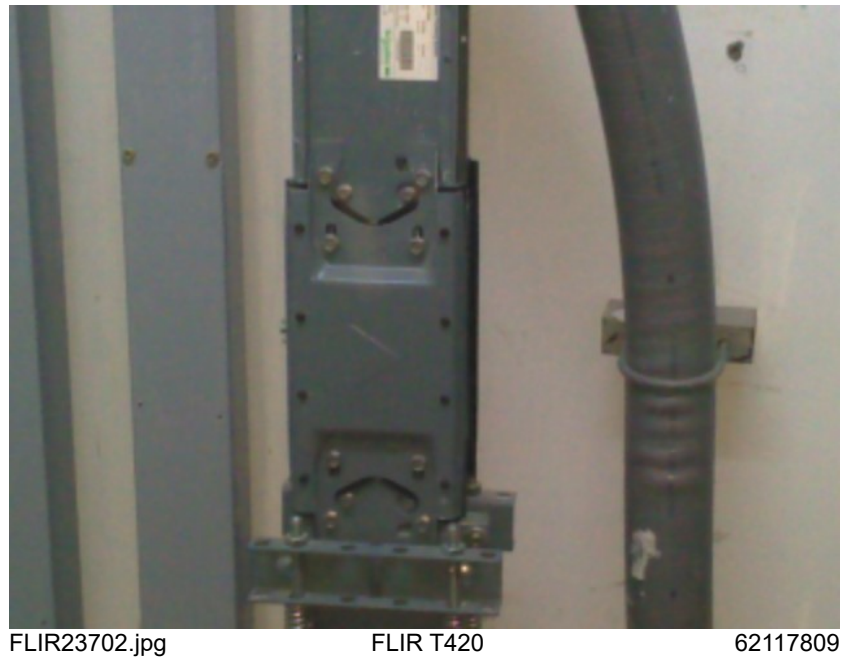
11/7/2567 8:55:10

Location :	EE ROOM
Equipment :	Busduct
Detail :	Main Cable and Busbar Connection
Comment :	Normal operation, Not found hotspot
	Should also keep for your future reference

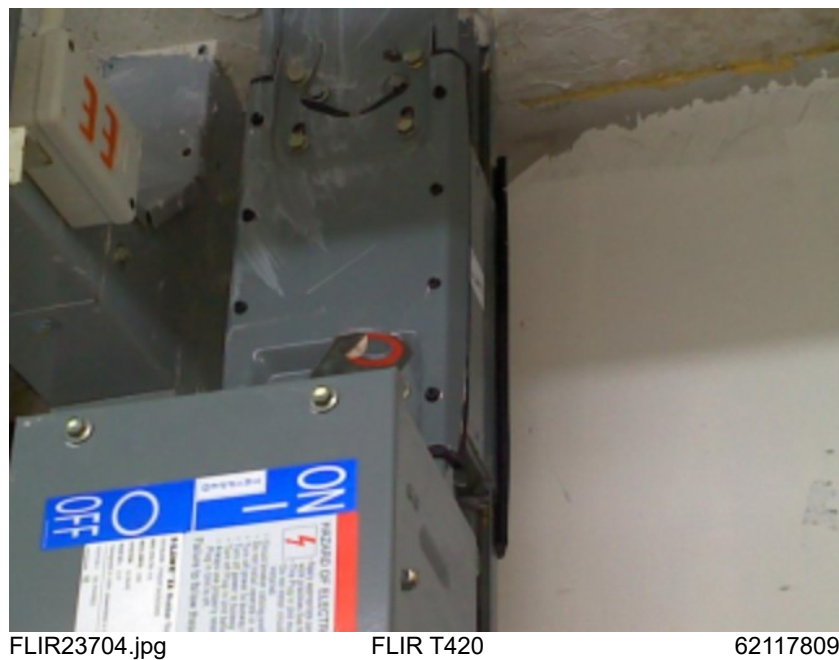
Location :	EE ROOM
Equipment :	Busduct
Detail :	Main Cable and Busbar Connection
Comment :	Normal operation, Not found hotspot
	Should also keep for your future reference

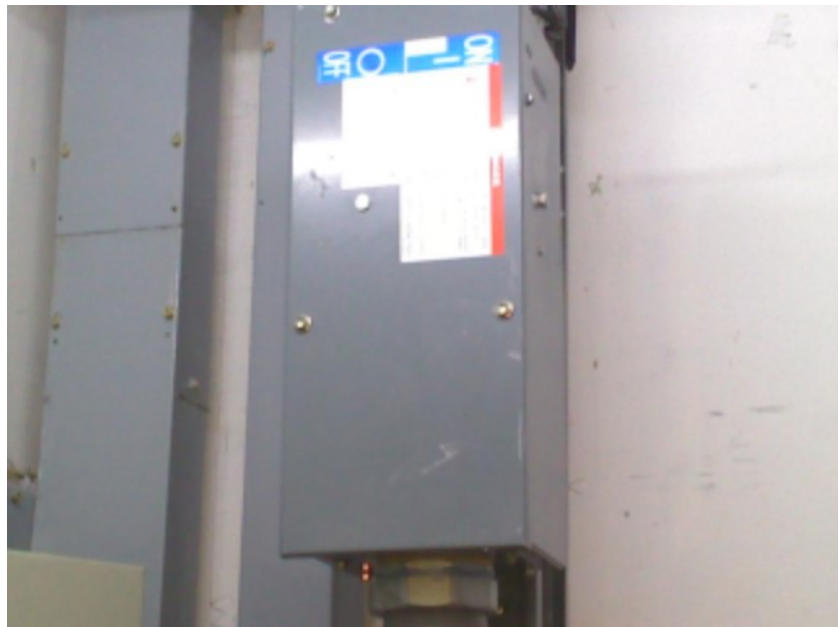
FLIR23706.jpg

Location :	EE ROOM
Equipment :	Busduct
Detail :	Main Cable and Busbar Connection
Comment :	Normal operation, Not found hotspot
	Should also keep for your future reference

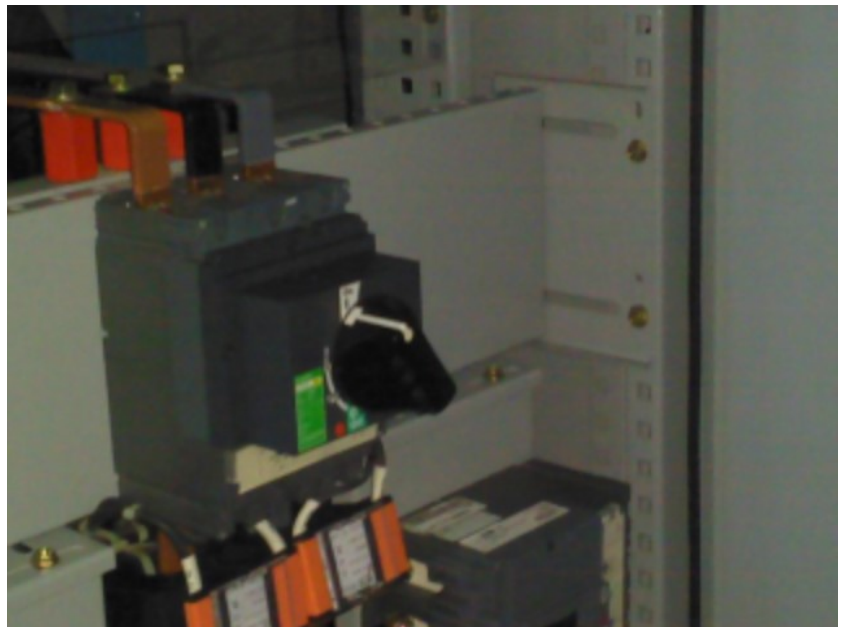
Location :	EE ROOM
Equipment :	MDB
Detail :	MCCB For Branch
Comment :	Normal operation, Not found hotspot
	Should also keep for your future reference

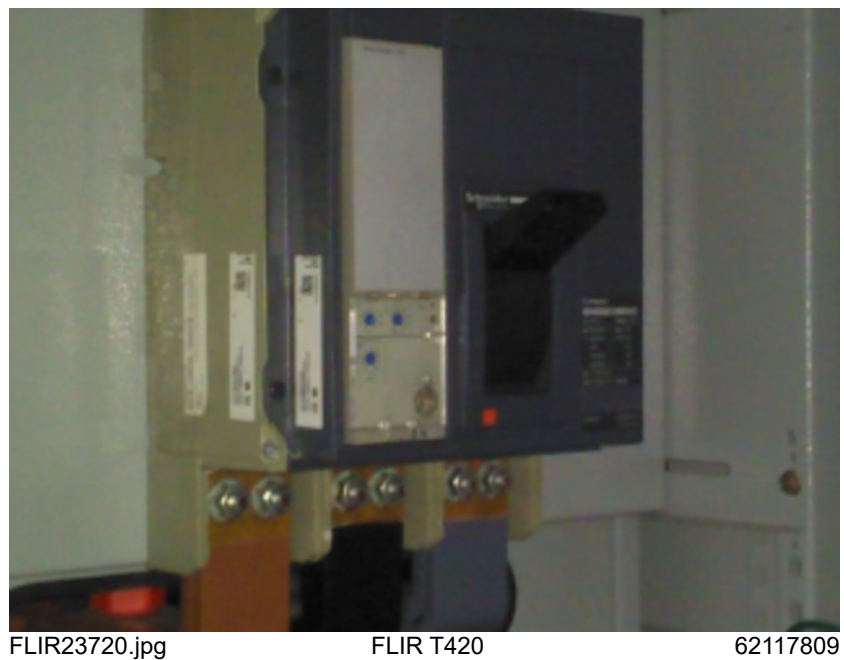
11/7/2567 9:05:29

Location :	EE ROOM
Equipment :	MDB
Detail :	Main ACB
Comment :	Normal operation, Not found hotspot
	Should also keep for your future reference

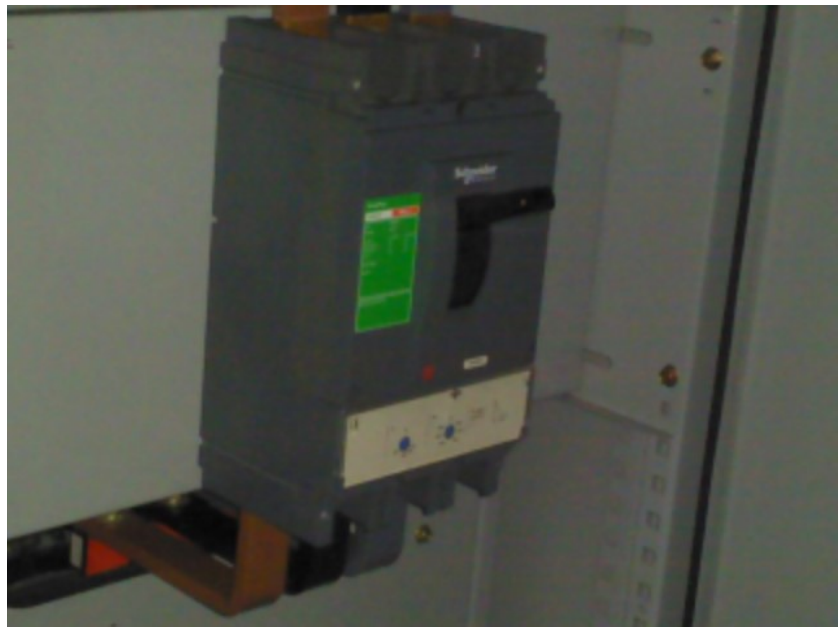
FLIR23722.jpg FLIR T420 62117809

Location :	EE ROOM
Equipment :	MDB
Detail :	MCCB For Branch
Comment :	Normal operation, Not found hotspot
	Should also keep for your future reference

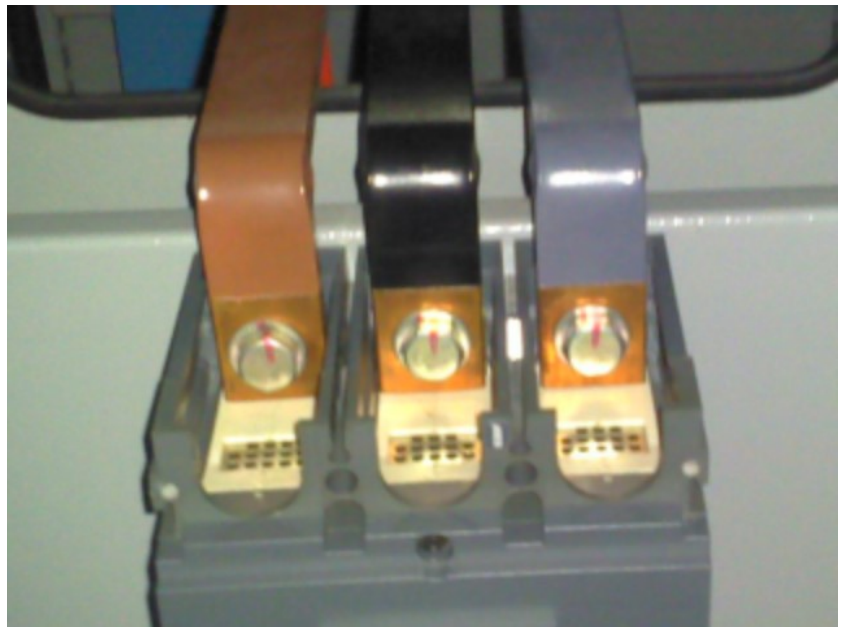
FLIR23724.jpg FLIR T420 62117809

Location :	EE ROOM
Equipment :	MDB
Detail :	Busbar Connection
Comment :	Normal operation, Not found hotspot
	Should also keep for your future reference

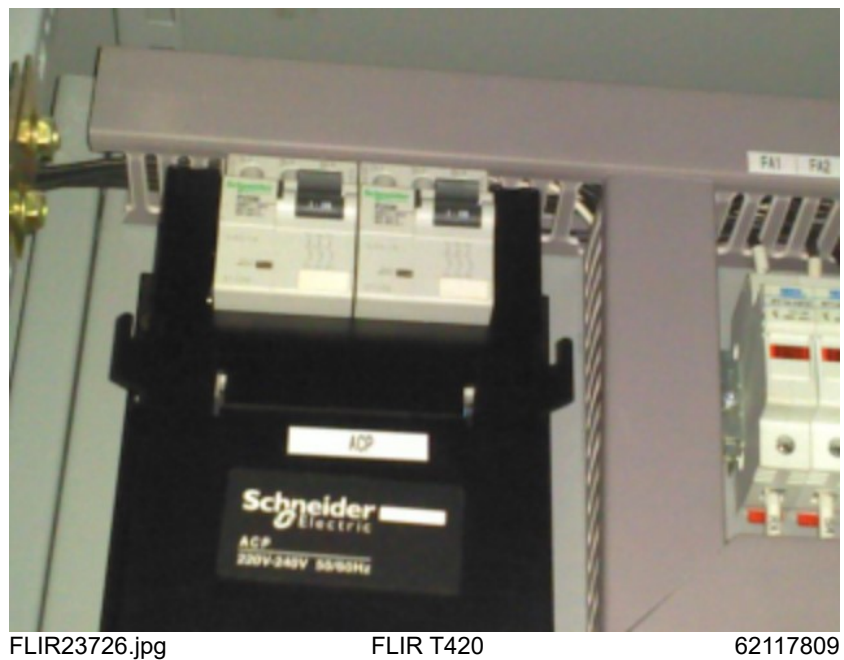
11/7/2567 9:06:30

Location :	EE ROOM
Equipment :	MDB
Detail :	MCCB For Branch
Comment :	Normal operation, Not found hotspot
	Should also keep for your future reference

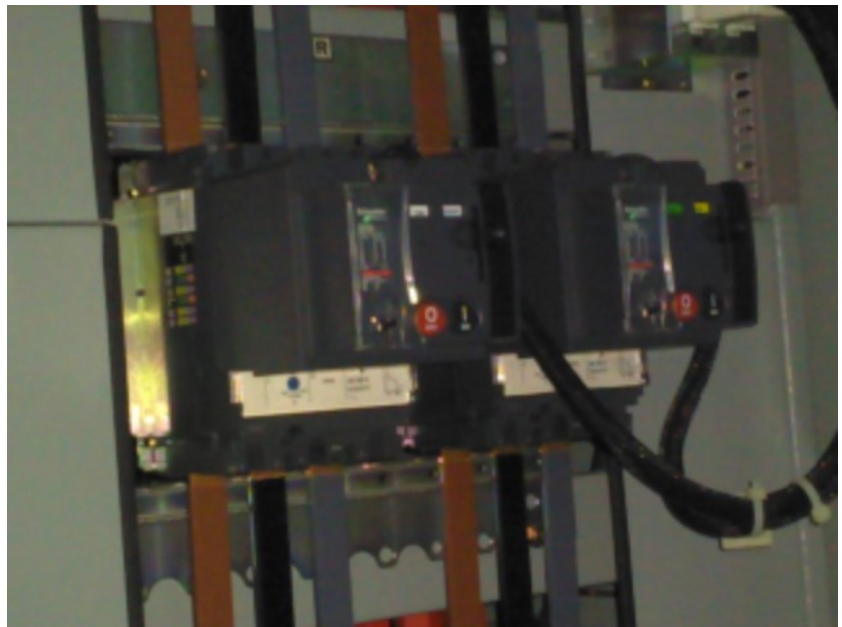
Location :	EE ROOM
Equipment :	MDB
Detail :	MCCB For Branch
Comment :	Normal operation, Not found hotspot
	Should also keep for your future reference

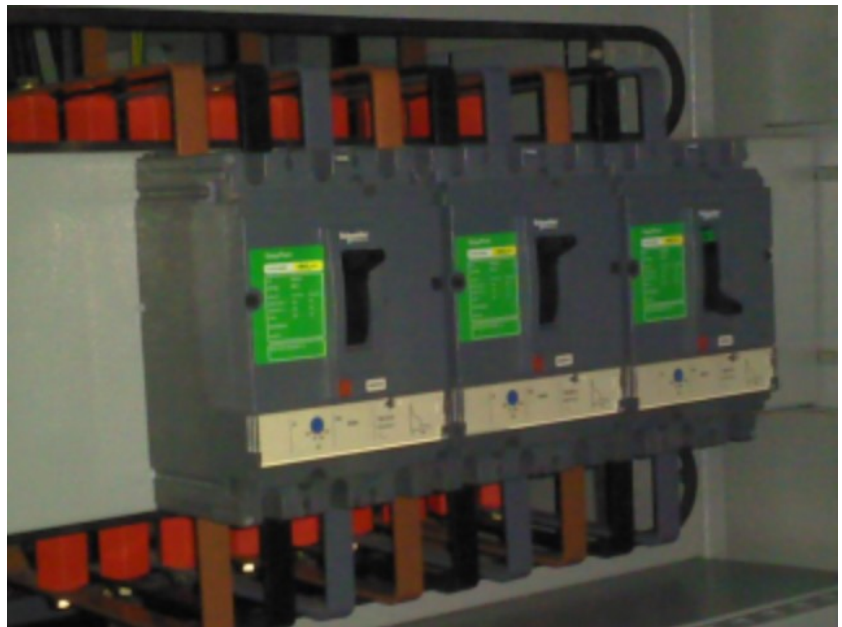
FLIR23732.jpg FLIR T420 62117809

Location :	EE ROOM
Equipment :	MDB
Detail :	MCCB For Branch
Comment :	Normal operation, Not found hotspot
	Should also keep for your future reference

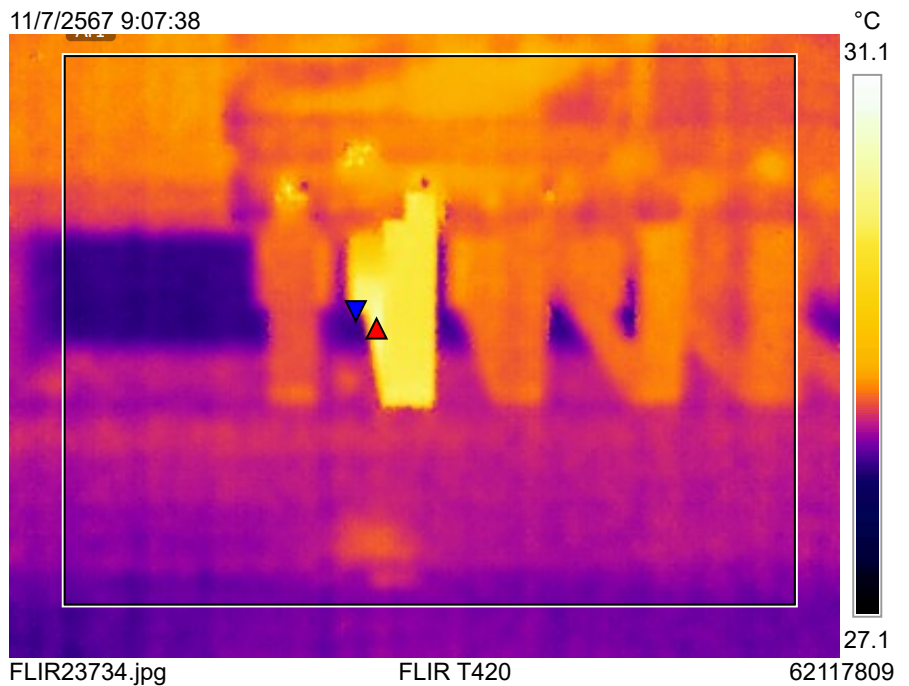
Location :	EE ROOM
Equipment :	MDB
Detail :	MCCB For Branch
Comment :	Normal operation, Not found hotspot
	Should also keep for your future reference

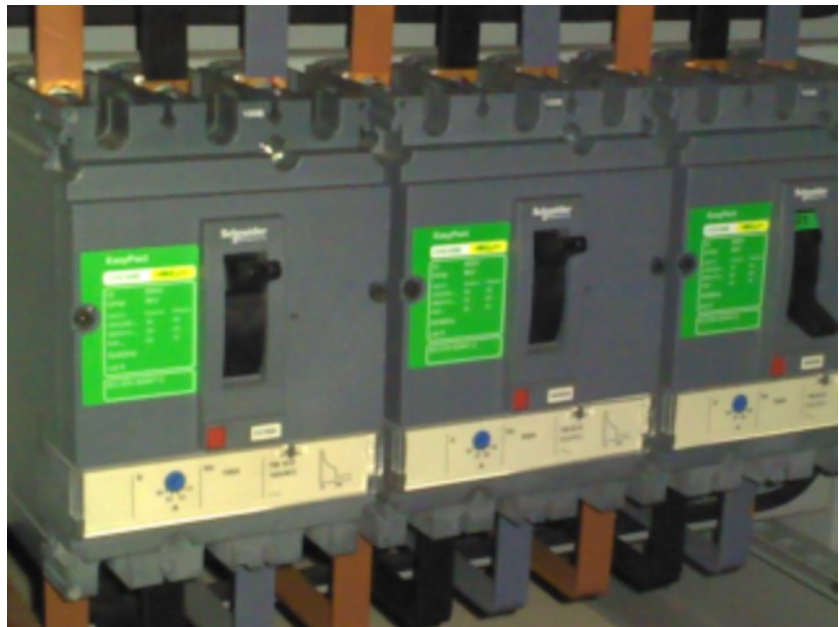
FLIR23736.jpg

Location :	EE ROOM
Equipment :	MDB
Detail :	MCCB For Branch
Comment :	Normal operation, Not found hotspot
	Should also keep for your future reference

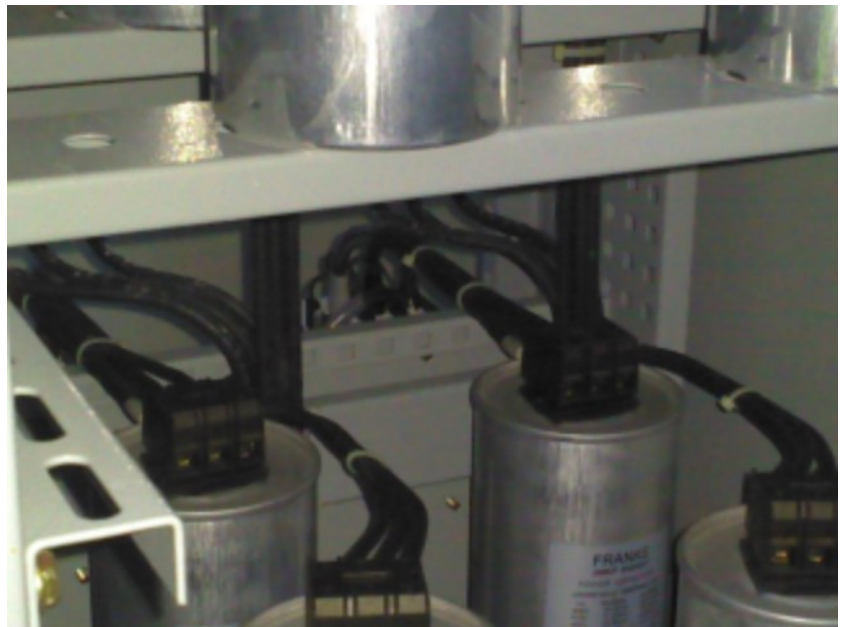
FLIR23746.jpg FLIR T420 62117809

Location :	EE ROOM
Equipment :	MDB
Detail :	Capacitor Bank
Comment :	Normal operation, Not found hotspot
	Should also keep for your future reference

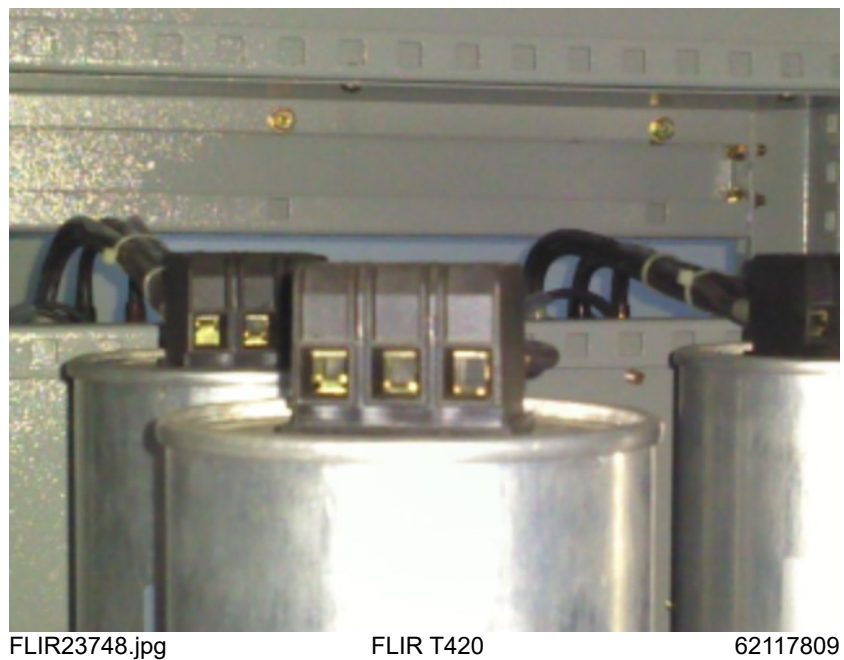
11/7/2567 9:10:29

Location :	EE ROOM
Equipment :	MDB
Detail :	Capacitor Bank
Comment :	Normal operation, Not found hotspot
	Should also keep for your future reference

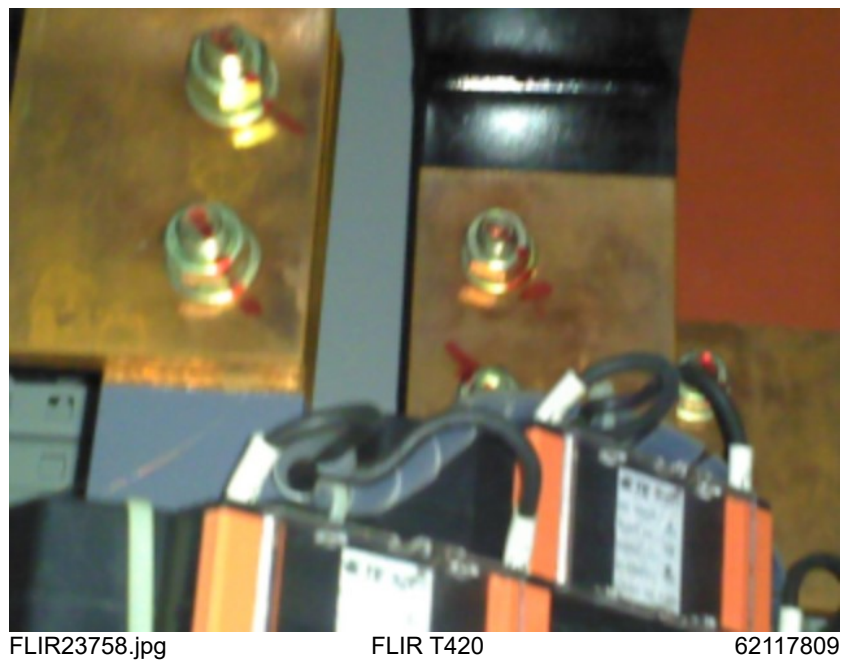
11/7/2567 9:12:11

Location :	EE ROOM
Equipment :	MDB
Detail :	Main Cable and Busbar Connection
Comment :	Normal operation, Not found hotspot
	Should also keep for your future reference

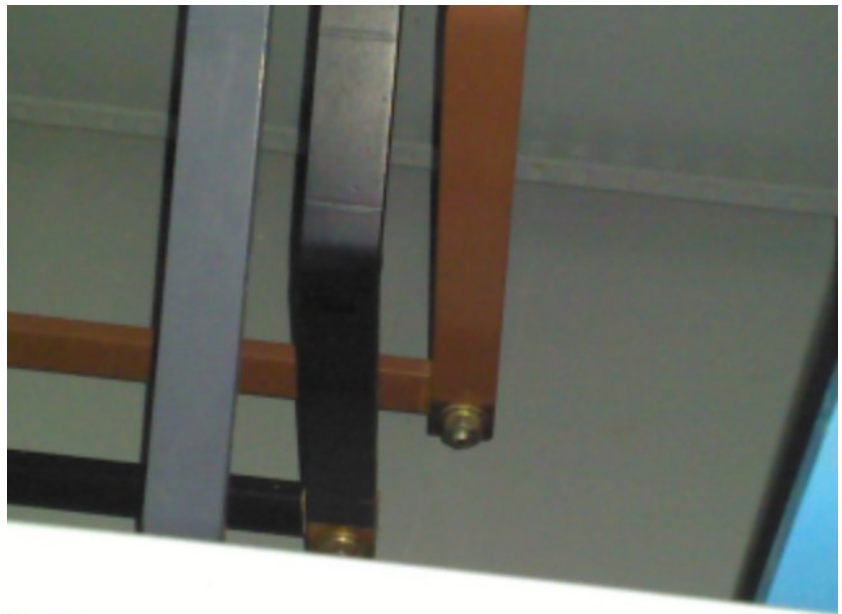
Location :	EE ROOM
Equipment :	MDB
Detail :	Main Cable and Busbar Connection
Comment :	Normal operation, Not found hotspot
	Should also keep for your future reference

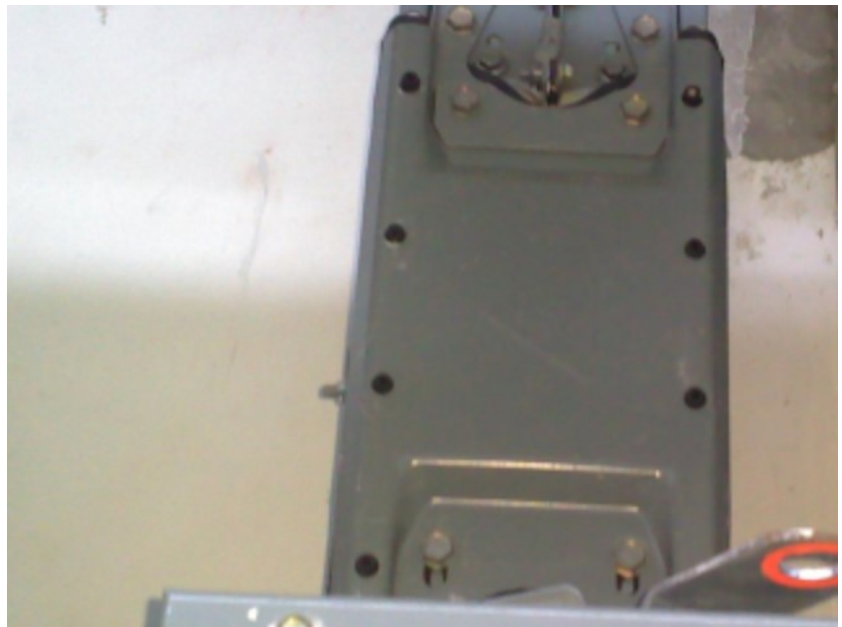
FLIR23778.jpg FLIR T420 62117809

Location :	EE ROOM
Equipment :	Busduct
Detail :	Main Cable and Busbar Connection
Comment :	Normal operation, Not found hotspot
	Should also keep for your future reference
