Diamond Condominium – MDB PM2024

Maintenance Report

Date of work : 25 July 2024

Preventive maintenance of MDB

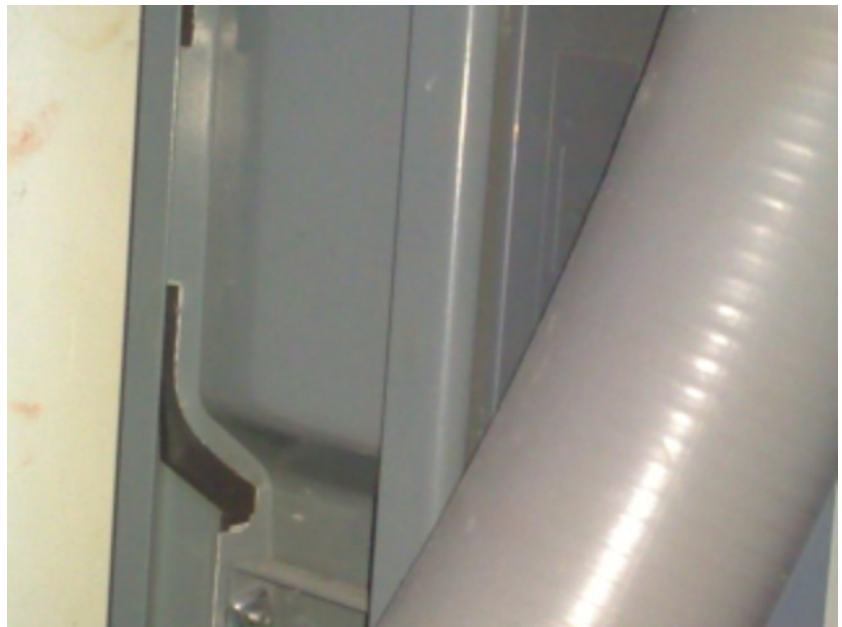
Location :	EE ROOM
Equipment :	Busduct
Detail :	Main Cable and Busbar Connection
Comment :	Normal operation, Not found hotspot
	Should also keep for your future reference

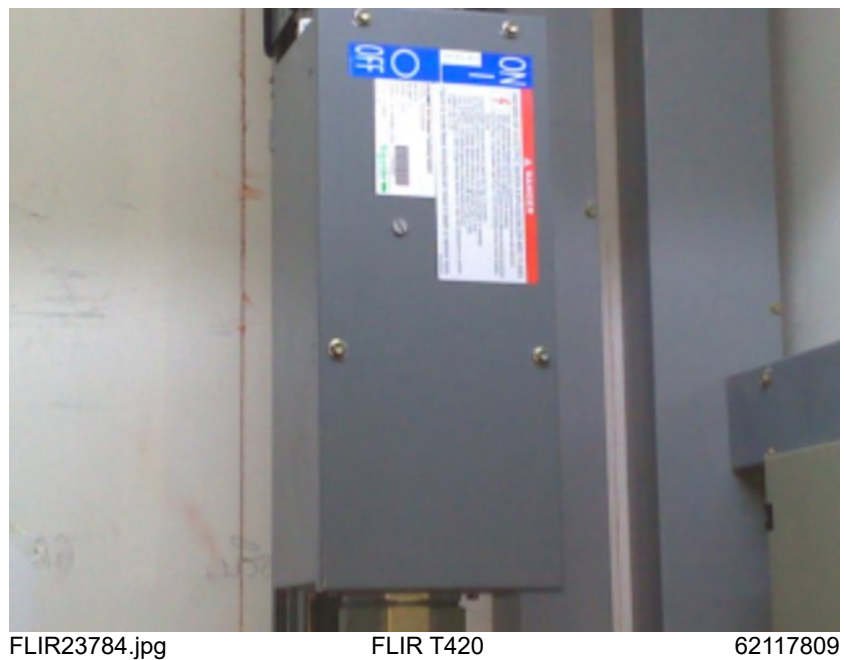
11/7/2567 9:32:10

Location :	EE ROOM
Equipment :	Busduct
Detail :	Main Cable and Busbar Connection
Comment :	Normal operation, Not found hotspot
	Should also keep for your future reference

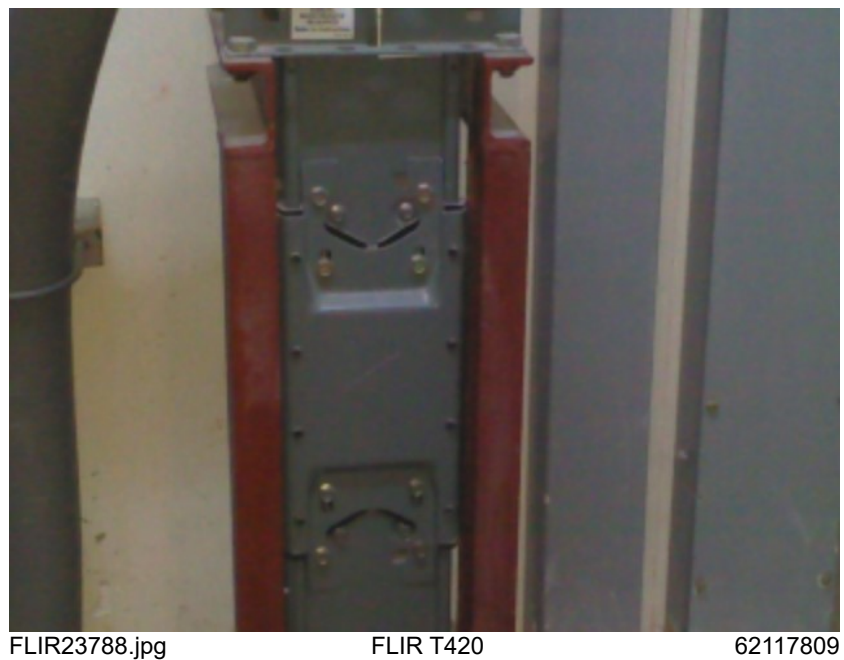
11/7/2567 9:32:50

Location :	EE ROOM
Equipment :	Busduct
Detail :	Main Cable and Busbar Connection
Comment :	Normal operation, Not found hotspot
	Should also keep for your future reference

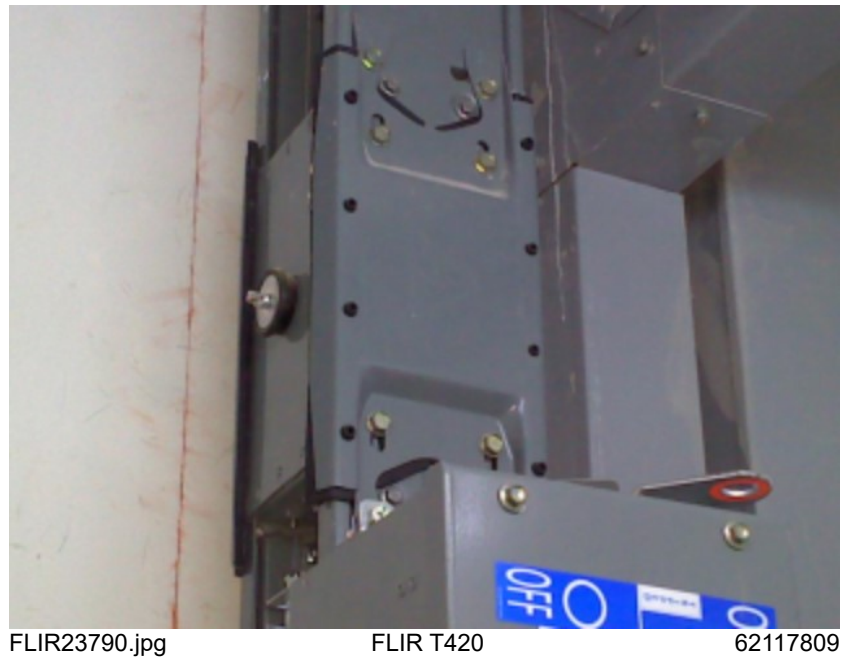
Location :	EE ROOM
Equipment :	Busduct
Detail :	Main Cable and Busbar Connection
Comment :	Normal operation, Not found hotspot
	Should also keep for your future reference

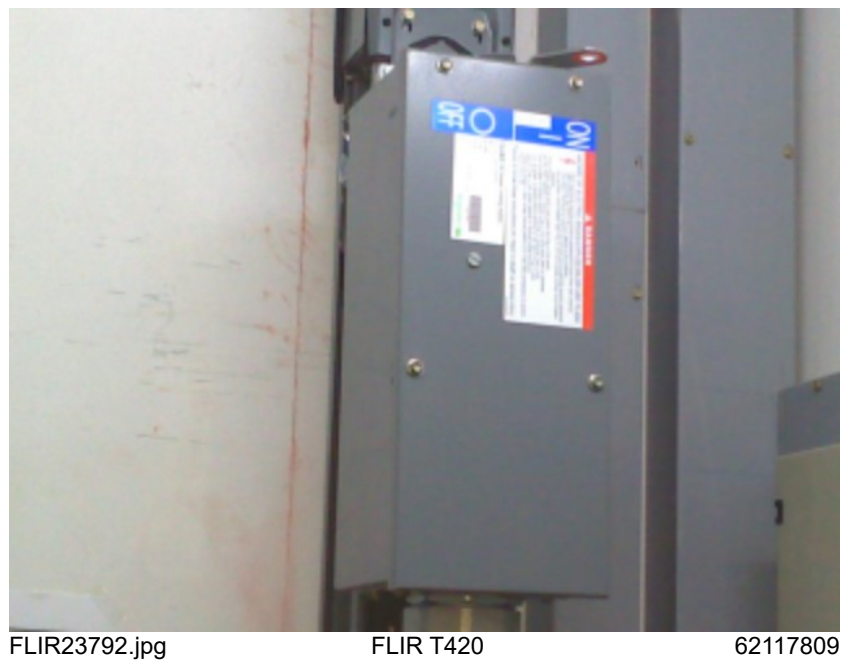
Location :	EE ROOM
Equipment :	Busduct
Detail :	Main Cable and Busbar Connection
Comment :	Normal operation, Not found hotspot
	Should also keep for your future reference

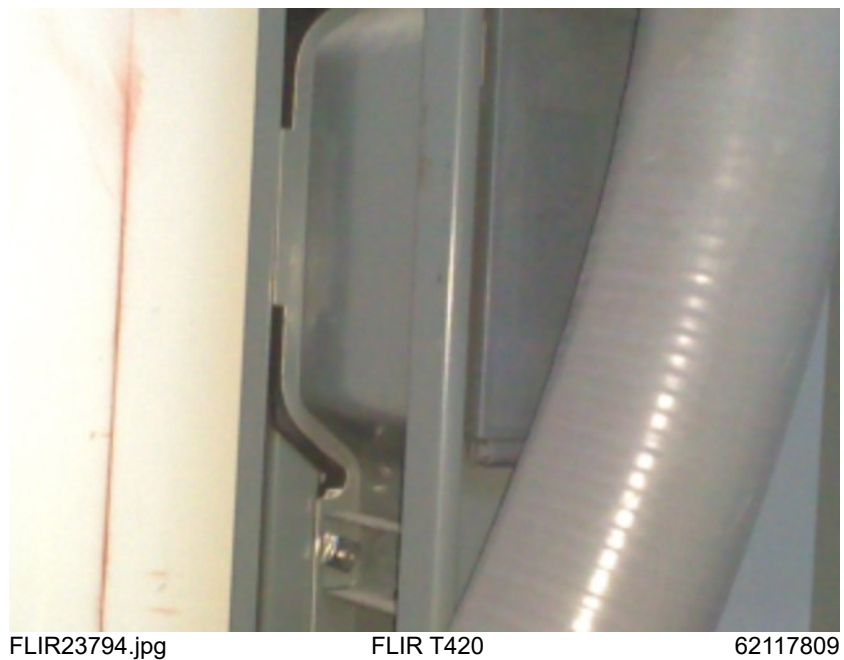
Location :	EE ROOM
Equipment :	Busduct
Detail :	Main Cable and Busbar Connection
Comment :	Normal operation, Not found hotspot
	Should also keep for your future reference

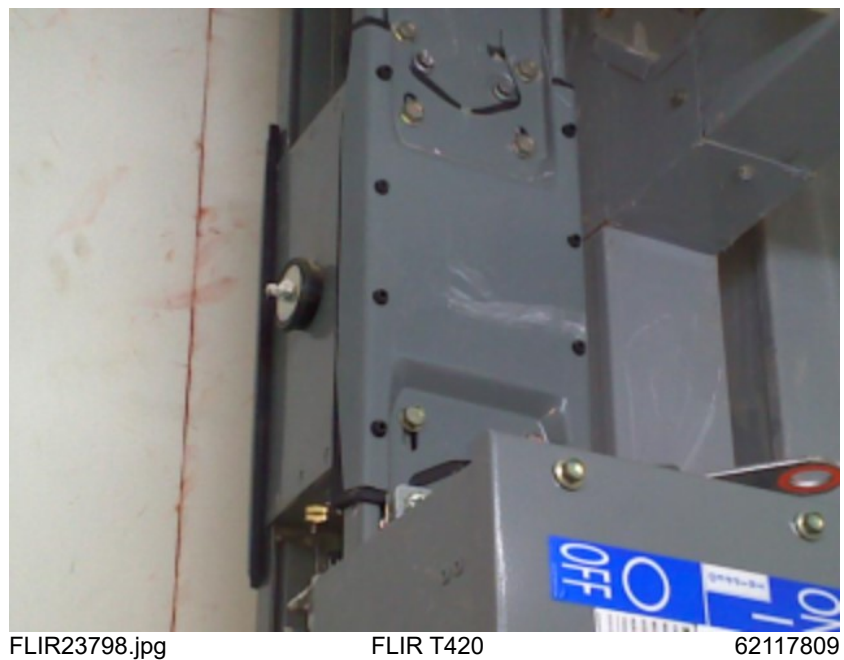
Location :	EE ROOM
Equipment :	Busduct
Detail :	Main Cable and Busbar Connection
Comment :	Normal operation, Not found hotspot
	Should also keep for your future reference

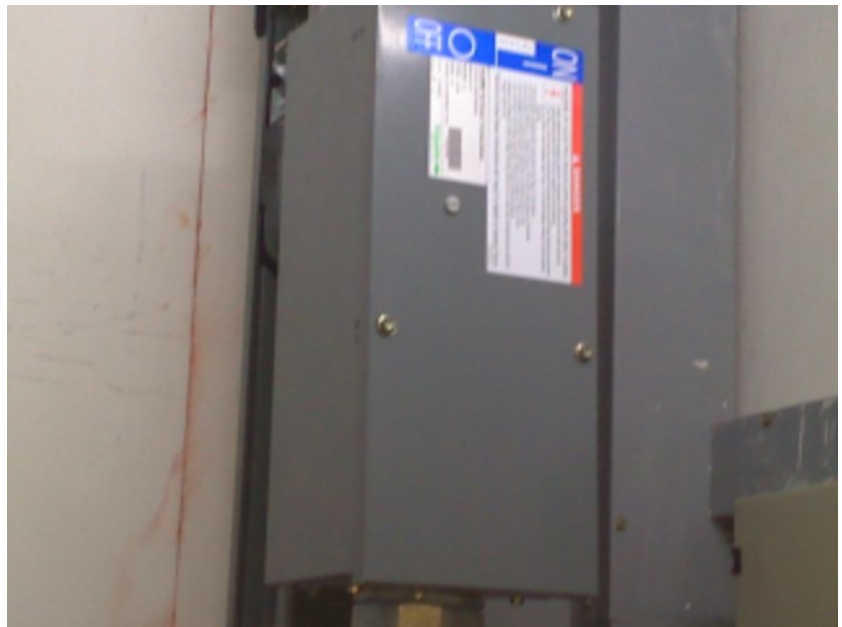
Location :	EE ROOM
Equipment :	Busduct
Detail :	Main Cable and Busbar Connection
Comment :	Normal operation, Not found hotspot
	Should also keep for your future reference

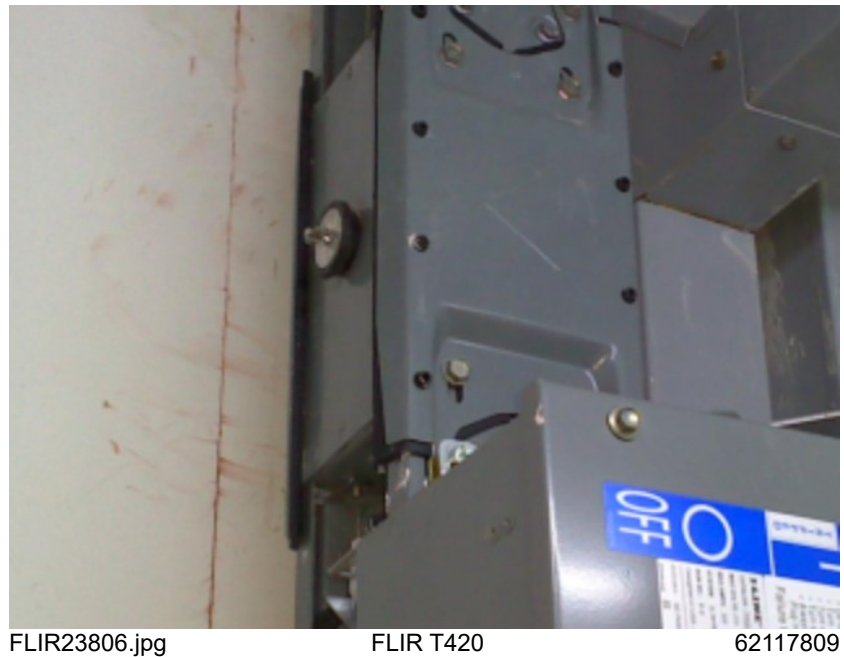
Location :	EE ROOM
Equipment :	Busduct
Detail :	Main Cable and Busbar Connection
Comment :	Normal operation, Not found hotspot
	Should also keep for your future reference

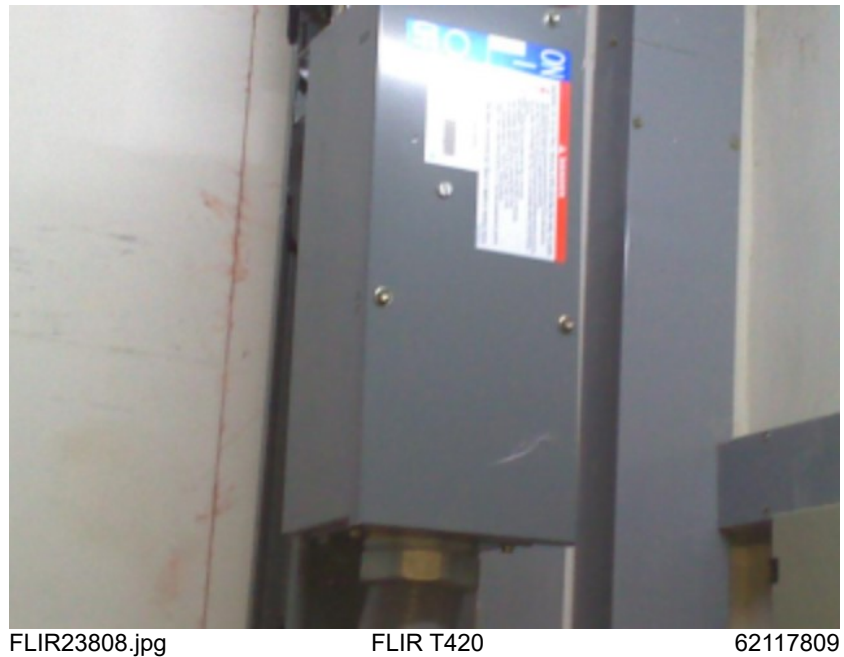
Location :	EE ROOM
Equipment :	Busduct
Detail :	Main Cable and Busbar Connection
Comment :	Normal operation, Not found hotspot
	Should also keep for your future reference

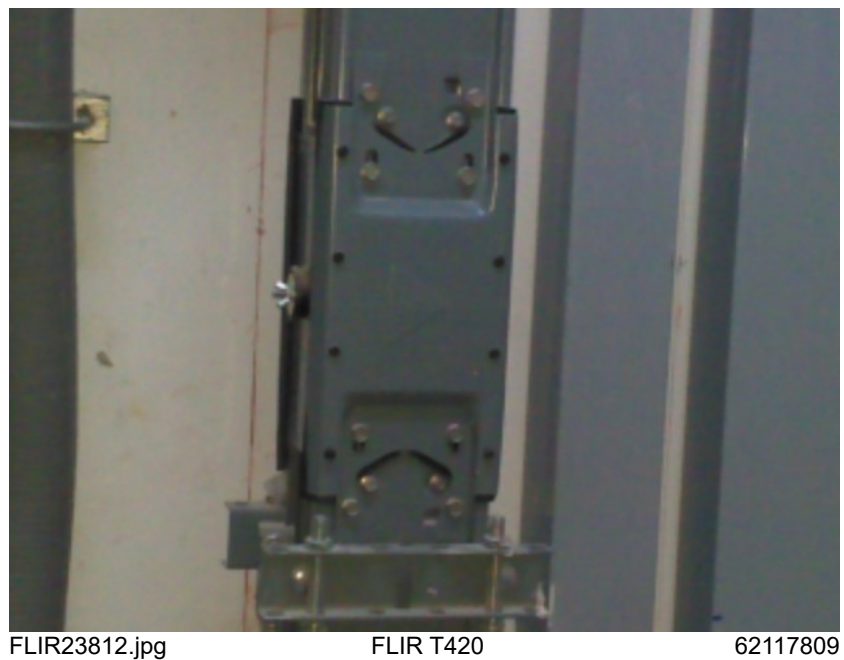
Location :	EE ROOM
Equipment :	Busduct
Detail :	Main Cable and Busbar Connection
Comment :	Normal operation, Not found hotspot
	Should also keep for your future reference

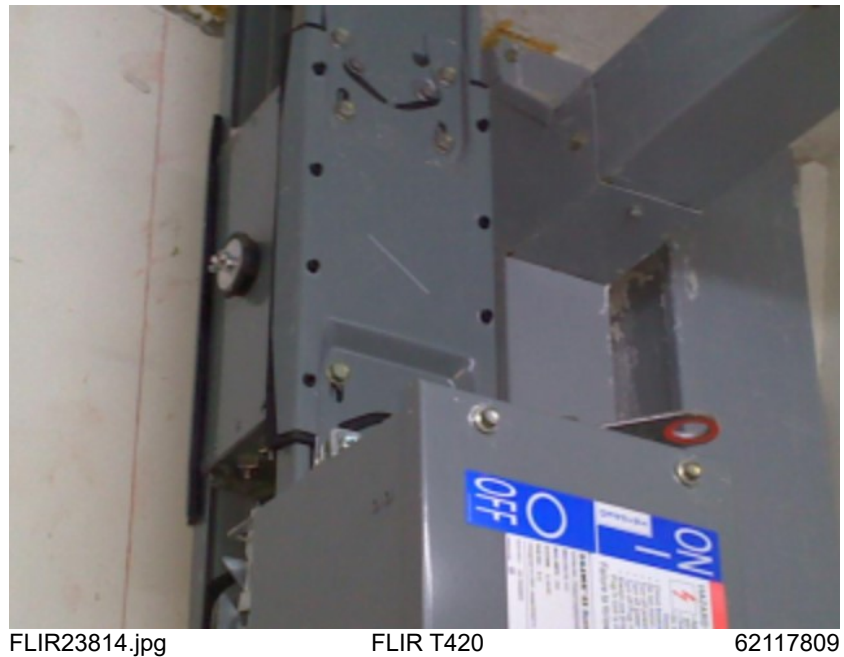
Location :	EE ROOM
Equipment :	Busduct
Detail :	Main Cable and Busbar Connection
Comment :	Normal operation, Not found hotspot
	Should also keep for your future reference

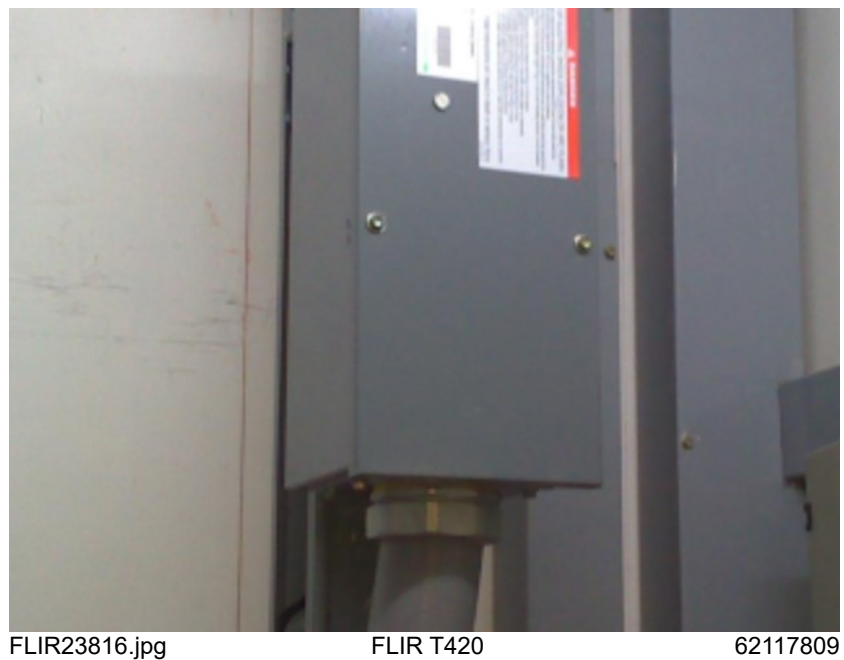
Location :	EE ROOM
Equipment :	Busduct
Detail :	Main Cable and Busbar Connection
Comment :	Normal operation, Not found hotspot
	Should also keep for your future reference

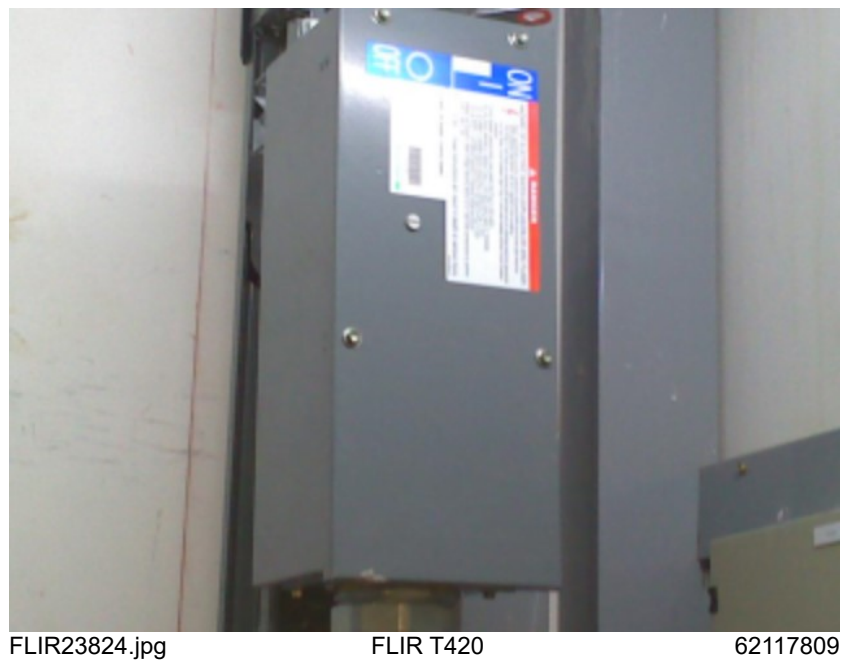
Location :	EE ROOM
Equipment :	Busduct
Detail :	Main Cable and Busbar Connection
Comment :	Normal operation, Not found hotspot
	Should also keep for your future reference

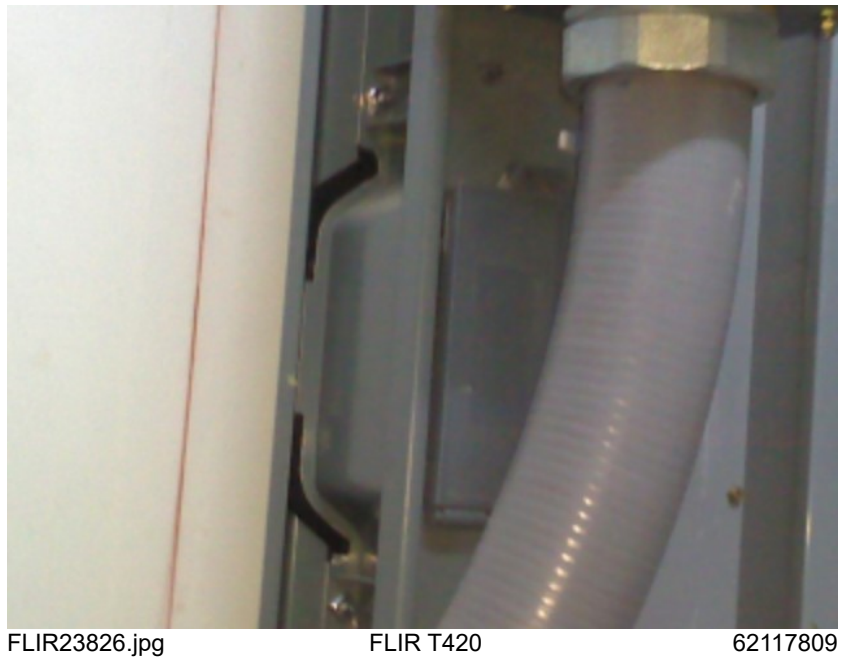
Location :	EE ROOM
Equipment :	Busduct
Detail :	Main Cable and Busbar Connection
Comment :	Normal operation, Not found hotspot
	Should also keep for your future reference

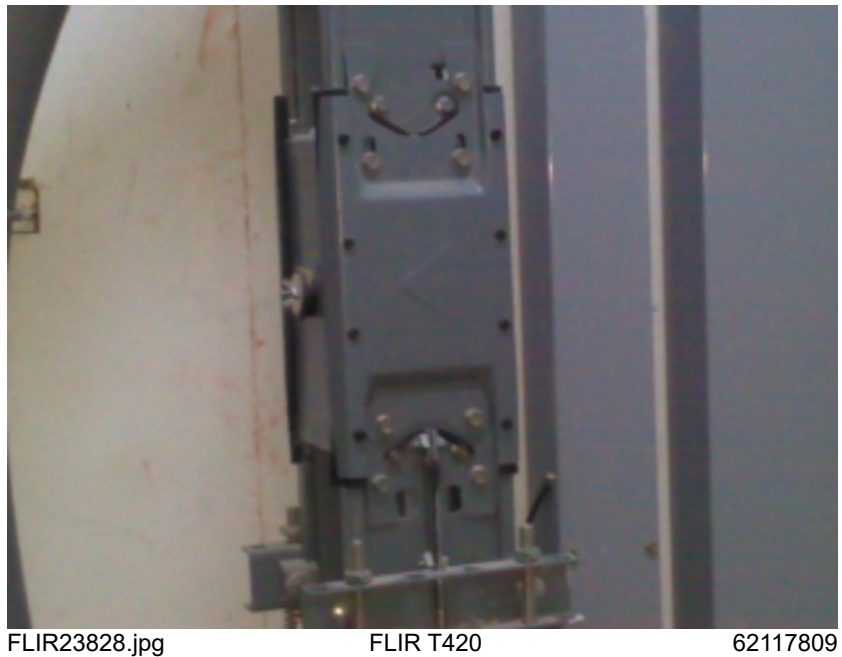
Location :	EE ROOM
Equipment :	Busduct
Detail :	Main Cable and Busbar Connection
Comment :	Normal operation, Not found hotspot
	Should also keep for your future reference
