รายงานการตรวจวัดระดับแสง เสียง ความร้อน ในพื้นที่ปฏิบัติงาน  
(*Light Noise Heat Monitoring*)

**Environmental Quality Monitoring Report**  
**Petroleum Production Project in North Pailin Field**  
**Chevron Thailand Exploration and Production, Ltd.**  
**April 25-27, 2024**

**Environmental Quality Monitoring Report**  
**Petroleum Production Project in South Pailin Field**  
**Chevron Thailand Exploration and Production, Ltd**  
**April 29 – May 2, 2024**

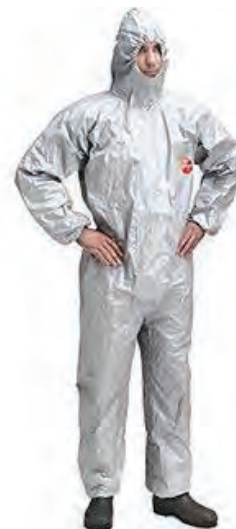
A chemical suit (Tyvek Coverall) suitable for mercury handling must be worn when stipulated by the Work permit or Work Plan. These are specifically designed without pockets and without access to avoid transferring mercury contamination to the body or underclothing. When wearing coveralls, it is essential that the pant legs overlap boots.

Heat stress is a significant concern while wearing this type of suit.

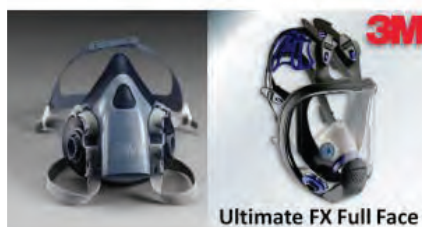
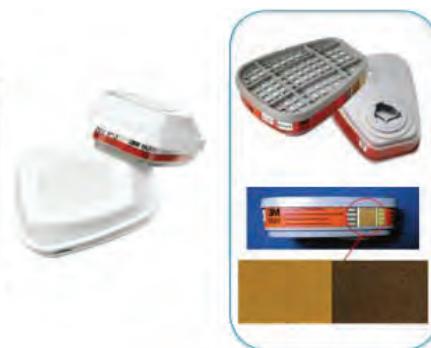
Correctly selected mercury canister respirators must be worn when stipulated by the work procedure or work permit, for work with a possible mercury exposure.

Inspect respirators properly before each use.

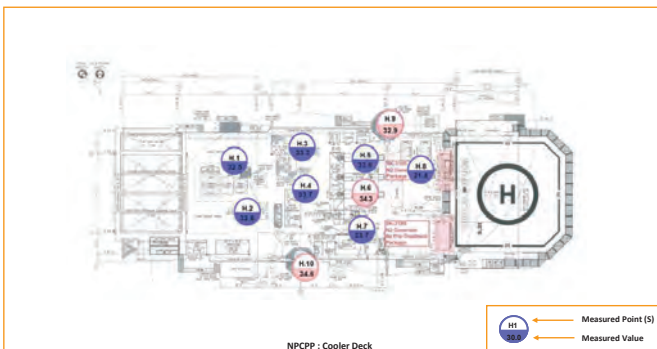
Figure 2-1 Layout of Heat Stress Measuring Points in the Workplace at NPCPP of the Petroleum Production Project in North Pailin Field

The monitoring results, measuring pictures and layouts were shown in **Table 2-3, Picture 2-1** and **Figure 2-1**, respectively. The heat stress monitoring result was found in the range of 29.2-34.6 °C. The activities at measuring points were machine controlling and inspection which can be compared to the light workload, and crane driving which can be compared to the moderate work load.

When comparing the results with the standards for working with light workload (not exceed 34 °C) and moderate workload (not exceed 32 °C), it was found that most results of measuring points complied with the standard.

- 1) Adjust the appropriate work and break periods.
- 2) Arrange the appropriate clothing and personal protective equipment for working activities.
- 3) Provide water drinking and electrolyte beverages for risk employees.
- 4) Install heat warning signs in any working area having a heat value exceeding the standard.

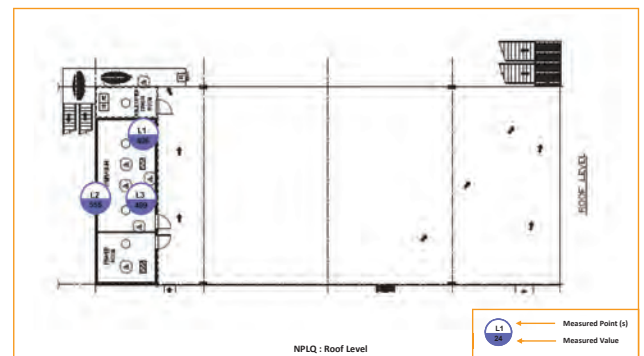
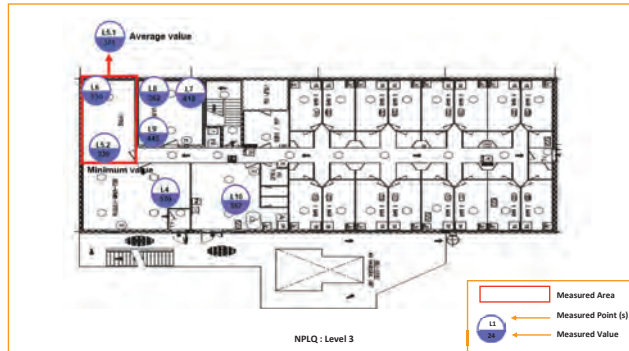
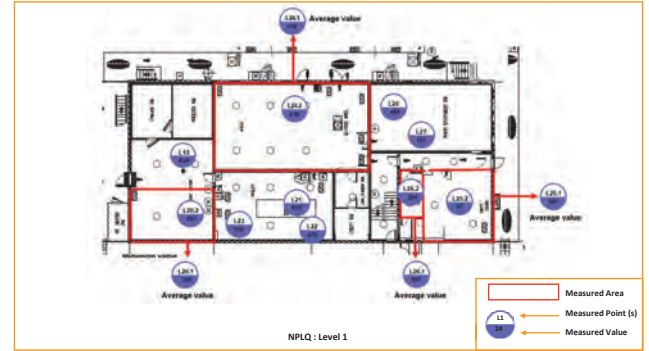
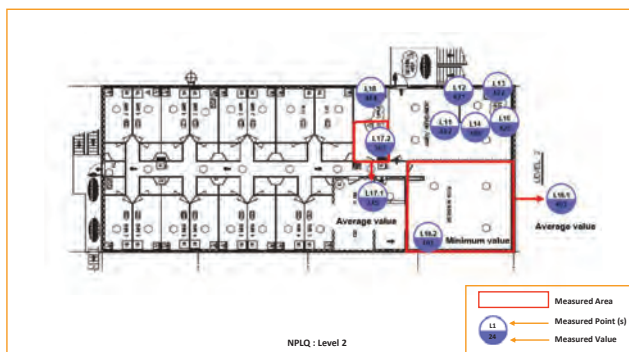
Figure 3-1 Layout of Light Intensity Measuring Points in the Workplace (Daytime) at NPLQ of the Petroleum Production Project in North Pailin Field

The monitoring of light intensity in workplace at NPLQ and NPCPP of the petroleum production project in North Pailin field, Chevron Thailand Exploration and Production, Ltd. was conducted on April 25 and 27, 2024 and all results complied with the standard.

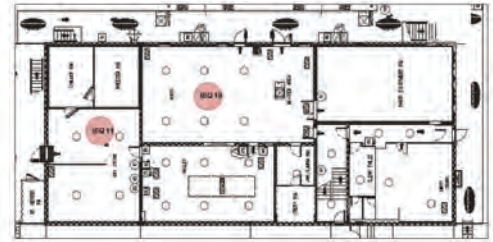
Figure 5-1 Indoor Air Quality Monitoring of the Petroleum Production Project in North Pailin Field

- Indoor Air Quality: Monitoring parameters included Temperature, Relative Humidity, Carbon dioxide, Particulate Matter (PM-10) and Air Movement. There was a total of 19 measuring points consisted of 12 measuring points at NPLQ and 7 measuring points at NPCPP. In addition, there was 1 outdoor measuring point for reference.
- Face Velocity of chemical hoods: There were a total of 2 stations at NPCPP

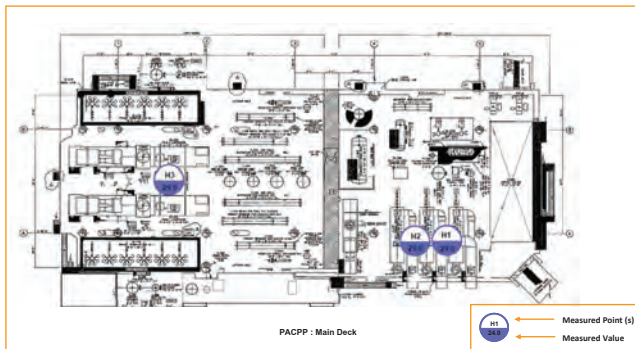
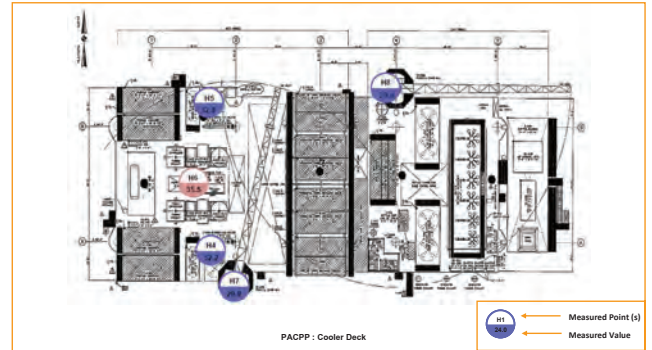
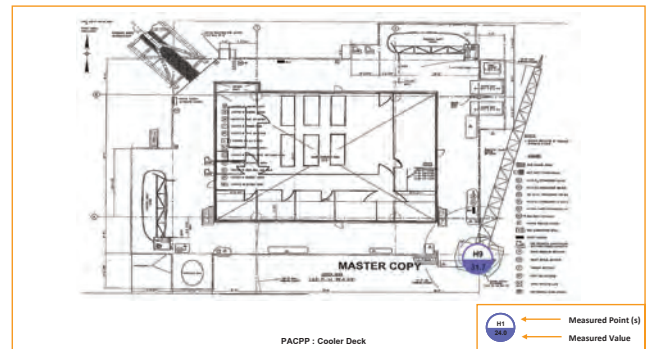
Figure 2-1 Layout of Heat Stress Measuring Points in the Workplace at PACPP

The monitoring results, measuring pictures and layouts were shown in **Table 2-3, Picture 2-1** and **Figure 2-1**, respectively. The heat stress monitoring result was found in the range of 29.0-35.5 °C. The activities at measuring points were machine controlling and inspection which can be compared to the light work load and moderate work.

When compared with the standards for light work load which shall not be more than 34°C, and moderate work which shall not be more than 32°C, it was found that all measuring points were complied with the standard.

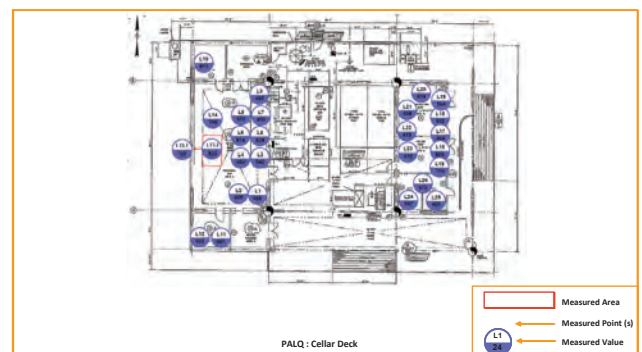
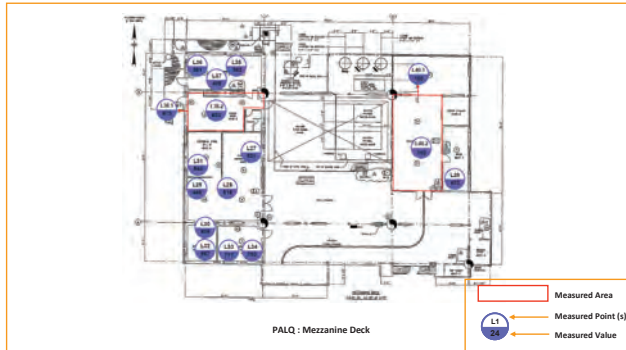
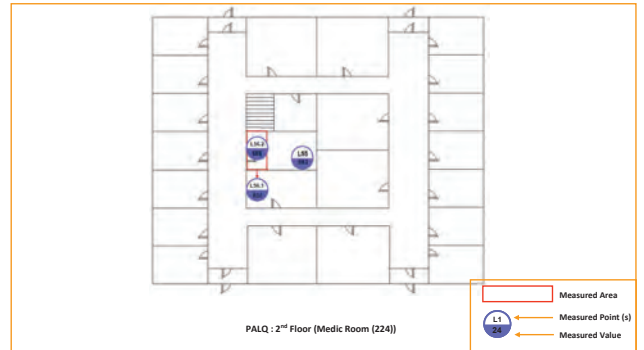
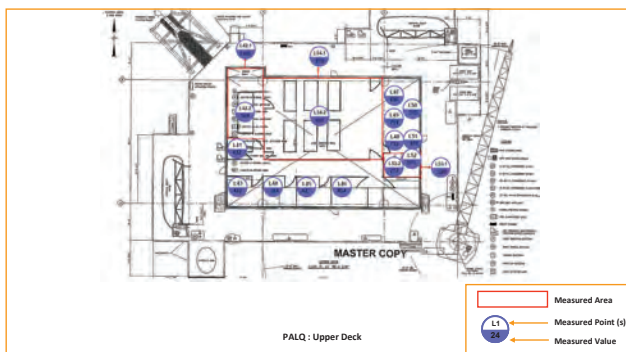
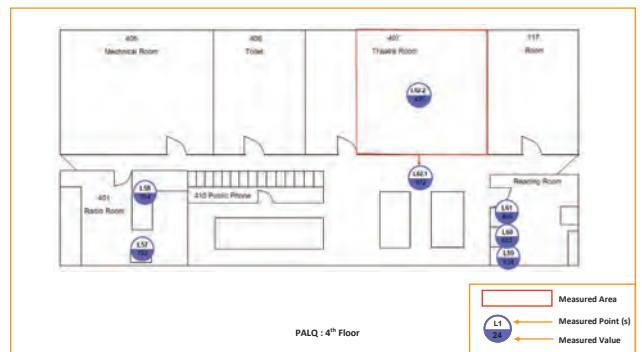
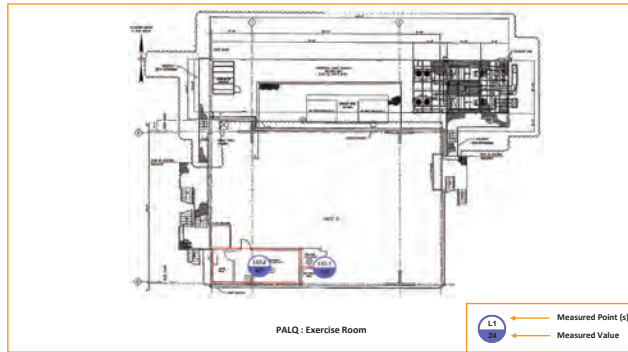
Figure 3-1 Layout of Light Intensity Measuring Points in the Workplace at PALQ

According to the monitoring results of all 54 measuring points and 9 measuring areas, it was found that all results having sufficient light for working.

- 1) Change new devices of light sources when they are used for a long time or damaged.
- 2) Regularly check and clean the devices of light sources.

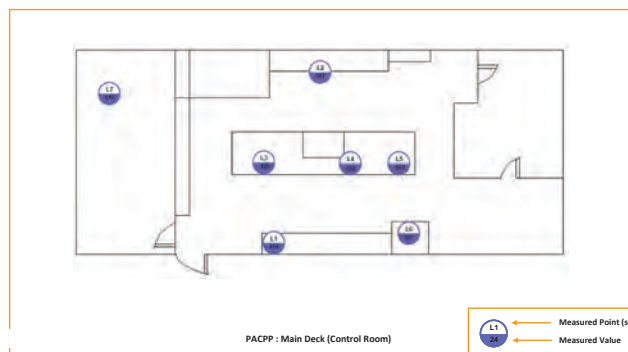
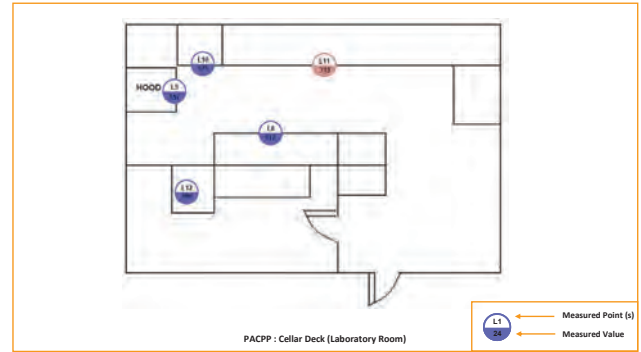
Figure 3-2 Layout of Light Intensity Monitoring at PACPP

According to the monitoring results at PACPP of all 12 measuring points, it was found that most results having sufficient light for working.
