ภาคผนวก 18

ตัวอย่างแผนการฝึกซ้อมการอพยพกรณีเกิดไต้ฝุ่น และการฝึกซ้อมเหตุฉุกเฉิน
(Typhoon and Emergency Drill Exercise)

รายงานการตรวจวัดระดับแสง เสียง ความร้อน ในพื้นที่ปฏิบัติงาน
(*Light Noise Heat Monitoring*)

รายงานการตรวจวัดคุณภาพสิ่งแวดล้อม
โครงการผลิตปิโตรเลียมแหล่งไพลินเหนือ (North Pailin)
บริษัท เชฟรอนประเทศไทยสำรวจและผลิต จำกัด
ระหว่างวันที่ 10-12 พฤศจิกายน 2568

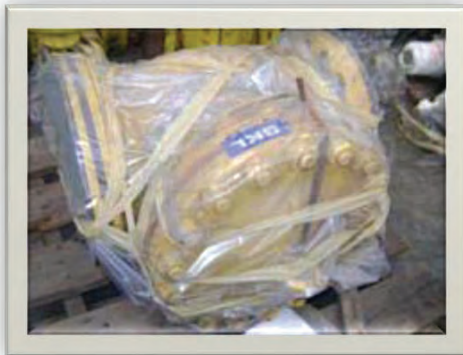
Ball Valve

- If mercury is detected either by visual inspection or by mercury vapor measurement (measured mercury vapor level exceeds $25 \mu\text{g}/\text{m}^3$, the equipment/material shall be wrapped with plastic sheet and all openings shall be blinded and sealed to prevent potential exposure to mercury vapor.
