ภาคผนวกที่ 5

สำเนาเอกสารประกอบการปฏิบัติตามมาตรการฯ

สำเนาแบบรายงานสรุปการทำงานของระบบบำบัดน้ำเสีย

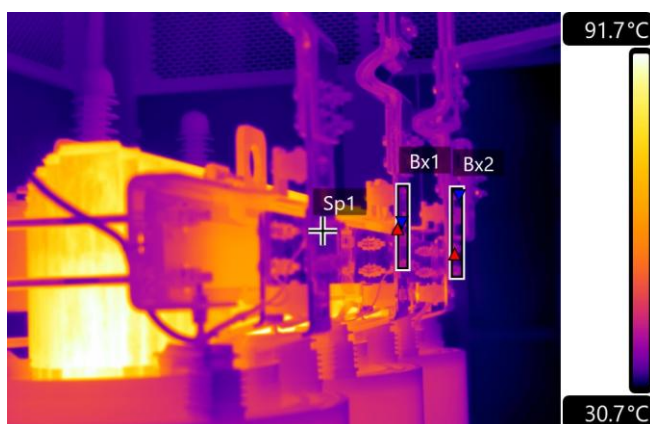
| Location / Area : | MDB ROOM L FL. / METERING |

| Equipment / Status : | Normal |

| Measurements | |
|---|---|
| Sp1 Value | 38.4 °C |

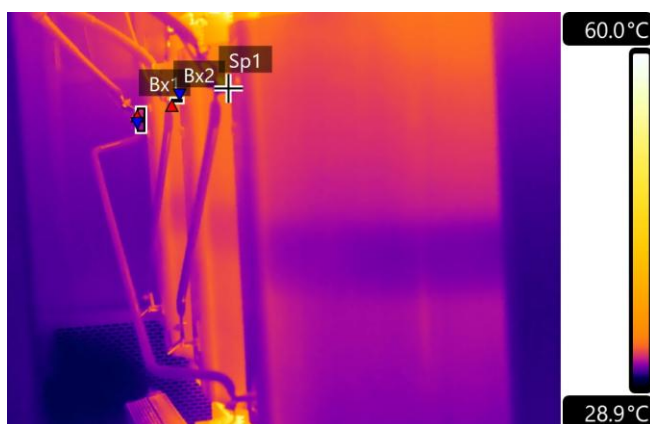
| Location / Area : | MDB ROOM / TR4 1600KVA (High Volt) |

| Equipment / Status : | Normal |

| Measurements | |
|---|---|
| Sp1 Value | 32.0 °C |

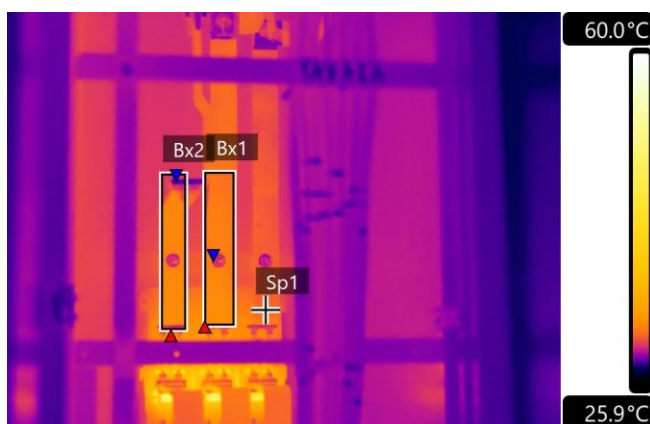
| Location / Area : | MDB ROOM / MDB1 Panel CAP1 |

| Equipment / Status : | Normal |

| Measurements | |
|---|---|
| Sp1 Value | 32.0 °C |

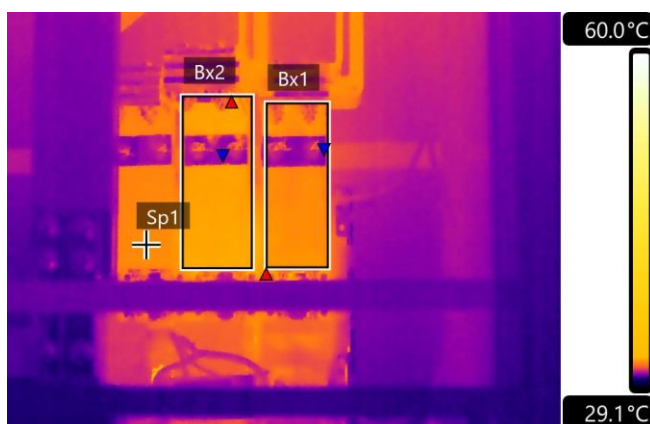
| Location / Area : | MDB ROOM / MDB4 Panel MAIN ACB |

| Equipment / Status : | Normal |

| Measurements | |
|---|---|
| Sp1 Value | 31.8 °C |

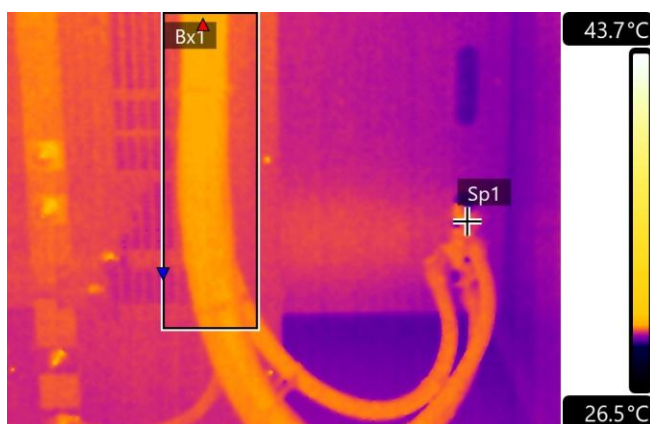
| Location / Area : | MDB ROOM / MDB4 Panel MCC-HP |

| Equipment / Status : | Normal |

| Measurements | |
|---|---|
| Sp1 Value | 29.6 °C |

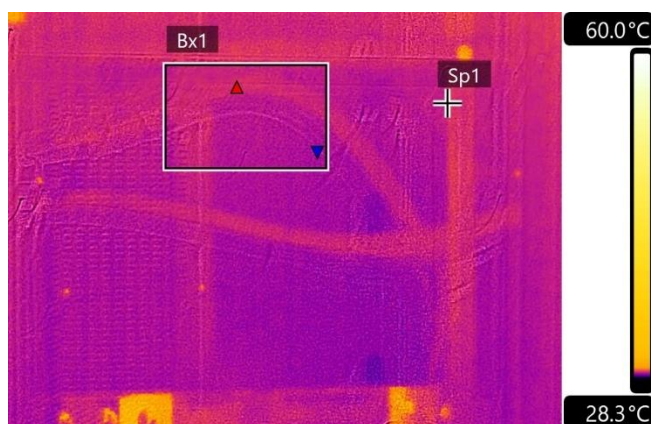
| Location / Area : | MDB ROOM / EMDB Panel PF-R-05&06, EX-L05-01, EPP-AC5 |

| Equipment / Status : | Normal |

| Measurements | |
|---|---|
| Sp1 Value | 30.1 °C |

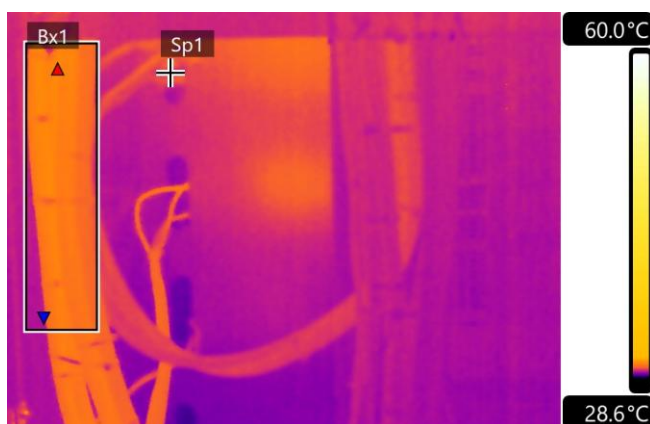
| Location / Area : | MDB ROOM / EMDB Panel UDPP1, ELP5, UDPP5, EPPKE5 |

| Equipment / Status : | Normal |

| Measurements | |
|---|---|
| Sp1 Value | 30.5 °C |

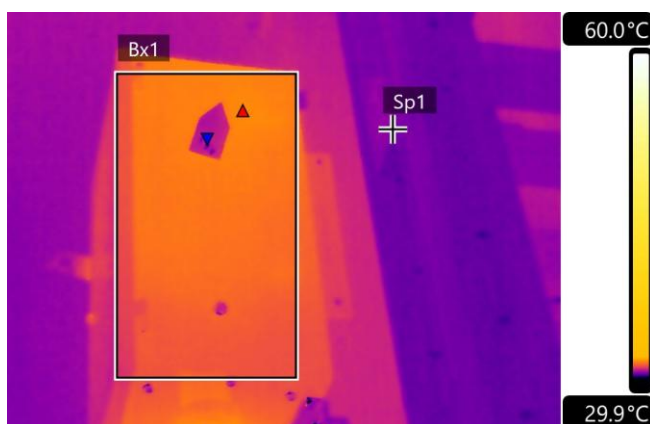
| Location / Area : | EE ROOM 22 FL. / PLUG-IN (TOP) |

| Equipment / Status : | Normal |

| Measurements | |
|---|---|
| Sp1 Value | 31.5 °C |

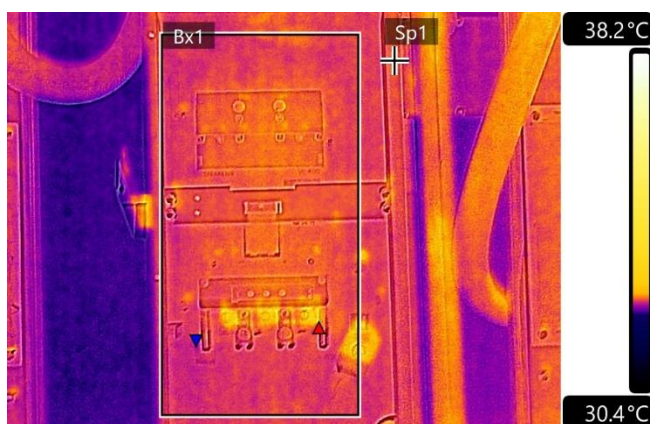
| Location / Area : | EE ROOM B4 FL. / PLUG-IN |

| Equipment / Status : | Normal |

| Measurements | |
|---|---|
| Sp1 Value | 32.5 °C |
