เอกสารประกอบการปฏิบัติตามมาตรการ
ป้องกันและแก้ไขผลกระทบสิ่งแวดล้อม

คู่มือการป้องกันและรองรับเหตุฉุกเฉิน โรงแรมอลอฟท์ กรุงเทพฯ สุขุมวิท 11

จัดทำโดย นาย พีรวัส ทฤษฎี
ผู้จัดการแผนกรักษาความปลอดภัย ประจำปี 2566

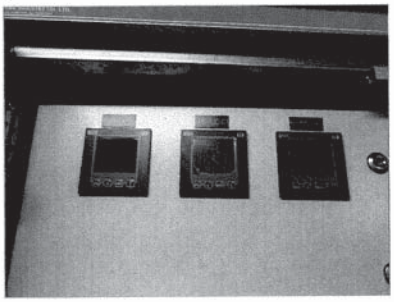
ภาพอุปกรณ์ที่เสื่อมสภาพและชำรุด

NO.	RATED (KVA)	EQUIPMENT NO./ LOCATION	SERIAL NO.	TYPE	CONDITION	REMARK
1	2000	TR.1 / ห้องควบคุมระบบไฟฟ้า	5202323	DRY TYPE	ไม่สมบูรณ์	(1)
2	2000	TR.2 / ห้องควบคุมระบบไฟฟ้า	5202322	DRY TYPE	ปกติ	-

NO.	LOCATION	รายการตรวจสอบตู้แผงสวิตช์แรงต่ำ (ตู้ MDB)					
		GENERAL CONDITION	GROUND RESISTANCE	INSULATION RESISTANCE	CIRCUIT BREAKER	CAPACITOR BANK	REMARK
1.	MDB1	ผิดปกติ (1)	ปกติ	ปกติ	ปกติ	ปกติ	-
2.	MDB2	ผิดปกติ (2)	ปกติ	ปกติ	ปกติ	ปกติ	-

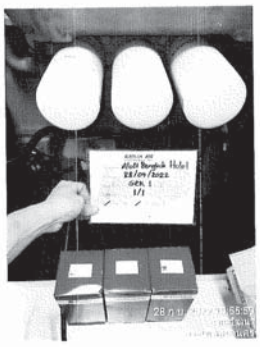
งานเปลี่ยนไส้กรองน้ำมันเครื่อง

- งานเปลี่ยนกรองน้ำมันเครื่อง
