สำเนาหนังสือแจ้งผลการพิจารณารายงานการประเมินผลกระทบสิ่งแวดล้อม

เรื่อง รายงานการวิเคราะห์ผลกระทบสิ่งแวดล้อมโครงการโรงแรมวีรันดา

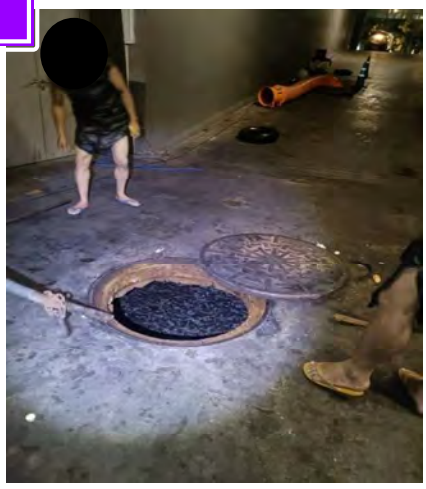
บ่อเติมอากาศ
ก่อนการทำ

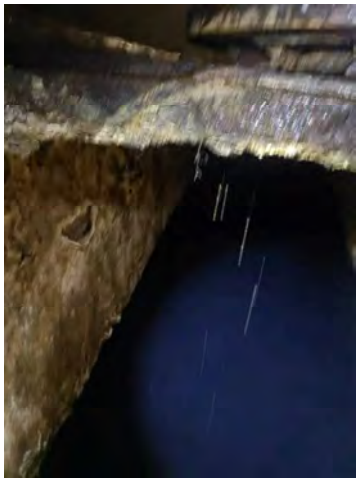
บ่อเติมอากาศ
ขณะกำลังทำ

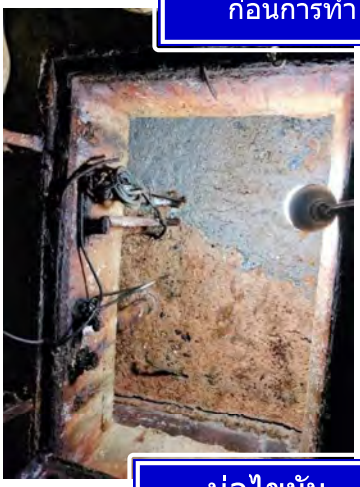
บ่อเติมอากาศ
หลังทำเสร็จ

(บ่อบำบัดน้ำเสีย - ก่อนการทำ ขณะทำ และหลังทำเสร็จ)

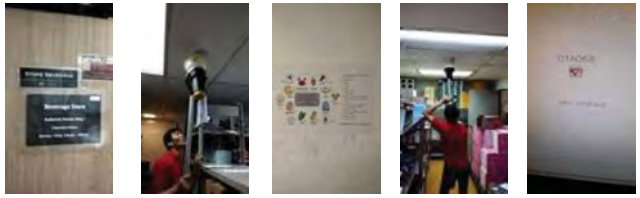
Floor B1 Toilet Women Service Test Smoke Detector 3 head ..Normal 2 nowork 1

Floor B1 Storage,Bottle,Corridor Service Test Smoke Detector 4 head ..Normal 3 nowork 1

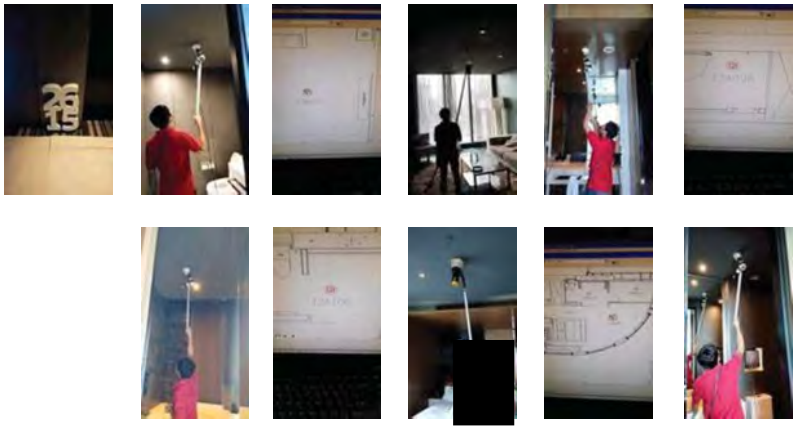
Floor 26 Room 2615 Service Test Smoke Detector 3 head..normal and Heat Detector 3 head…nowork 1

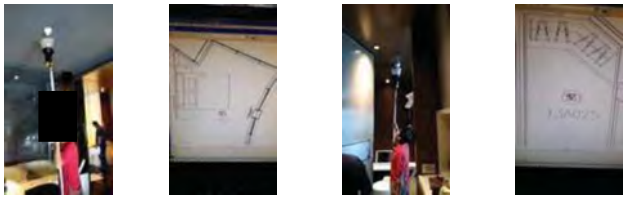
Floor 27 Room 2711 Service Test Smoke Detector 2 head..normal and Heat Detector 3 head…Nowork 1

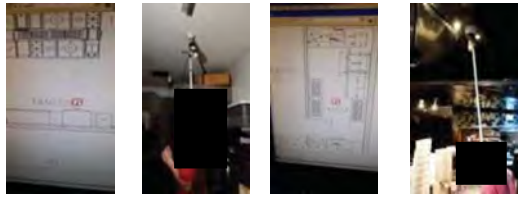
Floor 29 Stoke and Springer nowork

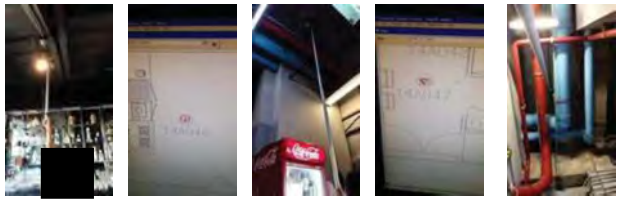
Floor 29 Bar Service Test Smoke Detector 3 head ..Noalarm 1 and Heat Detector 4 head..Normal

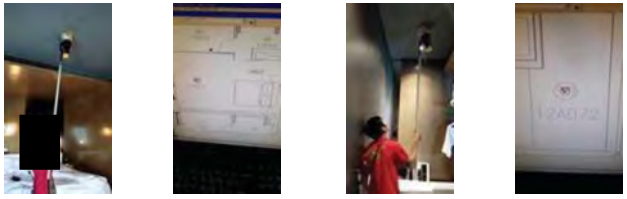
Floor 18 Room 1804 Service Test Smoke Detector 1 head and Heat Detector 1 head..Normal
