# รายงานการใช้ไฟฟ้า/น้ำ

## Stay Wellbeing – TR PM2023

# Maintenance Report

***Date of work : 31 Aug 2023***

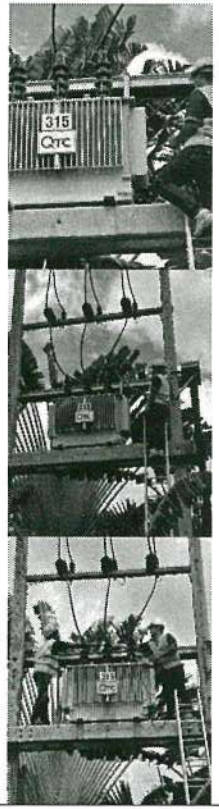
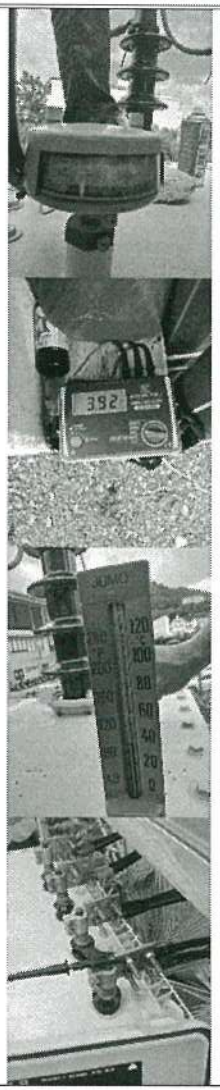
***Photo 1-20***

Preventive maintenance of TR

- Inspect physical and mechanical condition.
- Cleaning overall ,
- Test Insulation Resistance
- Connection tightening torque
- Oil - Dielectric Breakdown Strength Test.
