กรกฎาคม-ธันวาคม
2568

รายงานผลการปฏิบัติตามมาตรการป้องกันแก้ไขผลกระทบสิ่งแวดล้อม และมาตรการติดตามตรวจสอบผลกระทบสิ่งแวดล้อม ระยะดำเนินการ

โครงการ อาคารพักอาศัย พงษ์ทอง ทาวเวอร์ (อาคาร C)

ของบริษัท พงษ์ทอง ทาวเวอร์ จำกัด

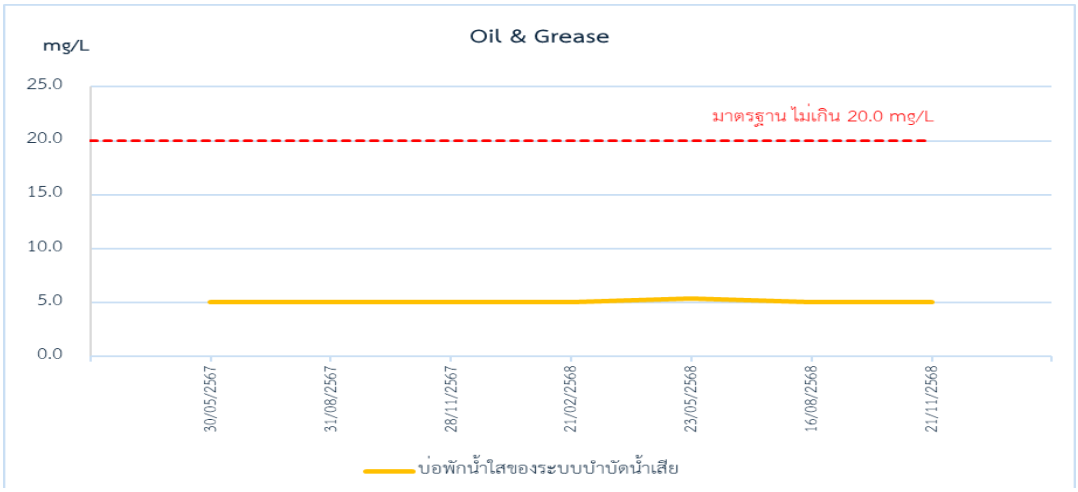
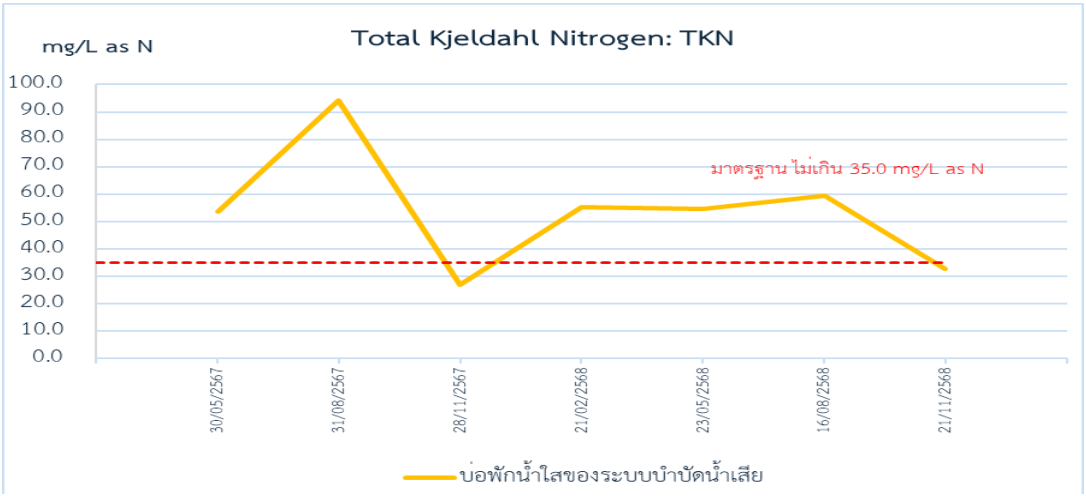
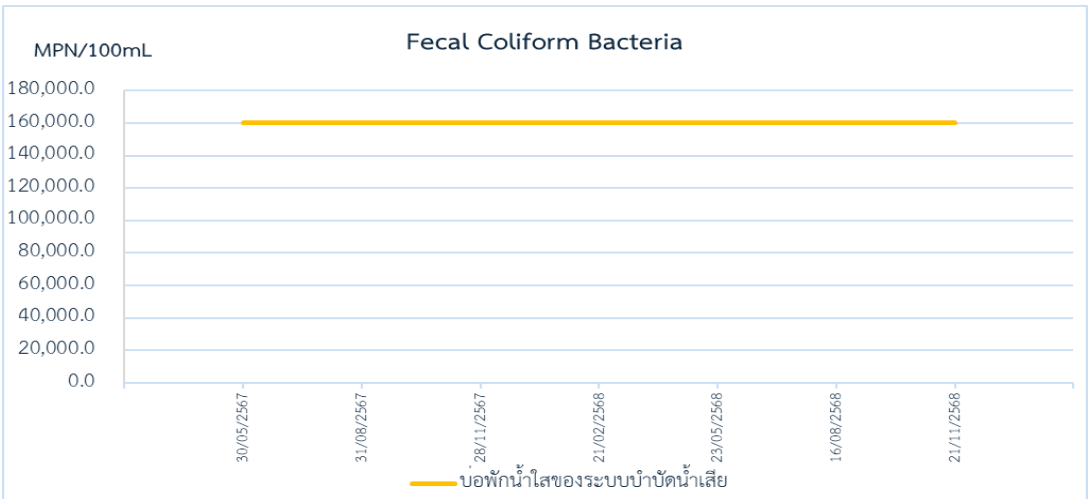
รูปที่ 3.2-2 กราฟแสดงผลตรวจวิเคราะห์คุณภาพน้ำทิ้ง

Effluent หลังอาคาร C	7.0	32.0	74.0	<LOQ (5.0)	32.76	>160,000
ค่ามาตรฐาน[2/]			**5.5-9.0**	**≤30**	**≤40**	**≤20**	**≤35**	**-**
