PREVENTIVE MAINTENANCE
DB PANEL

Maintenance Equipment for Fire Alarm Systems
(การตรวจสอบเชิงบำรุงรักษา อุปกรณ์และระบบสัญญาณแจ้งเตือนเหตุเพลิงไหม้)

PREVENTIVE MAINTENANCE AND TESTING REPORT

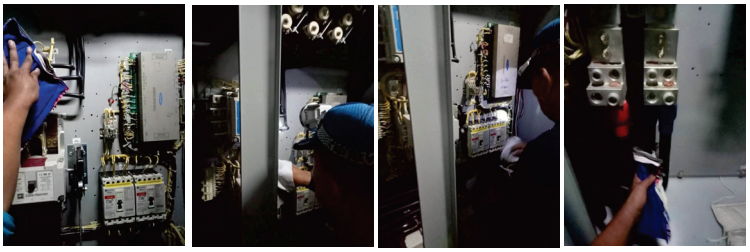
ตรวจสอบและทำความสะอาดภายใน และภายนอกตู้
ด้วยการเป่า และดูดฝุ่น เช็คการคลายตัวของน็อตสกรู
ตรวจเช็ค Busbar ตรวจสอบความเที่ยงตรงค่าต่าง ๆ
เมื่อวันที่ 11 สิงหาคม 2568

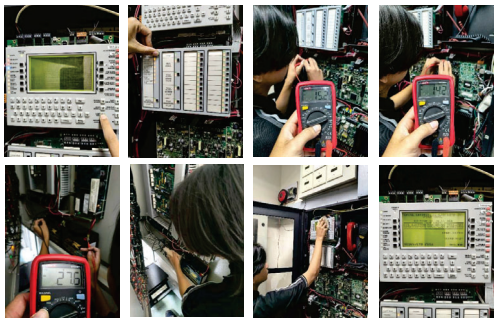
Control Panel (ตู้ควบคุมระบบ)

- Check the signal cable connection point on the circuit board in the control panel that receives the signal from the Detector device of the system.
  ตรวจเช็คจุดเชื่อมต่อสายสัญญาณที่ตู้ควบคุมทำหน้าที่รับและส่งสัญญาณจากอุปกรณ์ตรวจจับในระบบ
- Check the power supply and battery. By checking the terminals and measuring the input voltage of the battery.
  ตรวจเช็คแหล่งจ่ายไฟและ แบตเตอรี่ โดยตรวจสอบขั้วต่อสายพร้อมวัดแรงดันไฟฟ้าเข้าของแบตเตอรี่
- Check the integrity of the display and notifications LED.
  ตรวจเช็คความสมบูรณ์ของจอแสดงผลและ LED แจ้งเตือน
- Check the integrity of the operation switch and response to function.
  ตรวจเช็คความสมบูรณ์ของสวิตช์ควบคุมการทำงานและการตอบสนองฟังก์ชั่นการทำงาน
- Clean the control panel in ready to use.
  ทำความสะอาดตู้ควบคุม ให้อยู่ในสภาพที่พร้อมใช้งาน

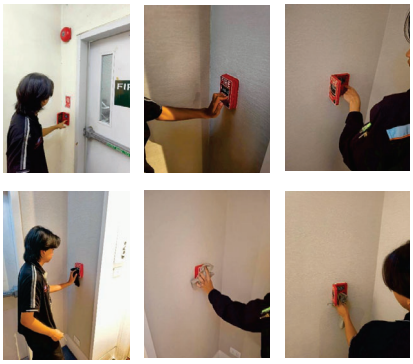
Manual Station(อุปกรณ์แจ้งเหตุด้วยมือผู้ใช้)

- Test user notification device (Manual Station). By testing the availability of equipment various with actual use. Such as pulling the lever (Pull Down), Push Button or break the glass to break (Break glass). To inform according to the usage of the device
  ทดสอบอุปกรณ์แจ้งเหตุด้วยมือผู้ใช้ (Manual Station) โดยทดสอบความพร้อมของอุปกรณ์ต่างๆ ด้วยการใช้งานจริง เช่น การดึงคันโยก (Pull Down) การกดปุ่ม (Push Button) หรือทุบกระจกให้แตก (Break glass) เพื่อแจ้งเหตุตามลักษณะการใช้งานของอุปกรณ์
- Cleaning equipment.
  ทำความสะอาดอุปกรณ์

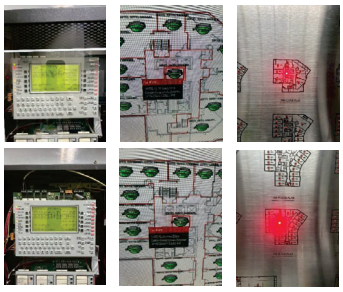
ตู้ควบคุมระบบ Fire Alarm Control Panel
ตู้แสดง Graphic Annunciator

- Check the control panel of the receiving signal system is stuck.
  ตรวจเช็คแผงควบคุมระบบรับสัญญาณ LED ติดค้าง ปกติ
- Check the notification sound Fire incident
  ตรวจเช็คเสียงแจ้งเตือน การเกิดเหตุเพลิงไหม้
- Test of Receive-send signal between the control cabinet, send signal to the cabinet, map showing the incident spot Fire displays. The notification (LED) and computers (PC) in the event of a fire.
  ทดสอบการ รับ-ส่ง สัญญาณระหว่างตู้ควบคุมส่งสัญญาณไปยังตู้แผนผังแสดงจุดเกิดเหตุ
  เพลิงไหม้ LED แจ้งเตือน และ คอมพิวเตอร์ (PC) เมื่อเกิดเหตุเพลิงไหม้
- Show status and location map to match the location of the incident.
  แสดงสถานะแจ้ง Location Map ตรงตามตำแหน่งที่เกิดเหตุ

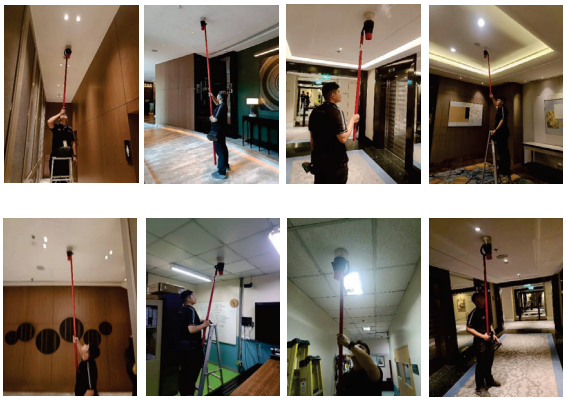
Smoke Detector (อุปกรณ์ตรวจจับควันไฟ)

- The test uses a simulated smoke generator, such as a Smoke tester, to test detection and the response signal is sent back to the Control panel and displayed to other peripherals in the system.
  การทดสอบจะใช้อุปกรณ์สร้างควันจำลอง เช่น สเปรย์ควันทดลองเพื่อทดสอบการตรวจจับและการส่งสัญญาณตอบสนองกลับไปที่ตู้ควบคุมและแสดงผลไปที่อุปกรณ์ต่อพ่วงอื่นๆ ในระบบ

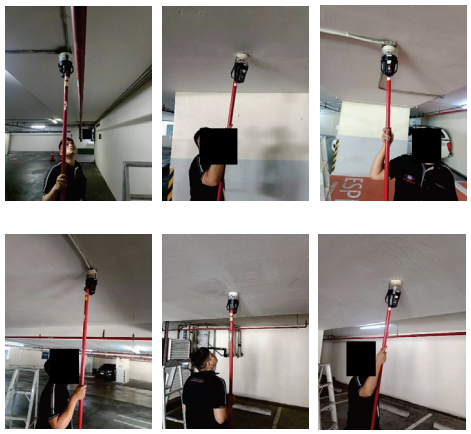
Heat Detector(อุปกรณ์ตรวจจับความร้อน)

- The test uses heat generation equipment. To test the operation of the heat detector Along with checking the situation of the equipment alerts and sending alarm signals to the source control cabinet or other peripherals
  การทดสอบใช้อุปกรณ์กำเนิดความร้อน เพื่อทดสอบการทำงานของอุปกรณ์ตรวจจับความร้อน พร้อมเช็คสถานการณ์แจ้งเตือนของอุปกรณ์ และ การส่งสัญญาณแจ้งเหตุไปยังตู้ควบคุมต้นทางหรืออุปกรณ์ต่อพ่วงอื่นๆ

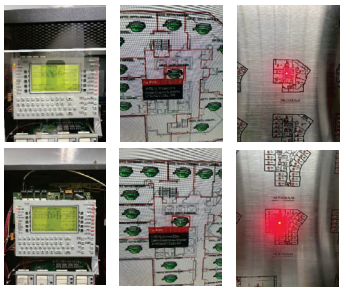
Manual Station(อุปกรณ์แจ้งเหตุด้วยมือผู้ใช้)

- Test user notification device (Manual Station). By testing the availability of equipment various with actual use. Such as pulling the lever (Pull Down), Push Button or break the glass to break (Break glass). To inform according to the usage of the device
  ทดสอบอุปกรณ์แจ้งเหตุด้วยมือผู้ใช้ (Manual Station) โดยทดสอบความพร้อมของอุปกรณ์ต่างๆ ด้วยการใช้งานจริง เช่น การดึงคันโยก (Pull Down) การกดปุ่ม (Push Button) หรือทุบกระจกให้แตก (Break glass) เพื่อแจ้งเหตุตามลักษณะการใช้งานของอุปกรณ์
- Cleaning equipment.
  ทำความสะอาดอุปกรณ์
