สถิติการเกิดอุบัติเหตุในโรงไฟฟ้า
บริษัท ราชบุรีเพาเวอร์ จำกัด

| โรงไฟฟ้าบริษัท ราชบุรีเพาเวอร์ จำกัด | | RPCL Incident Inform | |
|---|--|---|---|
| Title: Concrete curb was damaged by oil tanker at fuel oil unloading. | | | |

| บริษัท ผลิตไฟฟ้าราชบุรีโฮลดิ้ง จำกัด | | RPCL Incident Inform | |
|---|--|---|--|
| Title: Water flow out from HP/IP FWP 20A barrel during pump overhaul work. | | | |

| โรงไฟฟ้าบริษัท ราชบุรีไฟฟ้า จำกัด | | RPCL Incident Inform | |
|--|--|---|--|
| Title: GT22 Control Oil Supply Diff. Pressure Switch A B Terminal Socket broken | | | |

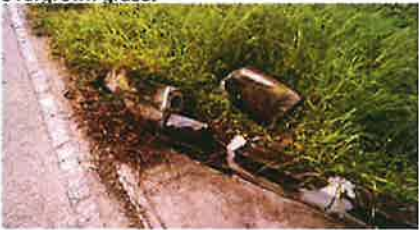
| โรงไฟฟ้าบริษัท ราชบุรีเพาเวอร์ จำกัด | | RPCL Incident Inform | |
|---|--|---|---|
| <p>On 19 May 2022, at 08.45 hrs. During the parking management to prepare the fuel Truck license plate no. 75-4580 Chon Buri (72-4589 Chon Buri, trailer's license plate) turned to right side to prepare to reverse into fuel oil unloading. At that time, the rear wheel of the trailer on the left side got stuck with concrete curb caused the concrete curb and Tires of trailer damaged. After the incident, the driver confessed he did not see a concrete curb due to vision obstruction, Overgrown grass.</p> | | | |

| Root Cause (สาเหตุ) (Describe the cause and the counter measures proposed in/after the investigation) Truck driver can't see concrete curb clearly. | | |

| โรงไฟฟ้าบริษัท ราชบุรีเพาเวอร์ จำกัด | | RPCL Incident Inform | |
|---|--|---|---|
| 1) Concrete curb repair and painting with Black and white. (Plan to finish end of June 2022) 2) Install poles to show the curb line complying with arrangements for safe parking of oil tankers.(Plan to finish end of June 2022) | | | |
