รายงานการตรวจสอบสภาพและความหนาของระบบท่อ

PIPING INSPECTION SUMMARY REPORT

Report/ Project	Sheet
			2112012	S 1/1
STT-CC-001-02-01 (TRL 001 G-Base 95 Tank Receiving line (Jetty to Tank No.1,2,3))				
Date of inspections: 24 December 2021

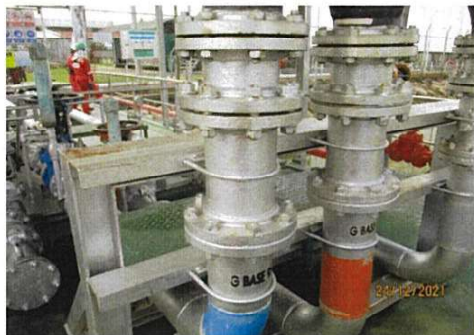
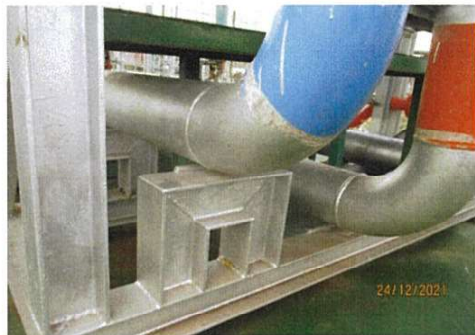
Name of part / Location		Findings		Name of part / Location		Findings	
TRL 001 Tank Receiving line (Jetty to Tank No.3,10)		Still in normal condition		TRL 001 Tank Receiving line (Jetty to Tank No.3,10)		Still in normal condition

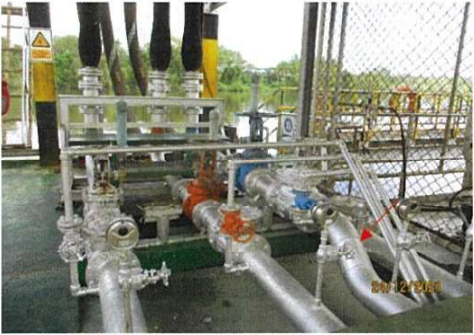
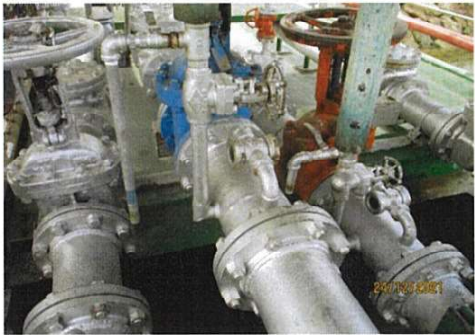
Name of part / Location		Findings		Name of part / Location		Findings	
TRL 001 Tank Receiving line (Jetty to Tank No.3,10)		Still in normal condition		TRL 001 Tank Receiving line (Jetty to Tank No.3,10)		Still in normal condition

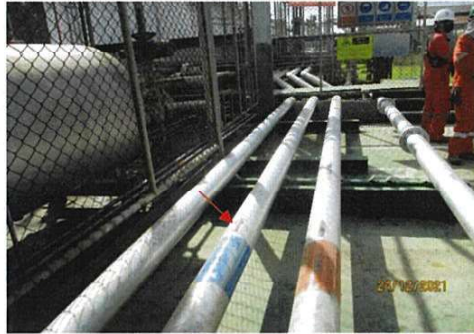
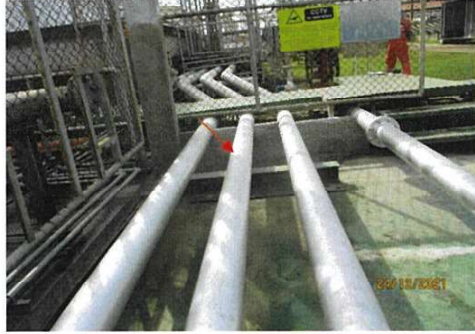
Name of part / Location		Findings		Name of part / Location		Findings	
TRL 001 Tank Receiving line (Jetty to Tank No.3,10)		Still in normal condition		TRL 001 Tank Receiving line (Jetty to Tank No.3,10)		Still in normal condition

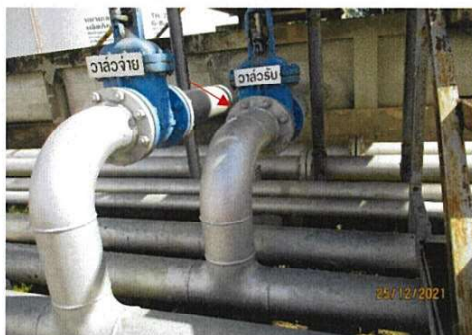
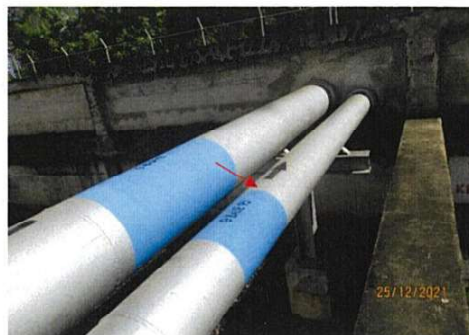
Still in normal condition

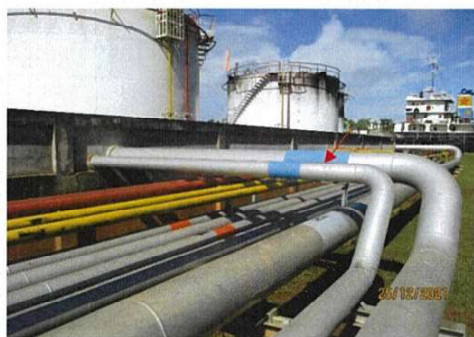
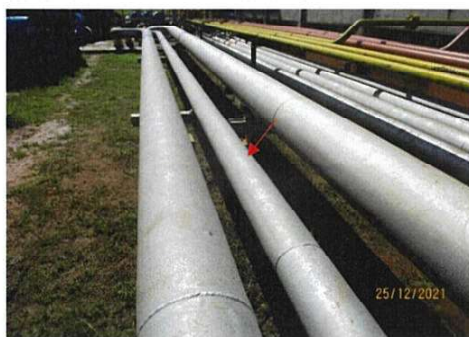
Still in normal condition

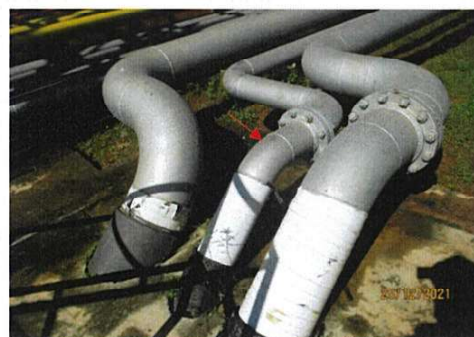
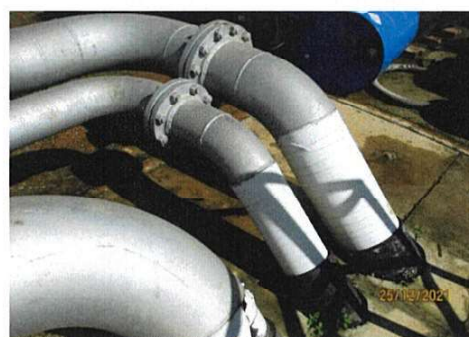
Still in normal condition

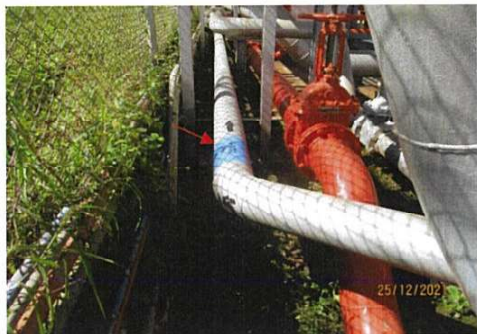
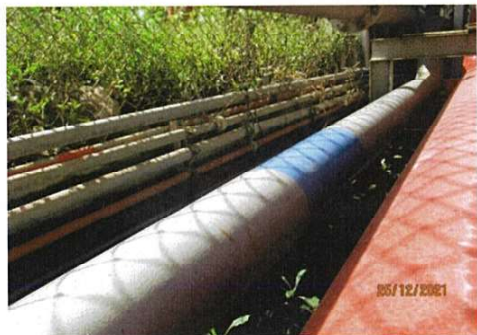
Name of part / Location			Findings		Name of part / Location			Findings	
TRL 001 Tank Receiving line (Jetty to Tank No.3,10)			Still in normal condition		TRL 001 Tank Receiving line (Jetty to Tank No.3,10)			Still in normal condition

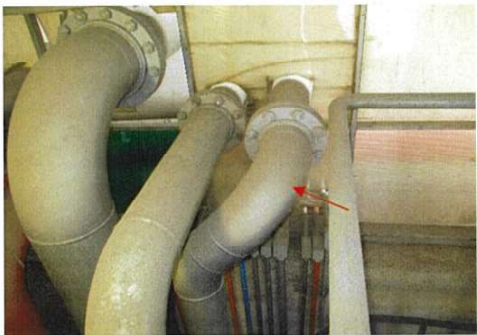
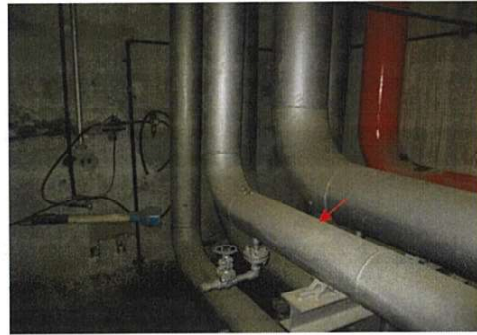
Name of part / Location			Findings		Name of part / Location			Findings	
TRL 001 Tank Receiving line (Jetty to Tank No.3,10)			Still in normal condition		TRL 001 Tank Receiving line (Jetty to Tank No.3,10)			Still in normal condition

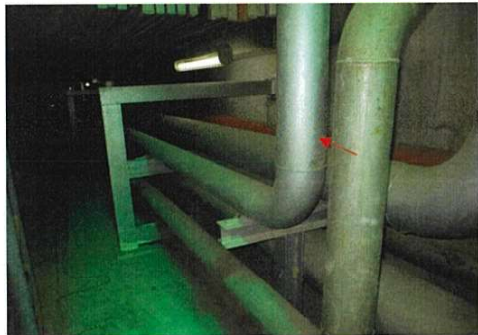
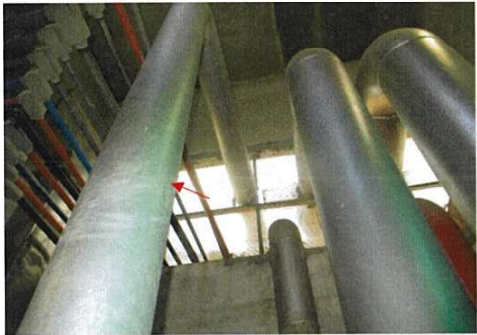
Name of part / Location			Findings		Name of part / Location			Findings	
TRL 001 Tank Receiving line (Jetty to Tank No.3,10)			Still in normal condition		TRL 001 Tank Receiving line (Jetty to Tank No.3,10)			Still in normal condition

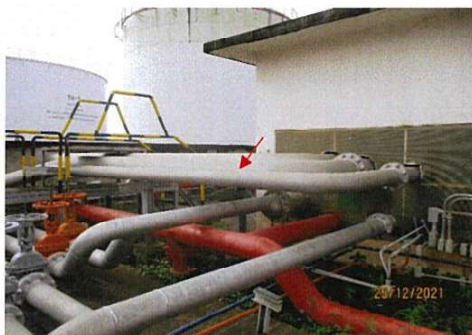
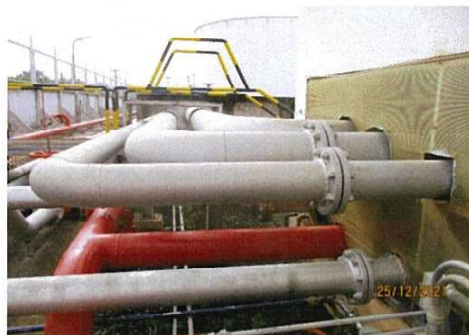
Name of part / Location	Findings	Name of part / Location	Findings
TRL 001 Tank Receiving line (Jetty to Tank No.3,10)	Still in normal condition	TRL 001 Tank Receiving line (Jetty to Tank No.3,10)	Still in normal condition

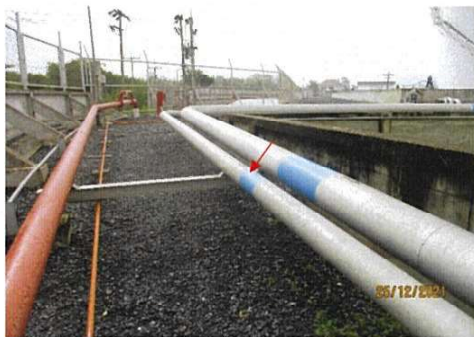
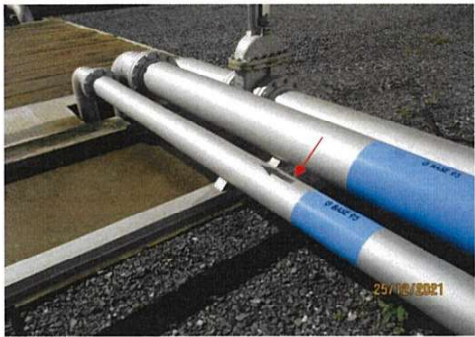
Name of part / Location			Findings		Name of part / Location			Findings	
TRL 001 Tank Receiving line (Jetty to Tank No.3,10)			Still in normal condition		TRL 001 Tank Receiving line (Jetty to Tank No.3,10)			Still in normal condition

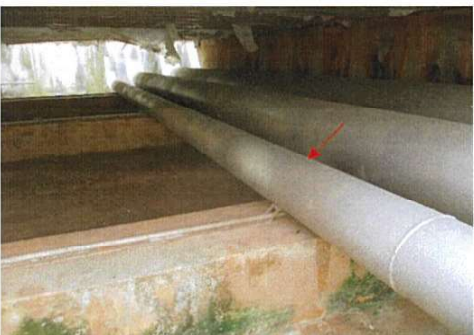
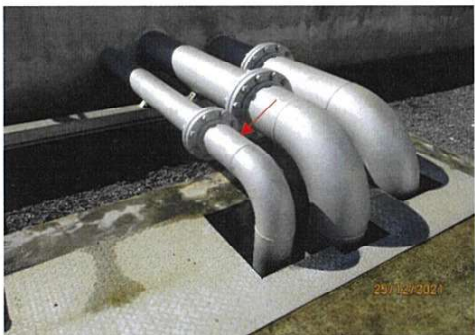
Name of part / Location			Findings		Name of part / Location			Findings	
TRL 001 Tank Receiving line (Jetty to Tank No.3,10)			Still in normal condition		TRL 001 Tank Receiving line (Jetty to Tank No.3,10)			Still in normal condition

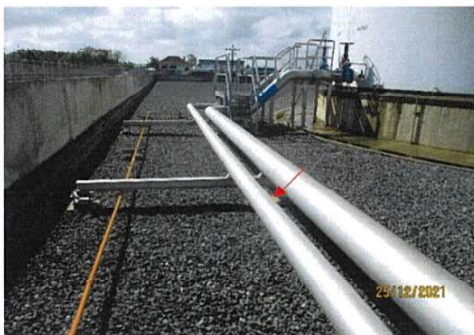
Name of part / Location			Findings		Name of part / Location			Findings	
TRL 001 Tank Receiving line (Jetty to Tank No.3,10)			Still in normal condition		TRL 001 Tank Receiving line (Jetty to Tank No.3,10)			Still in normal condition
