PIPING INSPECTION PICTURE LOG

Report/ Project	Sheet
						2112012	PL 1/7
TRL 002 G-Base 91 Tank Receiving line (Jetty to Tank No.9&Tank No.2)

Report/ Project		Sheet				
						2112012		UTM 1/8				
STT-CC-001-03-01_Gbase 91												
CML	Size	Type	Direction	Nom. (Thk) 1-Jan-95 (mm)	Min Required (mm)	UTM date 6-Dec-16 (mm)	UTM date 16-Dec-21 (mm)	UTM date (mm)	Short term corrosion Rate (mm)/yr	Long term corrosion Rate (mm)/yr	Short term remaining life (yr)	Long term remaining life (yr)
1A	6"	Elbow	0°	7.11	2.80	6.57	7.31		-0.147	-0.007	No Corrosion	No Corrosion
			90°			6.98	7.51		-0.105	-0.015	No Corrosion	No Corrosion
			180°			6.47	7.37		-0.179	-0.010	No Corrosion	No Corrosion
			270°			6.99	7.86		-0.173	-0.028	No Corrosion	No Corrosion
1B	6"	Elbow	0°	7.11	2.80	6.42	6.96		-0.107	0.006	No Corrosion	748.12
			90°			6.95	7.51		-0.111	-0.015	No Corrosion	No Corrosion
			180°			7.08	7.41		-0.066	-0.011	No Corrosion	No Corrosion
			270°			6.76	7.44		-0.135	-0.012	No Corrosion	No Corrosion
1C	6"	Elbow	0°	7.11	2.80	6.64	7.17		-0.105	-0.002	No Corrosion	No Corrosion

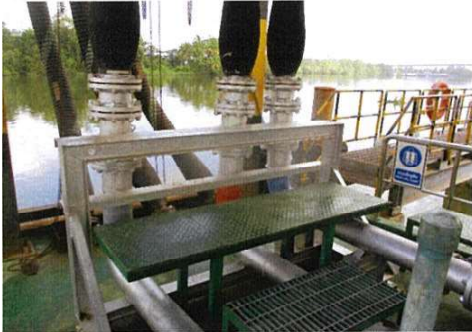
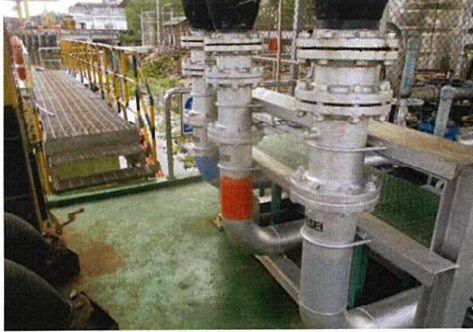
Name of part / Location		Findings		Name of part / Location		Findings	
TRL 002 G-Base 91 Tank Receiving line (Jetty to Tank No.9&Tank No.2)		Still in normal condition		TRL 002 G-Base 91 Tank Receiving line (Jetty to Tank No.9&Tank No.2)		Still in normal condition

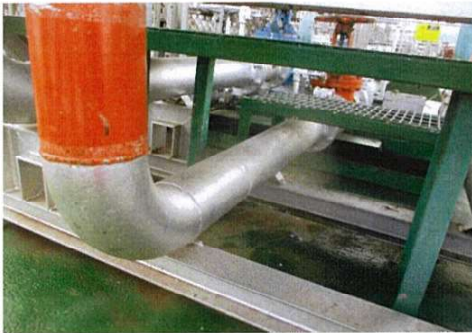
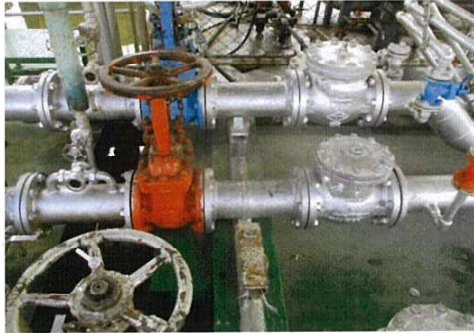
Name of part / Location		Findings		Name of part / Location		Findings	
TRL 002 G-Base 91 Tank Receiving line (Jetty to Tank No.9&Tank No.2)		Still in normal condition		TRL 002 G-Base 91 Tank Receiving line (Jetty to Tank No.9&Tank No.2)		Still in normal condition

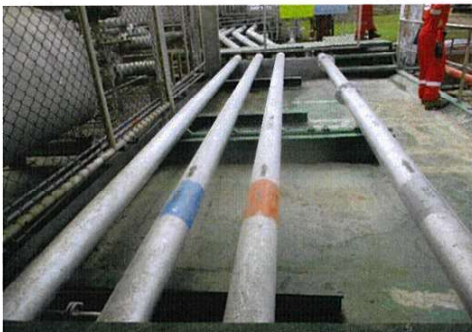
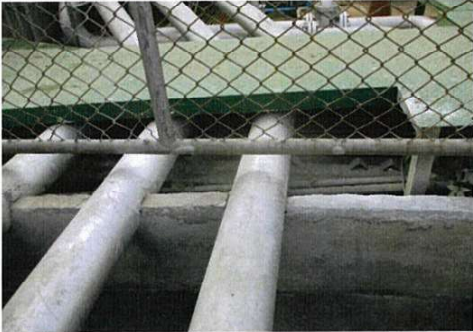
Name of part / Location		Findings		Name of part / Location		Findings	
TRL 002 G-Base 91 Tank Receiving line (Jetty to Tank No.9&Tank No.2)		Still in normal condition		TRL 002 G-Base 91 Tank Receiving line (Jetty to Tank No.9&Tank No.2)		Still in normal condition

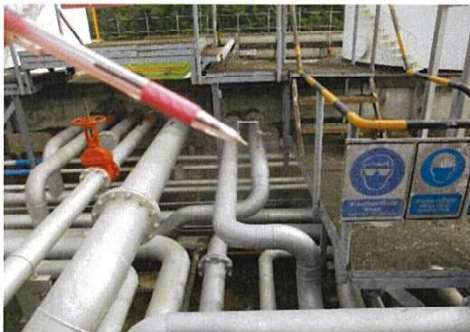
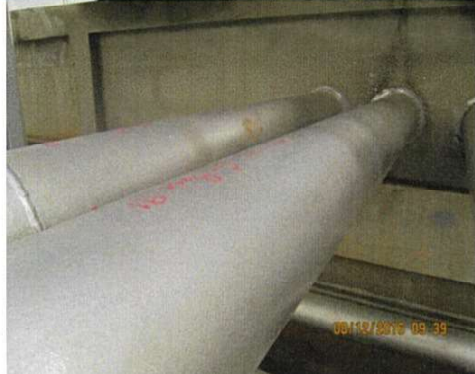
Name of part / Location		Findings	Name of part / Location		Findings
TRL 002 G-Base 91 Tank Receiving line (Jetty to Tank No.9&Tank No.2)		Still in normal condition	TRL 002 G-Base 91 Tank Receiving line (Jetty to Tank No.9&Tank No.2)		Still in normal condition

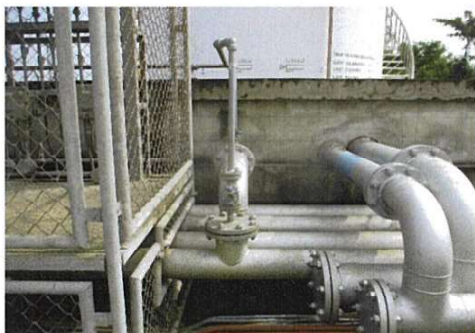
Name of part / Location		Findings	Name of part / Location		Findings
TRL 002 G-Base 91 Tank Receiving line (Jetty to Tank No.9&Tank No.2)		Slight corrosion on piping&Painting deterioration (1)	TRL 002 G-Base 91 Tank Receiving line (Jetty to Tank No.9&Tank No.2)		Still in normal condition

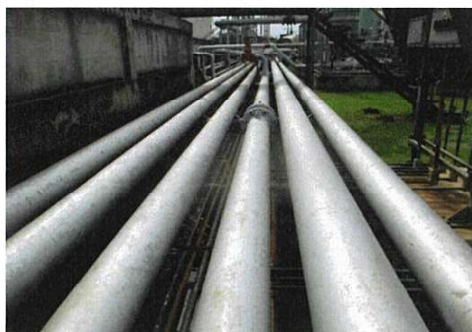
Name of part / Location		Findings	Name of part / Location		Findings
TRL 002 G-Base 91 Tank Receiving line (Jetty to Tank No.9&Tank No.2)		Still in normal condition	TRL 002 G-Base 91 Tank Receiving line (Jetty to Tank No.9&Tank No.2)		Painting deterioration (2)

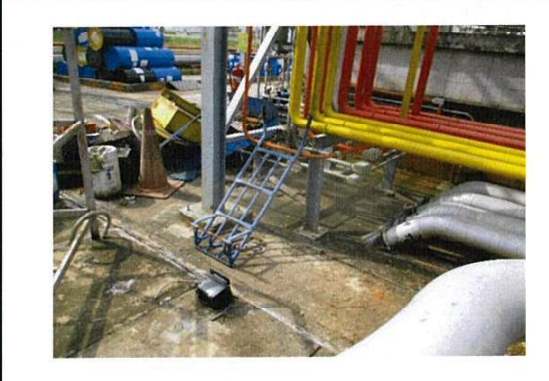
Name of part / Location		Findings	
TRL 002 G-Base 91 Tank Receiving line (Jetty to Tank No.9&Tank No.2)		Severe corrosion under sealing&Sealing damage. (7)		TRL 002 G-Base 91 Tank Receiving line (Jetty to Tank No.9&Tank No.2)		Still in normal condition

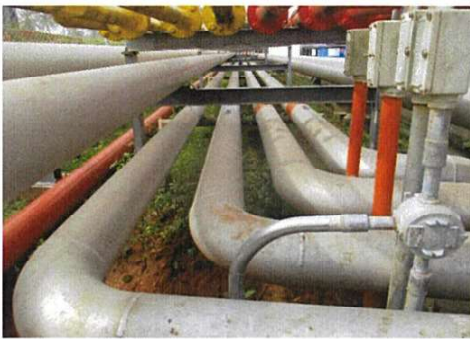
Name of part / Location		Findings		Name of part / Location		Findings	
TRL 002 G-Base 91 Tank Receiving line (Jetty to Tank No.9&Tank No.2)		Severe corrosion under pipe sleeve & Sealing damage. (8)		TRL 002 G-Base 91 Tank Receiving line (Jetty to Tank No.9&Tank No.2)		Still in normal condition

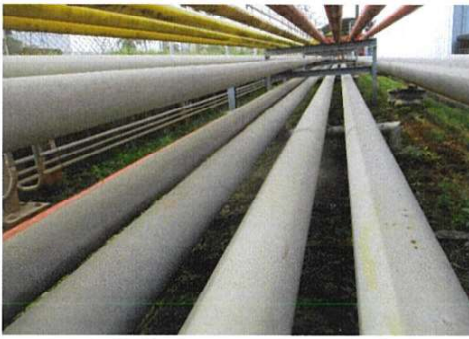
Name of part / Location		Findings		Name of part / Location		Findings	
TRL 002 G-Base 91 Tank Receiving line (Jetty to Tank No.9&Tank No.2)		Still in normal condition		TRL 002 G-Base 91 Tank Receiving line (Jetty to Tank No.9&Tank No.2)		Painting deterioration (9)

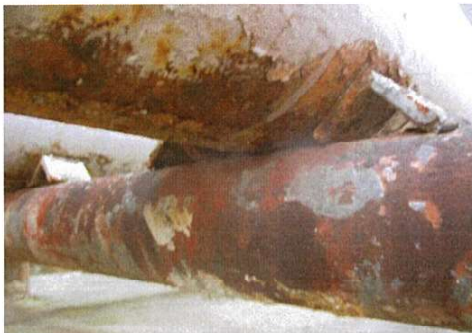
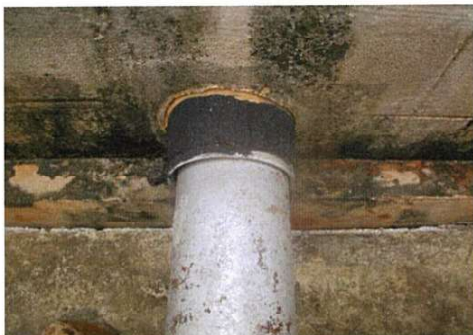
Name of part / Location		Findings			
TRL 002 G-Base 91 Tank Receiving line (Jetty to Tank No.9&Tank No.2)		Painting deterioration (13)

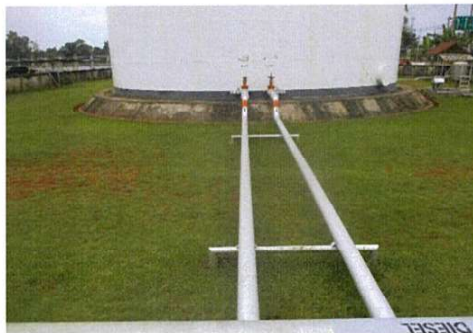
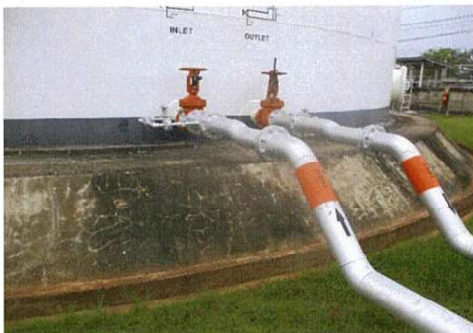
Name of part / Location		Findings			
TRL 002 G-Base 91 Tank Receiving line (Jetty to Tank No.9&Tank No.2)		Still in normal condition

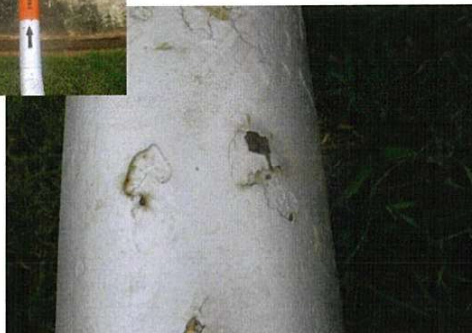
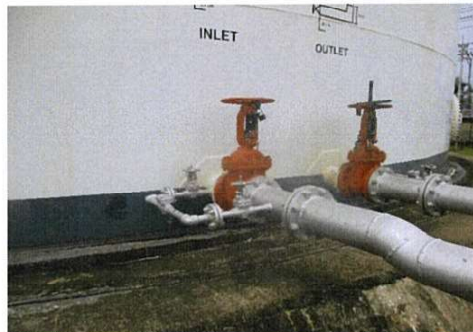
Name of part / Location		Findings			
TRL 002 G-Base 91 Tank Receiving line (Jetty to Tank No.9)		Painting deterioration (14)

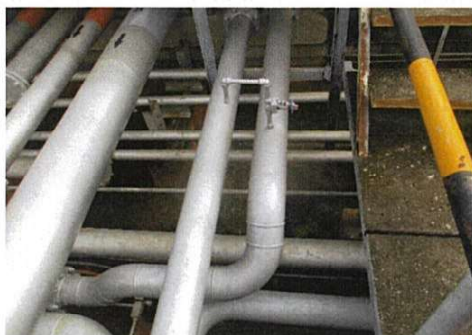
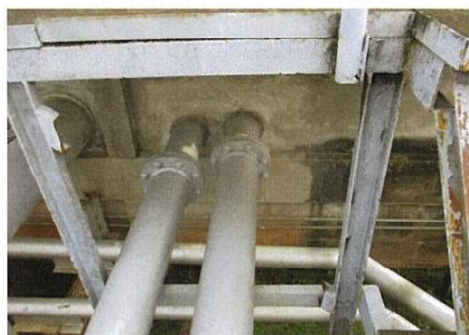
Still in normal condition

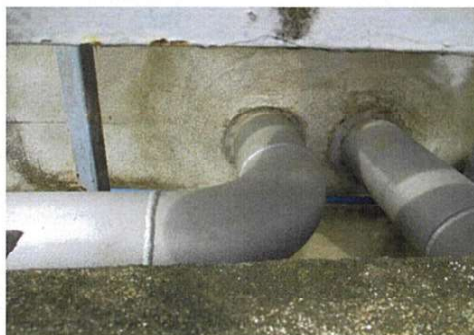
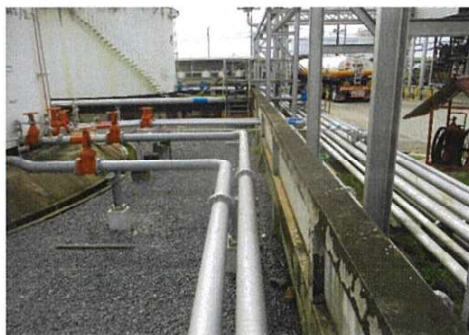
Still in normal condition

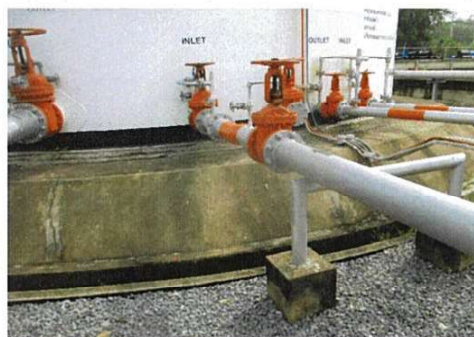
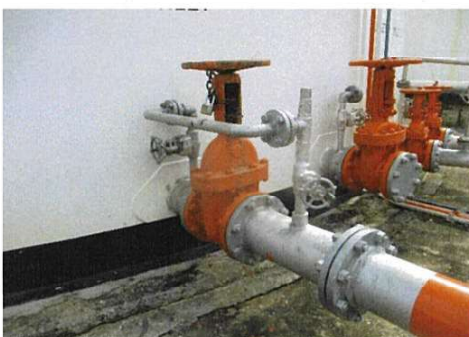
Still in normal condition

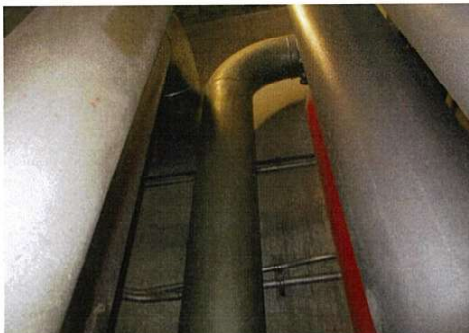
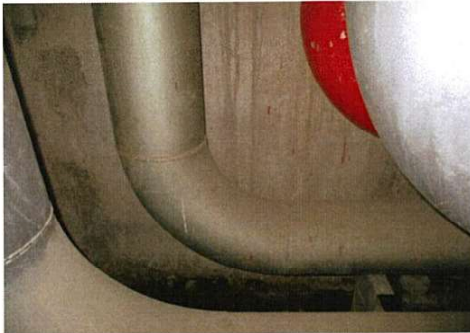
Name of part / Location		Findings	Name of part / Location		Findings
TRL 002 G-Base 91 Tank Receiving line (Under road)		Still in normal condition	TRL 002 G-Base 91 Tank Receiving line (Under road)		Still in normal condition

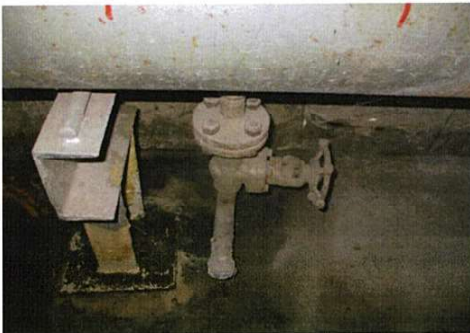
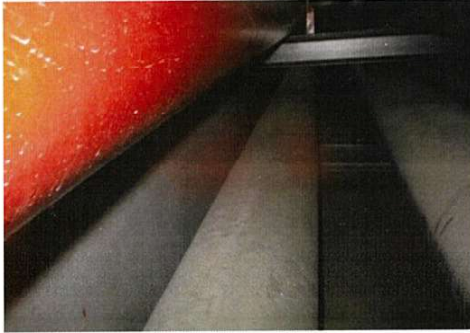
Name of part / Location		Findings	Name of part / Location		Findings
TRL 002 G-Base 91 Tank Receiving line (Jetty to Tank No.9&Tank No.2)		Still in normal condition	TRL 002 G-Base 91 Tank Receiving line (Jetty to Tank No.9&Tank No.2)		Still in normal condition

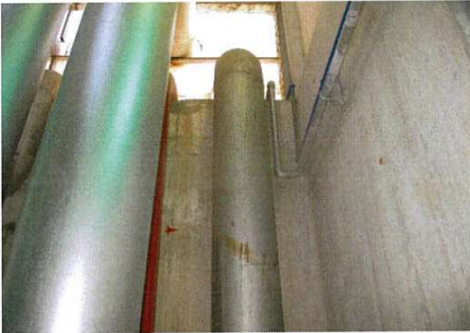
Name of part / Location		Findings	Name of part / Location		Findings
TRL 002 G-Base 91 Tank Receiving line (Jetty to Tank No.9&Tank No.2)		Slight corrosion on pipe. (15)	TRL 002 G-Base 91 Tank Receiving line (Jetty to Tank No.9&Tank No.2)		Still in normal condition

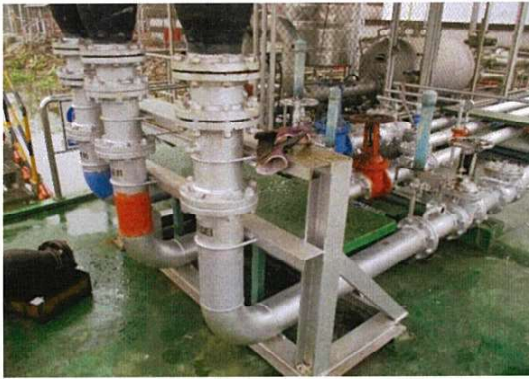
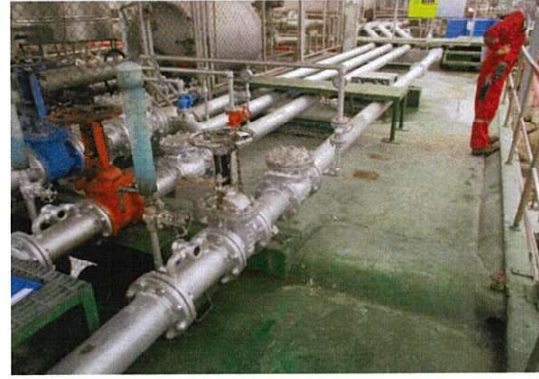
Still in normal condition

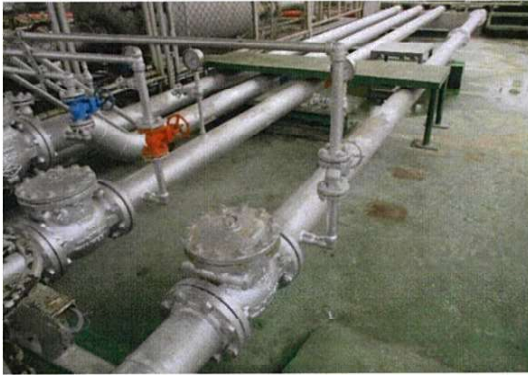
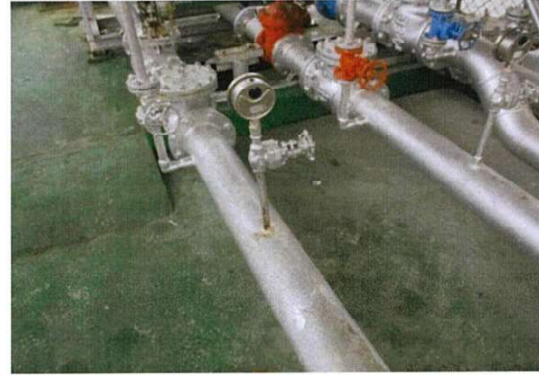
Still in normal condition

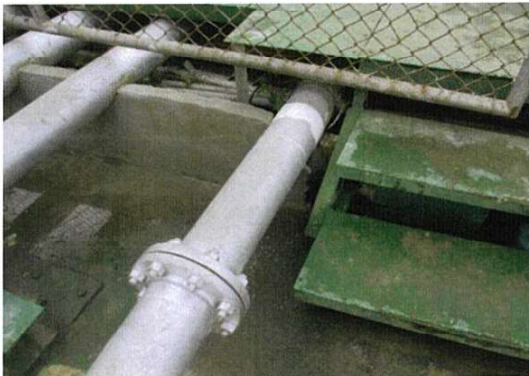
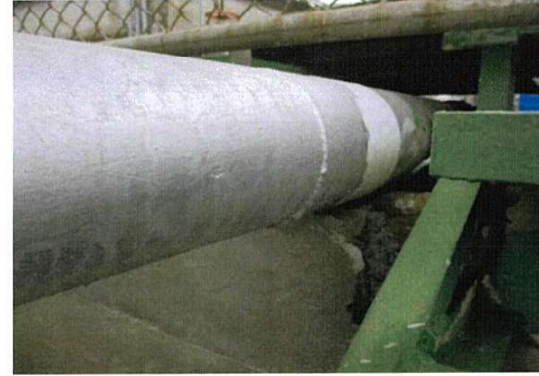
Still in normal condition

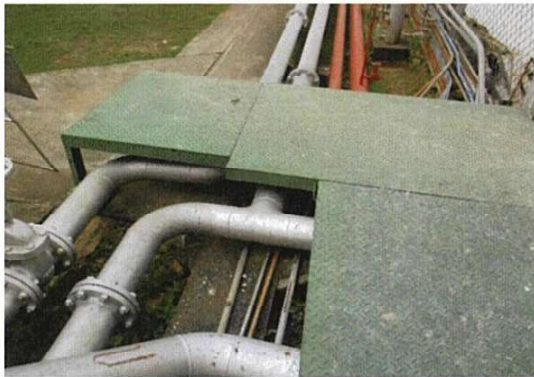
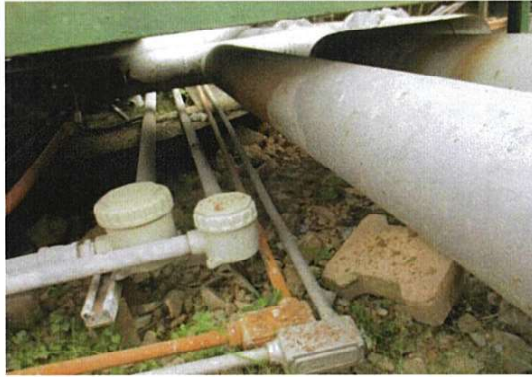
Name of part / Location			Findings		Name of part / Location			Findings	
TRL 003 Diesel Tank Receiving Line (Jetty to Tank No.6,8)			Still in normal condition		TRL 003 Diesel Tank Receiving Line (Jetty to Tank No.6,8)			Still in normal condition

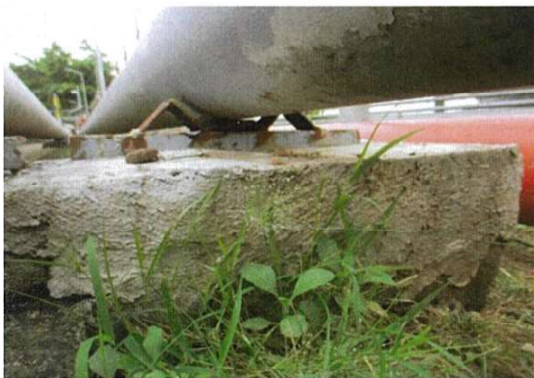
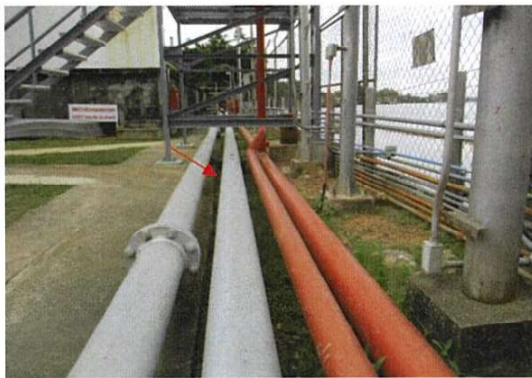
Name of part / Location			Findings		Name of part / Location			Findings	
TRL 003 Diesel Tank Receiving Line (Jetty to Tank No.6,8)			Still in normal condition		TRL 003 Diesel Tank Receiving Line (Jetty to Tank No.6,8)			Still in normal condition

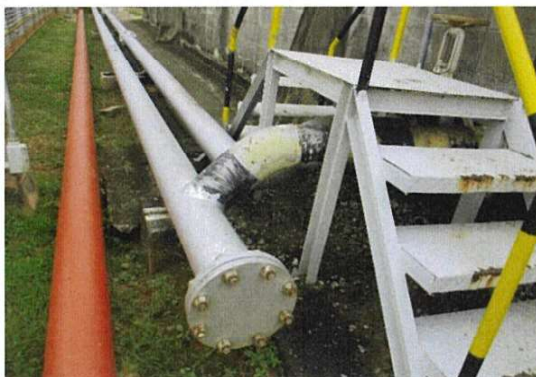
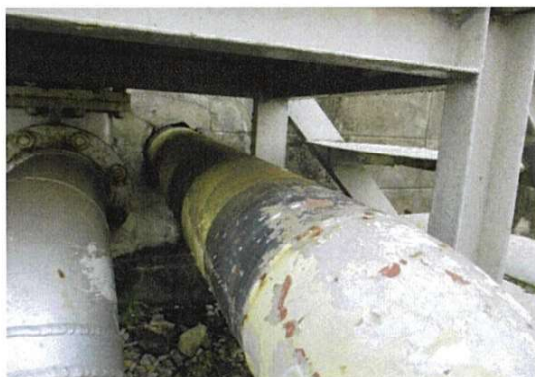
Name of part / Location			Findings		Name of part / Location			Findings	
TRL 003 Diesel Tank Receiving Line (Jetty to Tank No.6,8)			Still in normal condition		TRL 003 Diesel Tank Receiving Line (Jetty to Tank No.6,8)			Still in normal condition

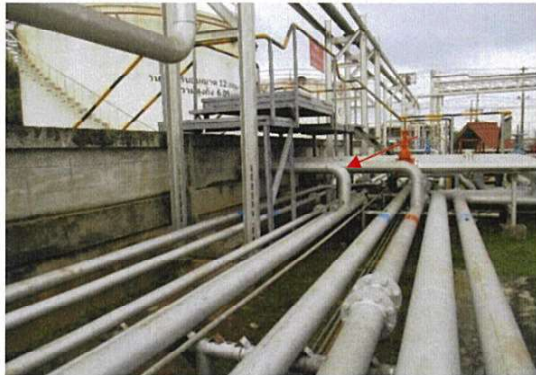
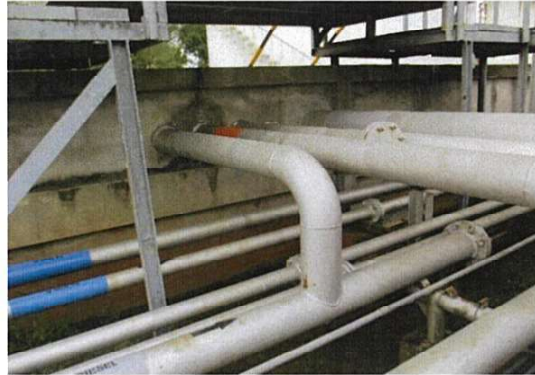
Name of part / Location	Findings	Name of part / Location	Findings	
TRL 003 Diesel Tank Receiving Line (Jetty to Tank No.6,8)	Still in normal condition	TRL 003 Diesel Tank Receiving Line (Jetty to Tank No.6,8)	Still in normal condition

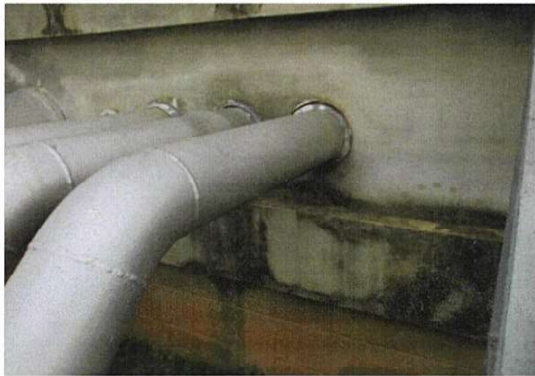
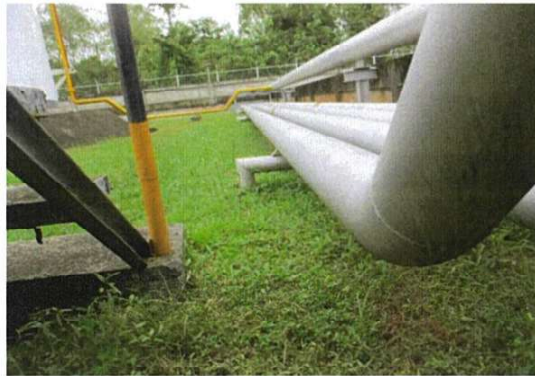
Name of part / Location	Findings	Name of part / Location	Findings	
TRL 003 Diesel Tank Receiving Line (Jetty to Tank No.6,8)	Still in normal condition	TRL 003 Diesel Tank Receiving Line (Jetty to Tank No.6,8)	Still in normal condition

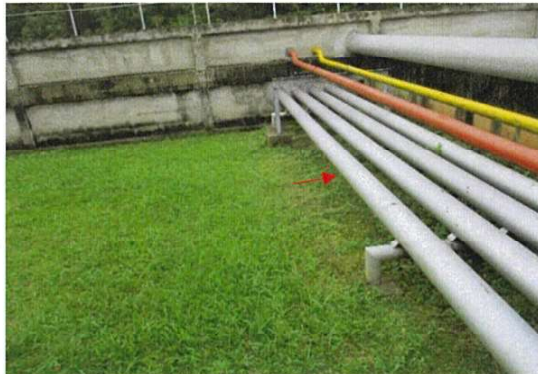
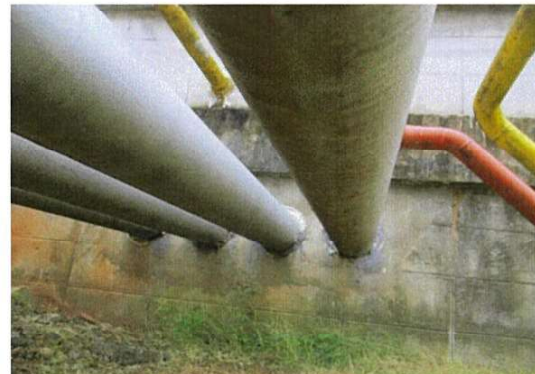
Name of part / Location	Findings	Name of part / Location	Findings	
TRL 003 Diesel Tank Receiving Line (Jetty to Tank No.6,8)	Still in normal condition	TRL 003 Diesel Tank Receiving Line (Jetty to Tank No.6,8)	Still in normal condition

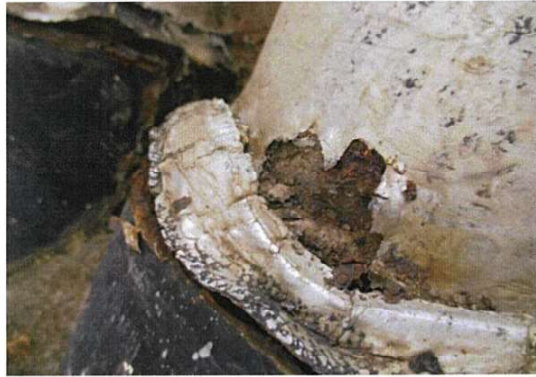
Name of part / Location	Findings	Name of part / Location	Findings	
TRL 003 Diesel Tank Receiving Line (Jetty to Tank No.6,8)	Sealing sleeve underground pipe was found degradation, damage and corrosion under sleeve underground pipe.	TRL 003 Diesel Tank Receiving Line (Jetty to Tank No.6,8)	Sealing sleeve underground pipe was found degradation, damage and corrosion under sleeve underground pipe.

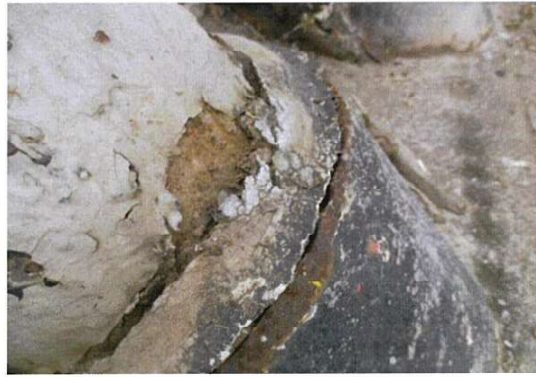
Name of part / Location	Findings	Name of part / Location	Findings	
TRL 003 Diesel Tank Receiving Line (Jetty to Tank No.6,8)	Sealing sleeve underground pipe was found degradation, damage and corrosion under sleeve underground pipe.	TRL 003 Diesel Tank Receiving Line (Jetty to Tank No.6,8)	Sealing sleeve underground pipe was found degradation, damage and corrosion under sleeve underground pipe.

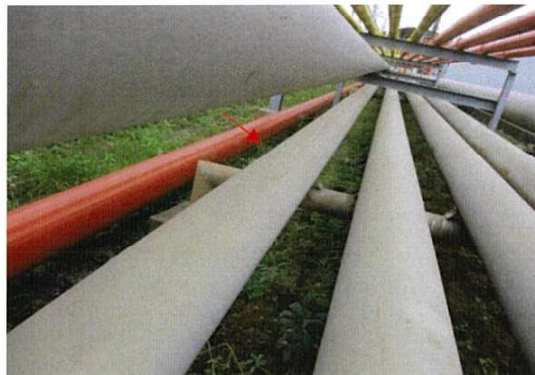
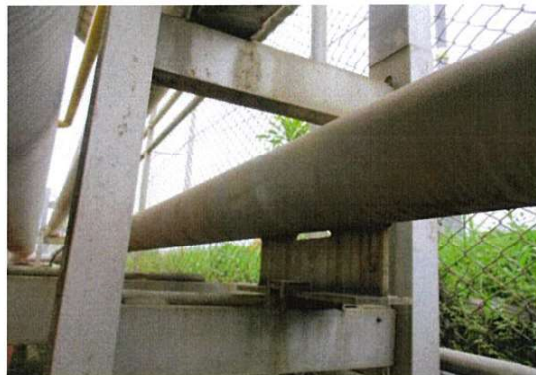
Name of part / Location	Findings	Name of part / Location	Findings	
TRL 003 Diesel Tank Receiving Line (Jetty to Tank No.6,8)	Still in normal condition	TRL 003 Diesel Tank Receiving Line (Jetty to Tank No.6,8)	Still in normal condition

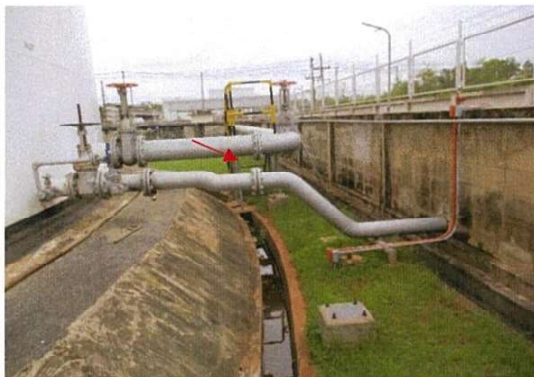
Name of part / Location	Findings	Name of part / Location	Findings	
TRL 003 Diesel Tank Receiving Line (Jetty to Tank No.6,8)	Still in normal condition	TRL 003 Diesel Tank Receiving Line (Jetty to Tank No.6,8)	Still in normal condition
